C-757 Solid and Low-Level Waste Processing Facility

Facility Overview Briefing

November 9, 2021

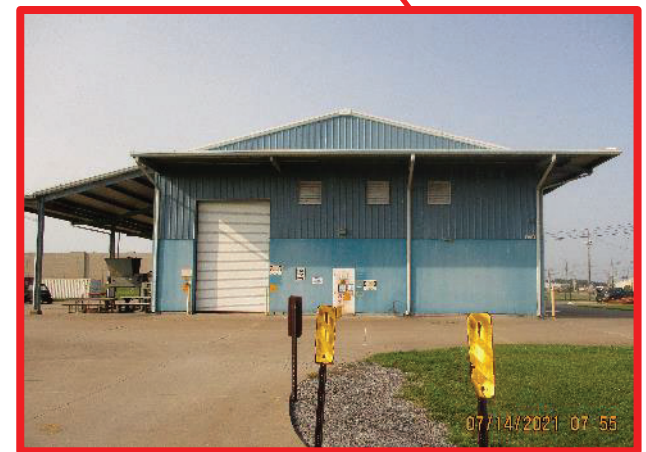
C-757 Facility Photo: 7/2021

- C-757 is located within the Paducah Site security fence, east of the C-616 Chromate Reduction facility.
- The facility was constructed in 1996.
- The facility is a prefabricated metal structure on an 8-inch concrete slab.
 - ❑ The facility has multiple points of entry (pedestrian and roll-up doors) and houses a mezzanine along the east wall of the north processing area.
 - ❑ The facility is divided into 8 main sections.
 - North Processing Area
 - South Processing Area
 - South East Interim Storage Area
 - Women’s Restroom
 - Men’s Restroom
 - Break Room
 - Office
 - Mechanical/Electrical Room (Janitorial)
 - ❑ A separate 300 kVa, 14 kv/480V dry-type transformer located on the west side of the facility provides power to the facility.
- The entire facility is approximately 10,206 ft².
 - ❑ Measuring ~126 ft x ~81 ft.

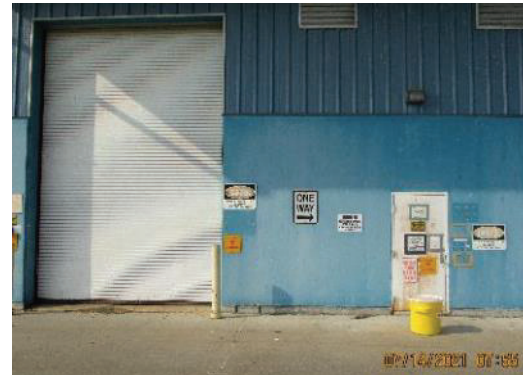
North Processing Bay

- In 1998, USEC converted the north processing bay and south east bay into 90-day RCRA accumulation areas.
 - ❑ The north bay 90-day RCRA accumulation area was designated as a radioactive material area (RMA) and used as a sorting area to inspect and sort low-level radioactive waste and potentially hazardous waste for further processing and storage.

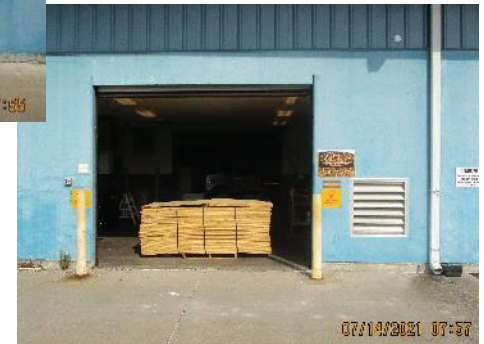
South East Bay

- ❑ The south east bay 90-day RCRA accumulation area was established as a temporary staging area with secondary containment for various types of hazardous liquids (e.g., ignitables, acids/corrosives, F-listed, etc.) and was designated as a RMA.

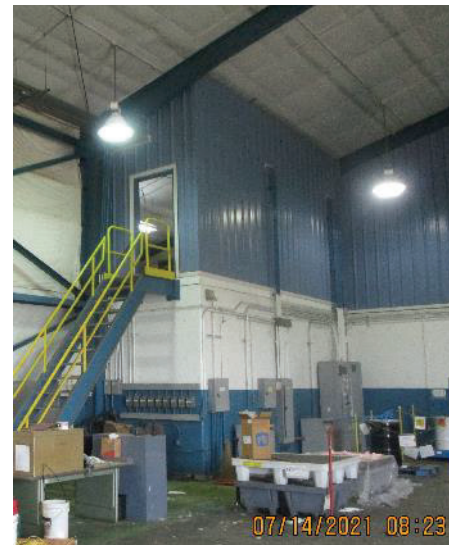
- ❑ Mezzanine used for NDA calibration grid system.
 - ❑ Transformer (300 kVa; 14 kv/480V) located on west-side of the facility.
 - Transformer is a dry-type transformer and does not contain any oil.

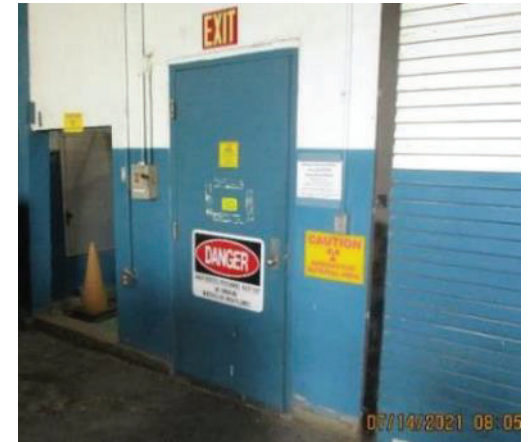
South Door Interior Entry to 90-Day Accumulation Area

- ❑ North processing bay is a designated 90-day RCRA accumulation area and is inspected every 7 days (south east bay is no longer designated as a 90-day RCRA accumulation area).

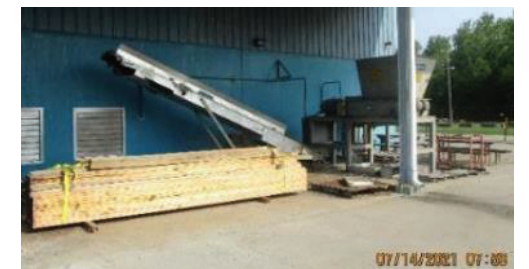
North East Outside Area – Conveyor and Shredder

- ❑ Various storage cabinets and shelving for storage of packaging supplies.
 - ❑ Outside area used to store shredder and conveyor.
 - ❑ Sulfuric acid spills from waste battery cells leaked onto the concrete floor and plastic within the north bay processing area; small-contained leaks that were immediately addressed.

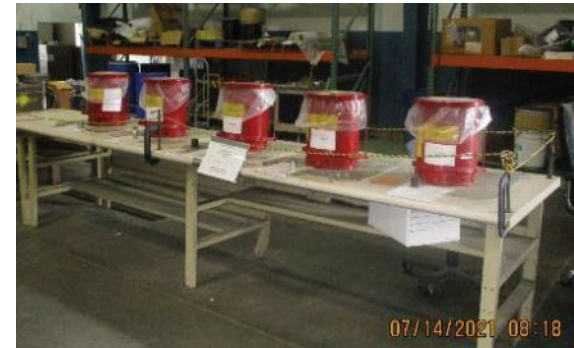
Satellite Accumulation Area

- ❑ One satellite accumulation area (SAA) and two generator staging areas (GSA) are present.
 - ❑ SAA - #S-757-01 houses 5 flip top containers for solid hazardous wastes (e.g., nickel/cadmium and lithium batteries, circuit boards, etc.).

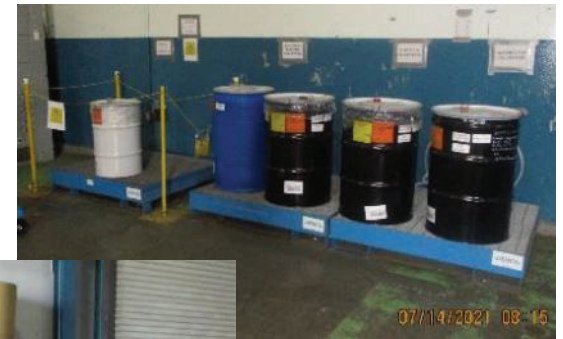
Generator Staging Area

- ❑ GSA - #G-757-01 contains non-PCB waste (e.g., light ballast, fuses, etc.).
 - ❑ GSA - #G-757-03 contains PCB waste (e.g., light ballast, fuses, etc.).

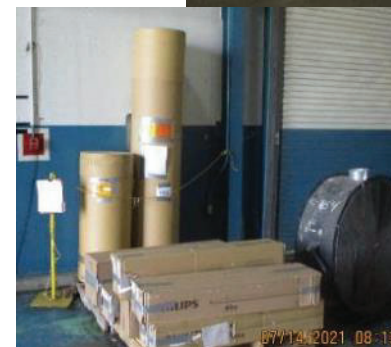
Fluorescent Bulb Storage Within 90-Day Accumulation Area

- ❑ Other staging areas are located within the 90-day area for collection of items (lead acid batteries, bulbs, aerosol cans, etc.).

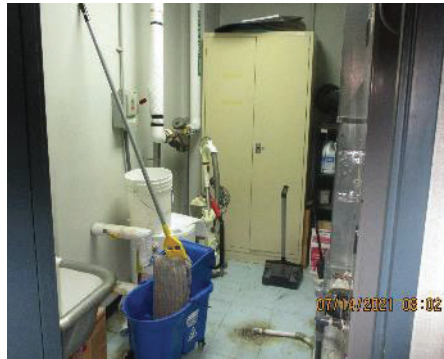
Floor Drain –
Mechanical/Electrical/Janitorial Room

- Walkdown inspection conducted in July 2021 and employee interviews confirmed no unusual conditions (Continued).
 - ❑ Floor drains associated with the men's and women's restroom, ice machine, and mechanical/electrical/janitorial room drain tie into the common sanitary line that exits out the west side of the facility.

- ❑ Deactivation will include removal of any accessible loose items being stored (to the extent practicable) prior to demolition.
 - ❑ Any floor drains will be delineated, documented, and isolated prior to demolition.

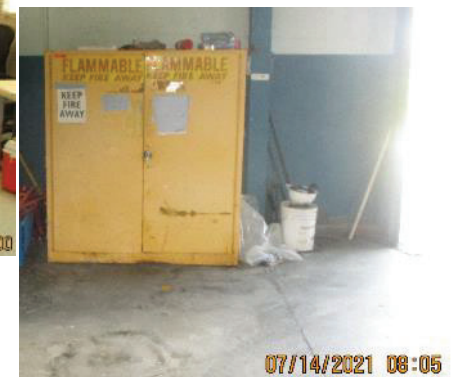
Flammable Cabinet

- ❑ No sumps or pits are present.
 - ❑ Flammable cabinet containing aerosol sprays (e.g., insect repellent, spray paint, Rustoleum, WD-40, etc.) stored in small quantities and in accordance with regulatory requirements and site procedures.
