**TRANSMITTAL OF THE OPERATION AND MAINTENANCE PLAN FOR
SECTIONS 1 AND 2 OF THE NORTH-SOUTH DIVERSION DITCH AT THE
PADUCAH GASEOUS DIFFUSION PLANT, PADUCAH, KENTUCKY,
DOE/LX/07-2484&D2**

**Operation and Maintenance Plan for
Sections 1 and 2 of the
North-South Diversion Ditch at the
Paducah Gaseous Diffusion Plant,
Paducah, Kentucky**

Date Issued—April 2024

Prepared by
FOUR RIVERS NUCLEAR PARTNERSHIP, LLC,
managing the
Deactivation and Remediation Project at the
Paducah Gaseous Diffusion Plant
under Contract DE-EM0004895

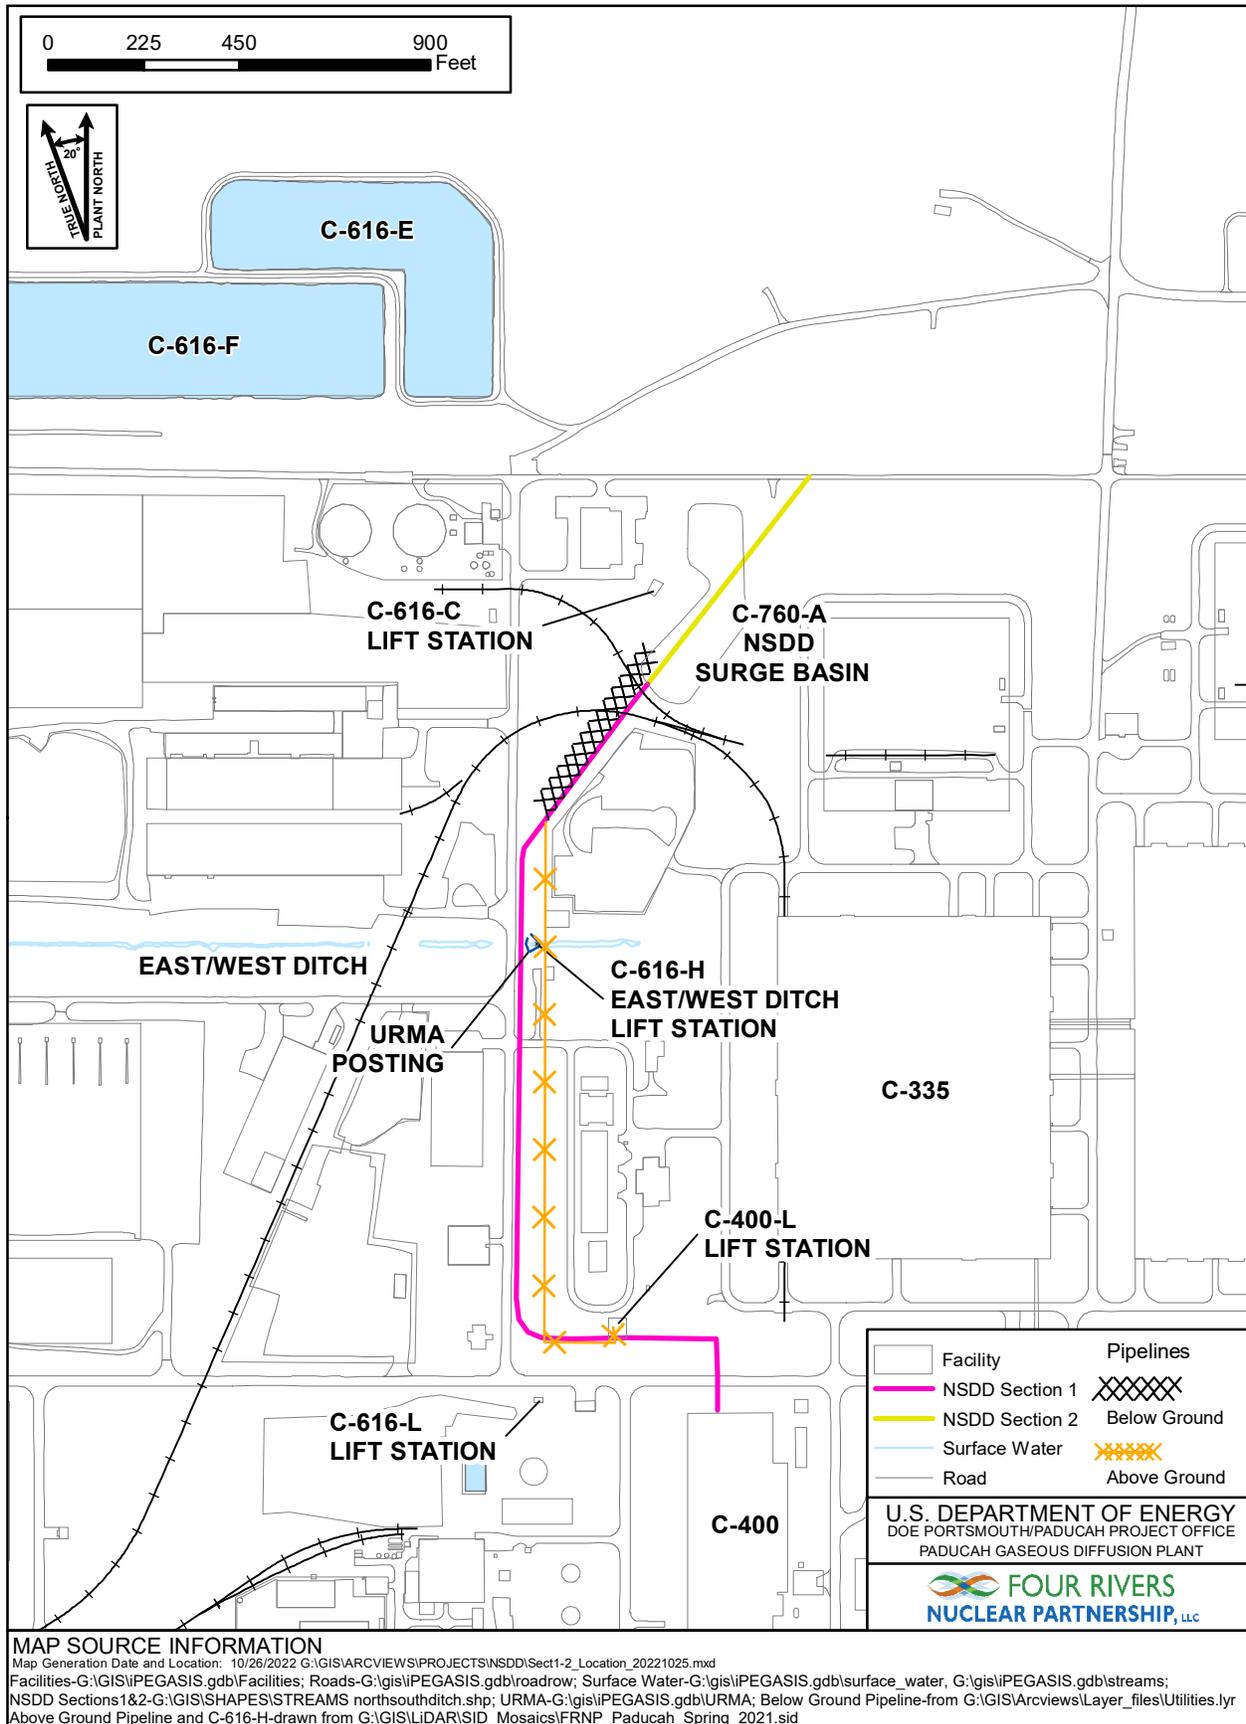
Figure 1. North-South Diversion Ditch inside PGDP

The NSDD originates within the north central portion of PGDP (Figure 1) and joins with Little Bayou Creek to the north. Historically, the NSDD received wastewater from the C-400 Cleaning Building, C-602 Coal Storage Yard coal pile runoff, and storm water runoff. In 1977, the C-616-C Lift Station was constructed upstream of the point where the NSDD exits the PGDP security fence. This lift station diverts all normal flow from upstream locations in the NSDD to the C-616-F Full Flow Lagoon for settlement of suspended solids prior to discharge to Bayou Creek through the Kentucky Pollutant Discharge Elimination System (KPDES) Outfall 001 ditch system. The C-616-H East-West Ditch Lift Station (also known as the Outfall 001 Ditch Lift Station and the C-615-K Lift Station) began operation in 1991 to control pH and temperature of the discharge water. This lift station pumped effluent of the C-335 and C-337 Process Buildings and the C-535 and C-537 Switchyards into the NSDD for downstream capture by the C-616-C Lift Station and treatment through the C-616-F Full Flow Lagoon. As of 2023, the C-616-H East-West Ditch Lift Station was no longer necessary for pH and temperature control because the discharge water meets the KPDES Permit limits for these parameters, and the lift station has been taken out of service. The pH and temperature of the discharge water did not meet the KPDES Permit limits prior to the ceasing of operations at PGDP. Table 1 provides a summary of the facilities used in operation of the NSDD.

Equipment, materials, and structures incorporated into this remedial action include three lift stations (C-400-L, C-616-C, and C-616-L), transfer piping, surge basin containing a concrete-paved ditch section and spillway, and institutional controls.

The features described above are annotated on Figure 1.
