TRANSMITTAL OF THE PADUCAH GASEOUS DIFFUSION PLANT INDUSTRIAL AREA VAPOR INTRUSION PRELIMINARY INVESTIGATION WORK PLAN FOR THE PADUCAH GASEOUS DIFFUSION PLANT, PADUCAH, KENTUCKY, DOE/LX/07-2447&D1

**DOE/LX/07-2447&D1
Secondary Document**

**Paducah Gaseous Diffusion Plant Industrial Area Vapor
Intrusion Preliminary Investigation Work Plan
for the Paducah Gaseous Diffusion Plant,
Paducah, Kentucky**

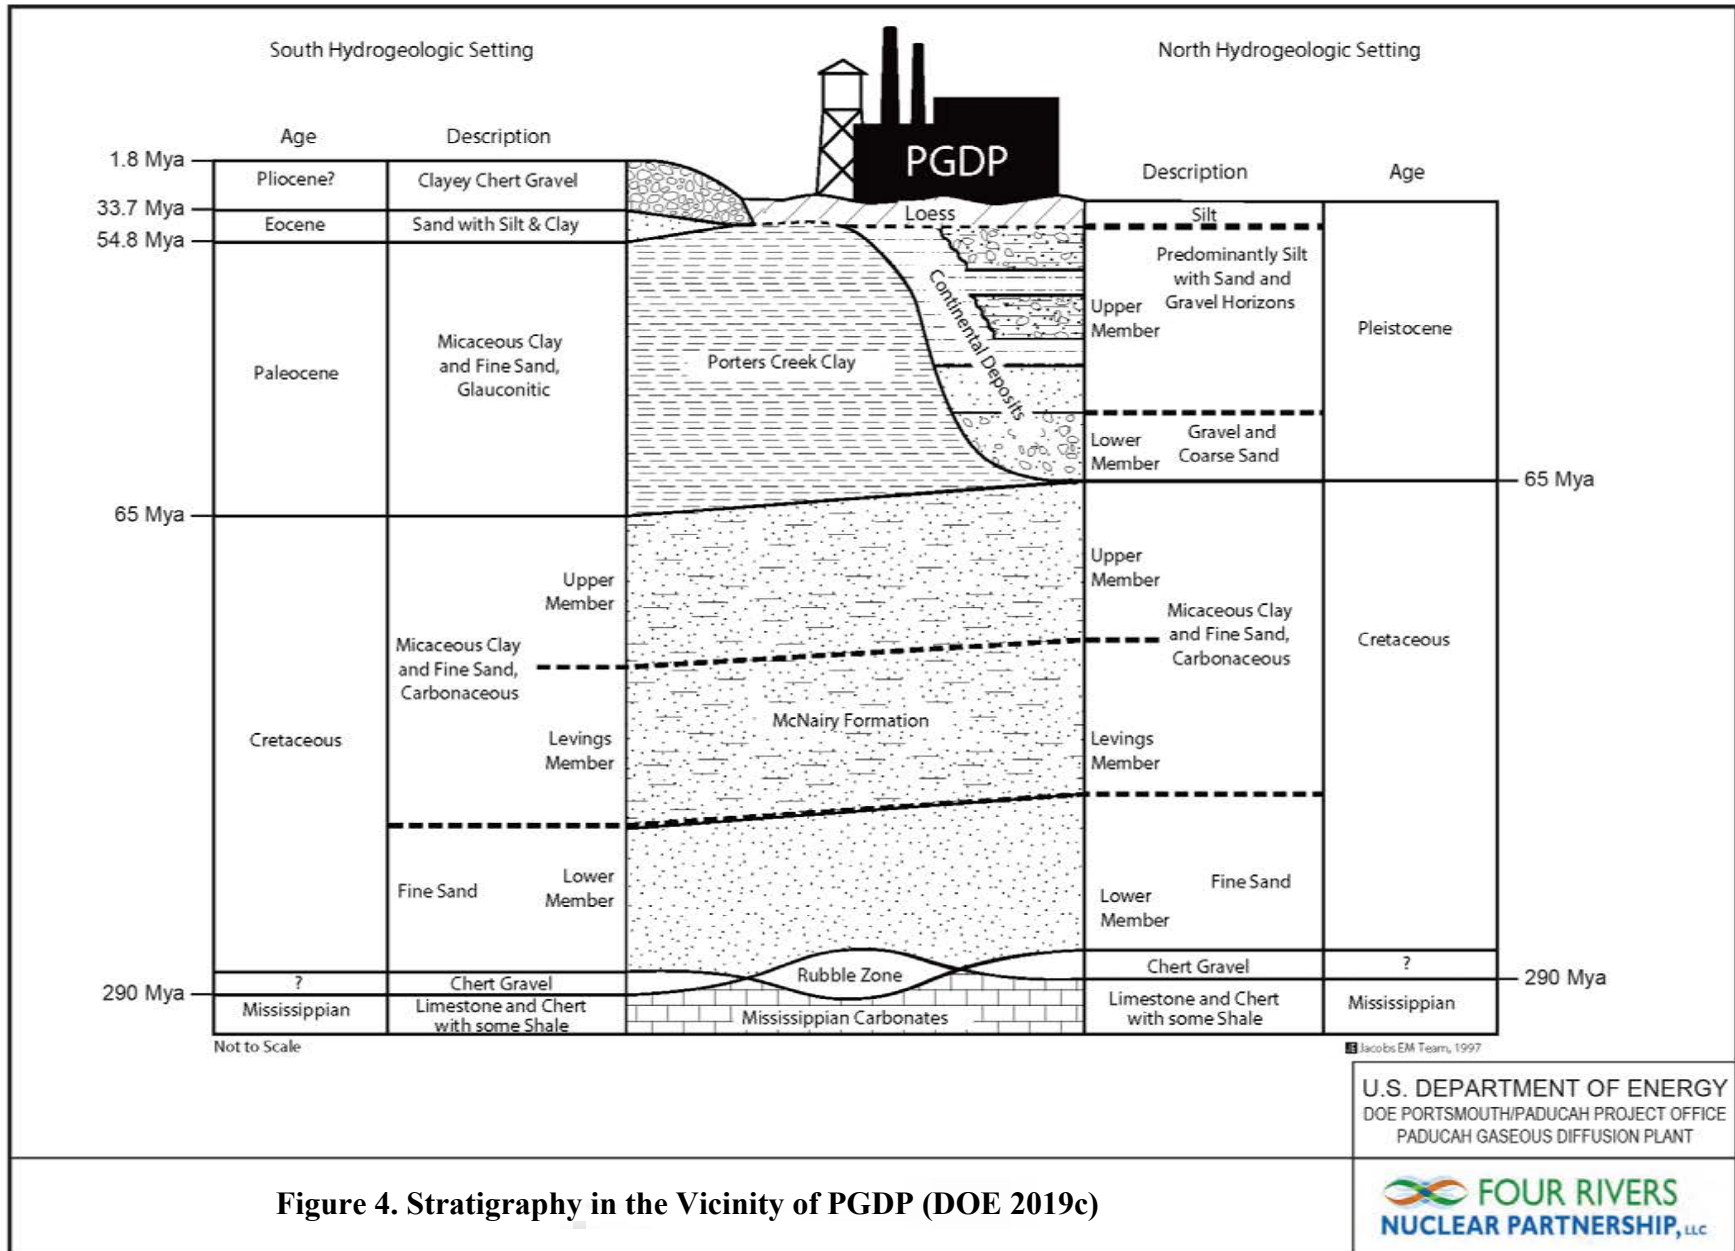
Figure 4. Stratigraphy in the Vicinity of PGDP (DOE 2019c)

- (1) Lower Continental Deposits. The Lower Continental Deposits is a gravel facies consisting of chert, ranging from pebbles to cobbles, in a matrix of poorly sorted sand and silt. Gravels of the Lower Continental Deposits overlie three distinct terraces in the Paducah Site area.
 - The upper terrace of the Lower Continental Deposits consists of Pliocene (?-age uncertain) gravel units, ranging in thickness from near 0 to 30 ft, occurring in the southern portion of the Paducah Site at elevations greater than 350 ft above mean sea level (amsl). This gravel unit overlies the Eocene sands and Porters Creek Clay (where the Eocene sands are missing).

The Paducah Site is underlain by a sequence of clay, silt, sand, and gravel layers unconformably overlying limestone bedrock. The sediments above the limestone bedrock are grouped into three major stratigraphic units (loess, Continental Deposits, and McNairy Formation) and three major hydrogeologic units (HUs) (UCRS, RGA, and McNairy Flow System) as shown in Figure 5. Additional information on Paducah Site geology can be found in numerous documents, including in the *Remedial Investigation/Feasibility Study Work Plan for the C-400 Complex Operable Unit at the Paducah Gaseous Diffusion Plant, Paducah, Kentucky* (DOE 2019c).

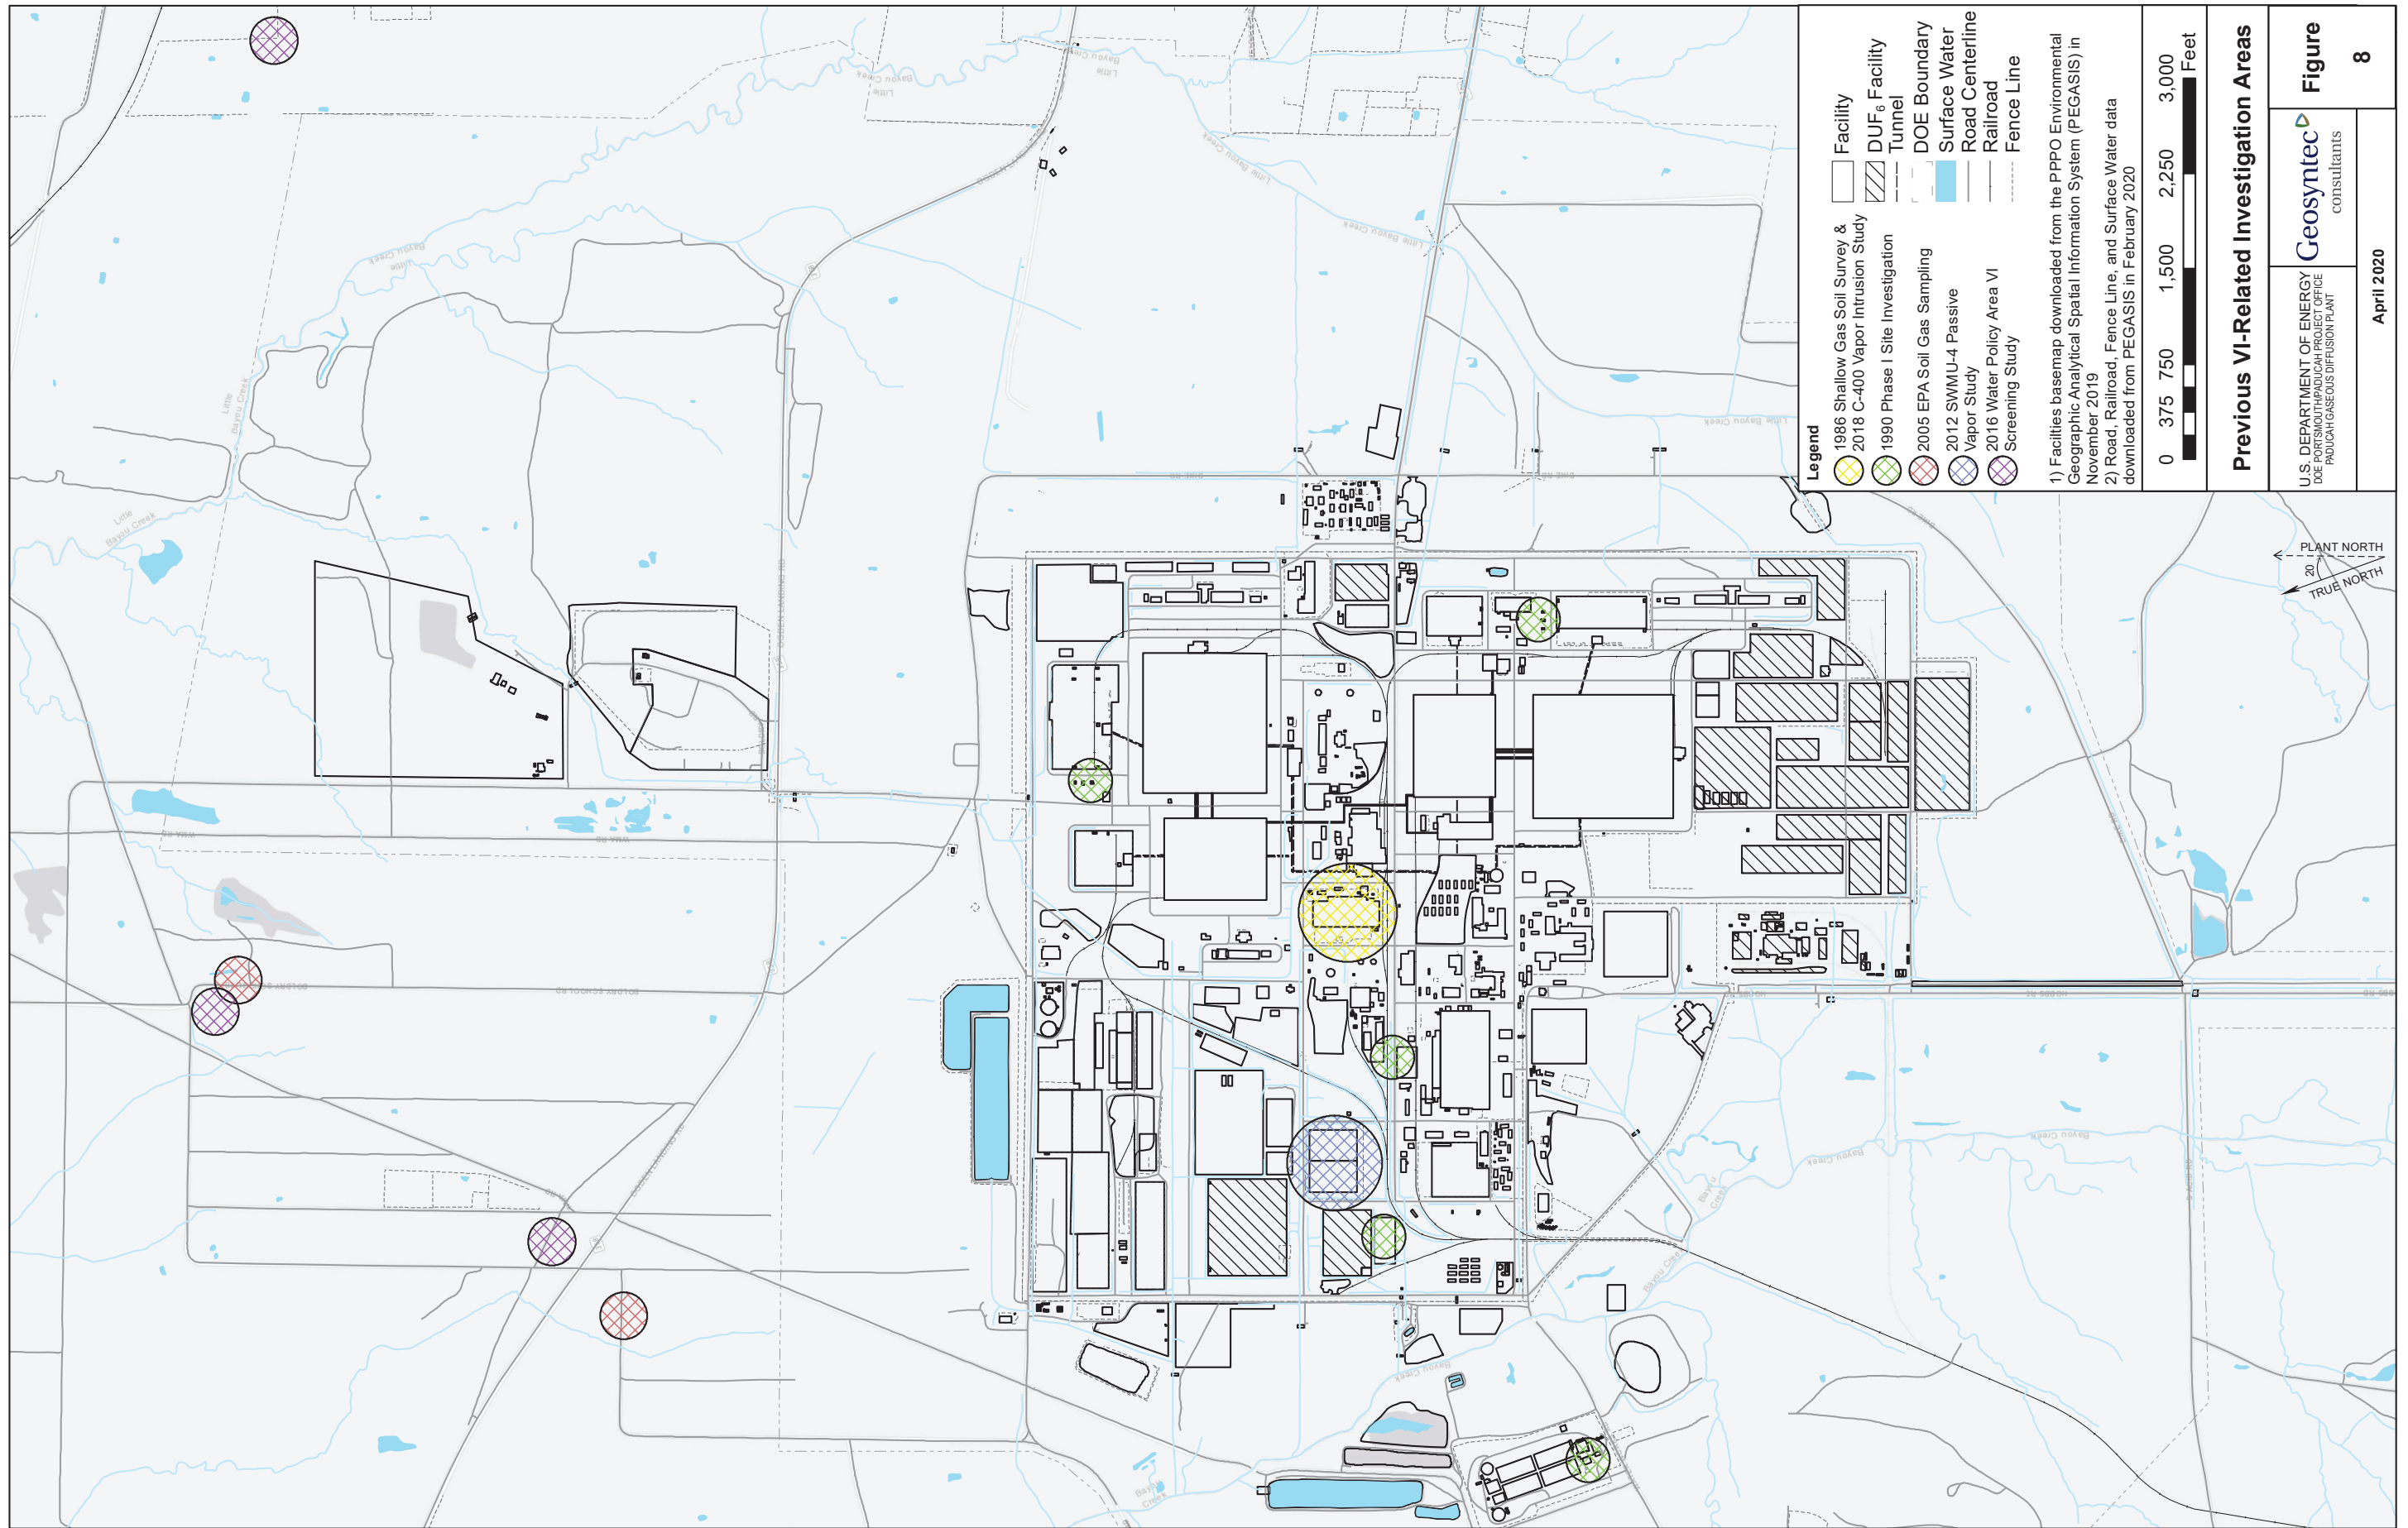
Figure 8. Previous VI-Related Investigation Areas

A shallow soil gas survey was conducted in August 1986 (Tracer Research Corporation 1986) to identify any locations along a sewer line where contaminants may have leaked out into the subsurface. A total of 28 soil gas samples was taken and analyzed for 1,1,1-trichloroethane (TCA), TCE, and tetrachloroethene (PCE); however, TCE was found to be the primary contaminant. The results of this investigation indicated that the source of TCE contamination was located where the sewer line leaves the C-400 Building and, while concentrations of TCE in soil and groundwater were high, vapor intrusion was not evident.

A soil gas study was conducted in September 2005 in the residential neighborhood adjacent to PGDP to evaluate VOC concentrations near the soil surface that may be caused by contaminated groundwater emanating from PGDP (EPA 2005). Three sampling locations were selected for soil gas sampling; however, due to tight soils, a complete soil gas sample was collected at only one location. Chloroform was the only VOC detected in the sample (an estimated concentration of 0.50 $\mu\text{g}/\text{m}^3$).

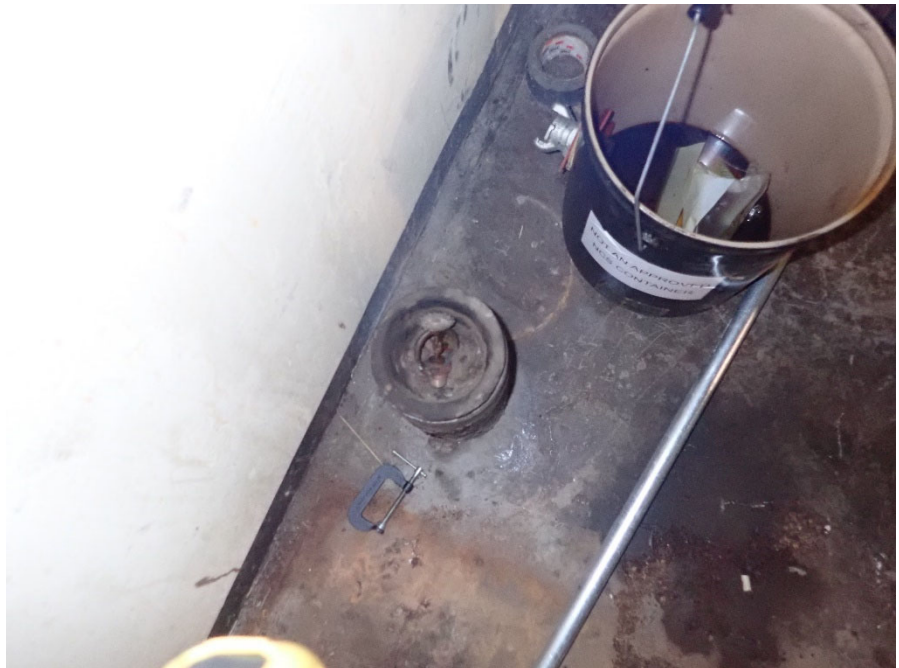
Comments: Stained concrete in ground floor of C-310.

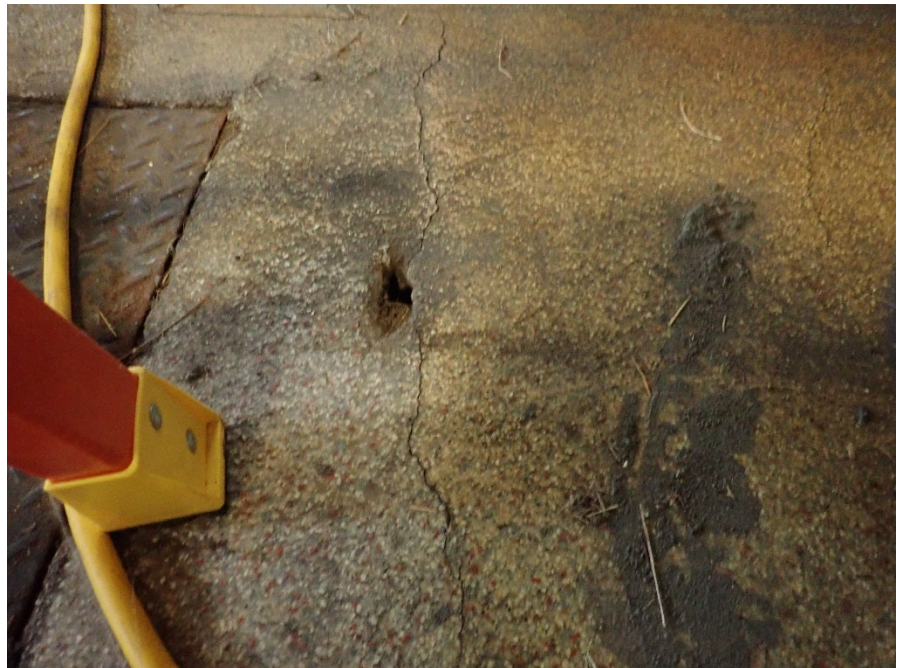
Comments: Cracked concrete on the first floor of C-310.

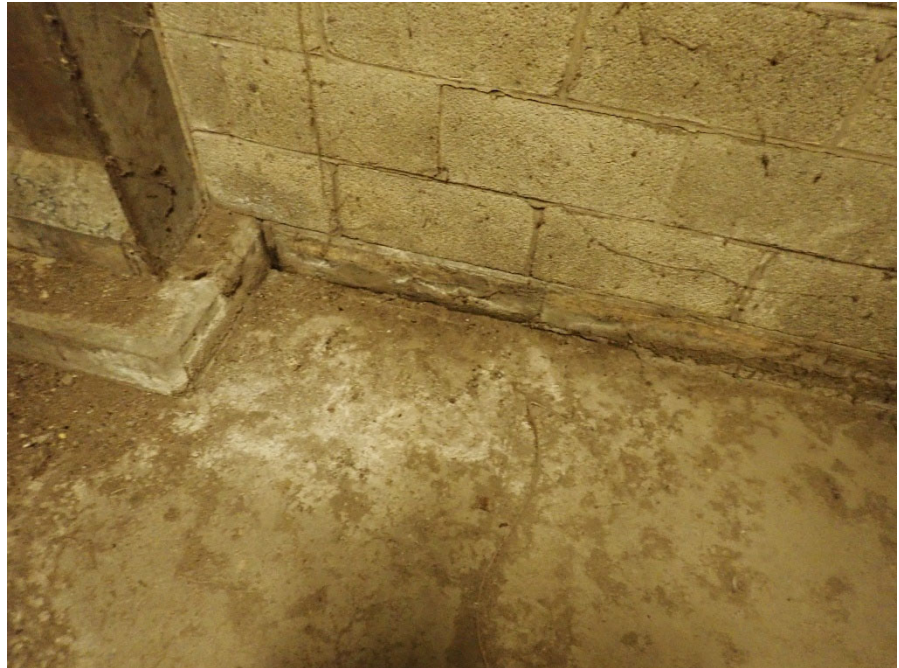
C-310

Comments: Foundation footers in Filter Room 2 in C-310.

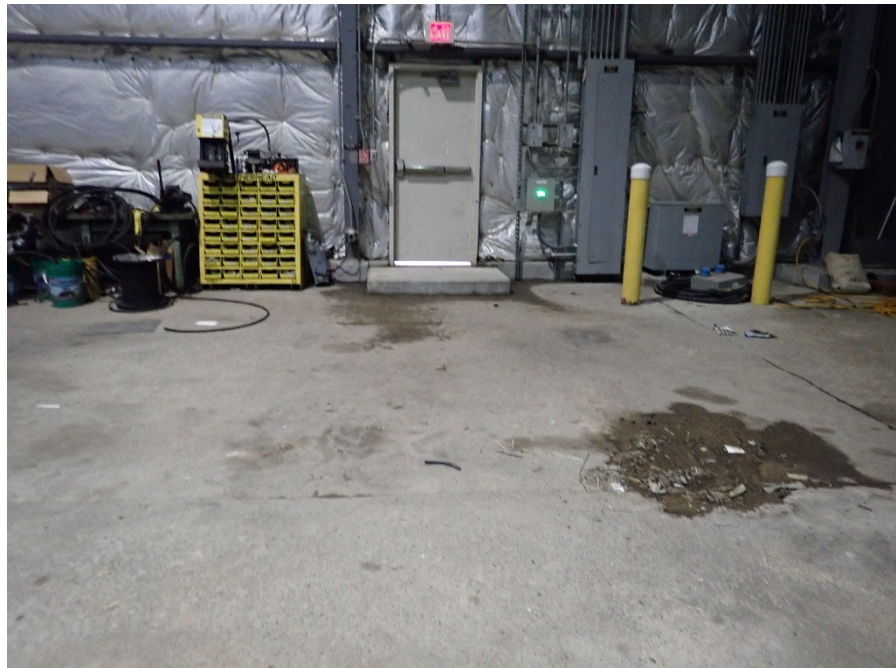
Comments: Floor stain and gap beneath door in C-360A.

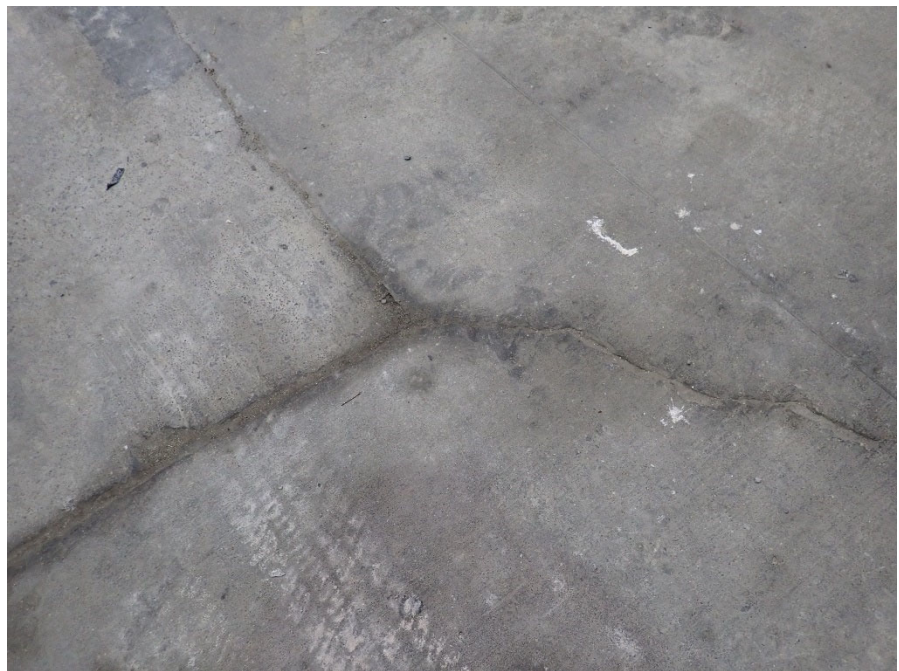
Comments: Cracked concrete in C-360-A.

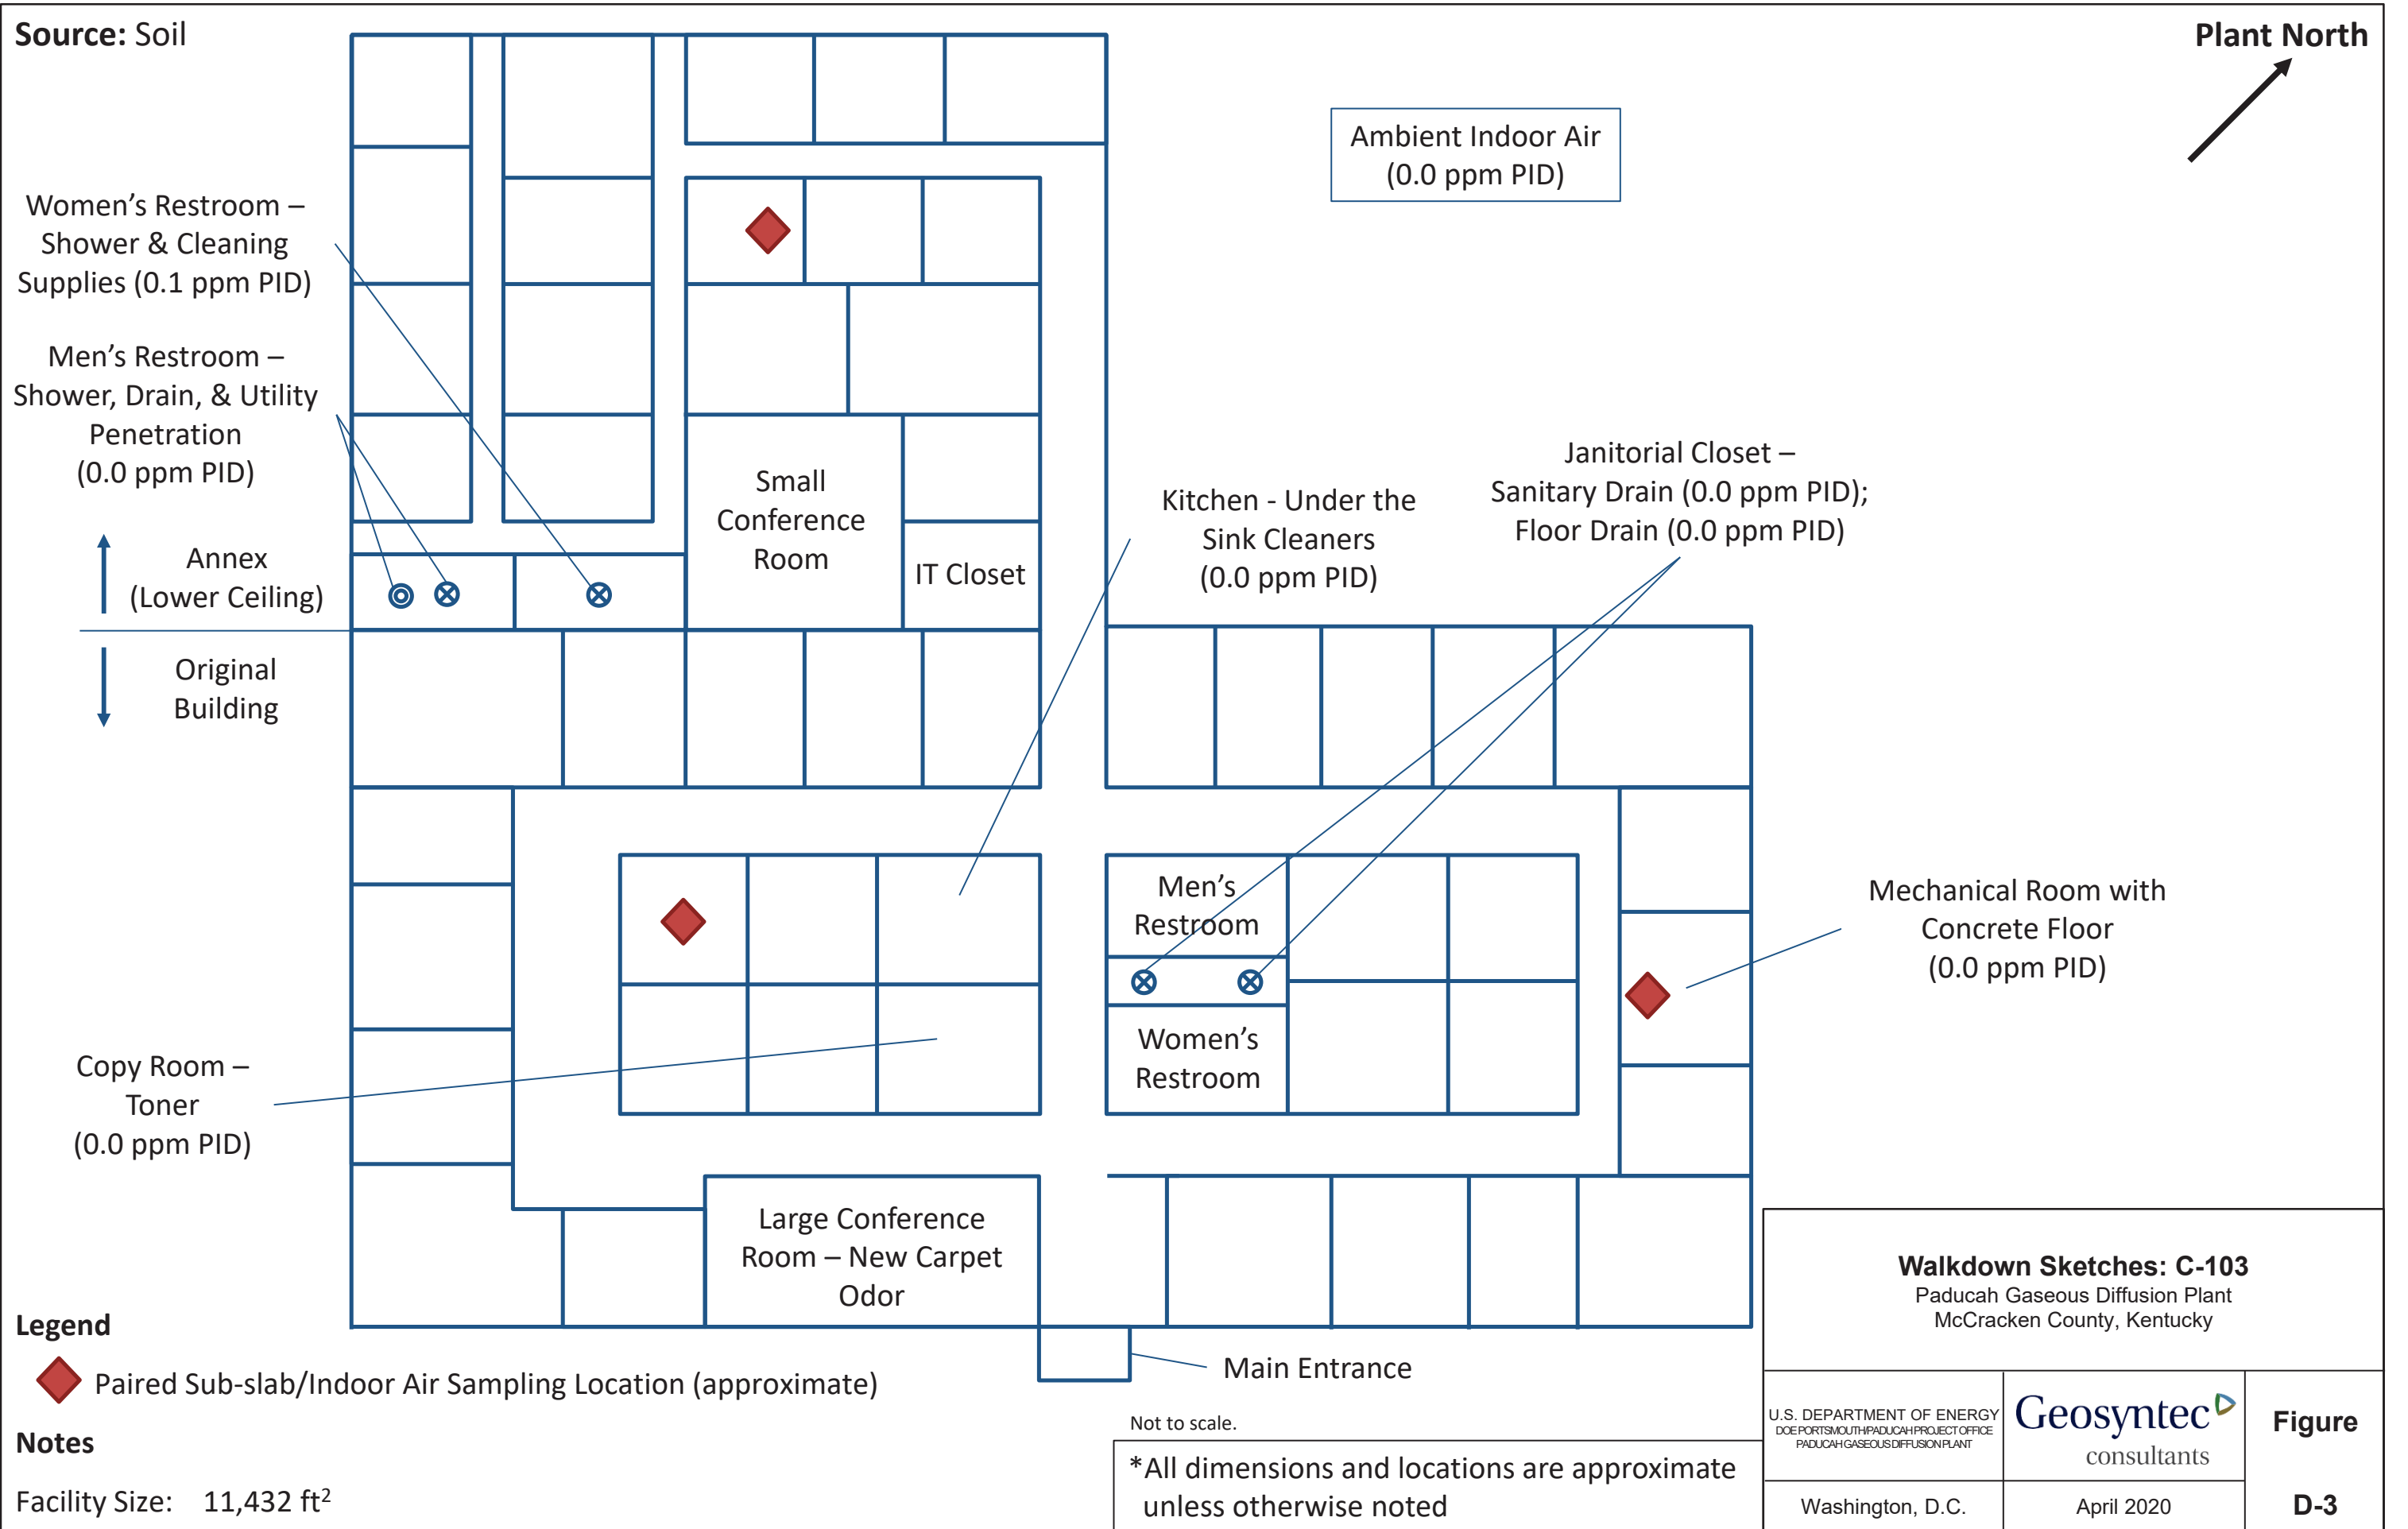
Figure D.3. Walkdown Sketches: C-103

Source: UCRS
Groundwater
and Soil
