**TRANSMITTAL OF THE SITEWIDE EVALUATION REPORT FOR THE SOILS  
OPERABLE UNIT AT THE PADUCAH GASEOUS DIFFUSION PLANT, PADUCAH,  
KENTUCKY (DOE/LX/07-1256&D2)**

**Document Identification:** *Sitewide Evaluation Report for the Soils Operable Unit at the Paducah Gaseous Diffusion Plant, Paducah Kentucky, DOE/LX/07-1256&D2*

**DOE/LX/07-1256&D2  
Primary Document**

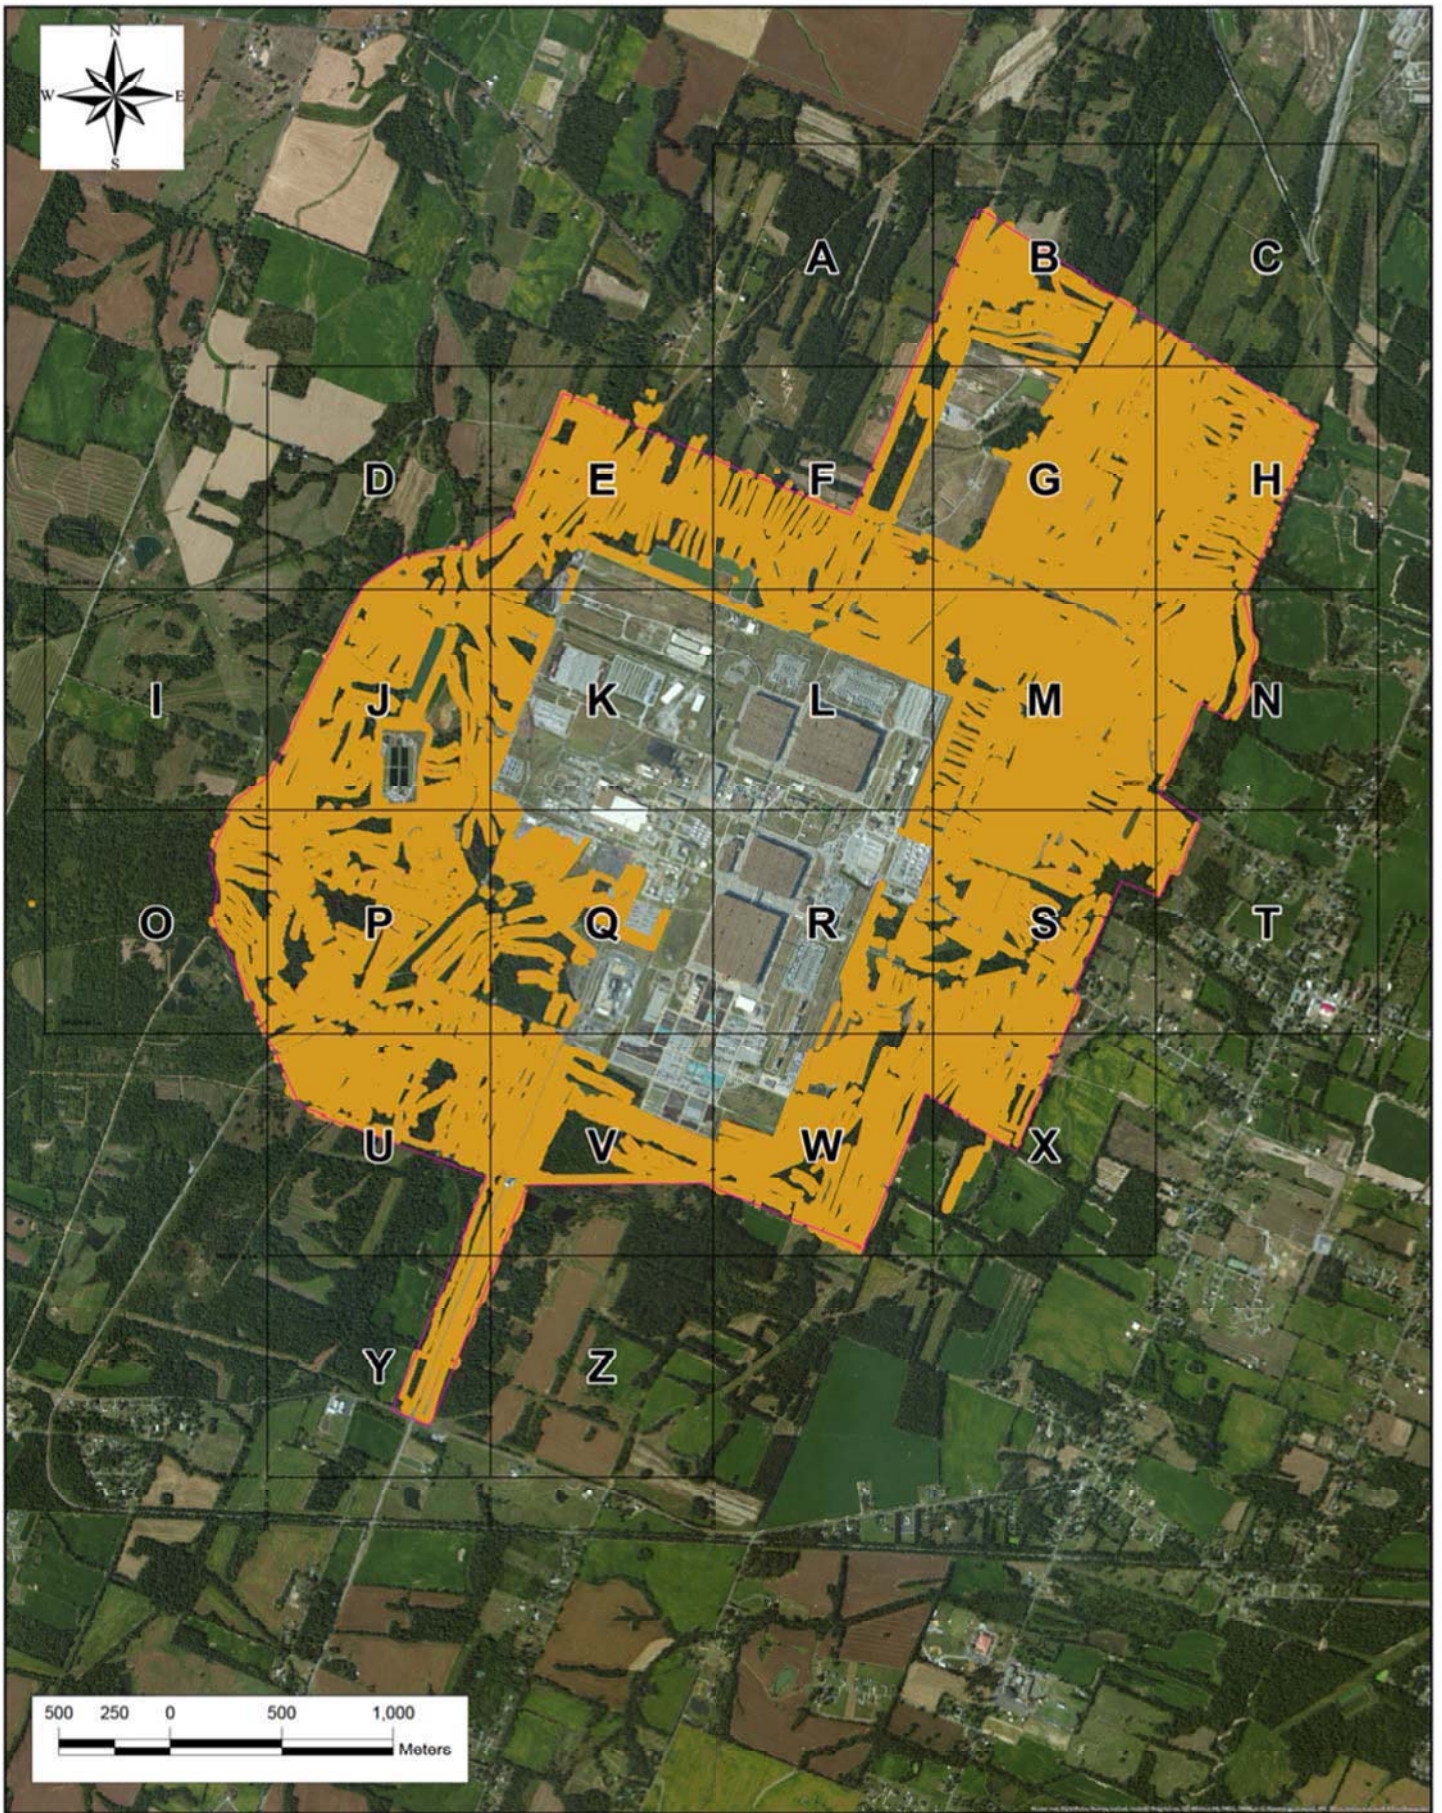
Figure 4.5. Visual Walkover

There were 633 anomalies visually identified. After crosswalking the anomalies with previously identified anomalies, 99 were found to be part of previous or ongoing evaluations/investigations [i.e., Soil Piles Addendum 2, Rubble Piles SER, Waste Area Grouping (WAG) 17, existing SWMUs] or part of anthropogenic structures (i.e., construction of rail/road beds, Kentucky Ordnance Works bunkers) and were removed from further evaluation in this effort. The remaining 534 new anomalies, presented on Figure 4.6, were evaluated as part of this SER. None of the 534 remaining anomalies exhibited the criteria established in the work plan (DOE 2011a) for determining DOE origin; therefore, the criteria for a maintenance action or soil sampling were not met. Appendix B contains the photographs of the 534 anomalies.

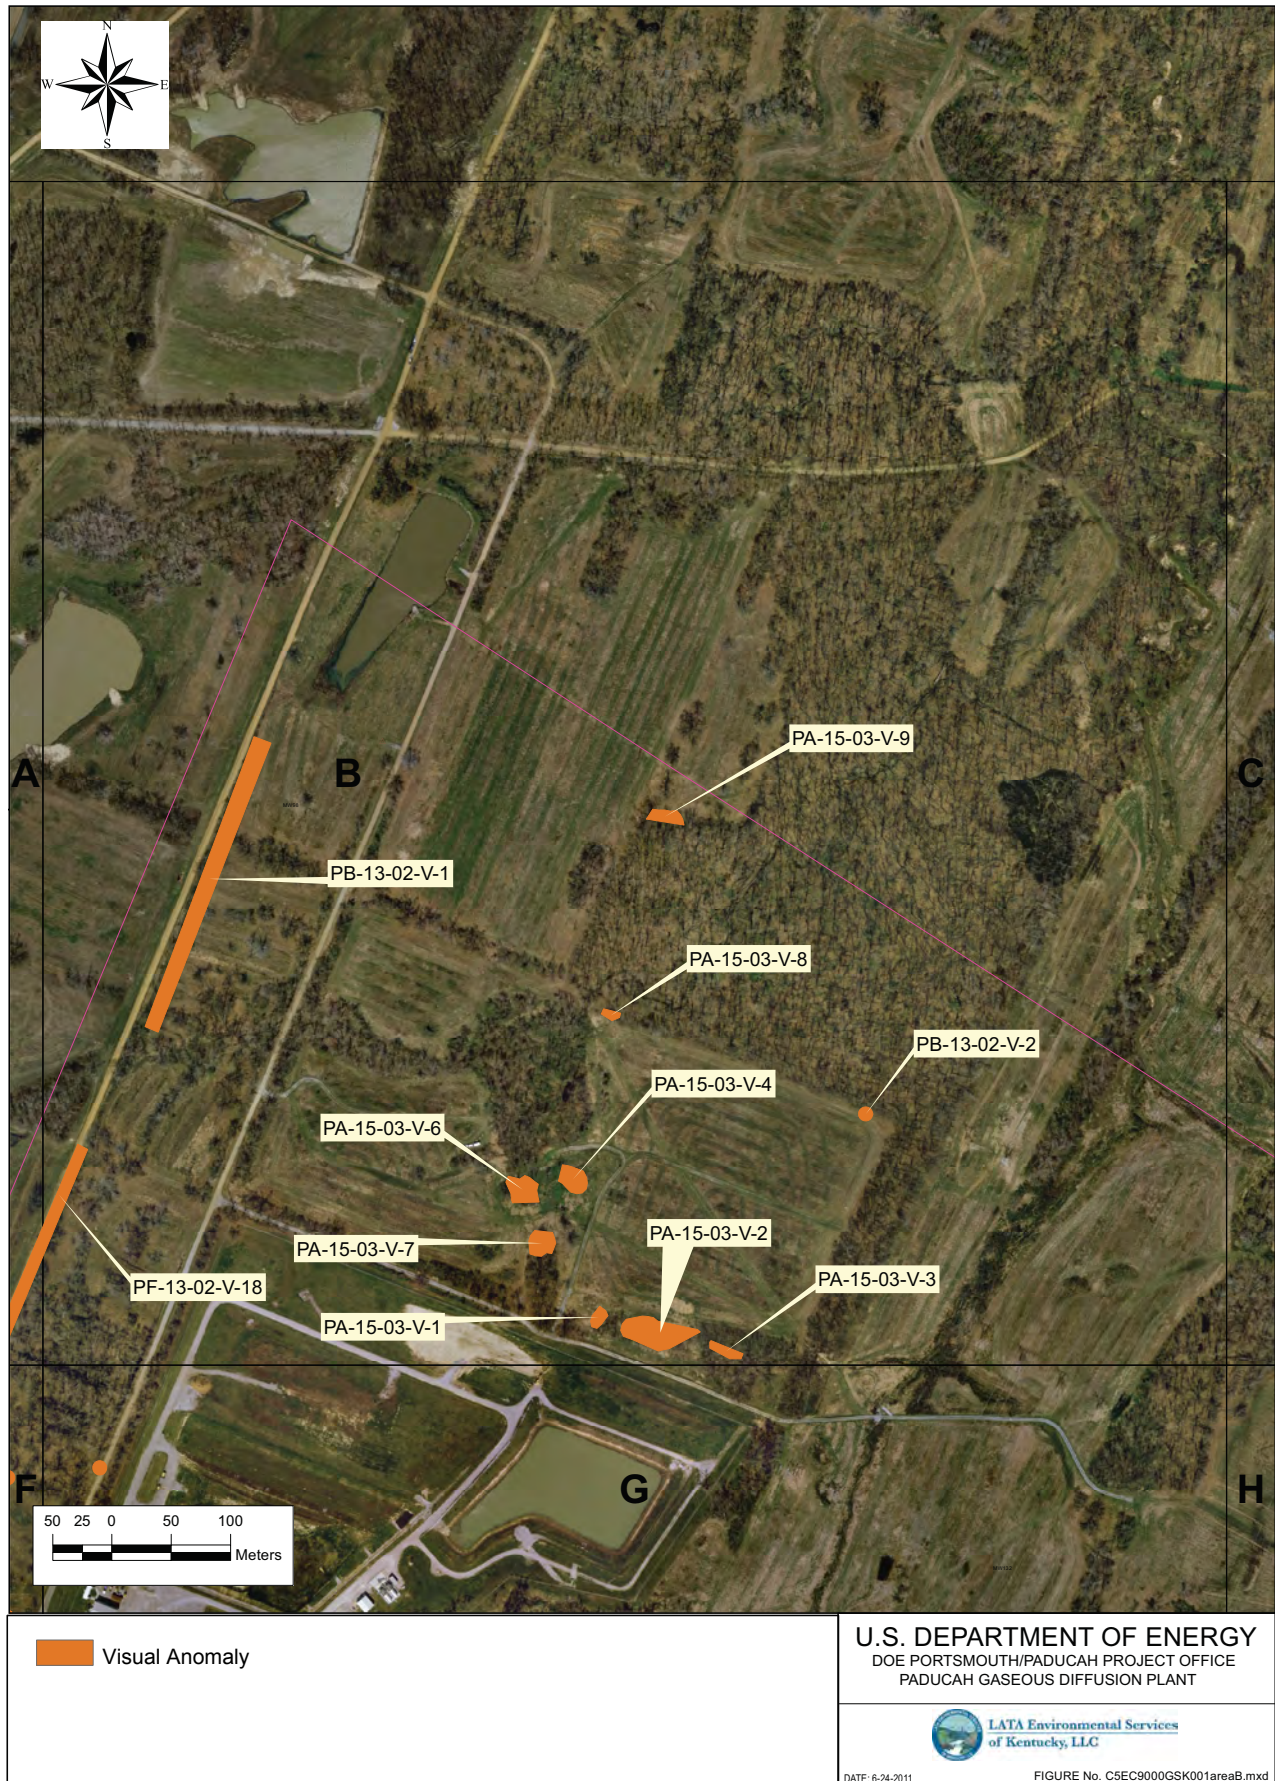
Figure 4.8. Visual Anomaly Map Area B

**Table 4.1. Anomalies within Area B**

<b>Anomaly Name</b>	<b>Photo</b>	<b>Description</b>
PA-15-03-V-1	x	dirt mound
PA-15-03-V-2	x	dirt mound
PA-15-03-V-3	x	dirt mound
PA-15-03-V-4	x	dirt mound
PA-15-03-V-6	x	dirt mound
PA-15-03-V-7	x	dirt mound
PA-15-03-V-8	x	dirt mound
PA-15-03-V-9	x	dirt mound
PB-13-02-V-1	x	dirt mound
PB-13-02-V-2	x	dirt mound

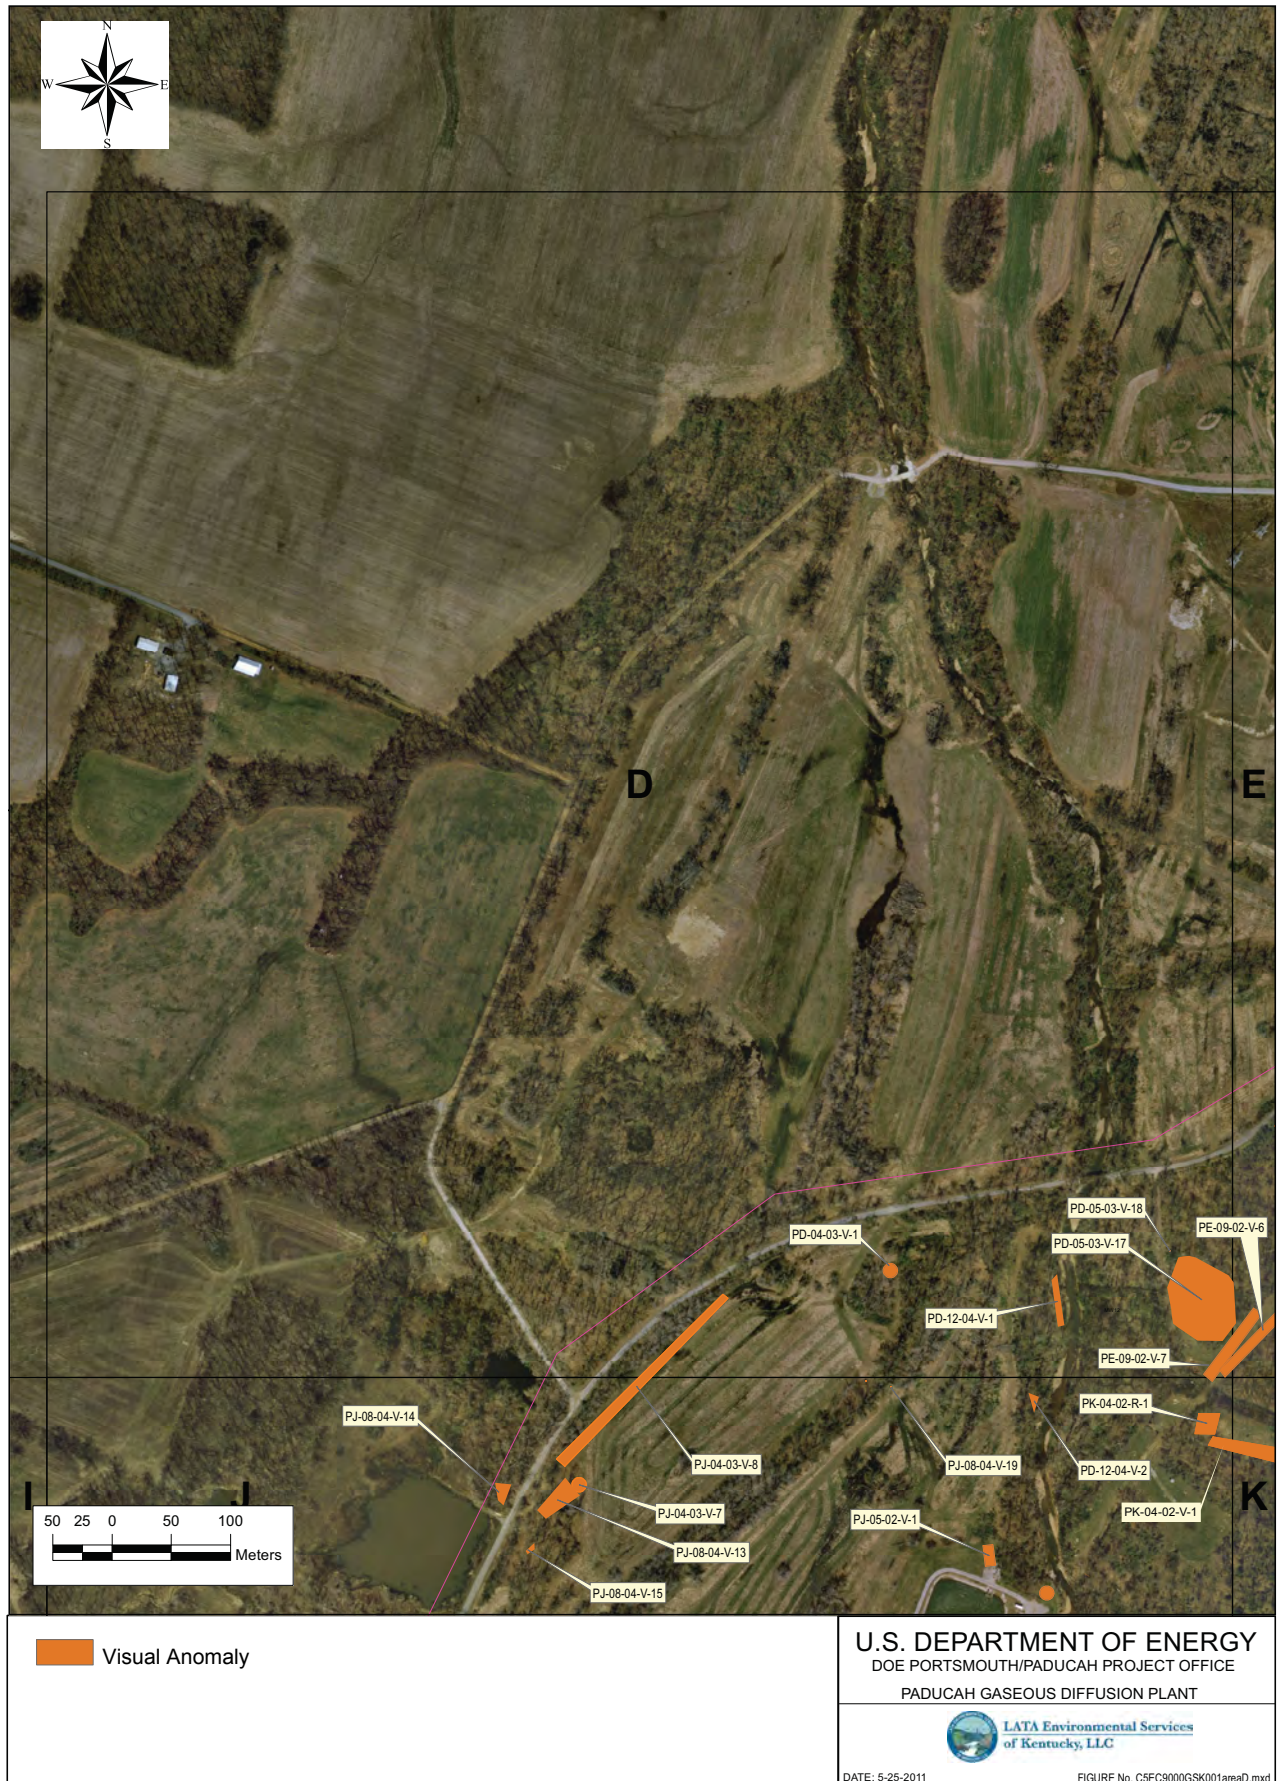
Figure 4.10. Visual Anomaly Map Area D

**Table 4.2. Anomalies within Area D**

<b>Anomaly Name</b>	<b>Photo</b>	<b>Description</b>
PD-04-03-V-1	x	dirt mound
PD-05-03-V-17	x	dirt mound
PD-05-03-V-18	x	metal pipe
PD-12-04-V-1	x	dirt mound
PE-09-02-V-7	x	soil, holding ponds, cable

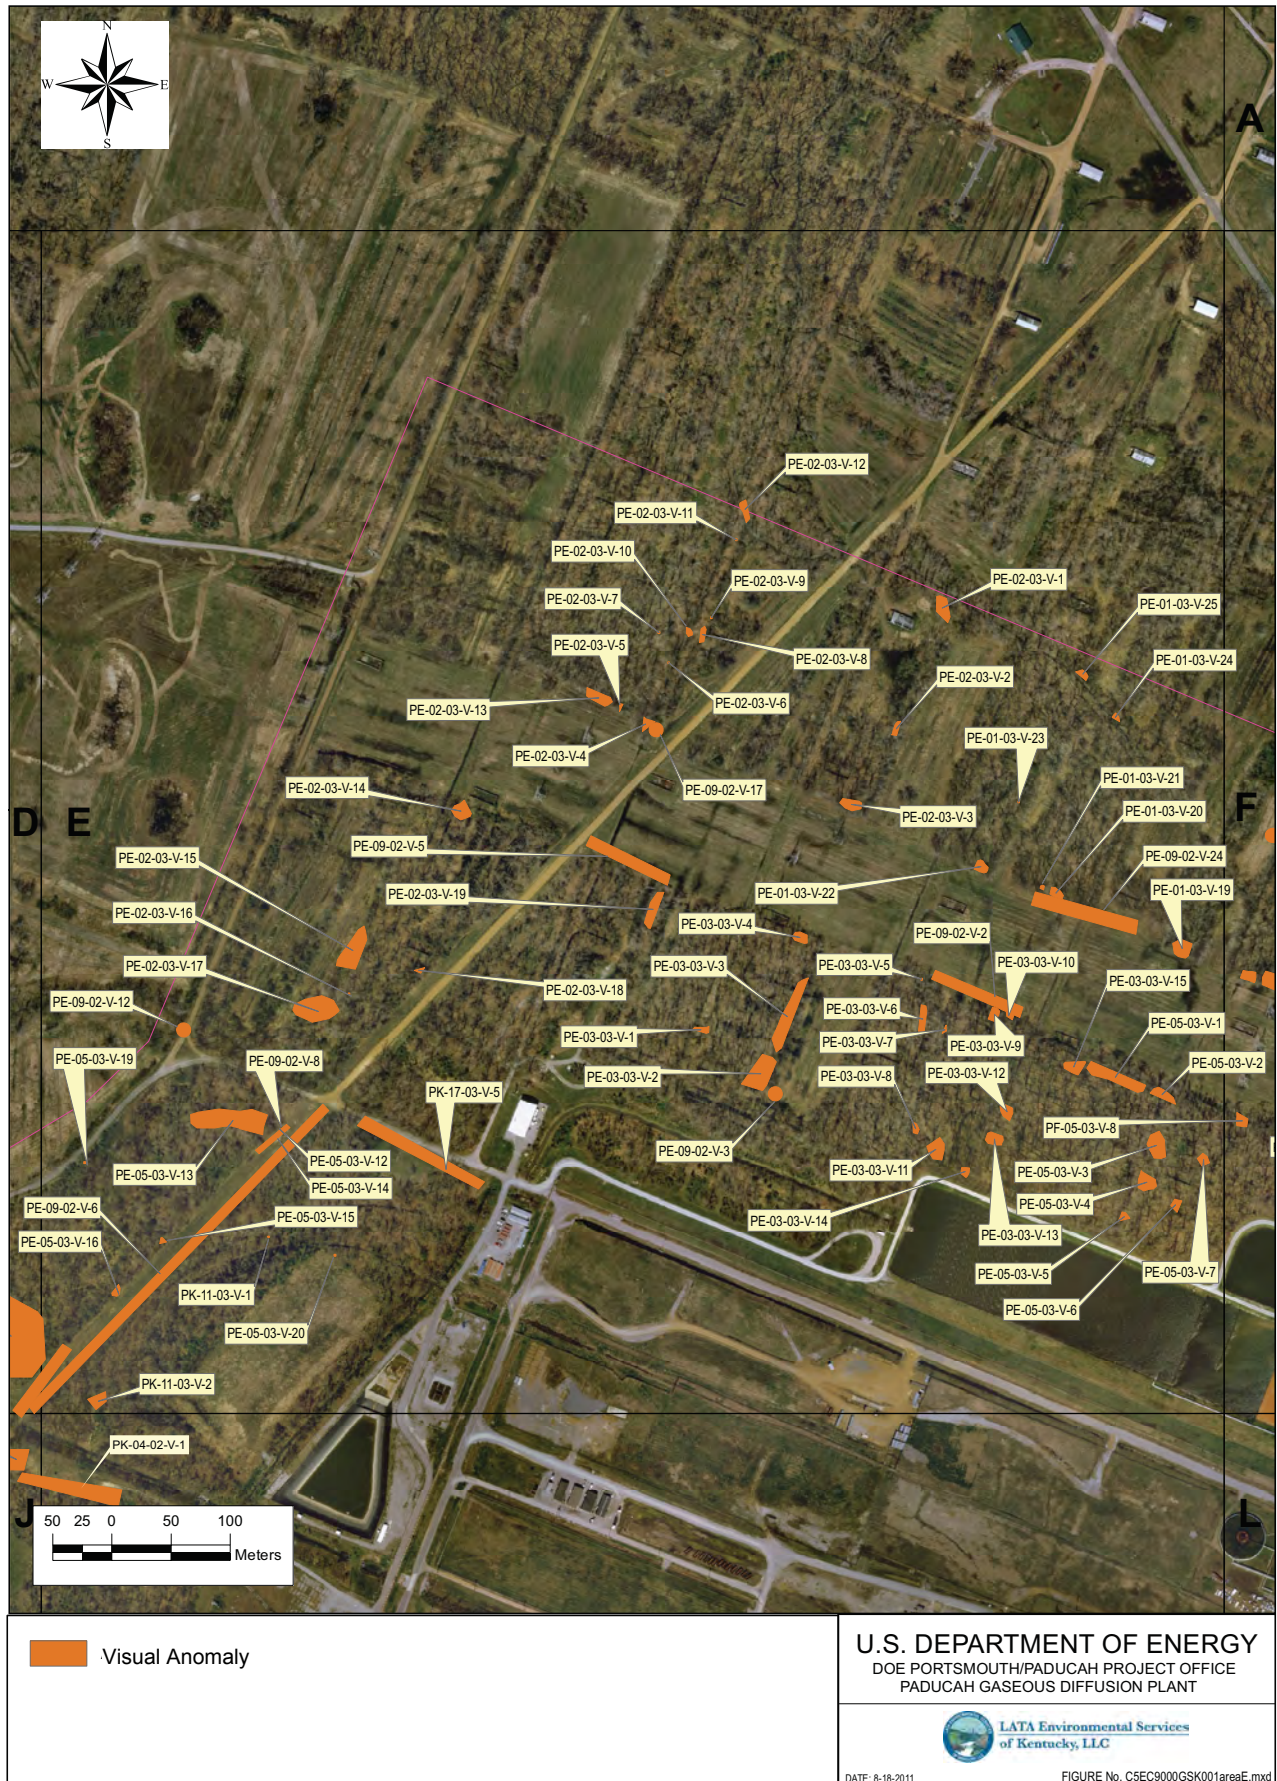
Figure 4.11. Visual Anomaly Map Area E

**Table 4.3. Anomalies within Area E**

<b>Anomaly Name</b>	<b>Photo</b>	<b>Description</b>
PE-03-03-V-3	x	small dirt mounds with ice storm debris
PE-03-03-V-4	x	dirt mound, limbs, tree debris
PE-03-03-V-5	x	small depression
PE-03-03-V-6	x	small depression
PE-03-03-V-7	x	metal fence post
PE-03-03-V-8	x	depression
PE-03-03-V-9	x	dirt mound
PE-05-03-V-1	x	dirt mound
PE-05-03-V-12	x	concrete
PE-05-03-V-13	x	concrete, dirt mounds
PE-05-03-V-14	x	bare soil
PE-05-03-V-15	x	concrete, dirt mounds
PE-05-03-V-16	x	dirt mound
PE-05-03-V-19		dirt mound
PE-05-03-V-2	x	dirt mound
PE-05-03-V-20		dirt mound
PE-05-03-V-3	x	dirt mound
PE-05-03-V-4	x	dirt mound
PE-05-03-V-5	x	dirt mound
PE-05-03-V-6	x	depression
PE-05-03-V-7	x	bucket of soil
PE-09-02-V-12	x	dirt mounds, miscellaneous debris
PE-09-02-V-17	x	railroad ties, soil
PE-09-02-V-2	x	dirt mounds, miscellaneous debris
PE-09-02-V-24	x	dirt mounds
PE-09-02-V-3	x	dirt mound
PE-09-02-V-5	x	concrete, well, manhole
PE-09-02-V-6	x	metal beams, railroad tracks, dirt mounds

PE-09-02-V-8	x	concrete, dirt mounds
PK-11-03-V-1		N/A
PK-11-03-V-2	x	dirt mound
PK-17-03-V-5	x	dirt mounds, concrete, pipe, miscellaneous debris

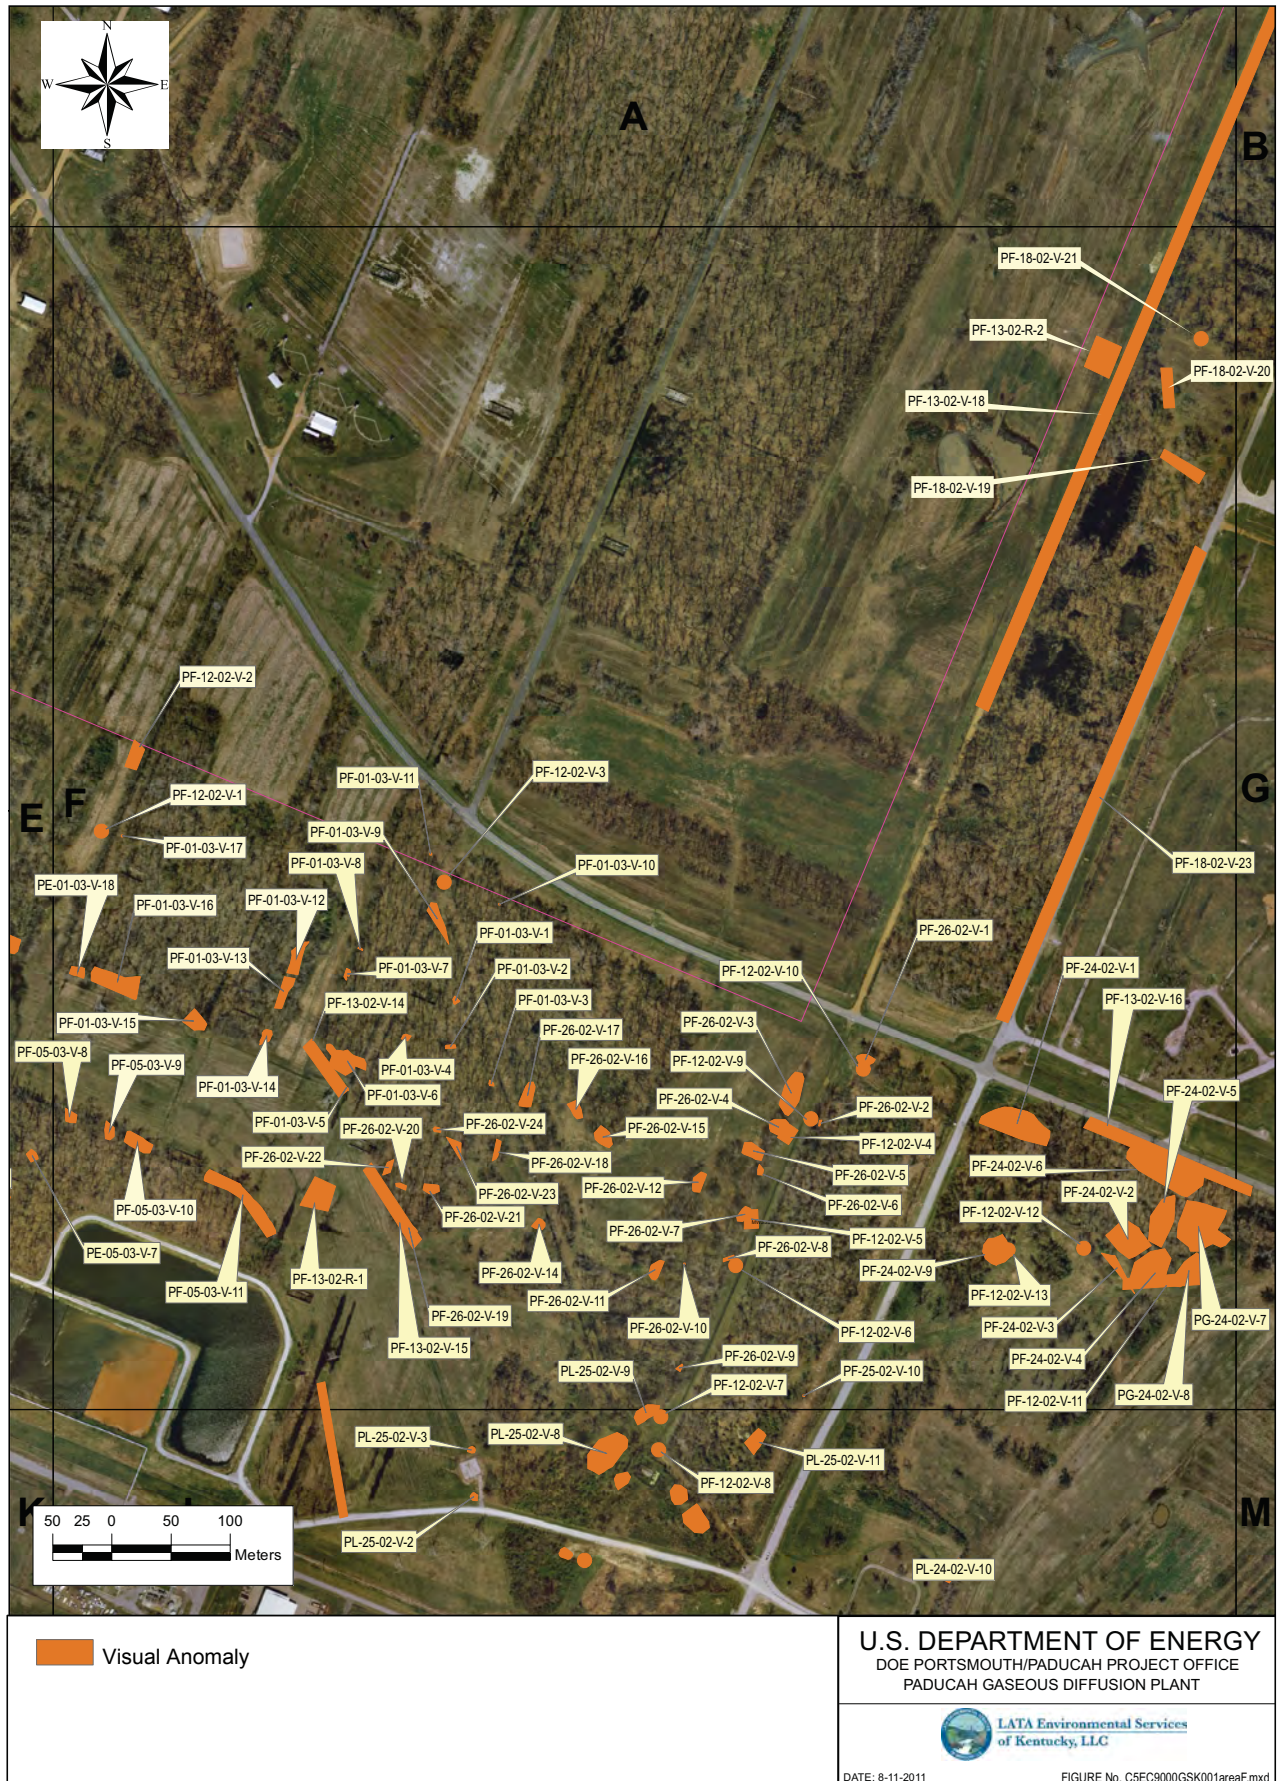
Figure 4.12. Visual Anomaly Map Area F

**Table 4.4. Anomalies within Area F**

**Table 4.4. Anomalies within Area F (Continued)**

<b>Anomaly Name</b>	<b>Photo</b>	<b>Description</b>
PF-26-02-V-10	x	barrel
PF-26-02-V-11	x	dirt mound
PF-26-02-V-12	x	dirt mound
PF-26-02-V-14	x	dirt mound
PF-26-02-V-15	x	dirt mound
PF-26-02-V-16	x	dirt mound
PF-26-02-V-17	x	dirt mound with pond
PF-26-02-V-18	x	dirt mound, limbs, tree debris
PF-26-02-V-19	x	dirt mound
PF-26-02-V-2	x	dirt mound
PF-26-02-V-20	x	concrete
PF-26-02-V-21	x	dirt mound
PF-26-02-V-22	x	dirt mound
PF-26-02-V-23	x	concrete, metal
PF-26-02-V-24	x	dirt mound
PF-26-02-V-3	x	dirt mound, limbs, tree debris
PF-26-02-V-4	N/A	N/A
PF-26-02-V-5	x	dirt mound beside depression
PF-26-02-V-6	x	dirt mound
PF-26-02-V-7	x	dirt mound, lumber
PF-26-02-V-8	x	dirt mound
PF-26-02-V-9	x	dirt mound
PG-24-02-V-7	x	dirt mound
PG-24-02-V-8	x	dirt mound

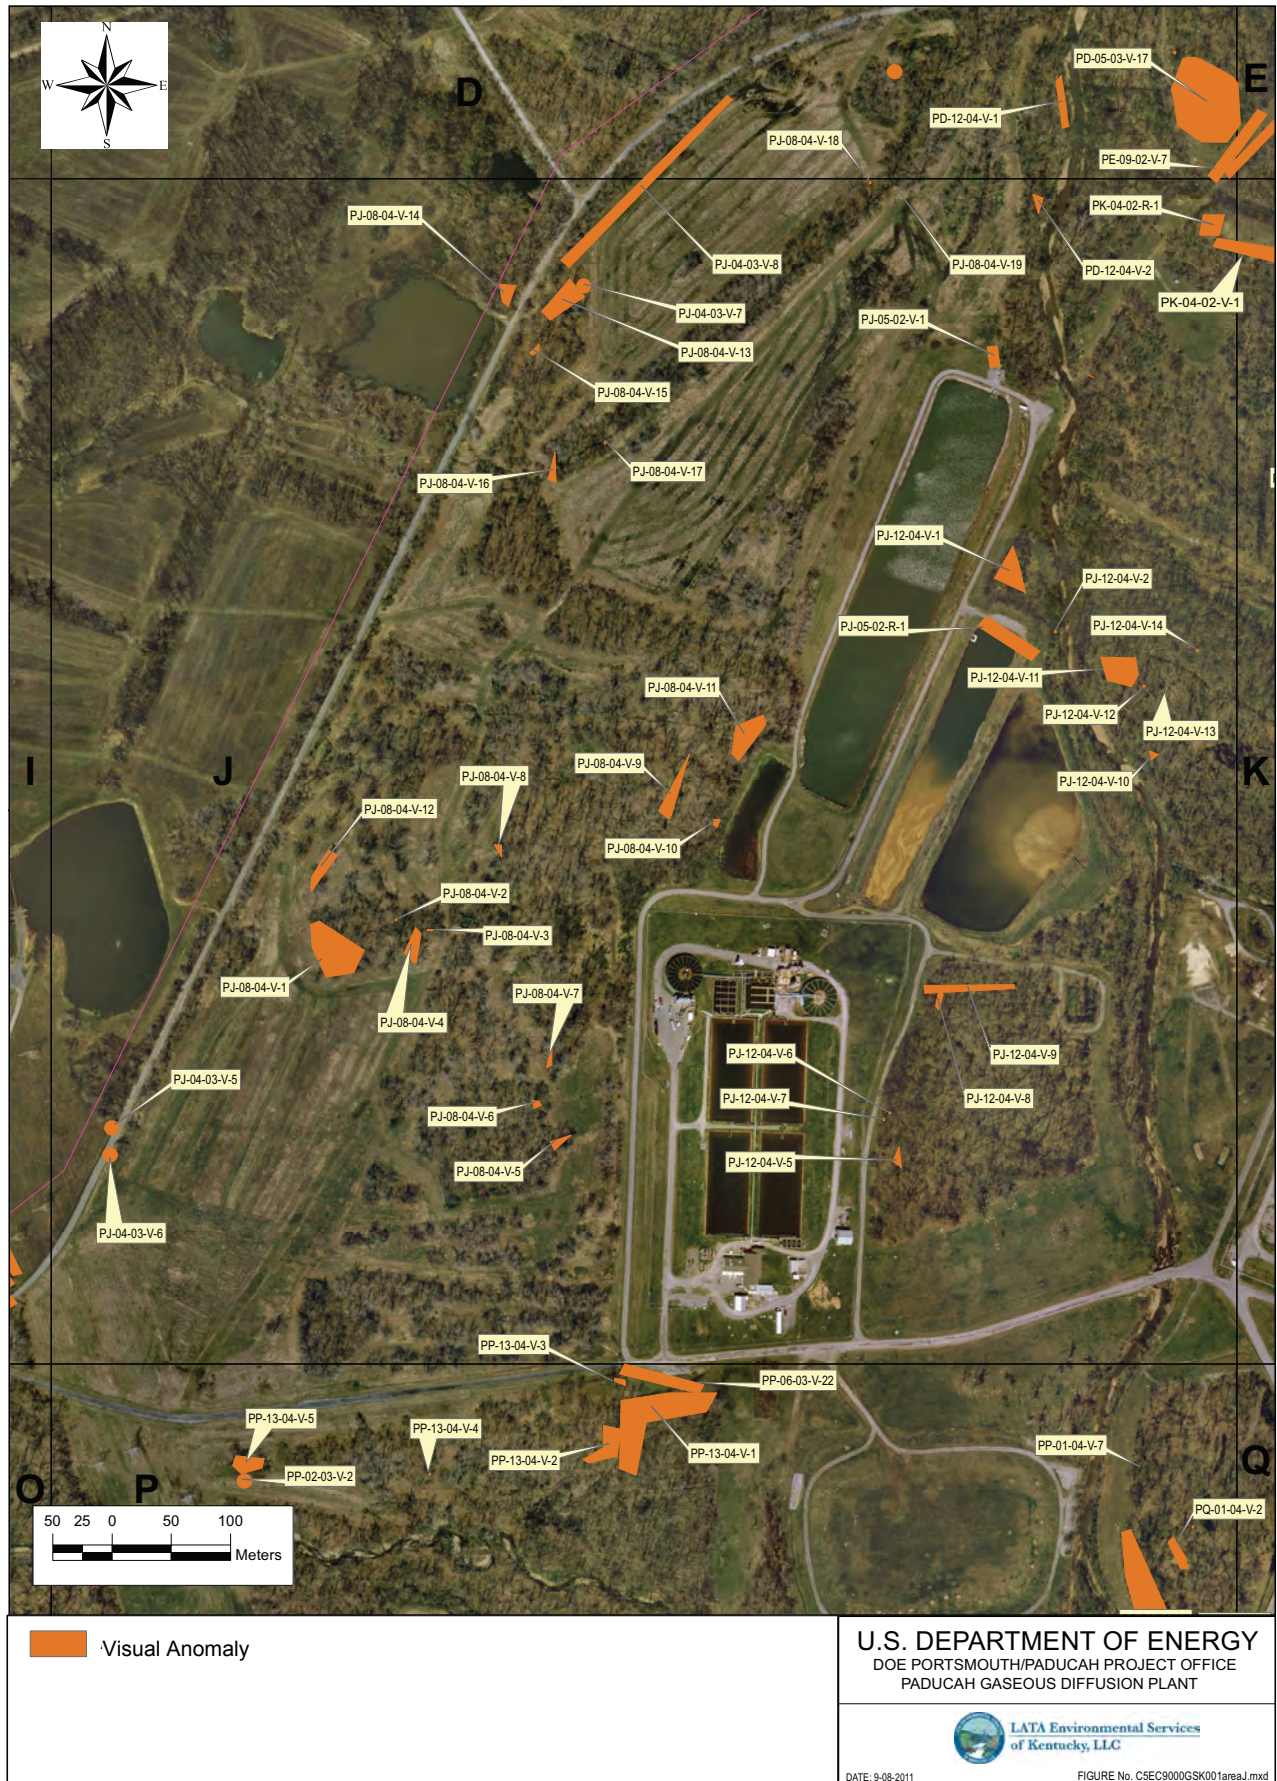
Figure 4.16. Visual Anomaly Map Area J

**Table 4.8. Anomalies within Area J (Continued)**

<b>Anomaly Name</b>	<b>Photo</b>	<b>Description</b>
PJ-08-04-V-11	x	dirt mound
PJ-08-04-V-12	x	dirt mound
PJ-08-04-V-13	x	dirt mound
PJ-08-04-V-14	x	dirt mound
PJ-08-04-V-15	x	dirt mound
PJ-08-04-V-16	x	dirt mound
PJ-08-04-V-17	x	dirt mound
PJ-08-04-V-18	x	dirt mound
PJ-08-04-V-19	N/A	dirt mound, concrete
PJ-08-04-V-2	x	metal culvert
PJ-08-04-V-3	x	concrete
PJ-08-04-V-4	x	dirt mound
PJ-08-04-V-5	x	dirt mound by pond/depression
PJ-08-04-V-6	x	dirt mound
PJ-08-04-V-7	x	dirt mound
PJ-08-04-V-8	x	dirt mound
PJ-08-04-V-9	x	dirt mound
PJ-12-04-V-1	x	metal
PJ-12-04-V-10	x	dirt mound
PJ-12-04-V-11	x	concrete
PJ-12-04-V-12	x	dirt mound
PJ-12-04-V-13	x	trash, paper, plastic
PJ-12-04-V-14	x	dirt mound
PJ-12-04-V-16	x	N/A
PJ-12-04-V-2	x	dirt mound
PJ-12-04-V-5	x	dirt mound
PJ-12-04-V-6	x	concrete
PJ-12-04-V-7	x	concrete
PJ-12-04-V-8	x	dirt mound

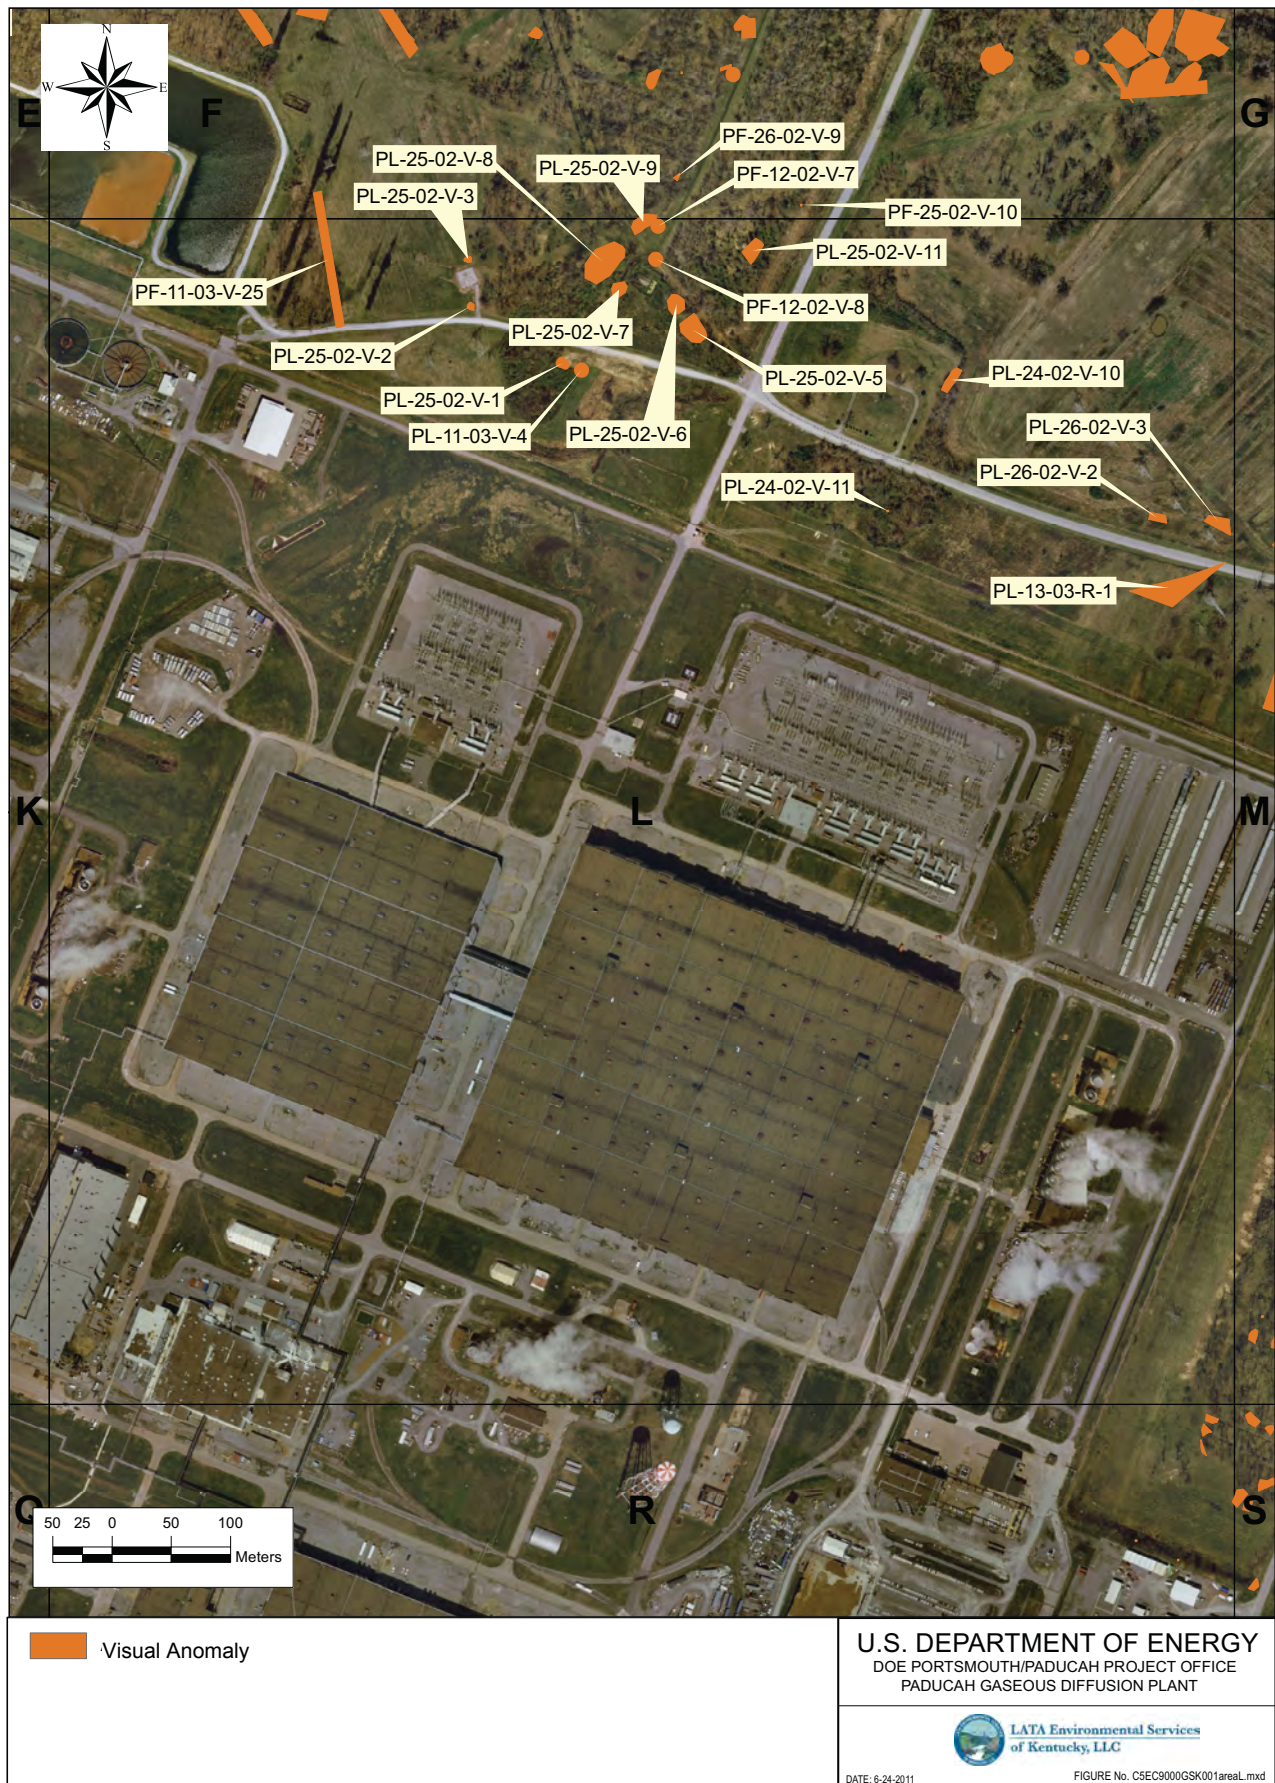
Figure 4.18. Visual Anomaly Map Area L

**Table 4.10. Anomalies within Area L**

<b>Anomaly Name</b>	<b>Photo</b>	<b>Description</b>
PF-11-03-V-25	x	dirt mounds
PF-12-02-V-7	x	dirt mound
PF-12-02-V-8	x	pipe
PL-11-03-V-4	x	concrete block
PL-13-03-R-1	x	dirt mounds, buried concrete
PL-24-02-V-10	x	metal, wood, limbs, tree debris
PL-24-02-V-11	x	clay pipe
PL-25-02-V-1	x	dirt mound
PL-25-02-V-11	x	dirt mound
PL-25-02-V-2	x	dirt mound
PL-25-02-V-3	x	dirt mound
PL-25-02-V-5	x	dirt mound, limbs, tree debris
PL-25-02-V-6	x	dirt mound, limbs, tree debris
PL-25-02-V-7	x	dirt mound
PL-25-02-V-8	x	dirt mound
PL-25-02-V-9	x	dirt mound, limbs, tree debris
PL-26-02-V-2	x	dirt mound
PL-26-02-V-3	x	dirt mound

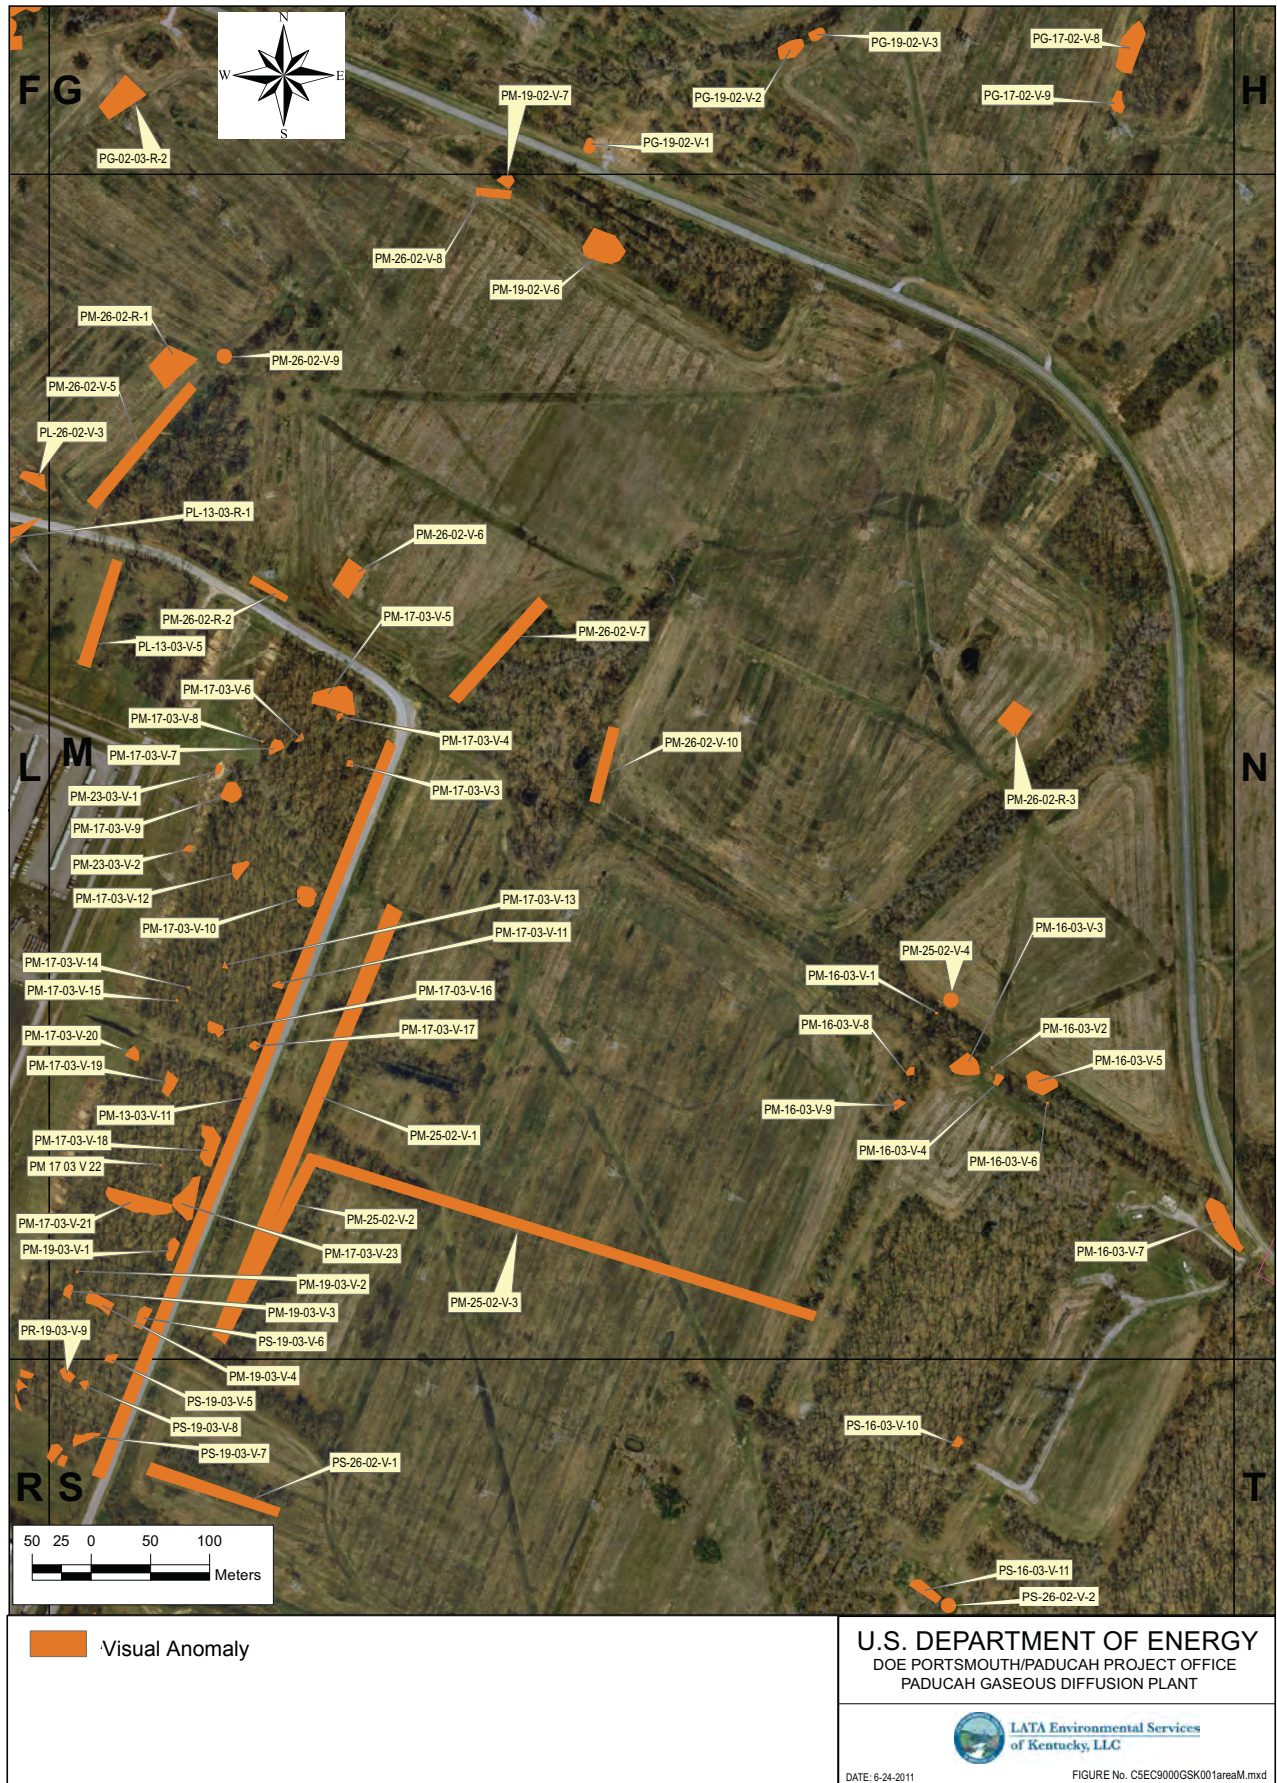
Figure 4.19. Visual Anomaly Map Area M

**Table 4.11. Anomalies within Area M**

<b>Anomaly Name</b>	<b>Photo</b>	<b>Description</b>
PL-13-03-V-5	x	dirt mound, gravel
PM-13-03-V-11	x	dirt mounds, metal pipe, misc. debris
PM-16-03-V-1	x	chevron oil can
PM-16-03-V-2	x	concrete, metal
PM-16-03-V-3	x	dirt mound, limbs, tree debris
PM-16-03-V-4	x	dirt mound, concrete, tree debris
PM-16-03-V-5	x	dirt mound
PM-16-03-V-6	x	concrete
PM-16-03-V-7	x	riprap, dirt mound
PM-16-03-V-8	x	dirt mound
PM-16-03-V-9	x	dirt mound
PM-17-03-V-10	x	concrete
PM-17-03-V-11	x	dirt mound
PM-17-03-V-12	x	concrete
PM-17-03-V-13	x	dirt mound
PM-17-03-V-14	x	dirt mound
PM-17-03-V-15	x	dirt mound
PM-17-03-V-16	x	dirt mound
PM-17-03-V-17	x	dirt mound, limbs, tree debris
PM-17-03-V-18	x	dirt mound, limbs, tree debris
PM-17-03-V-19	x	dirt mound
PM-17-03-V-20	x	dirt mound
PM-17-03-V-21	x	dirt mound, limbs, tree debris
PM-17-03-V-22	x	dirt mound
PM-17-03-V-23	x	dirt mound
PM-17-03-V-3	x	dirt mound
PM-17-03-V-4	x	dirt mound
PM-17-03-V-5	x	dirt mound, metal, trash, wood

PM-17-03-V-6	x	dirt mound
PM-17-03-V-7	x	dirt mound
PM-17-03-V-8	x	metal culvert
PM-17-03-V-9	x	dirt mound
PM-19-02-V-6	x	square pond
PM-19-02-V-7	x	dirt mound
PM-19-03-V-1	x	dirt mound
PM-19-03-V-2	x	dirt mound
PM-19-03-V-3	x	dirt mound
PM-19-03-V-4	x	depression
PM-23-03-V-1	x	dirt mound by concrete barricade
PM-23-03-V-2	x	chip mulch and soil
PM-25-02-V-1	x	dirt mound
PM-25-02-V-2	x	dirt mound
PM-25-02-V-3	x	dirt mound
PM-25-02-V-4	x	dirt mound, bucket
PM-26-02-R-1	x	concrete blocks
PM-26-02-R-2	x	concrete blocks
PM-26-02-R-3	x	bricks
PM-26-02-V-10	x	dirt mound
PM-26-02-V-5	x	concrete, dirt mounds
PM-26-02-V-6	x	dirt mound
PM-26-02-V-7	x	dirt mound
PM-26-02-V-8	x	dirt mounds covered in tree limbs inside wooded area
PM-26-02-V-9	x	trash can, fence, debris
PS-19-03-V-6	x	dirt mound

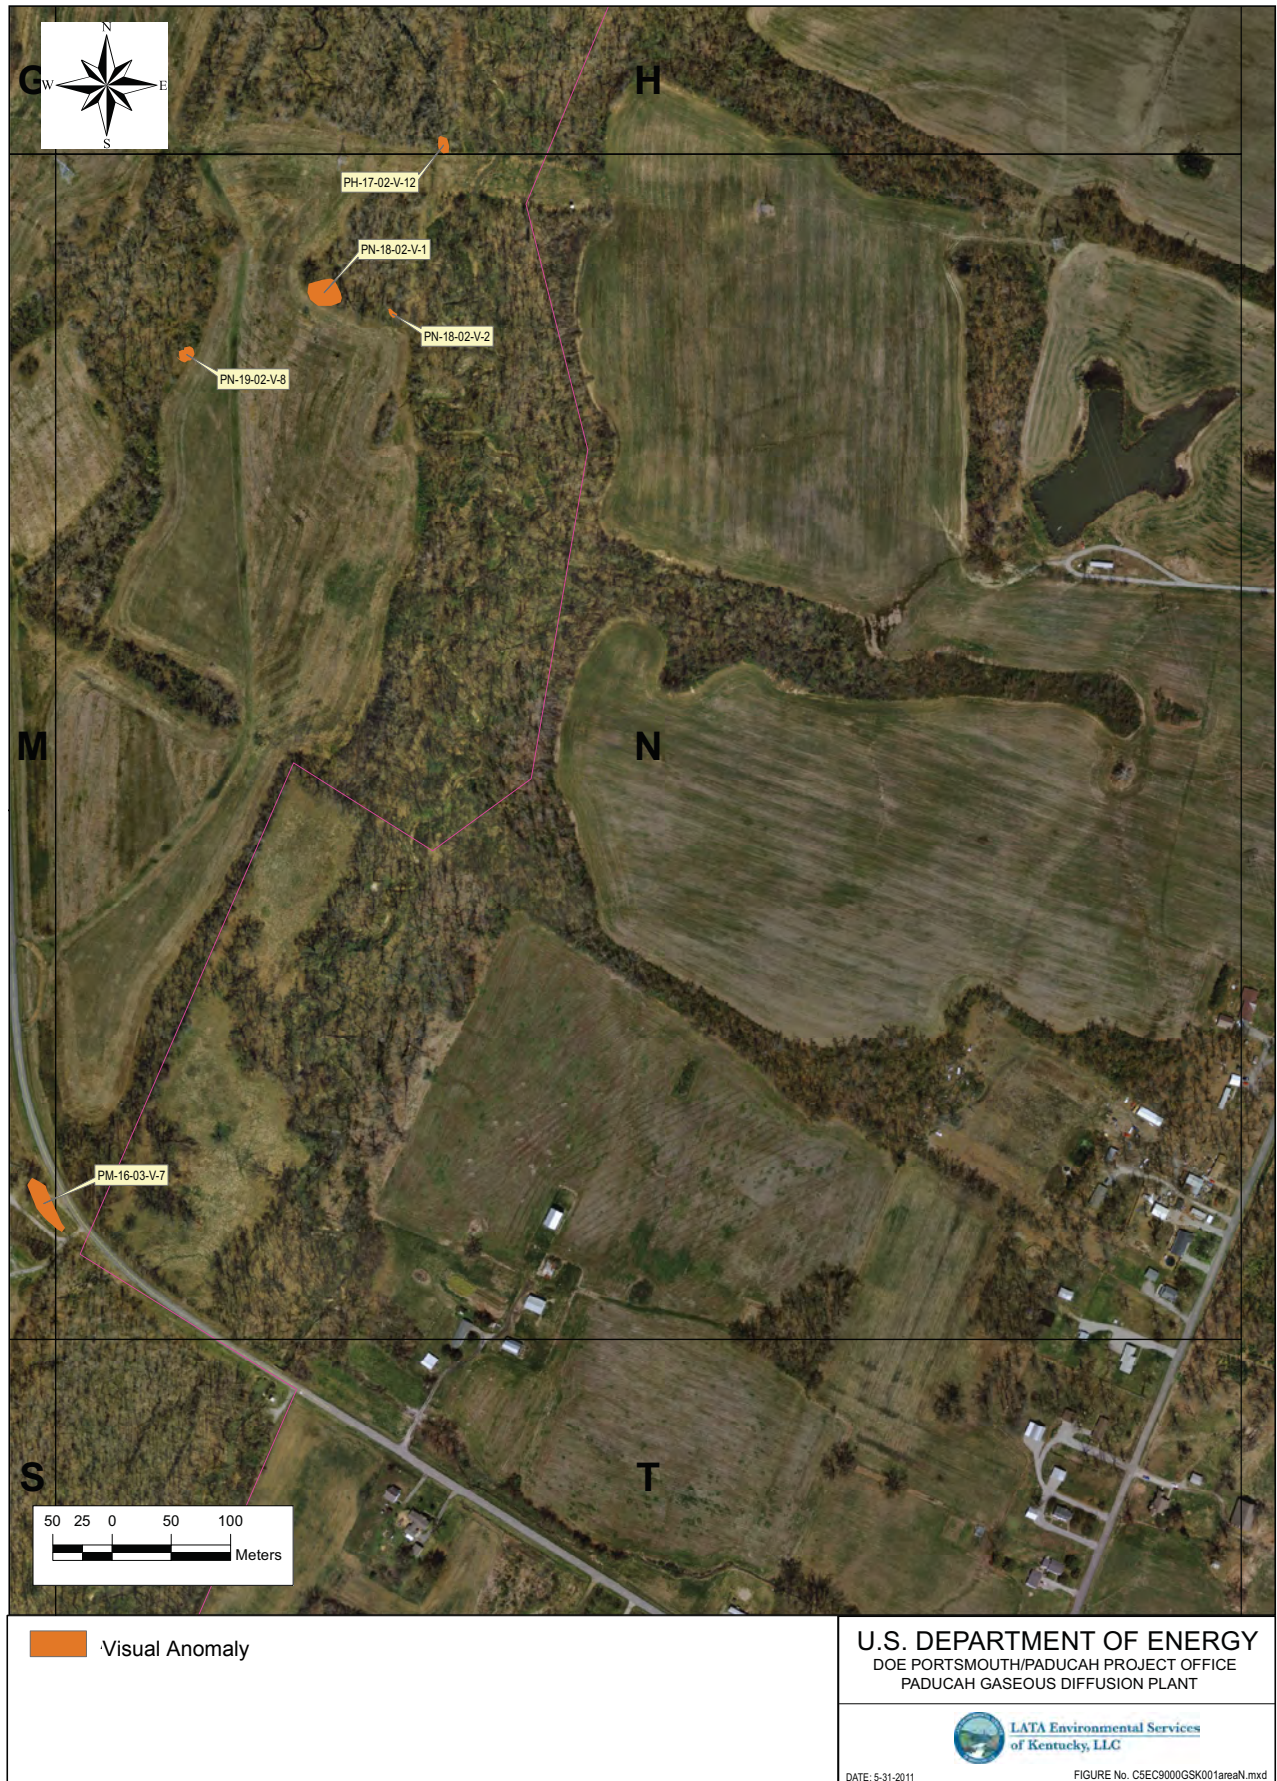
**Figure 4.20. Visual Anomaly Map Area N**

**Table 4.12. Anomalies within Area N**

<b>Anomaly Name</b>	<b>Photo</b>	<b>Description</b>
PN-18-02-V-1	x	dirt mound
PN-18-02-V-2	x	dirt mound
PN-19-02-V-8	x	dirt mound
