**TRANSMITTAL OF THE SITEWIDE EVALUATION REPORT FOR THE SOILS  
OPERABLE UNIT AT THE PADUCAH GASEOUS DIFFUSION PLANT, PADUCAH,  
KENTUCKY (DOE/LX/07-1256&D2)**

**Document Identification:** *Sitewide Evaluation Report for the Soils Operable Unit at the Paducah Gaseous Diffusion Plant, Paducah Kentucky, DOE/LX/07-1256&D2*

**DOE/LX/07-1256&D2  
Primary Document**

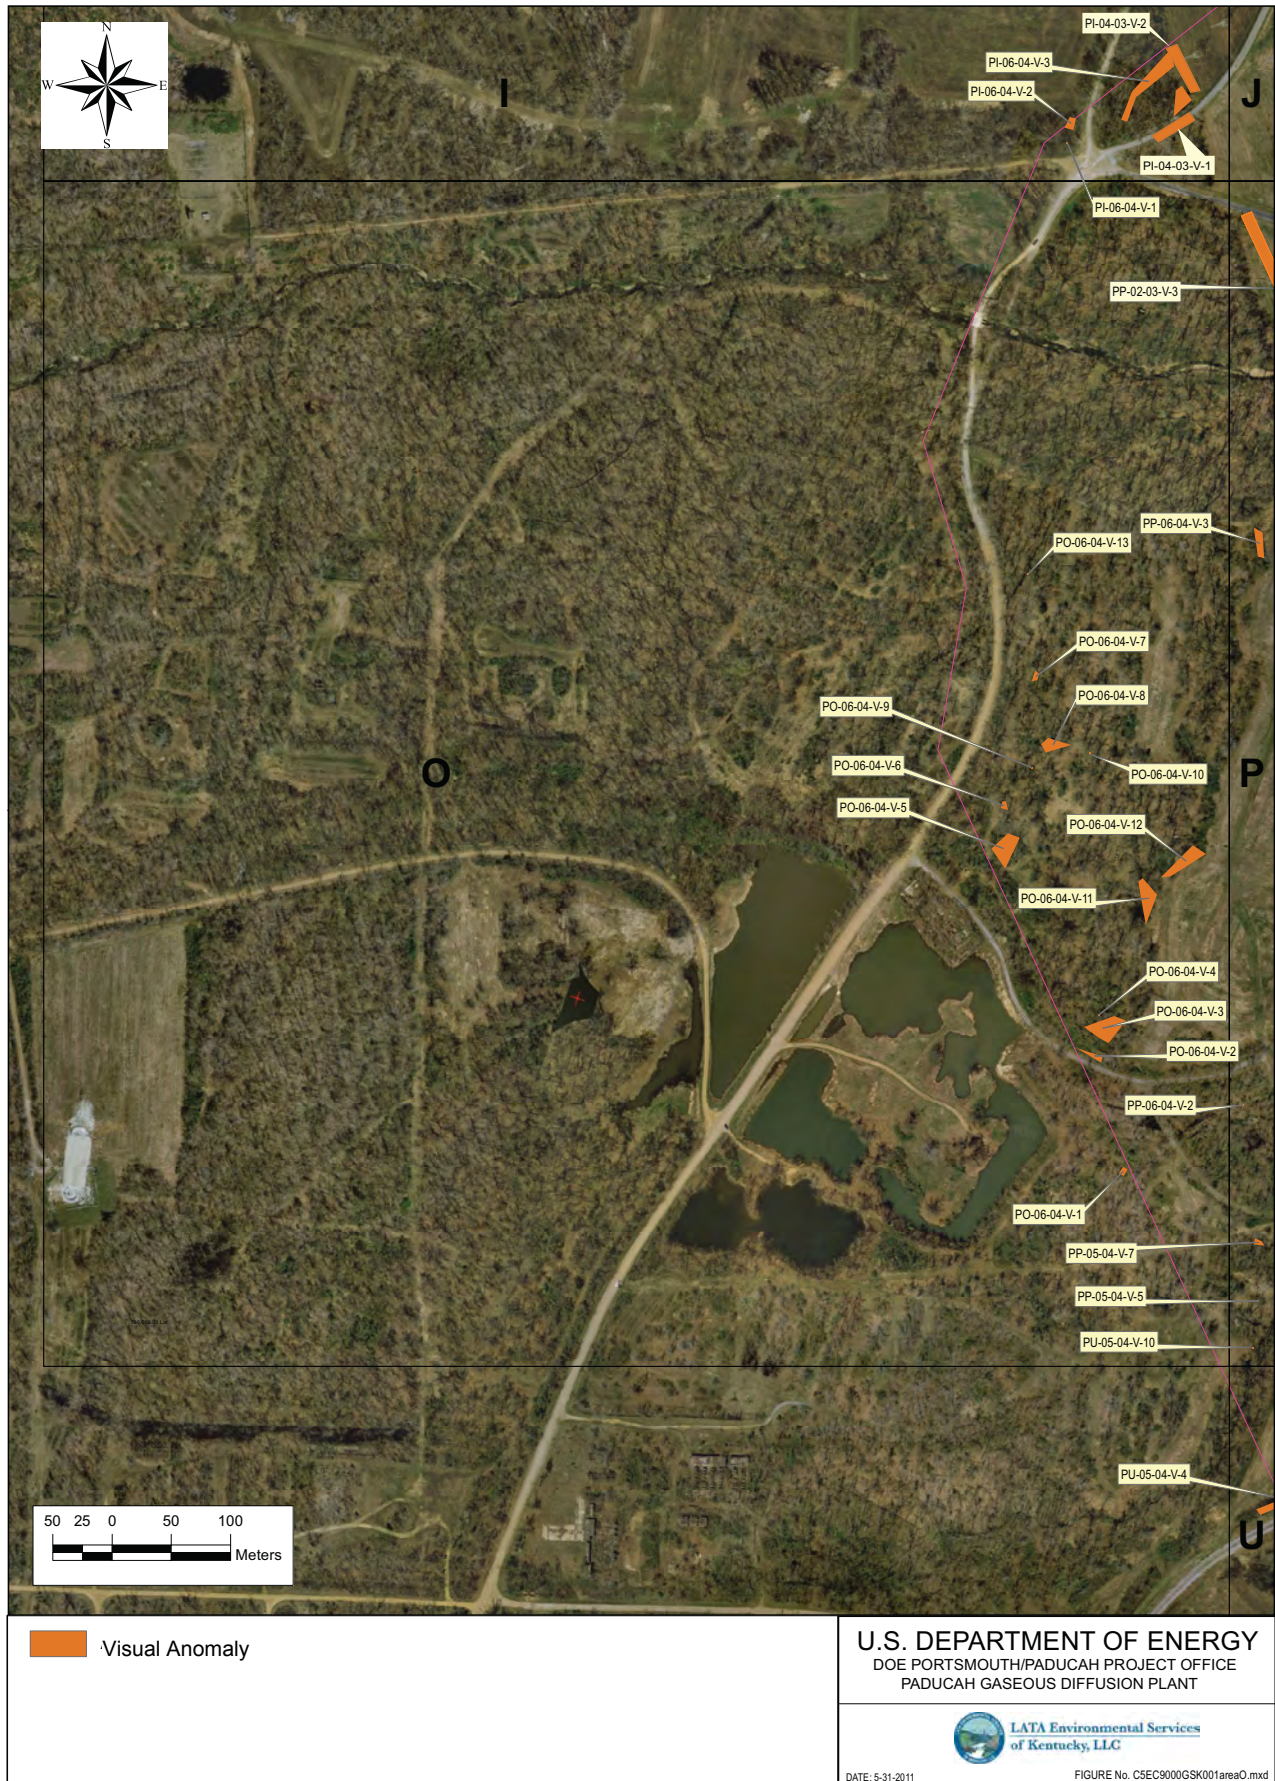
**Figure 4.21. Visual Anomaly Map Area O**

**Table 4.13. Anomalies within Area O**

<b>Anomaly Name</b>	<b>Photo</b>	<b>Description</b>
PO-06-04-V-1	x	dirt mound
PO-06-04-V-10	x	dirt mound
PO-06-04-V-11	x	dirt mound
PO-06-04-V-12	x	dirt mound
PO-06-04-V-13	x	dirt mound
PO-06-04-V-2	x	dirt mound
PO-06-04-V-3	x	concrete
PO-06-04-V-4	x	dirt mound
PO-06-04-V-5	x	dirt mound
PO-06-04-V-6	x	concrete
PO-06-04-V-7	x	dirt mound
PO-06-04-V-8	x	metal pipe
PO-06-04-V-9	x	dirt mound

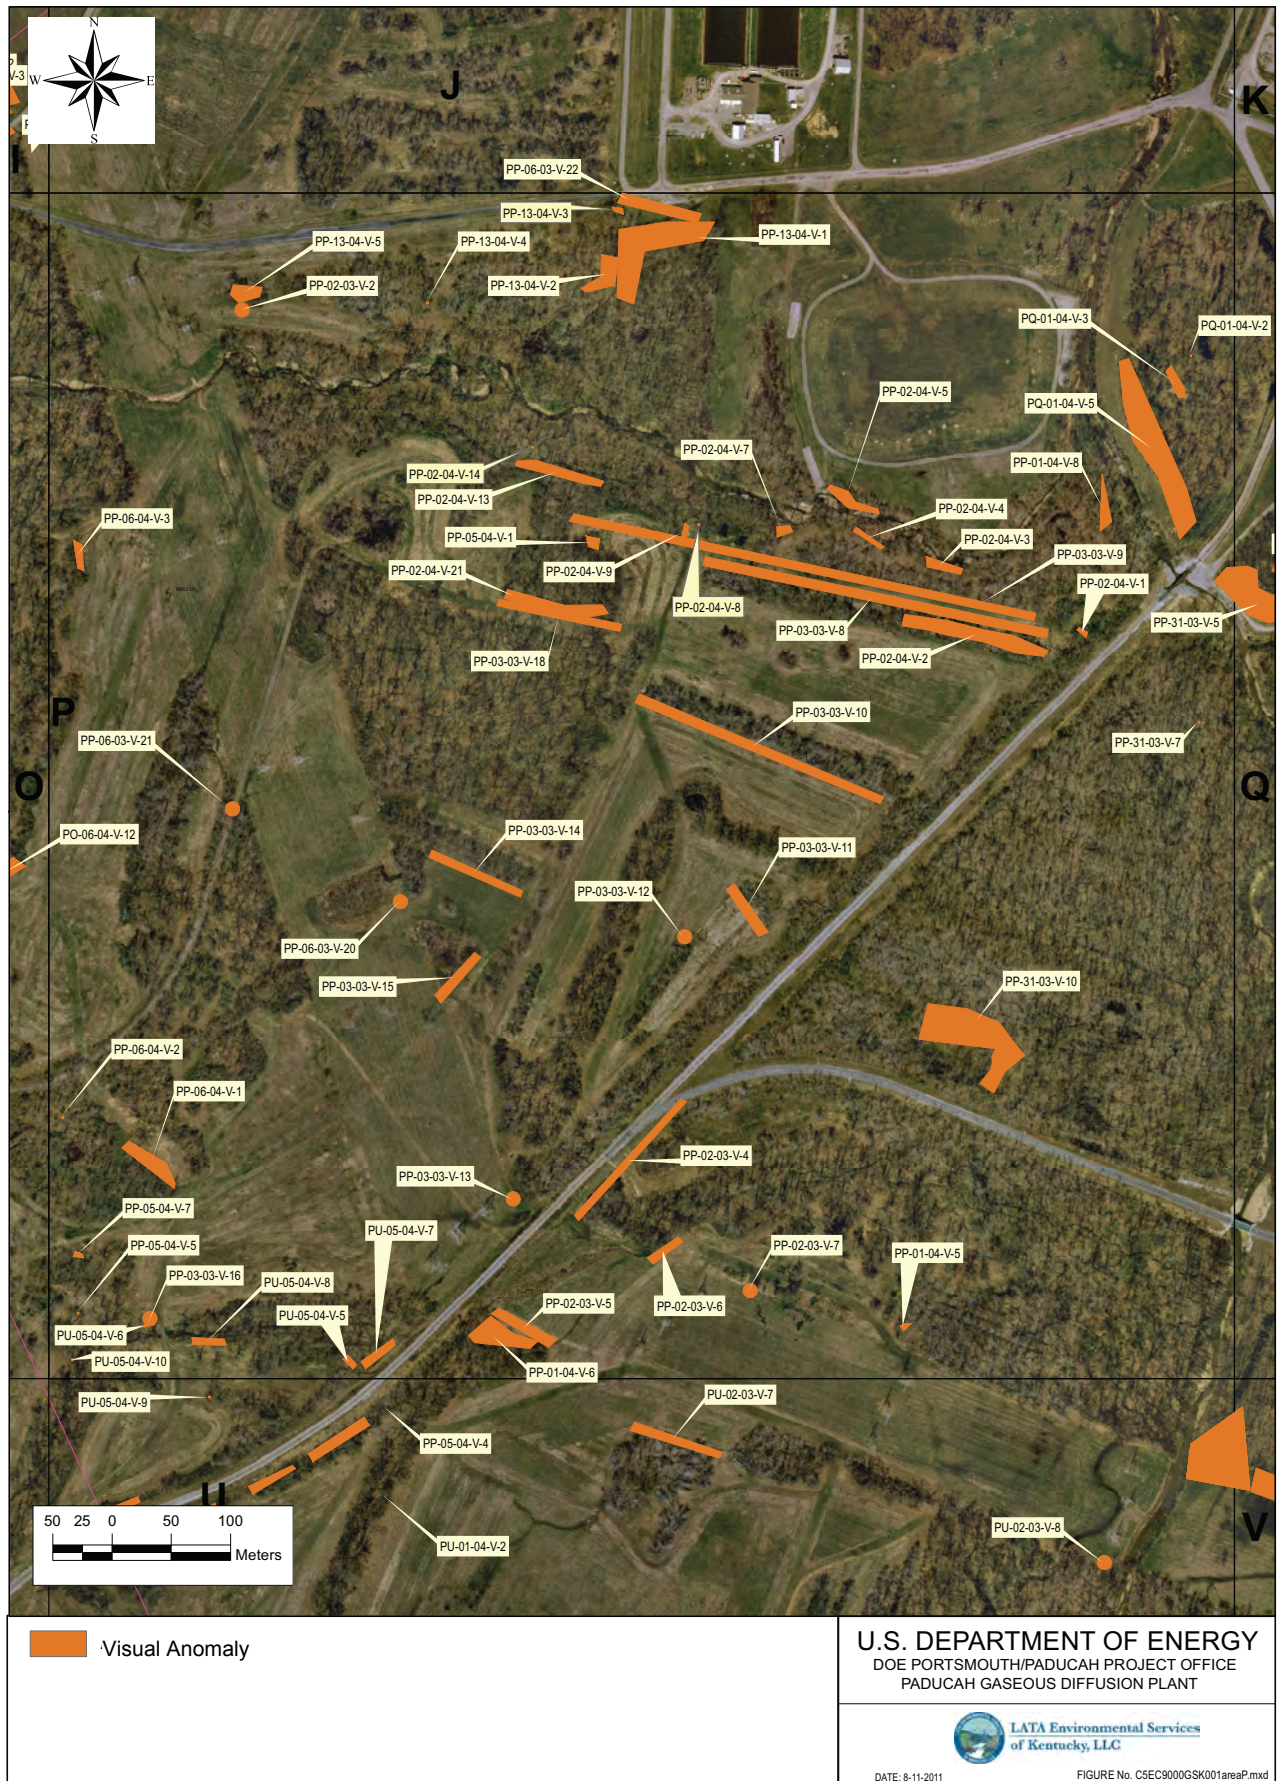
Figure 4.22. Visual Anomaly Map Area P

**Table 4.14. Anomalies within Area P**

<b>Anomaly Name</b>	<b>Photo</b>	<b>Description</b>
PP-01-04-V-5	x	dirt mound
PP-01-04-V-6	x	dirt mound
PP-01-04-V-8	x	dirt mound
PP-02-03-V-2	x	dirt mound, brick
PP-02-03-V-4	x	dirt mound
PP-02-03-V-5	x	dirt mound
PP-02-03-V-6	x	dirt mound
PP-02-03-V-7	x	dirt mound
PP-02-04-V-1	x	dirt mound, limbs, tree debris
PP-02-04-V-13	x	dirt mound
PP-02-04-V-14	x	dirt mound
PP-02-04-V-2	x	depression
PP-02-04-V-21	x	dirt mound
PP-02-04-V-3	x	dirt mound
PP-02-04-V-4	x	concrete
PP-02-04-V-5	x	dirt mound
PP-02-04-V-7	x	dirt mound
PP-02-04-V-8	x	dirt mound
PP-02-04-V-9	x	depression
PP-03-03-V-10	x	dirt mounds
PP-03-03-V-11	x	dirt mounds
PP-03-03-V-12	x	dirt mounds
PP-03-03-V-13	x	dirt mounds, concrete
PP-03-03-V-14	x	dirt mounds
PP-03-03-V-15	x	dirt mounds
PP-03-03-V-16	x	pipe, dirt mound
PP-03-03-V-18	x	dirt mounds
PP-03-03-V-8	x	dirt mounds
PP-03-03-V-9	x	dirt mounds
PP-05-04-V-1	x	soil, limbs, debris
PP-05-04-V-5	x	soil, concrete
PP-05-04-V-7	x	dirt mound

PP-06-03-V-20	x	dirt mound
PP-06-03-V-21	x	small dirt mound with fragments of clay pipe on mound
PP-06-03-V-22	x	dirt mound, concrete
PP-06-04-V-1	x	soil, concrete
PP-06-04-V-2	x	depression
PP-06-04-V-3	x	concrete
PP-13-04-V-1	x	dirt mound
PP-13-04-V-2	x	dirt mound
PP-13-04-V-3	x	rock, dirt mound
PP-13-04-V-4	x	dirt mound
PP-13-04-V-5	x	concrete
PP-31-03-V-10	x	dirt mound
PP-31-03-V-7	x	concrete
PQ-01-04-V-2	x	concrete
PQ-01-04-V-3	x	dirt mound
PQ-01-04-V-5	x	dirt mound
PU-05-04-V-10	x	concrete
PU-05-04-V-5	x	dirt mound
PU-05-04-V-6	x	dirt mound
PU-05-04-V-7	x	dirt mound
PU-05-04-V-8	x	dirt mound

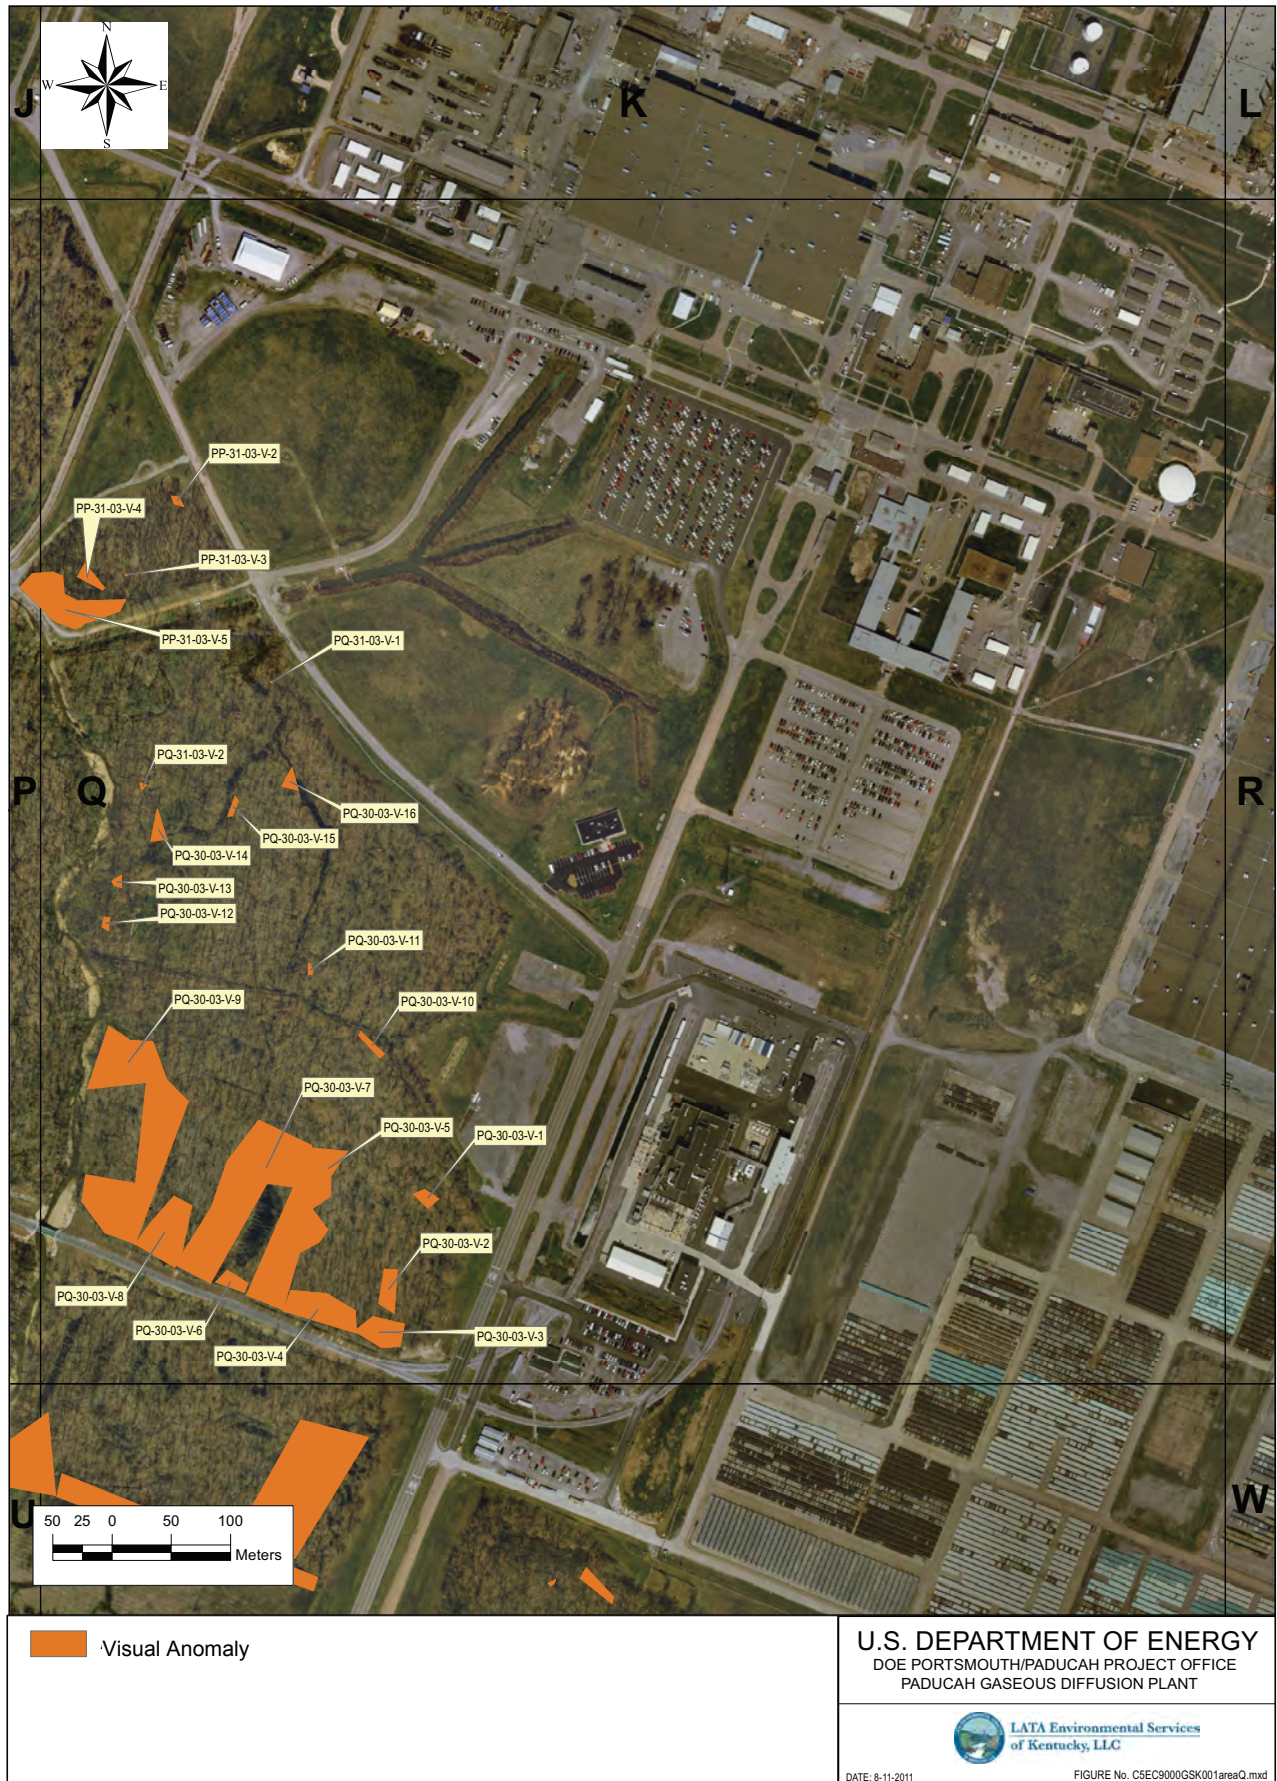
Figure 4.23. Visual Anomaly Map Area Q

**Table 4.15. Anomalies within Area Q**

<b>Anomaly Name</b>	<b>Photo</b>	<b>Description</b>
PP-31-03-V-2	x	depression
PP-31-03-V-3	x	concrete
PP-31-03-V-4	x	concrete
PP-31-03-V-5	x	concrete
PQ-30-03-V-1	x	dirt mound
PQ-30-03-V-10	x	depression
PQ-30-03-V-11	x	metal
PQ-30-03-V-12	x	dirt mound
PQ-30-03-V-13	x	dirt mound
PQ-30-03-V-14	x	dirt mound
PQ-30-03-V-15	x	metal
PQ-30-03-V-16	x	depression
PQ-30-03-V-2	x	dirt mound
PQ-30-03-V-3	x	dirt mound
PQ-30-03-V-4	x	dirt mound
PQ-30-03-V-5	x	soil, limbs, debris
PQ-30-03-V-6	N/A	N/A
PQ-30-03-V-7	x	concrete
PQ-30-03-V-8	x	concrete
PQ-30-03-V-9	x	dirt mound
PQ-31-03-V-1	x	concrete/rock
PQ-31-03-V-2	x	dirt mound

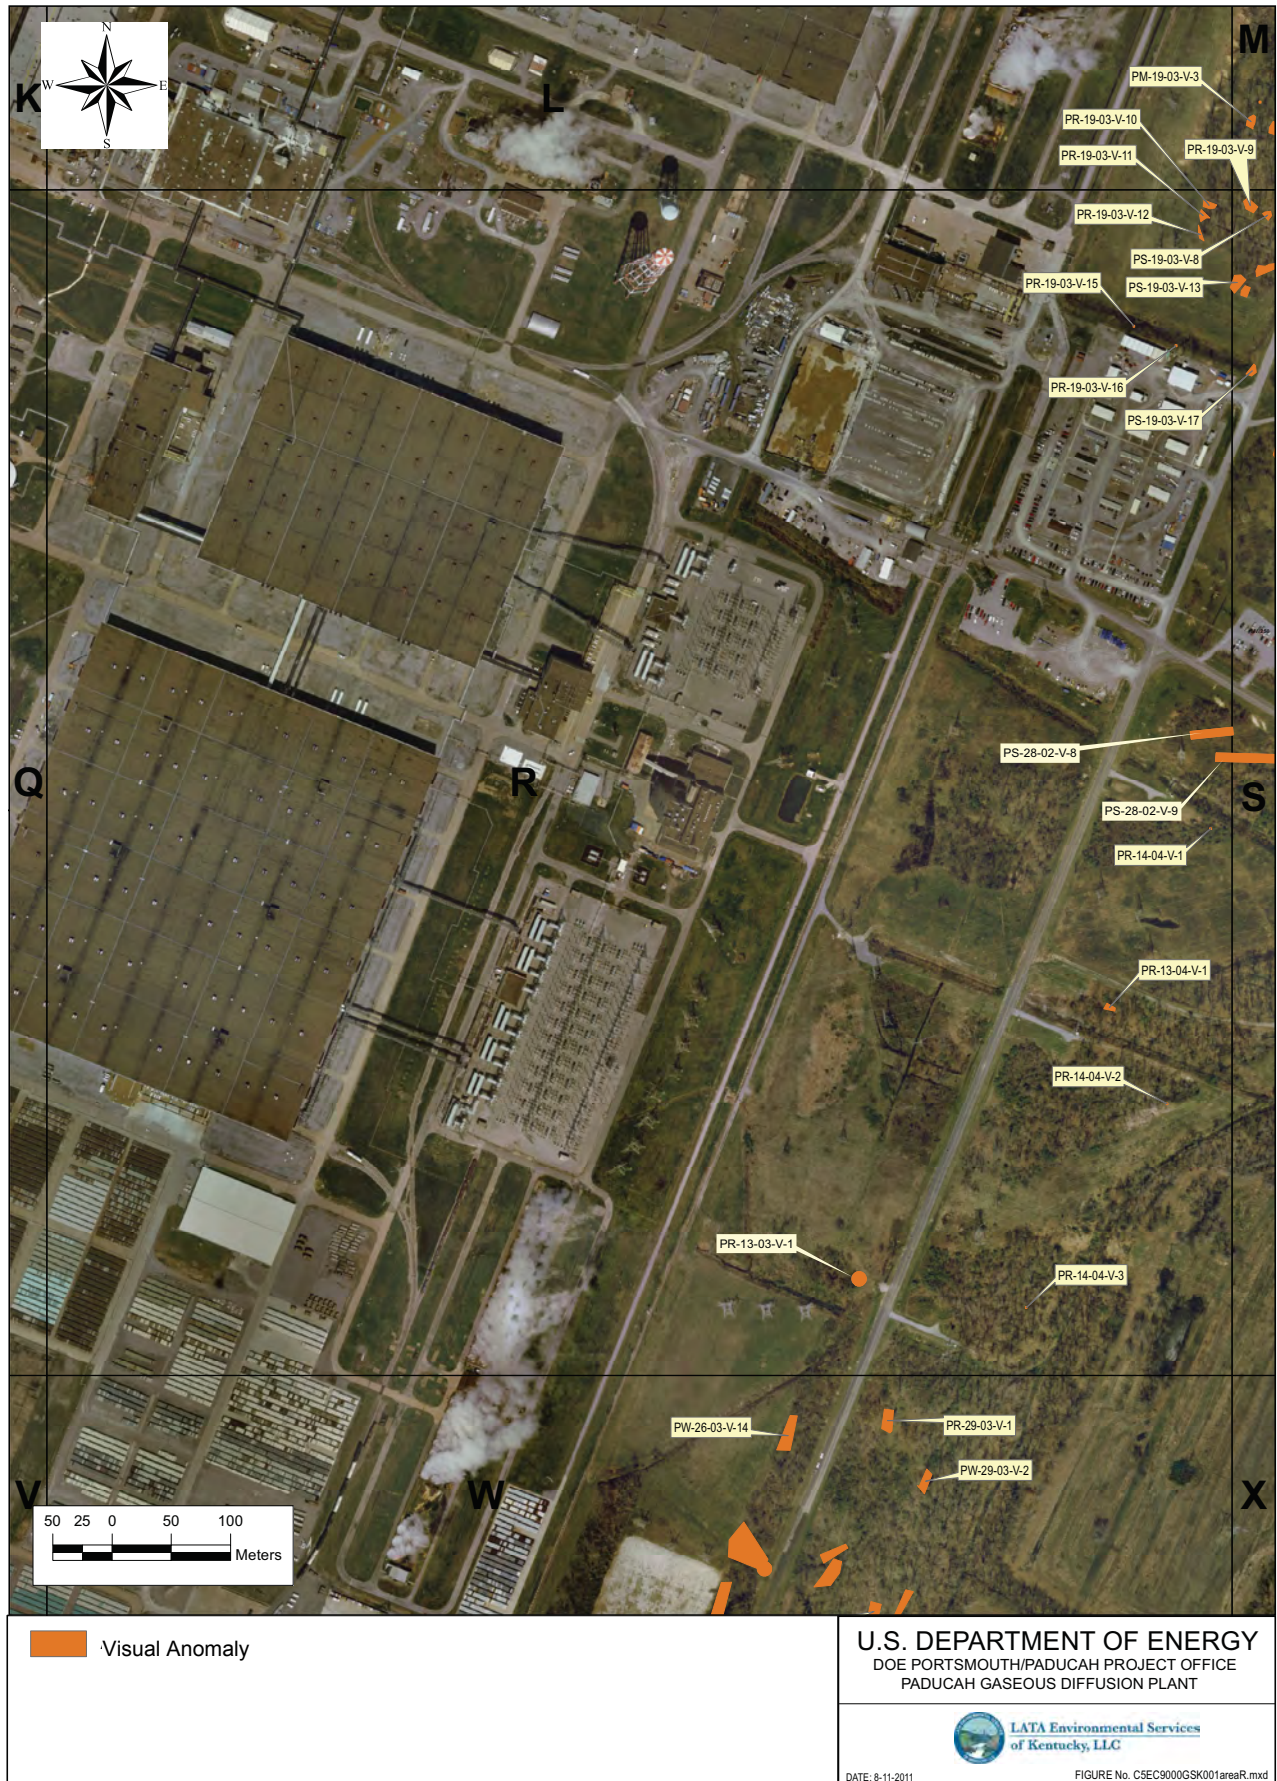
Figure 4.24. Visual Anomaly Map Area R

**Table 4.16. Anomalies within Area R**

<b>Anomaly Name</b>	<b>Photo</b>	<b>Description</b>
PR-13-03-V-1	x	N/A
PR-13-04-V-1	x	dirt mound
PR-14-04-V-1	x	concrete
PR-14-04-V-2	x	dirt mound
PR-14-04-V-3	x	metal
PR-19-03-V-10	x	concrete
PR-19-03-V-11	x	telephone pole, concrete
PR-19-03-V-12	x	concrete, riprap
PR-19-03-V-15	x	metal pipe
PR-19-03-V-16	x	concrete
PS-28-02-V-8	x	dirt mound, plastic

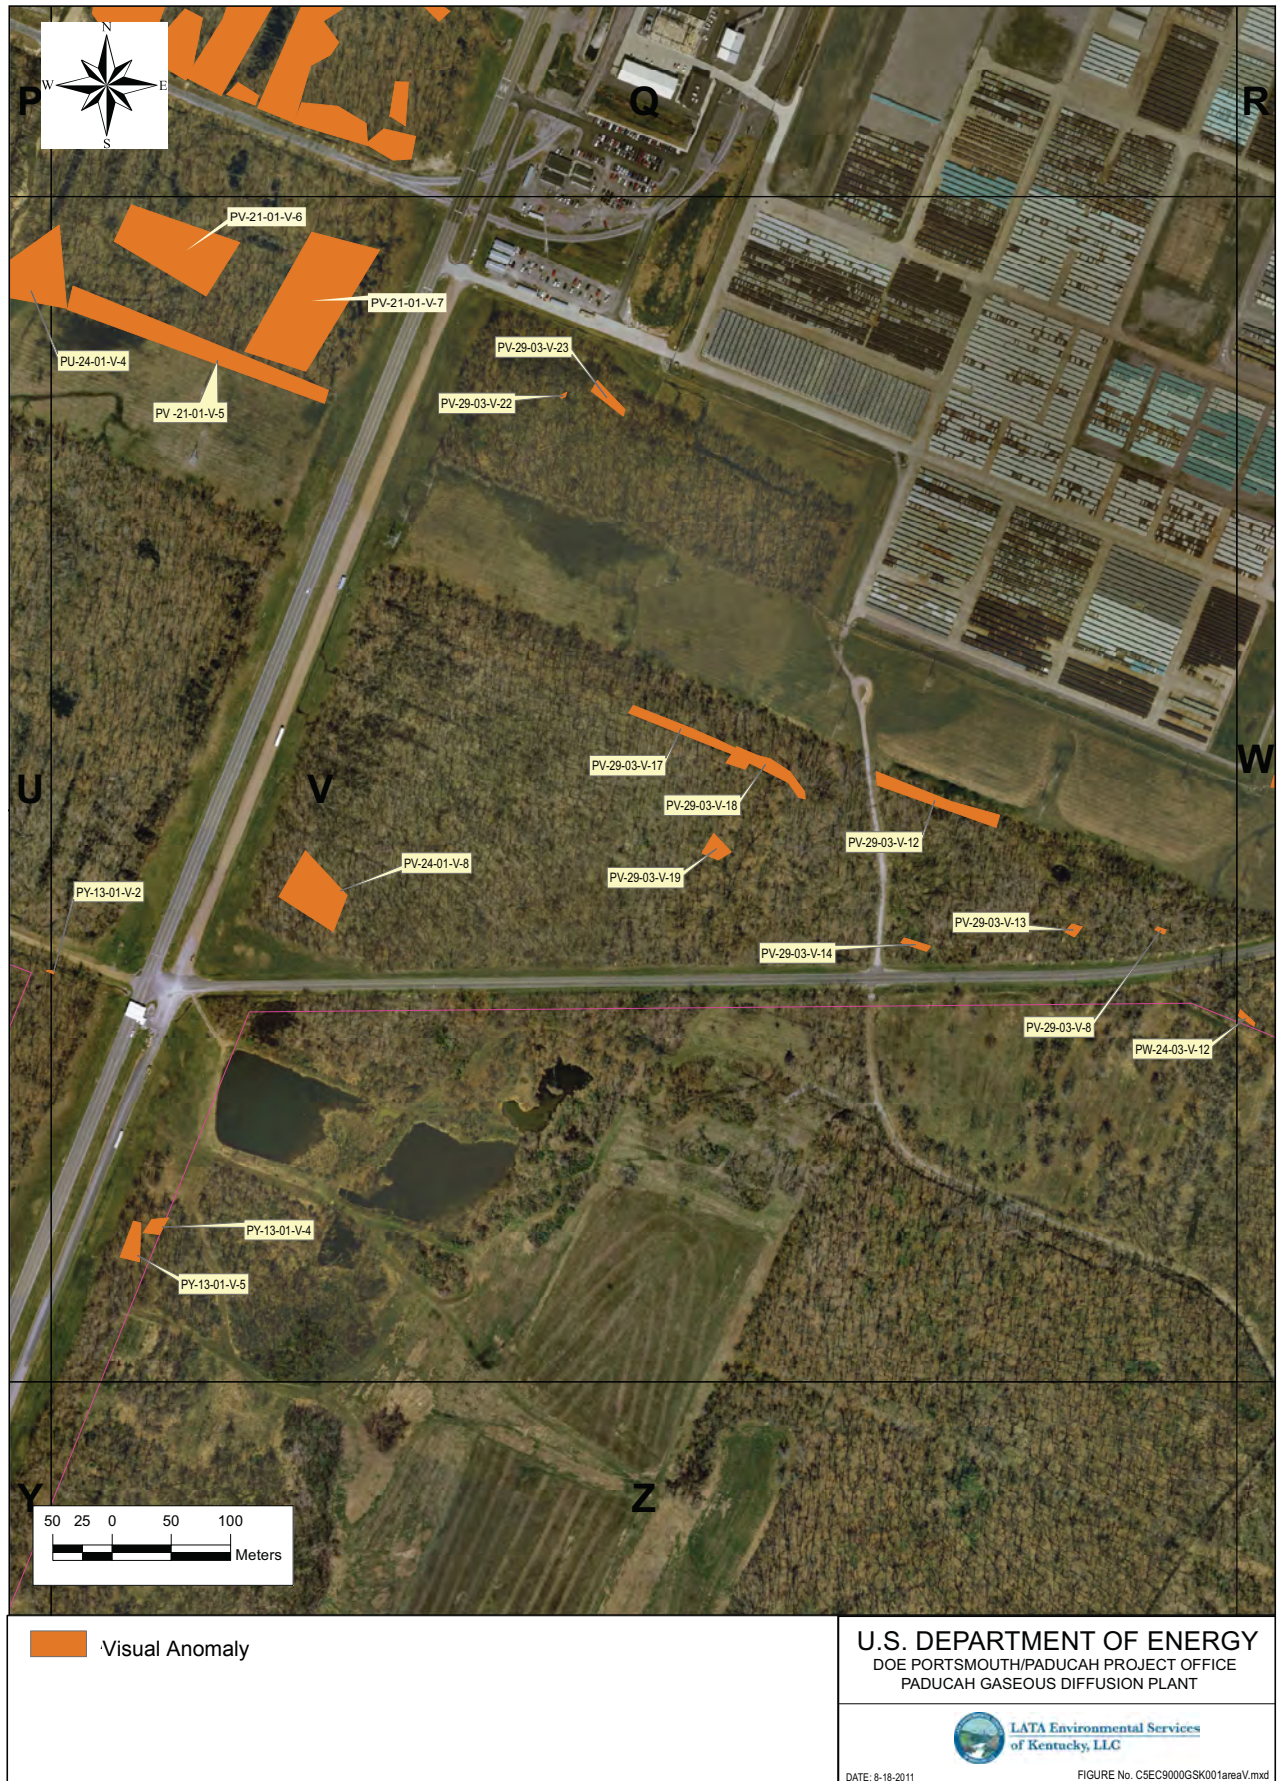
Figure 4.28. Visual Anomaly Map Area V

**Table 4.19. Anomalies within Area V**

<b>Anomaly Name</b>	<b>Photo</b>	<b>Description</b>
PV-21-01-V-5	x	dirt mound
PV-21-01-V-6	x	dirt mound
PV-21-01-V-7	x	concrete, dirt mounds
PV-24-01-V-8	N/A	dirt mound
PV-29-03-V-12	x	dirt mound
PV-29-03-V-13	x	concrete
PV-29-03-V-14	x	concrete
PV-29-03-V-17	x	dirt mound
PV-29-03-V-18	x	dirt mound
PV-29-03-V-19	x	concrete
PV-29-03-V-22	x	depression
PV-29-03-V-23	x	concrete
PV-29-03-V-8	x	dirt mound
PY-13-01-V-2	x	concrete pipe
PY-13-01-V-4	x	dirt mound
PY-13-01-V-5	x	concrete

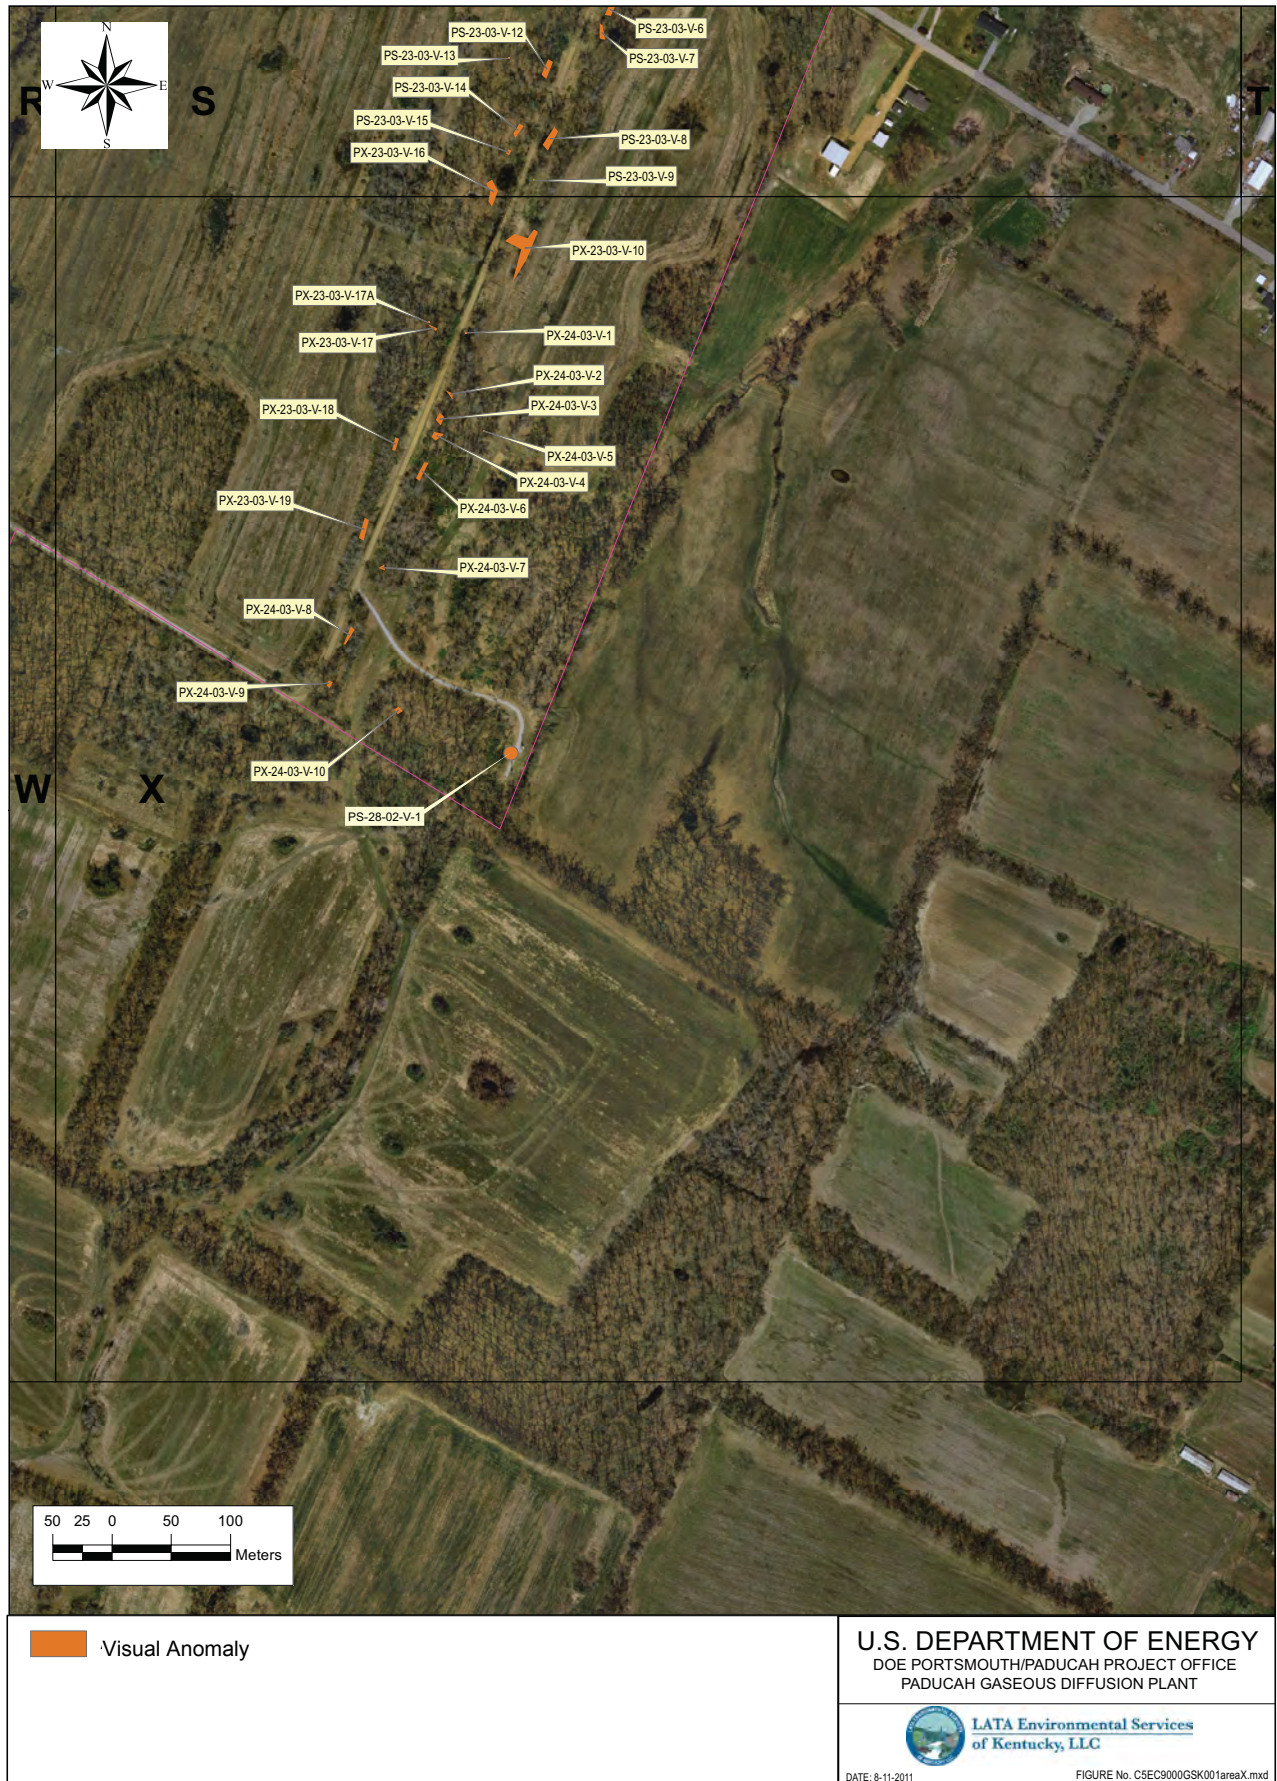
**Figure 4.30. Visual Anomaly Map Area X**

**Table 4.21. Anomalies within Area X**

<b>Anomaly Name</b>	<b>Photo</b>	<b>Description</b>
PS-28-02-V-1	N/A	dirt mound
PX-23-03-V-10	x	dirt mound, limbs, tree debris
PX-23-03-V-17	x	concrete
PX-23-03-V-17A	N/A	concrete
PX-23-03-V-18	x	dirt mound
PX-23-03-V-19	x	dirt mound
PX-24-03-V-1	N/A	dirt mound
PX-24-03-V-10	x	dirt mound
PX-24-03-V-2	N/A	dirt mound
PX-24-03-V-3	x	dirt mound
PX-24-03-V-4	x	dirt mound
PX-24-03-V-5	x	trash can
PX-24-03-V-6	x	dirt mound
PX-24-03-V-7	x	dirt mound
PX-24-03-V-8	x	dirt mound
PX-24-03-V-9	x	dirt mound

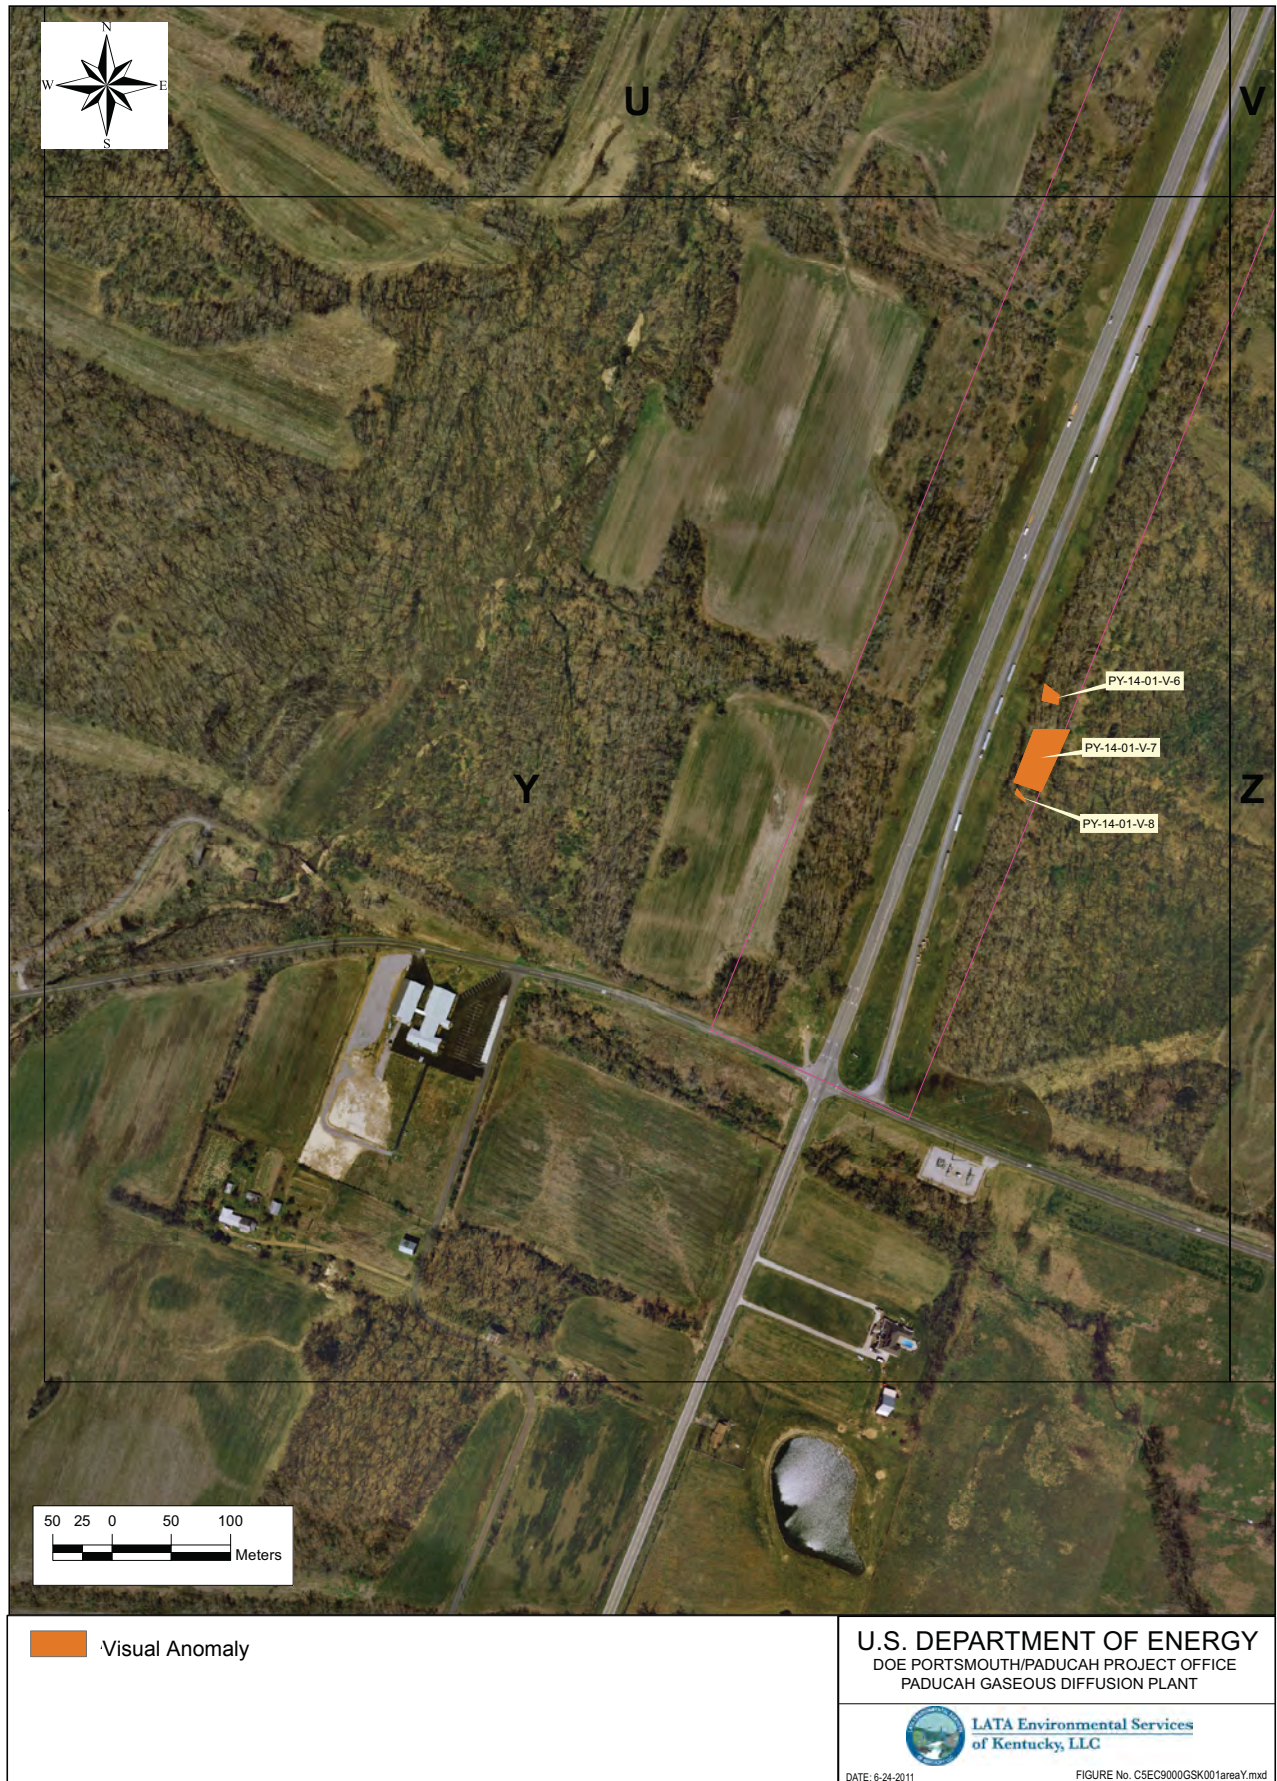
Figure 4.31. Visual Anomaly Map Area Y

**Table 4.22. Anomalies within Area Y**

<b>Anomaly Name</b>	<b>Photo</b>	<b>Description</b>
PY-14-01-V-6	x	dirt mound
PY-14-01-V-7	x	dirt mound, concrete
PY-14-01-V-8	x	dirt mound

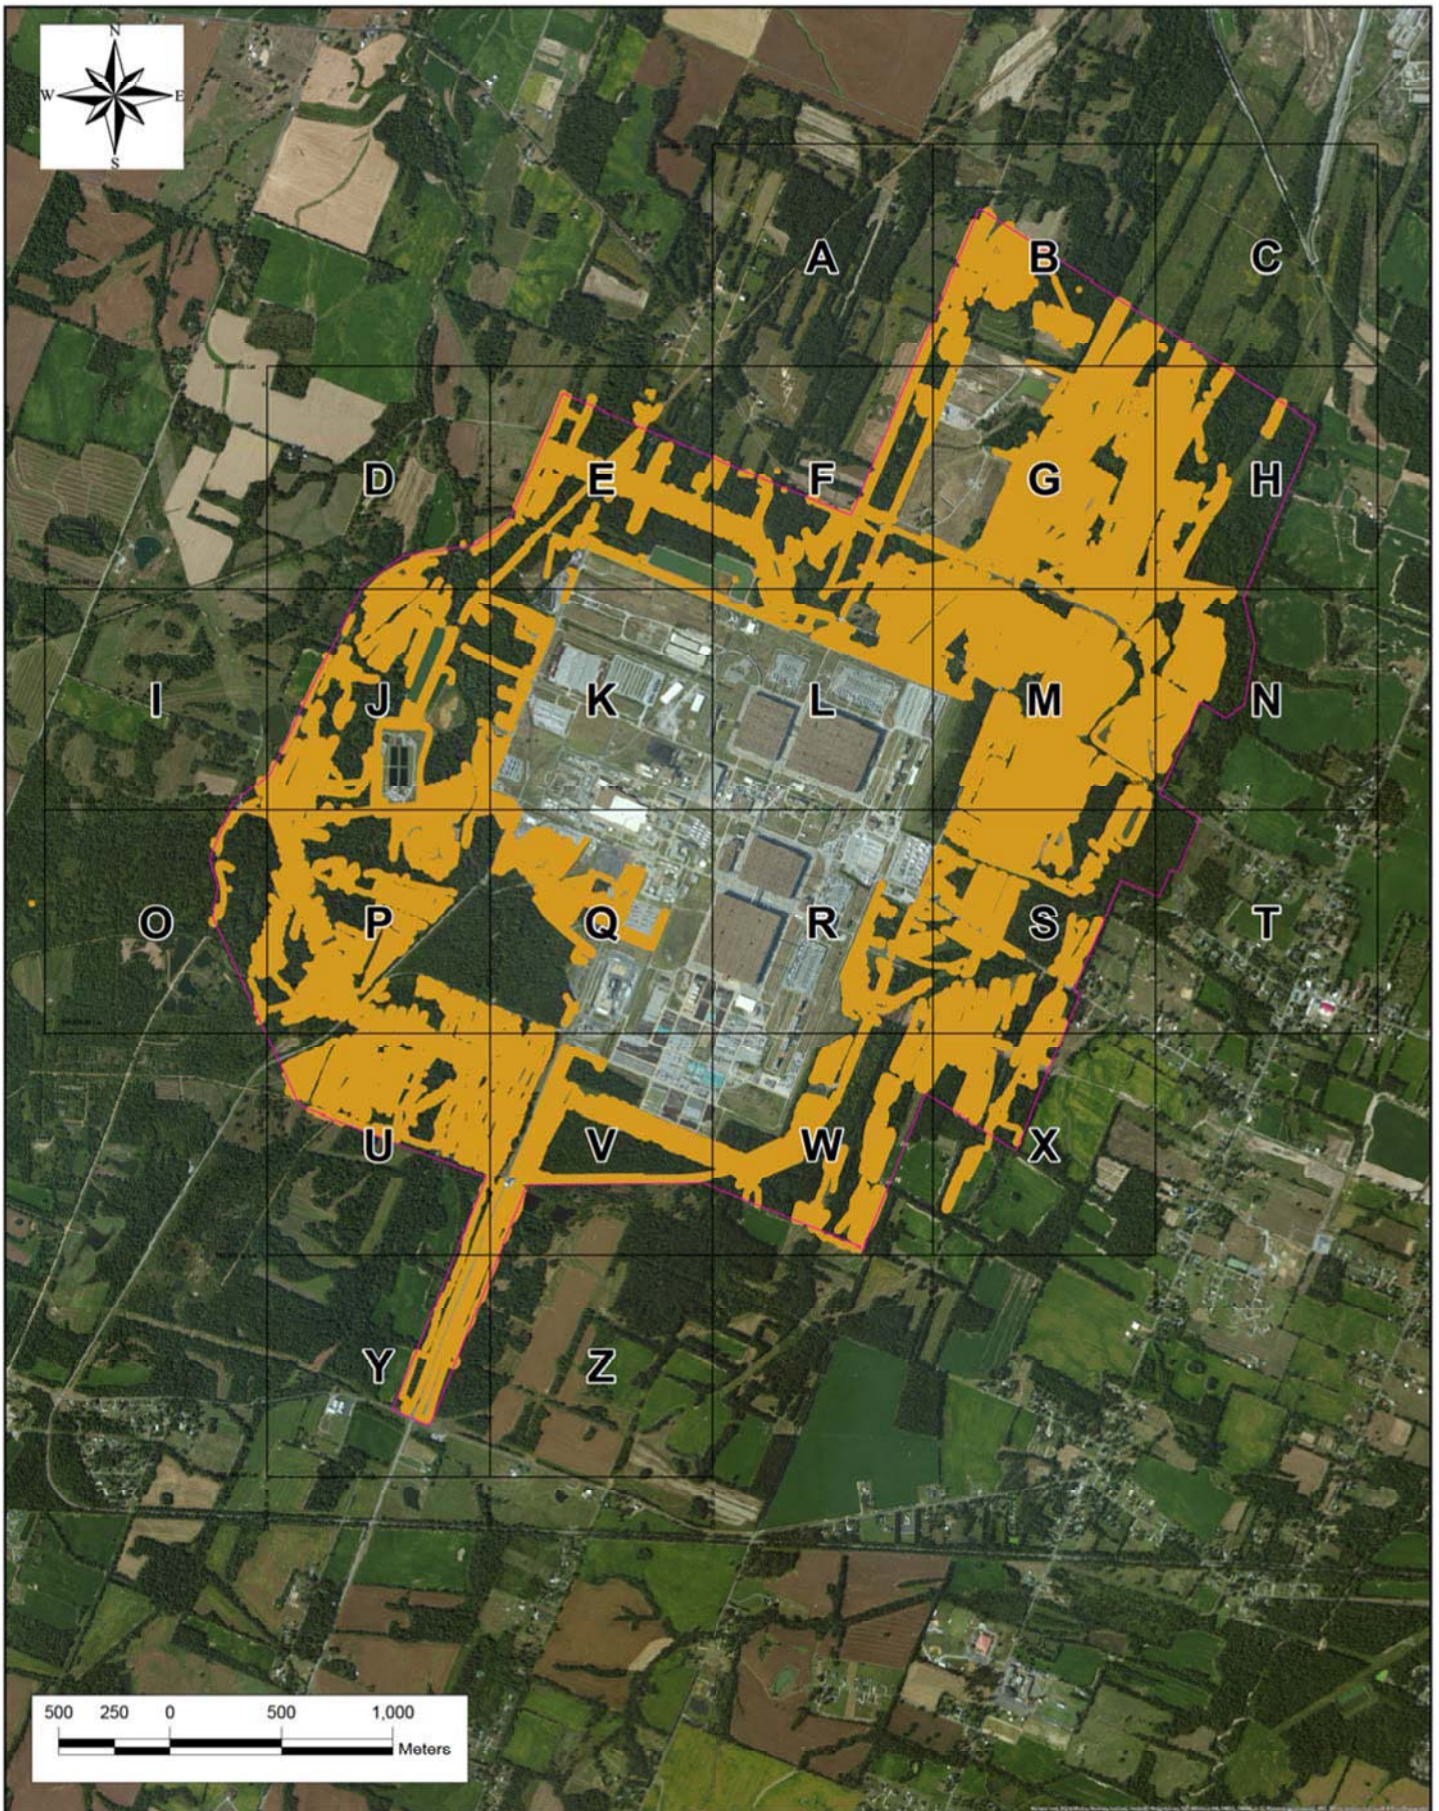
Figure 4.33. Radiological Walkover

Anomalies observed during the performance of the drive-over surveys also were surveyed by hand using a 3x3 detector.

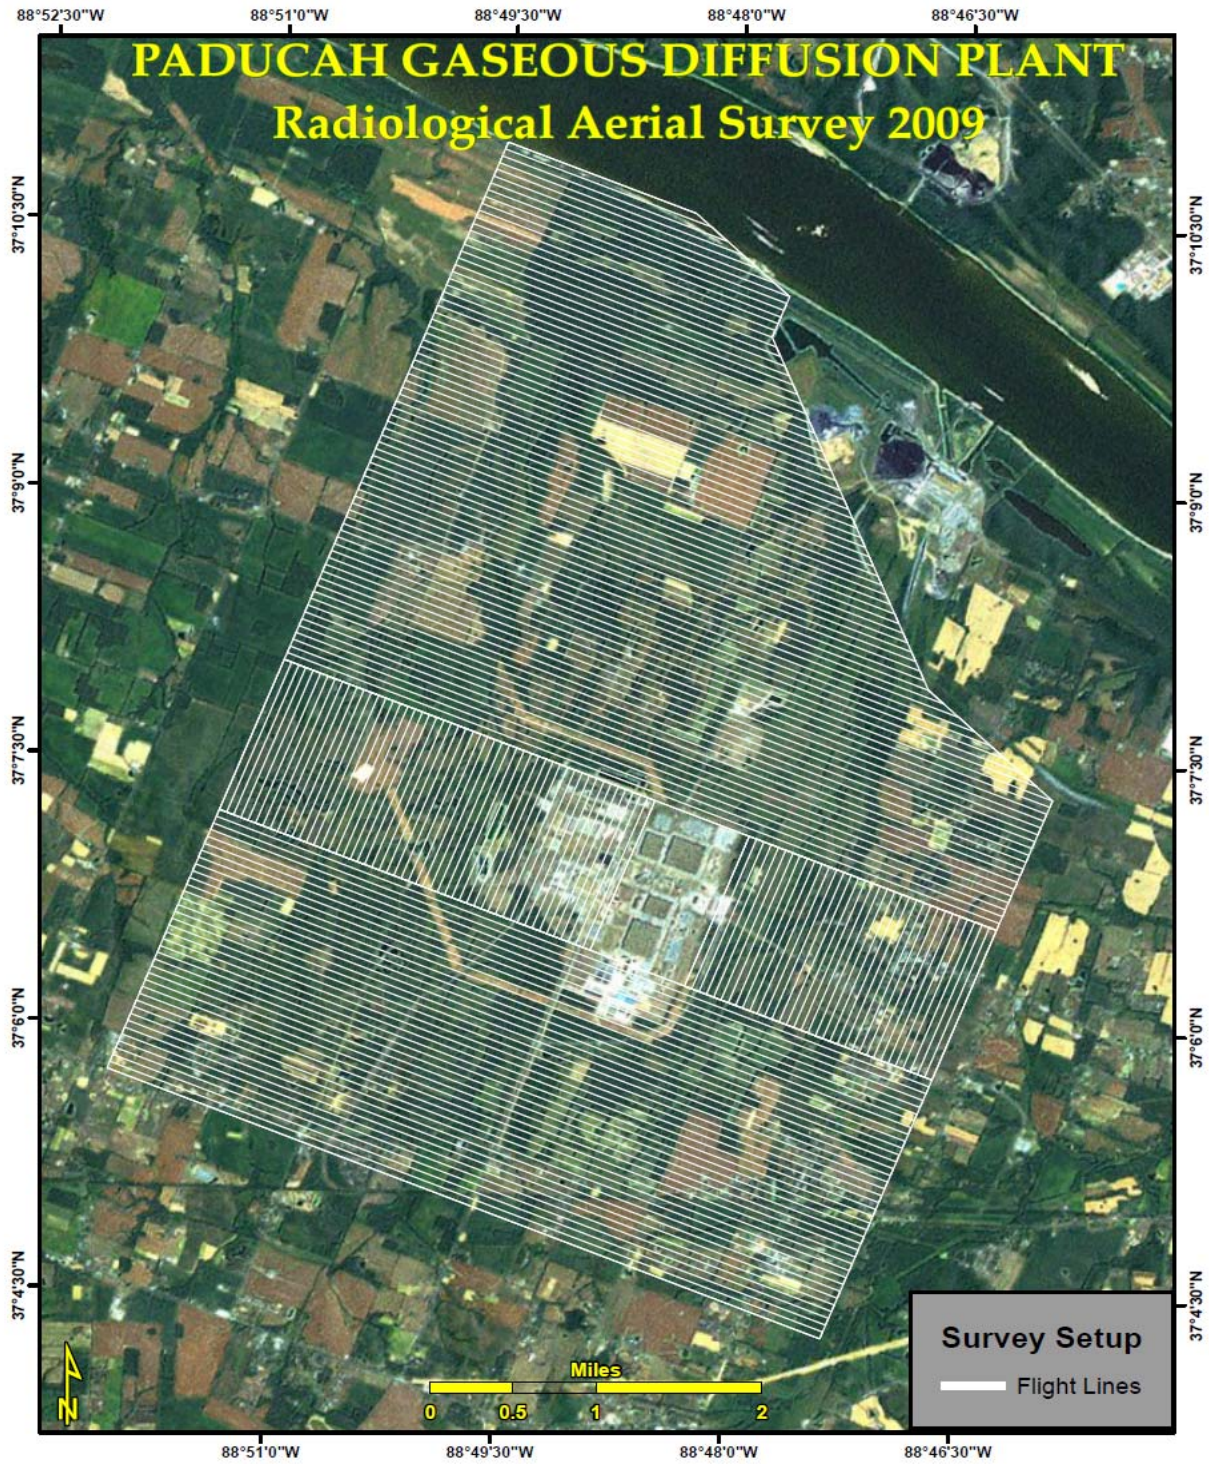
**Figure 1: Survey Setup for PGDP Aerial Survey. (The open region in the center of the survey area was a restricted flight zone.)**

The area was surveyed at a nominal ground speed of 70 knots (~36 meters per second) and a nominal altitude of 150 feet (~46 meters) above ground level (AGL). Parallel sets of flight lines spaced 250 feet (~76 meters) apart were flown. Due to flight restrictions over the PGDP, the survey area was broken into four regions, as shown in Figure 1. For the regions to the north and south of the restricted flight zone, the flight lines were flown in roughly an easterly or westerly direction. Conversely, the flight lines were flown in a generally northerly or southerly direction for the regions to the east and west of the restricted area. To assure data integrity and to monitor/correct for variations in detector background count rate due to aircraft, radon, and cosmic rays, measurements were made over a fixed test line and water line before and after each flight. The fixed test line was located along Ogden Landing Road, which is outside the eastern boundary of the survey area, and the fixed water line was over the Ohio River just to the northeast of the survey area.
