**TRANSMITTAL OF THE SITEWIDE EVALUATION REPORT FOR THE SOILS  
OPERABLE UNIT AT THE PADUCAH GASEOUS DIFFUSION PLANT, PADUCAH,  
KENTUCKY (DOE/LX/07-1256&D2)**

**Document Identification:** *Sitewide Evaluation Report for the Soils Operable Unit at the Paducah Gaseous Diffusion Plant, Paducah Kentucky, DOE/LX/07-1256&D2*

**DOE/LX/07-1256&D2  
Primary Document**

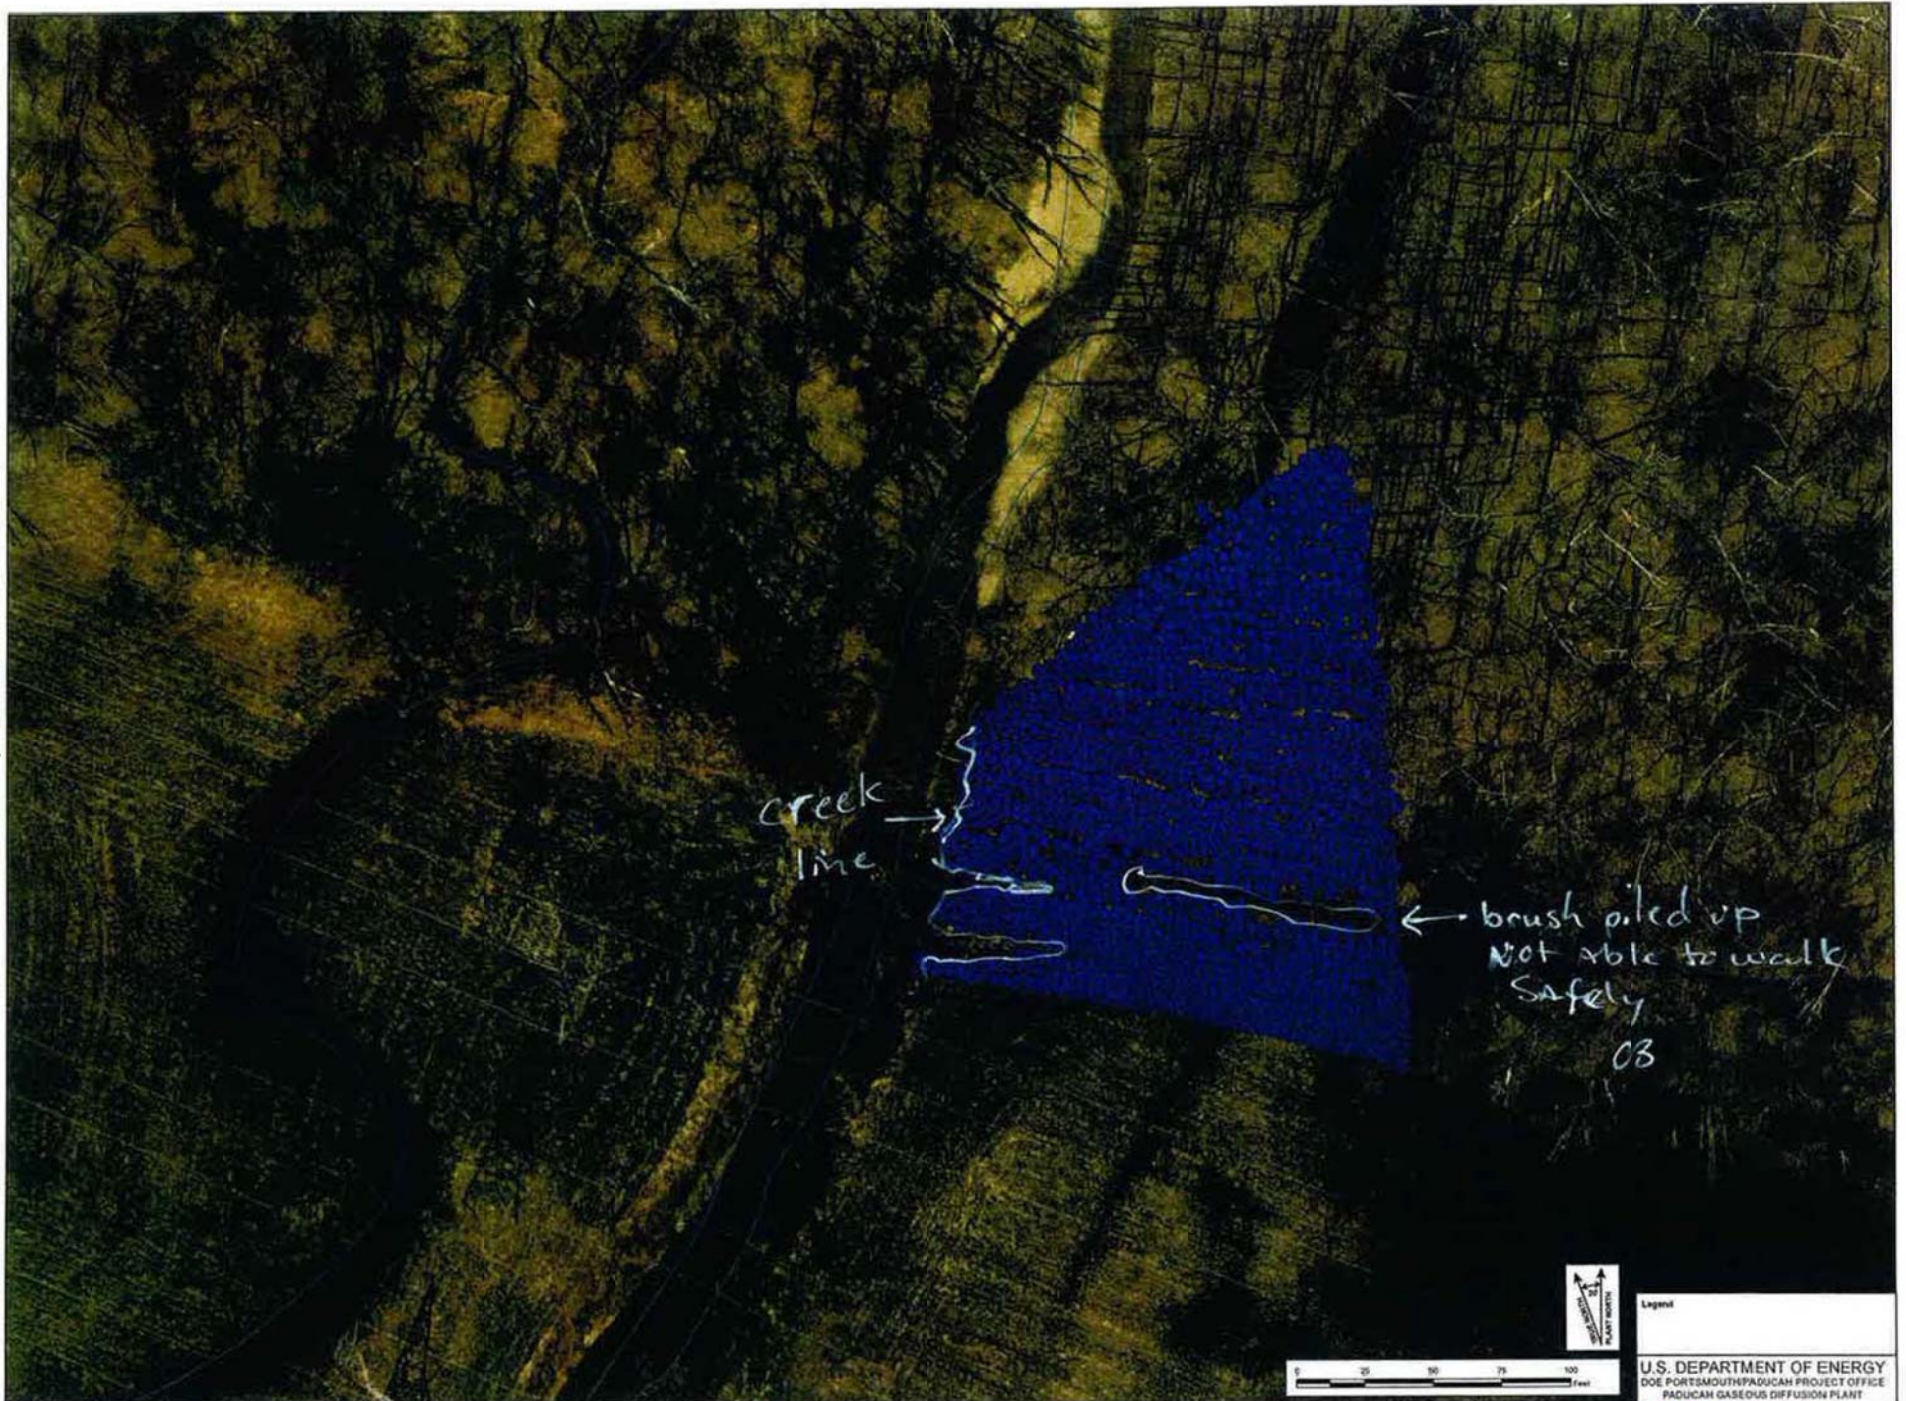
PQ-30-03-V-7 MAP

creek  
line →

← brush piled up  
Not able to walk  
safely  
03
