**REMEDIAL ACTION COMPLETION REPORT FOR *IN SITU* SOURCE TREATMENT  
BY DEEP SOIL MIXING OF THE SOUTHWEST GROUNDWATER PLUME  
VOLATILE ORGANIC SOURCE AT THE C-747-C OIL LANDFARM (SOLID WASTE  
MANAGEMENT UNIT 1) AT THE PADUCAH GASEOUS DIFFUSION PLANT,  
PADUCAH, KENTUCKY, DOE/LX/07-2405&D2**

**Remedial Action Completion Report  
for *In Situ* Source Treatment by Deep Soil Mixing  
of the Southwest Groundwater Plume Volatile Organic  
Source at the C-747-C Oil Landfarm  
(Solid Waste Management Unit 1),  
at Paducah Gaseous Diffusion Plant,  
Paducah, Kentucky**

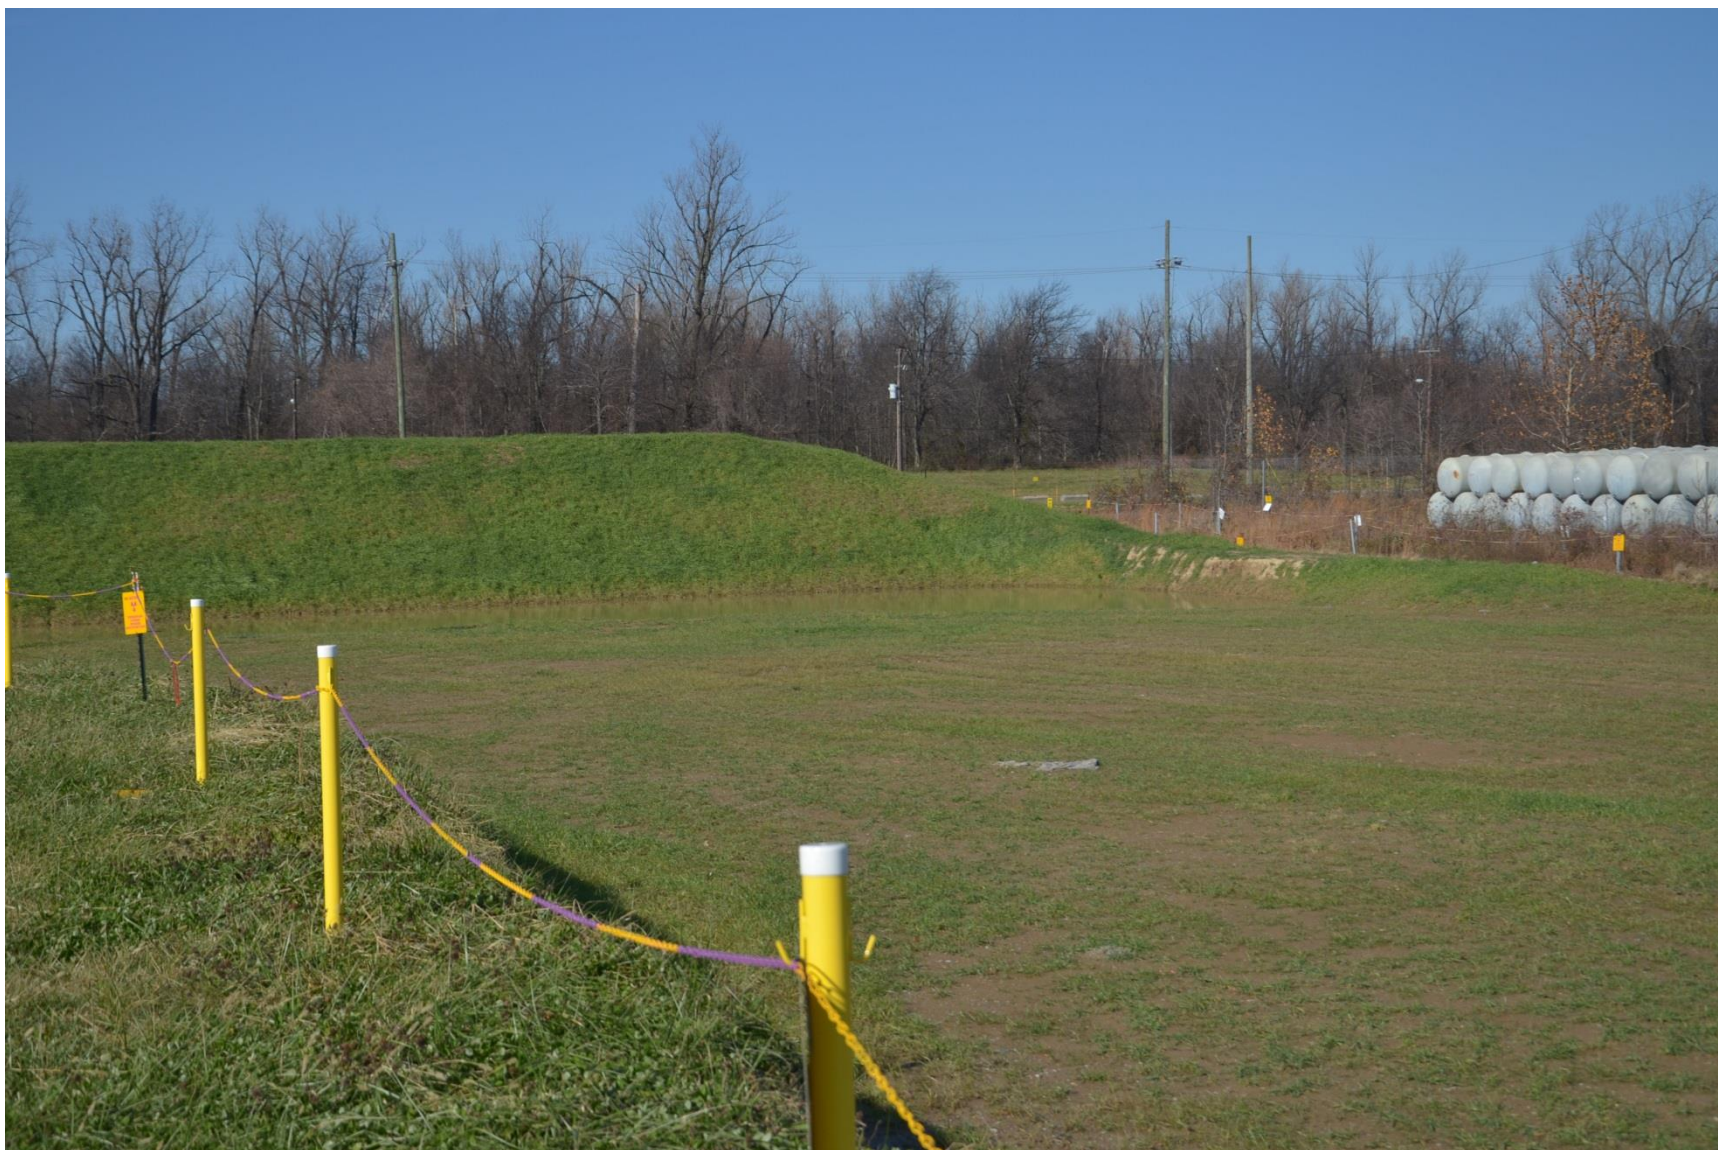
**Figure 4. SWMU 1 after Site Preparation and Soil Excavation (Looking Northwest on November 25, 2014)**

**Site Preparation and Soil Excavation.** The site preparation subtask was performed during the summer of 2014 and into early 2015. It included modifying the SWMU 1 area to that shown in Figure 4 and the following explanation:

- Excavated the area to be soil mixed to approximately 4 ft below ground surface (bgs) to remove identified alumina particles (trap-mix) that were present at SWMU 1 and located inside the soil mixing area;

- Performed gamma radiological walkover survey;
- Replaced approximately 2 ft of soil in the 4-ft deep excavation to make a less than 1% sloping surface for the soil mixing crane to operate on the soil mixing area. Constructed a 1% sloped pathway over SWMU 1 from 4th Street west to the soil mixing area, placed an aggregate base on access pathway for crane stability;
- Installed drainage culverts for conveying storm water around the soil mixing area; and
- Constructed a storm water containment pond to catch and convey storm water to a drainage ditch leading to Outfall 008.

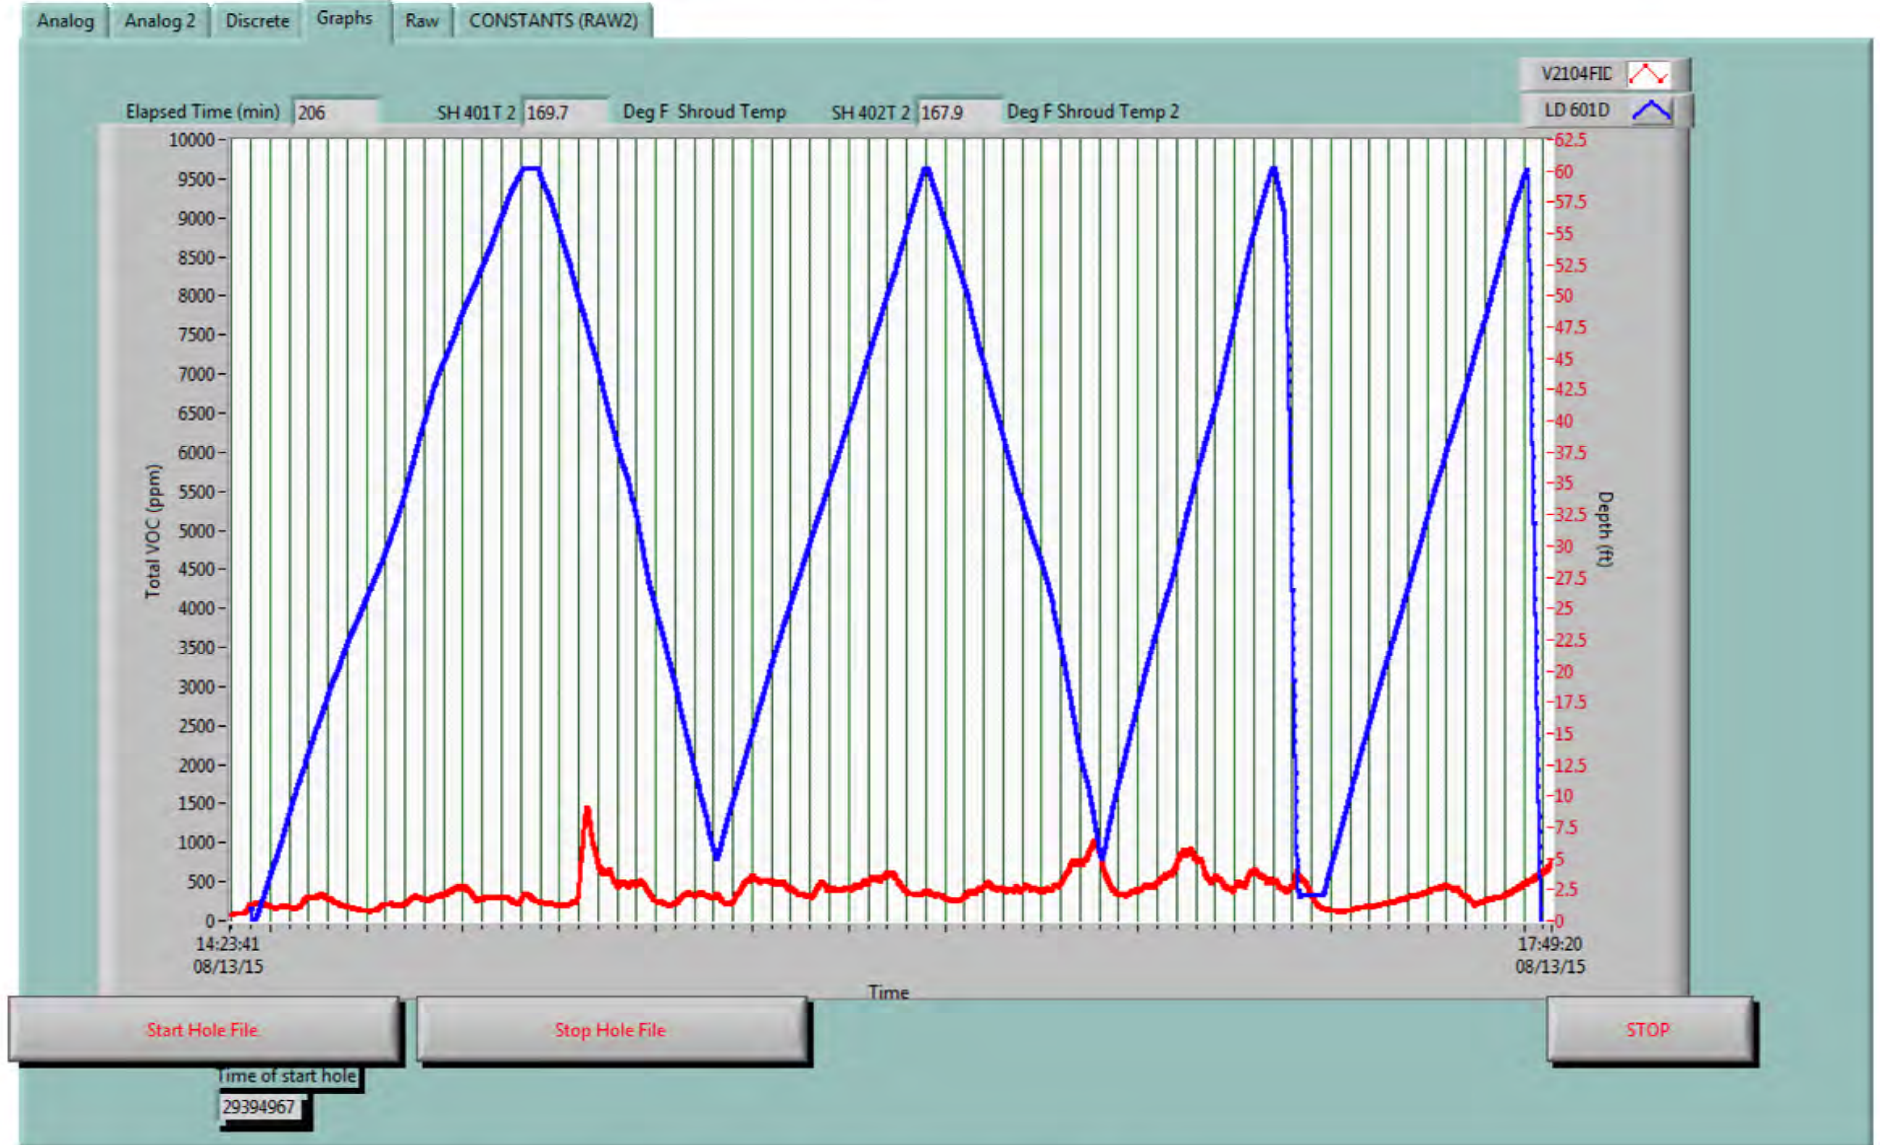
Figure 9. Soil Column 123 Labview® Graphic

The soil mixing treatment system was interfaced with control/monitoring software known as Labview<sup>®</sup>. Labview<sup>®</sup> provides a graphic indicating the depth of the soil mixing tool and the flame ionization detector VOC readings on a continuous basis versus time (see Figure 9). The vapor stream is also analyzed by two GCs, which pull live vapor samples offset by 3 minutes. The GCs analyze the vapor for the concentrations present of the target VOC compounds in the untreated vapor stream extracted from the soil column and prior to processing by the vapor conditioning system. Labview<sup>®</sup> also collects and assimilates the data from sensors on the steam generation and treatment system. This assimilation process allows the operators to determine on an instantaneous basis how the system is performing. Figure 10 presents a portion of the Labview<sup>®</sup>-collected performance shown in Microsoft Excel format output from the soil mixing of soil column 123. The explanation of information captured in the output is contained in Table 3. The system performance data in a Microsoft Excel format for all columns treated is included in Appendix B. The system performance data from the treatment of each column also is supplied in a graphical format captured in a Microsoft Word file format from the Labview<sup>®</sup> system. This information in electronic format also is included in Appendix B. Figure 11 presents a portion of the GC results collected from the treatment of soil column 123. The explanation of information captured in the output is contained in Table 4.

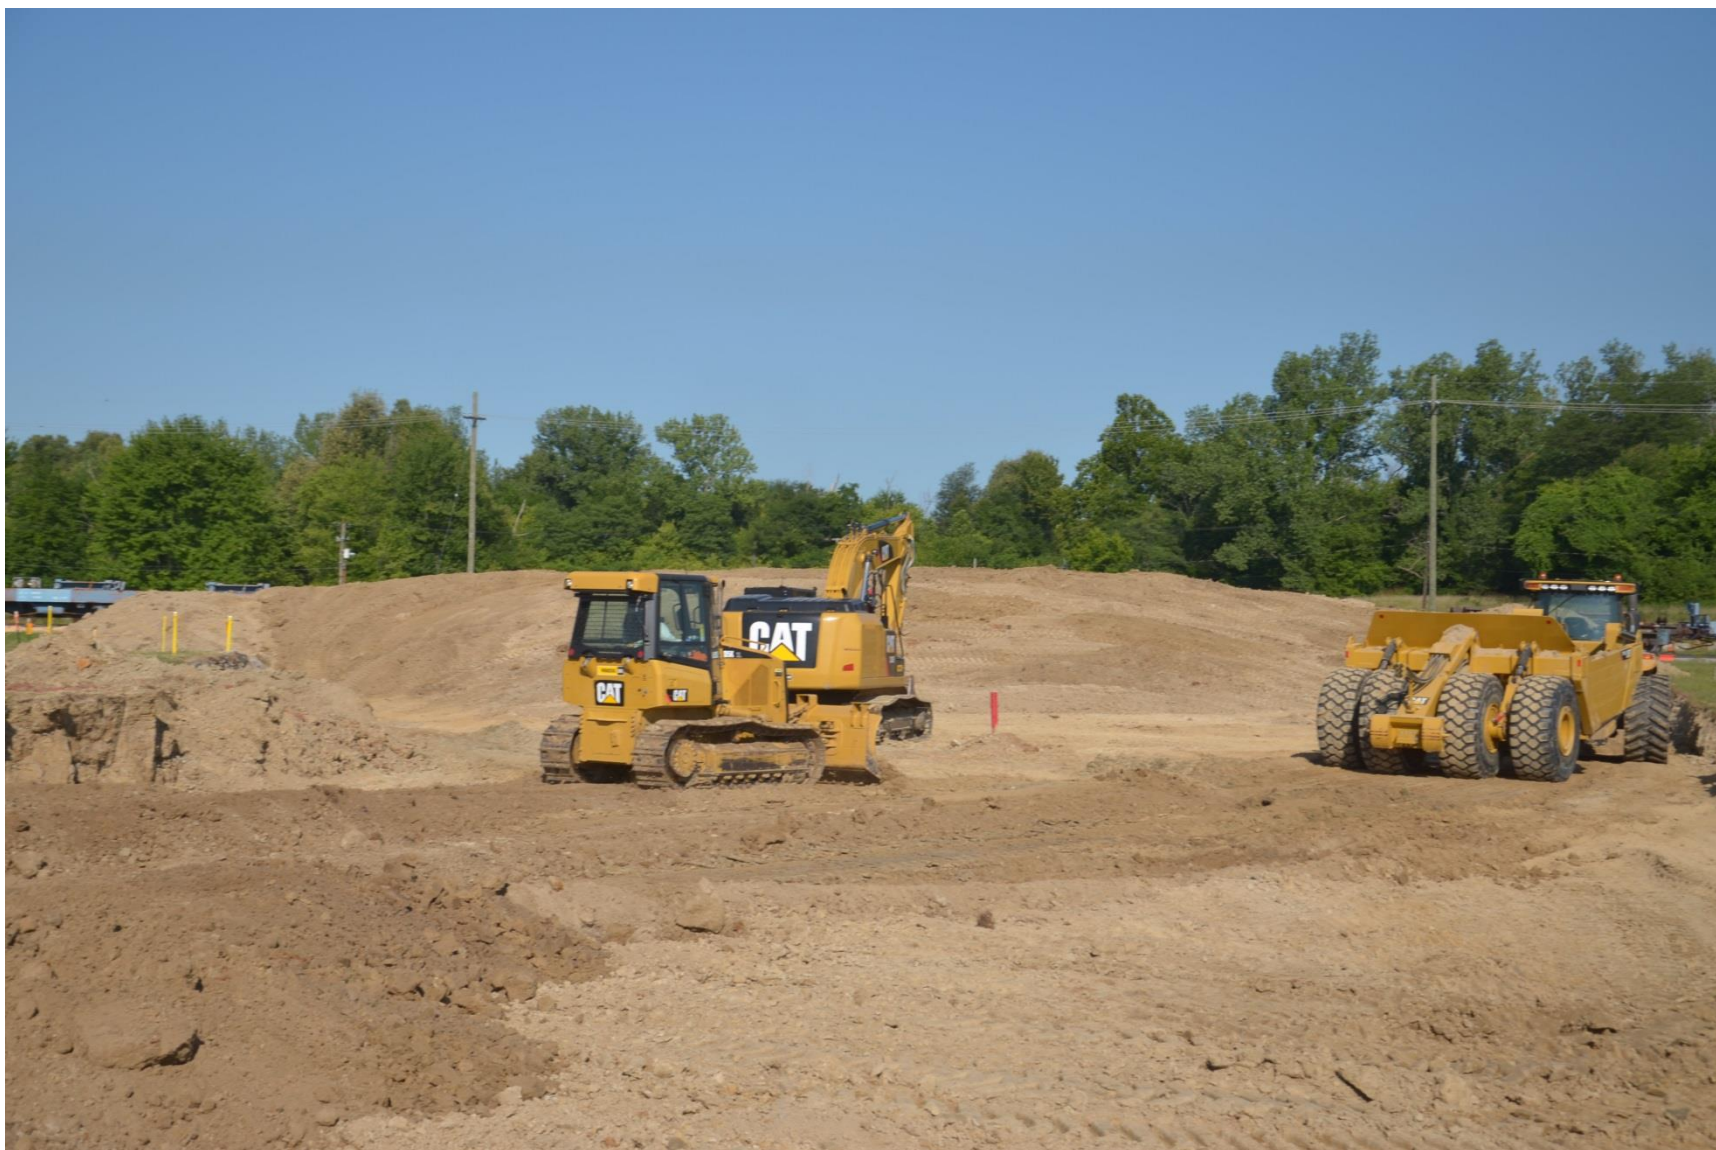
**Figure 12. SWMU 1 Excavated Soil Stockpile (Looking West on July 29, 2014)**

Excavation of the general area to be soil mixed was initiated in specific areas that an Electromagnetics 38 (EM-38) survey had identified potential subsurface anomalies. The EM-38 survey was performed to assist in identifying potential subsurface obstructions that could damage the soil mixing equipment. Some buried debris was identified in these anomaly areas as well as during the general excavation. The types of debris that were identified, collected, and disposed of included 25 drum lids and closure rings, poly drum covers, a crushed 16-gal drum, two 30-gal crushed drums, and a large quantity of alumina trap mix. Due to the quantity of the trap-mix and the small size of the individual pellets, the pellets along with associated soil was excavated and placed into intermodals for characterization and disposal. All other waste materials were containerized in intermodals for disposal after characterization. The remaining non-waste soils were excavated using a tractor and yardpan, bulldozer, and trackhoe excavator. These soils were carried to the western portion of the SWMU and stockpiled (Figure 12).

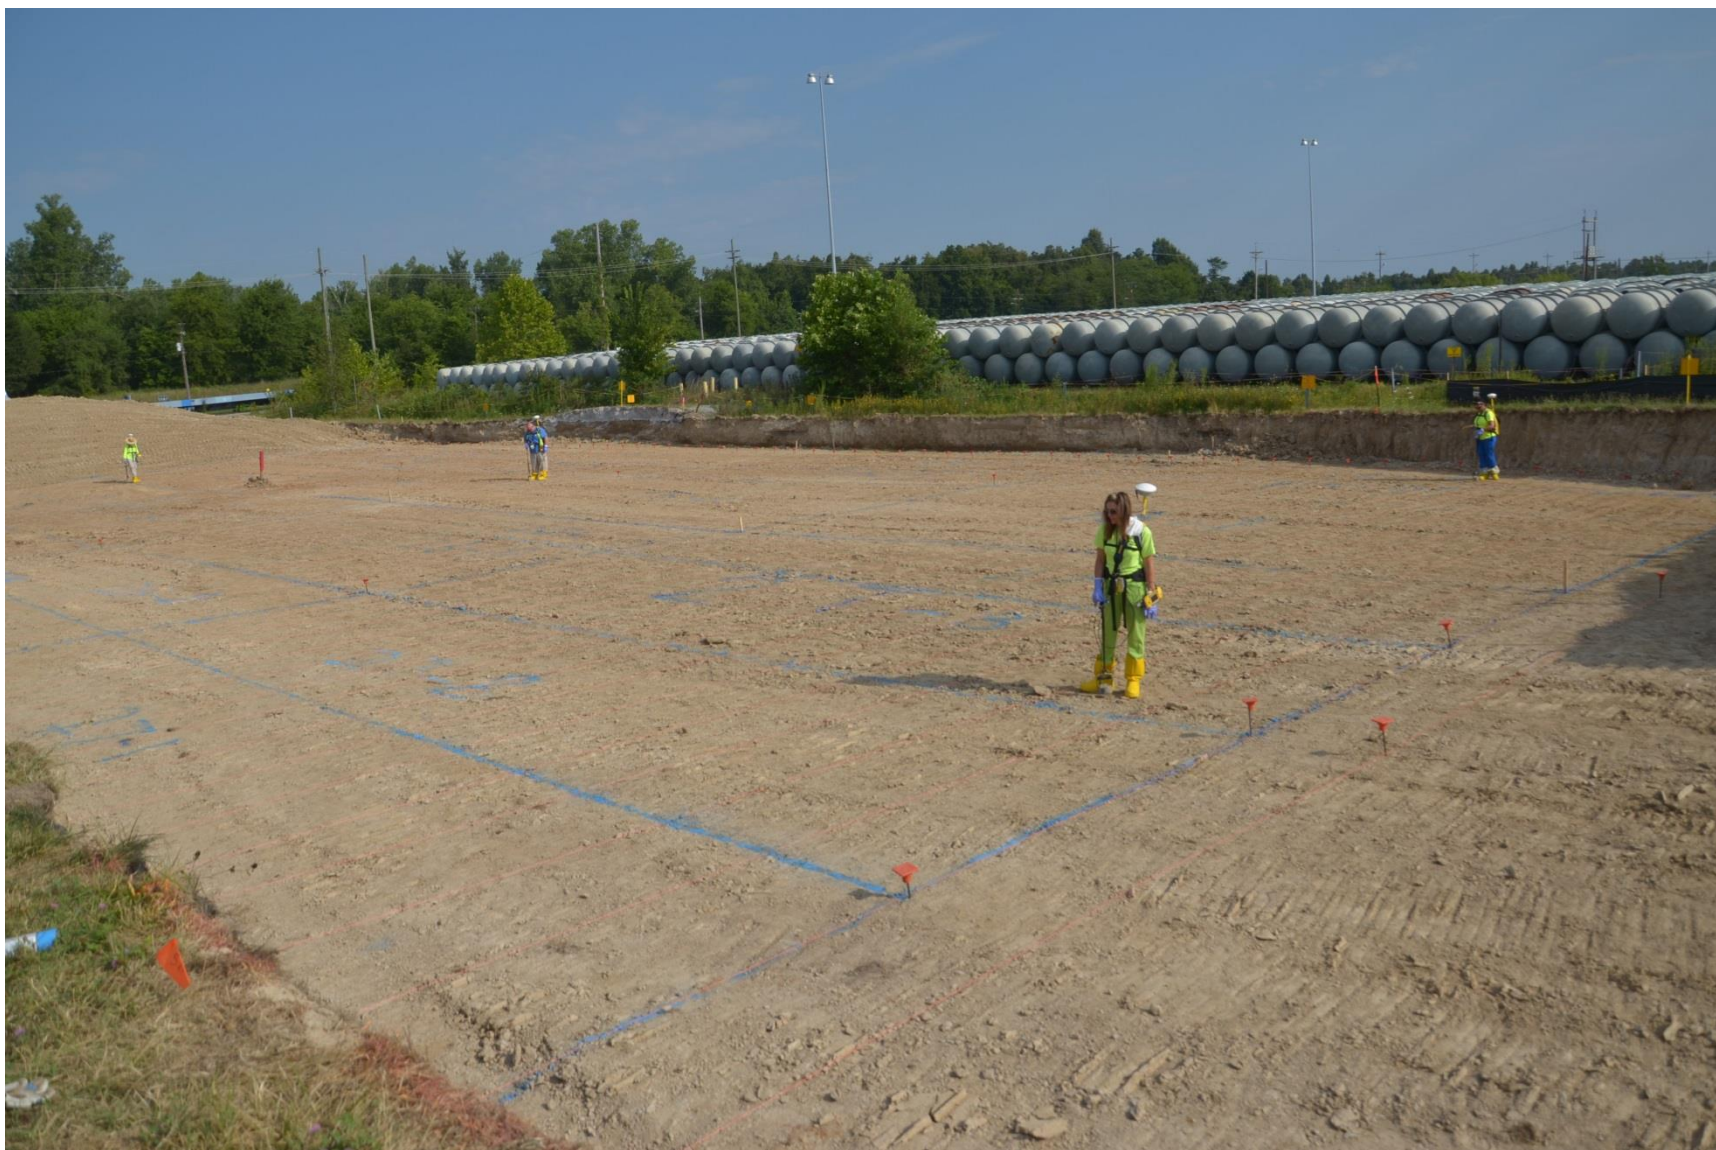
**Figure 13. SWMU 1 Grids for Radiological Scanning (Looking Northwest on August 1, 2014)**

Upon completing the removal of the 4 ft of soil from the general soil mixing area, the area was gridded in 45 ft by 45 ft areas. Radiological control technicians then used field instrumentation to scan the ground surface of each grid for elevated radiation, as prescribed in Section 12.2.8 of the RDR (Figures 13 and 14). Areas with elevated radiological readings were then marked for additional investigation to determine if a waste material was present (Figure 15). The additional radiological investigation did not identify additional waste materials to be containerized.

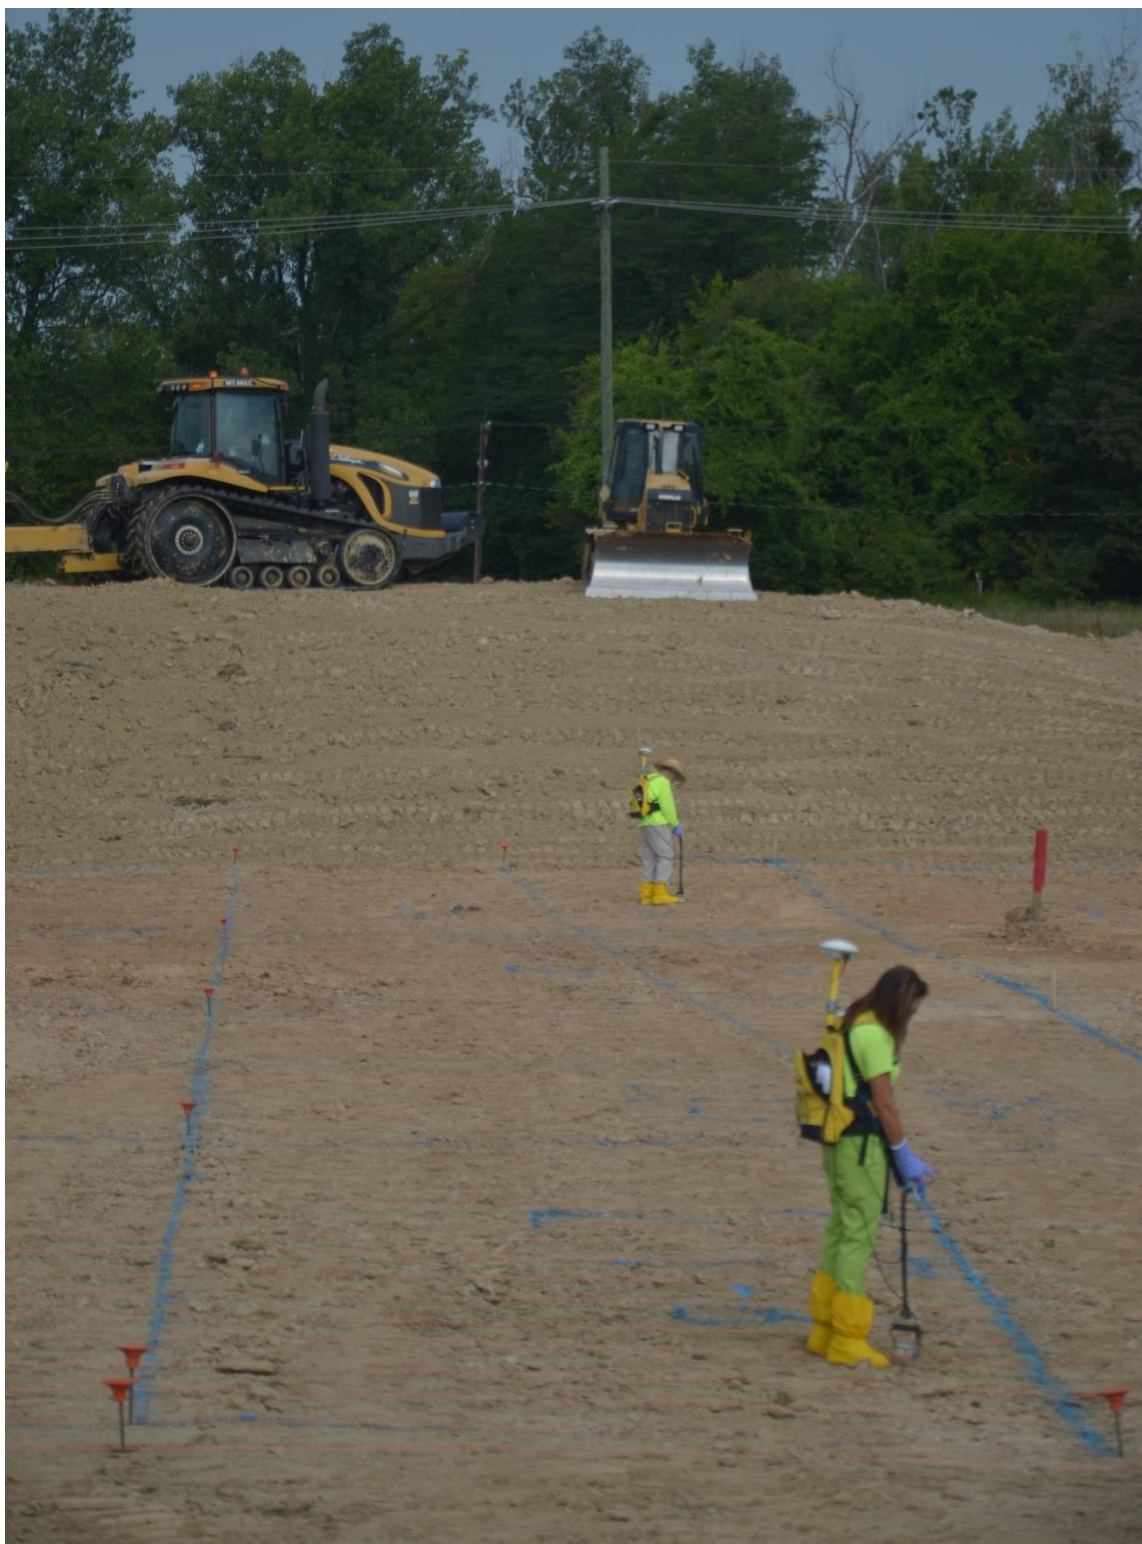
**Figure 14. Radiological Control Technicians Scanning Grids for Elevated Radiological Readings (looking West on August 1, 2014)**

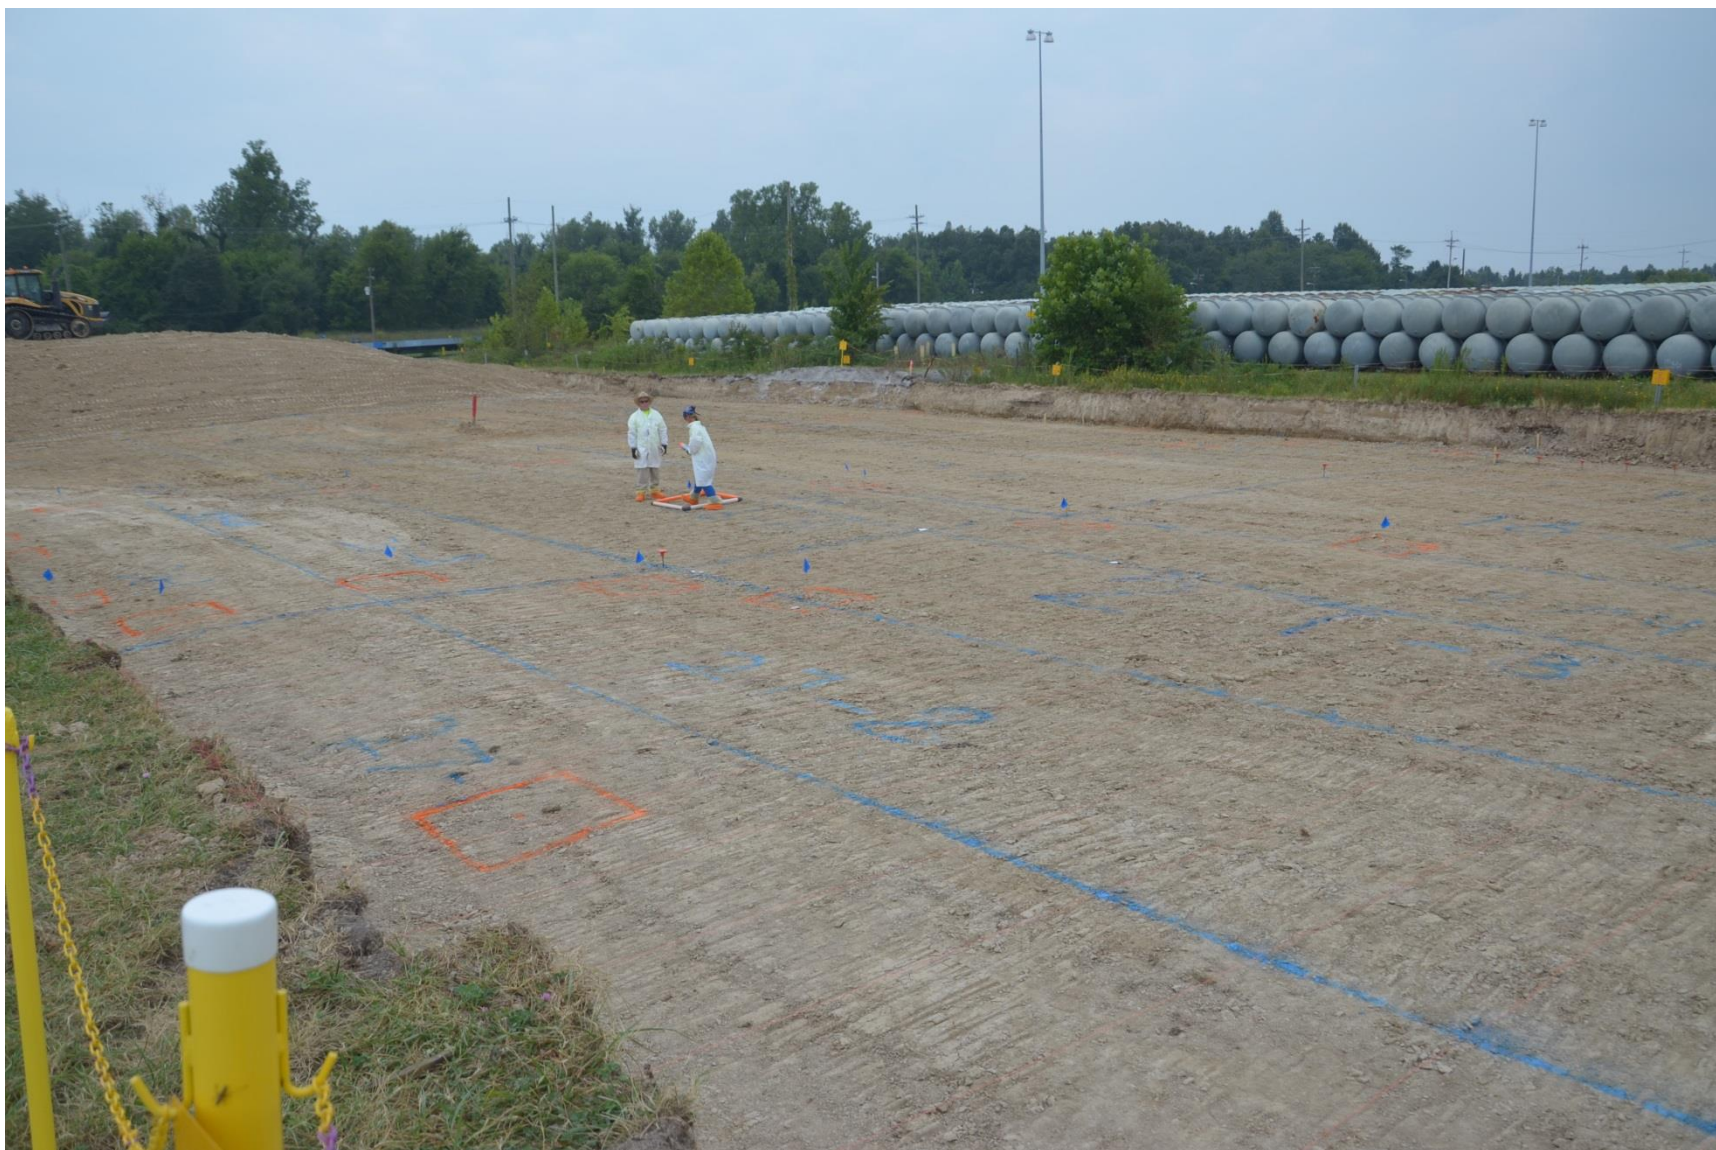
**Figure 15. Radiological Control Technicians Marking Areas for Further Scanning (Looking Northwest on August 5, 2014)**

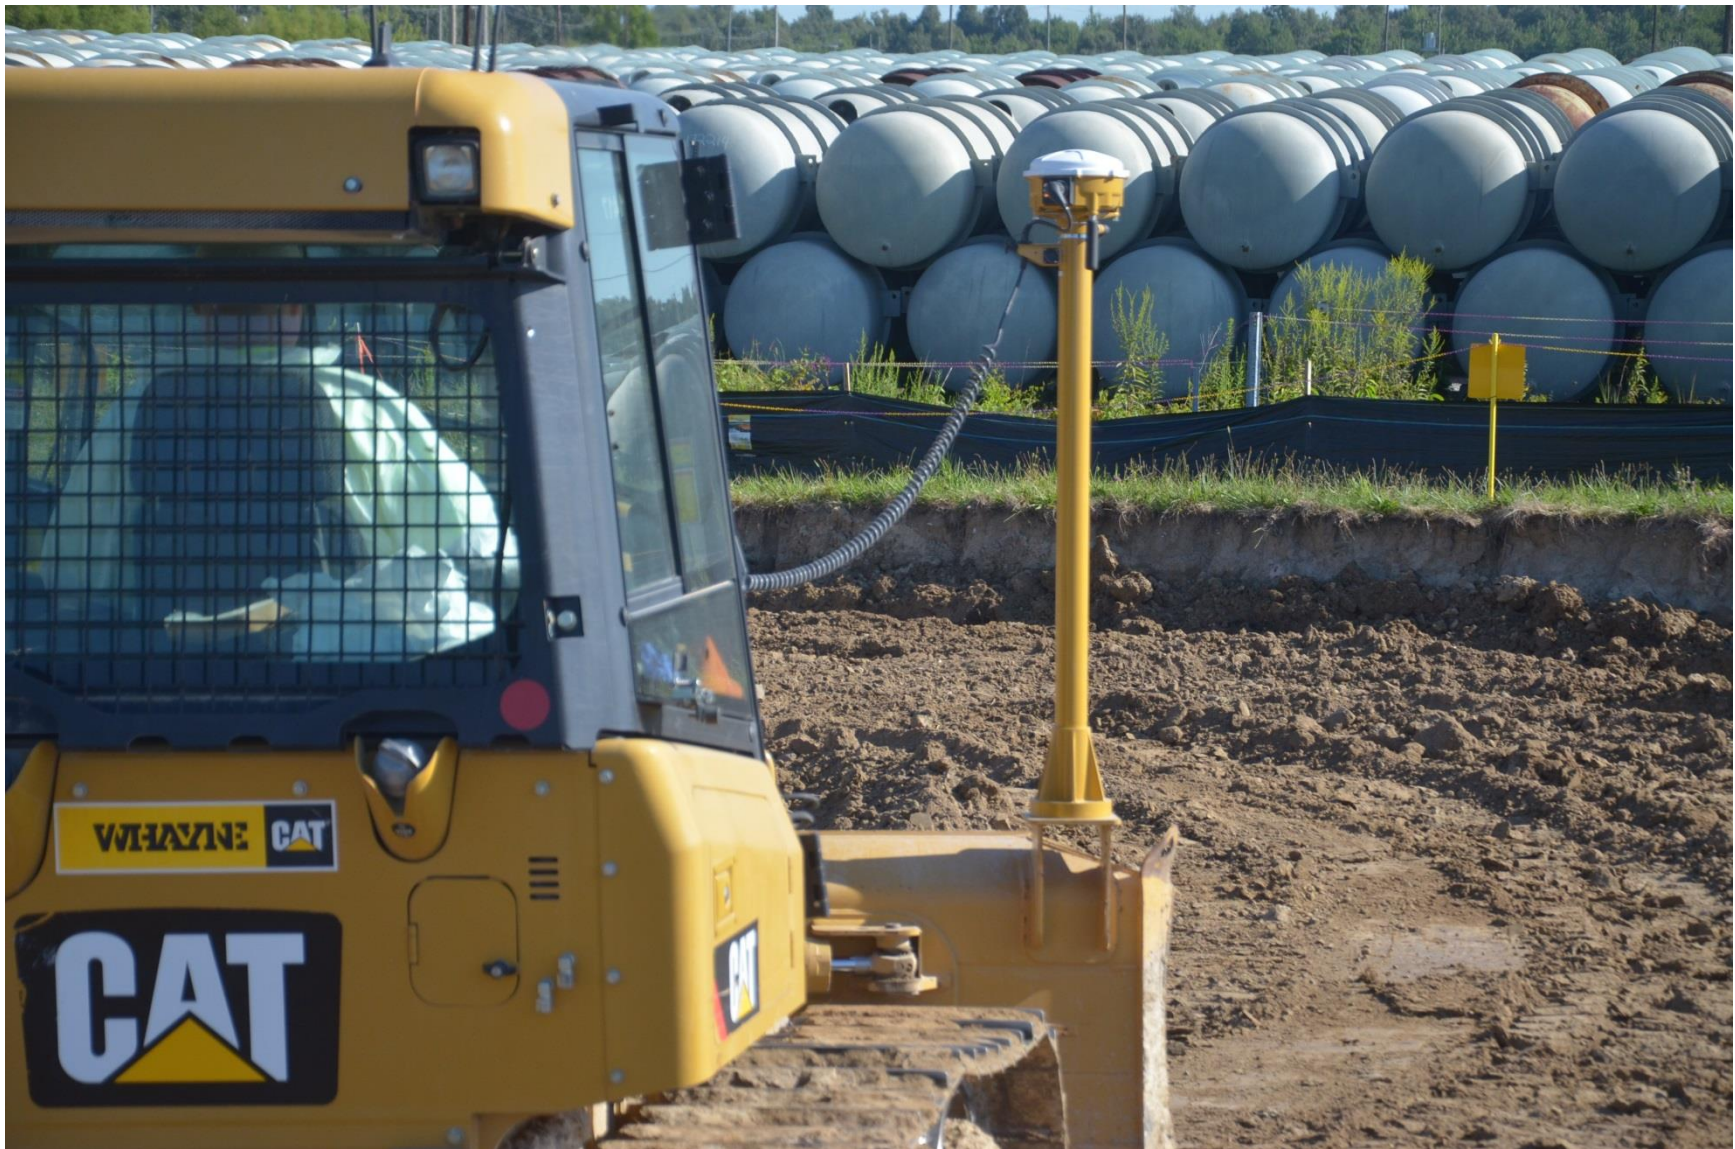
Figure 16. Bulldozer Mounted with AccuGrade™ System (Looking North on August 14, 2014)

The final portion of the excavation of soils subtask was to replace approximately 2 ft of soil back into the 4 ft deep excavation, compact the soil, and finish the replaced soil to a less than 1% slope. Soil was replaced using a bulldozer with a Caterpillar AccuGrade™ Grade Control System to control surface elevation and provide the needed 1% grade (Figure 16). During replacement, the soil was compacted with a vibratory roller. The final grade of the replaced soil provided the surface from which the soil mixing process took place. Additionally, a storm water basin with overflow piping was excavated at the western end of the SWMU 1 to allow control of storm water. For stability control of the soil mixing crane, a 30-ft driveway from the soil mixing area east to 4th Street provided the soil mixing equipment access. As with the slope of the soil mixing area, the driveway was excavated with a less than 1% slope. The driveway then was covered with approximately 1 ft of #3 stone, which was underlain with a geotextile (see Figure 17). The stone was vibration compacted to assist in achieving a suitable slope and better density for the crane and equipment to travel over. The entire soil exposed area was covered with hydromulch and seeded for erosion control until soil mixing operations began (see Figures 18 and 19). Sediment control materials and equipment were maintained during the soil excavation period and the initiation of the soil mixing. The SWMU 1 area, following the completion of the soil excavation phase and the planned layout of soil mixing columns and support equipment, is shown in Figure 20.

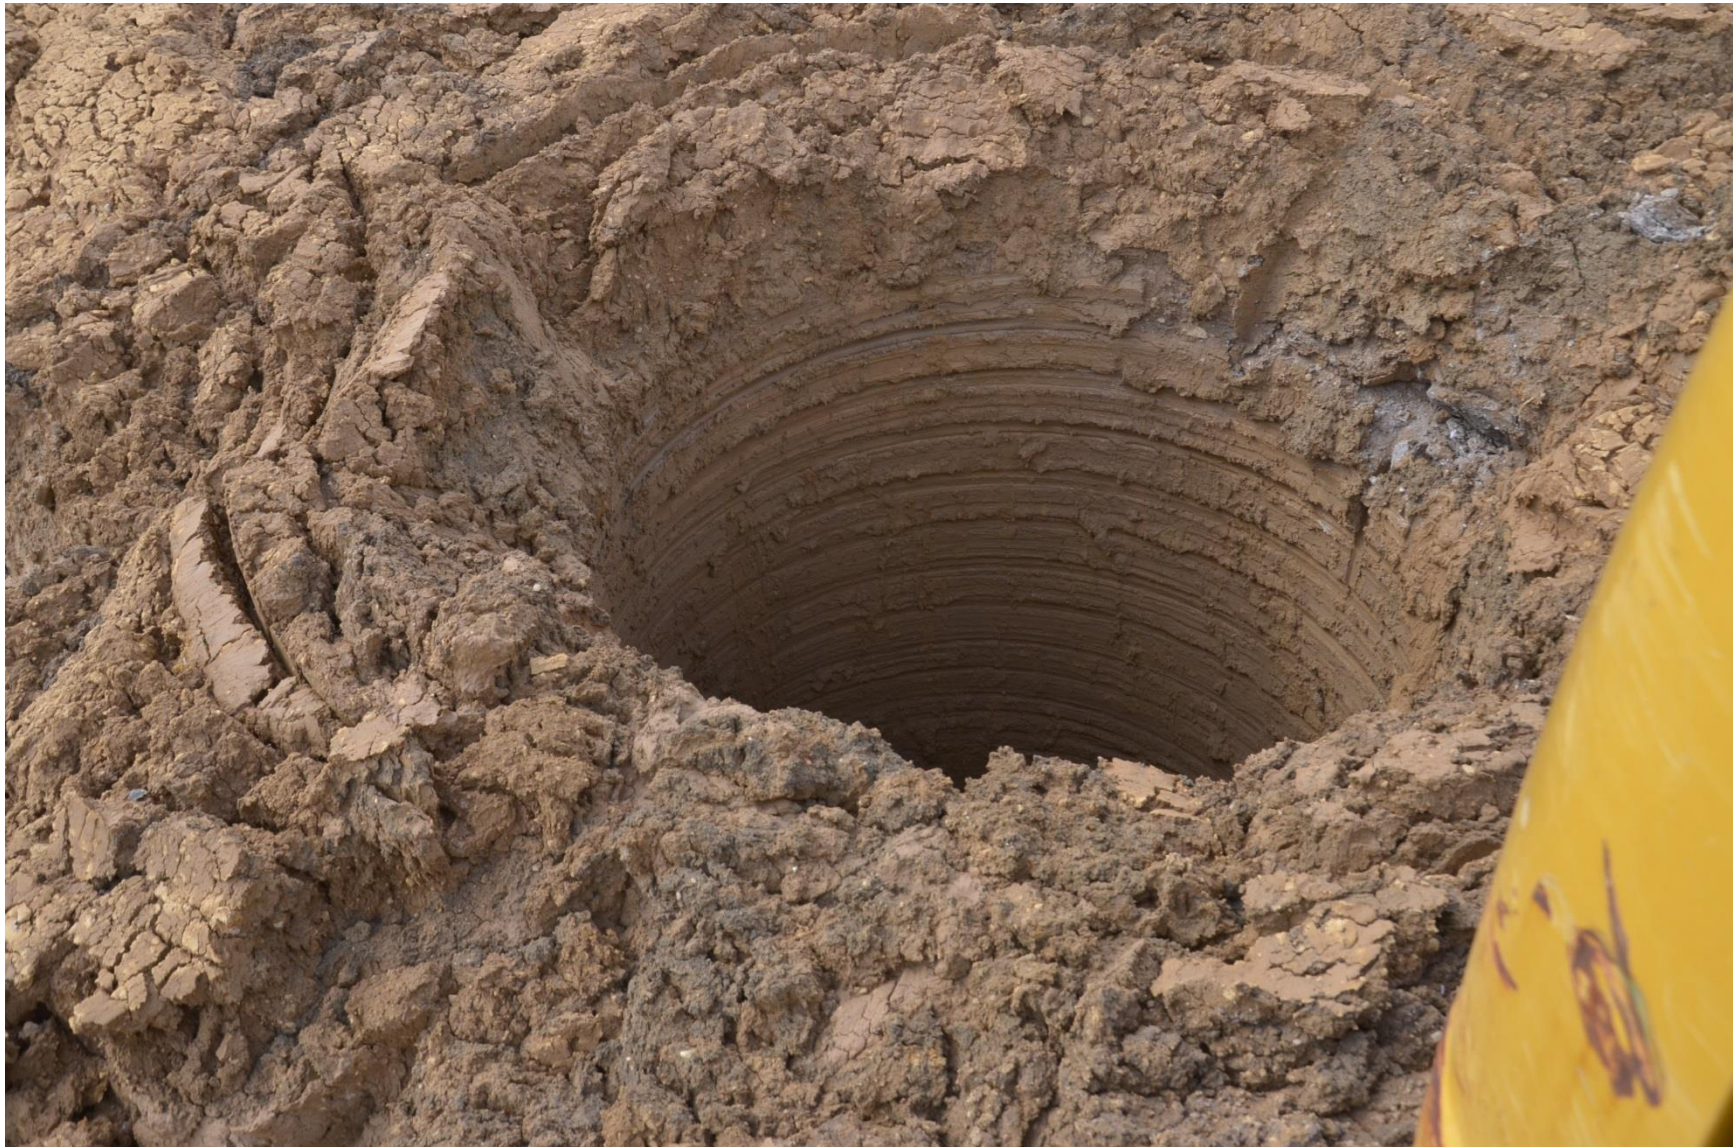
**Figure 24. Photo Indicating Hole in the Ground Left by Soil Ejection Resulting from a Particularly Strong Soil Burp  
(Hole was ~ 8 ft wide—Taken on April 20, 2015)**

- Unexpected ejection of loose soil from the soil column onto the ground surface (Figure 24);
- Violent movement (raising and falling) of the steam shroud, drilling assembly, and crane cables;
- Excess pressure on the vapor vacuum hose resulting in hose disconnection and vacuum loss; and
- Creation of steam vapor vents through the adjacent soil or from beneath the bottom edge of the shroud.

A number of methods were attempted to reduce the occurrence of the “soil burping.” Ultimately, three actions mitigated the impacts of the soil burping:

- Adjusted treatment protocols to allow variable quantities of steam to be injected in the soil column to be able to control the heat contained in each soil column, but still attain the 160°F (excluding columns where the first thermal pass exhibited less than 100 ppm VOCs), as stipulated by the treatment protocols.
- Mixed, initially, each soil column with water from surface to depth in a process known as slurring to fluidize the soil, allowing the steam to move more easily through the column.
- Modified the method of connecting the shroud and the drilling assembly, changing it from a rigid connection to a chain connection that allowed for limited movement of the shroud with respect to the drill assembly. This modification allowed the shroud to absorb the shock of the soil burp without the energy propagating through the drilling assembly and shock-loading the suspension cables.

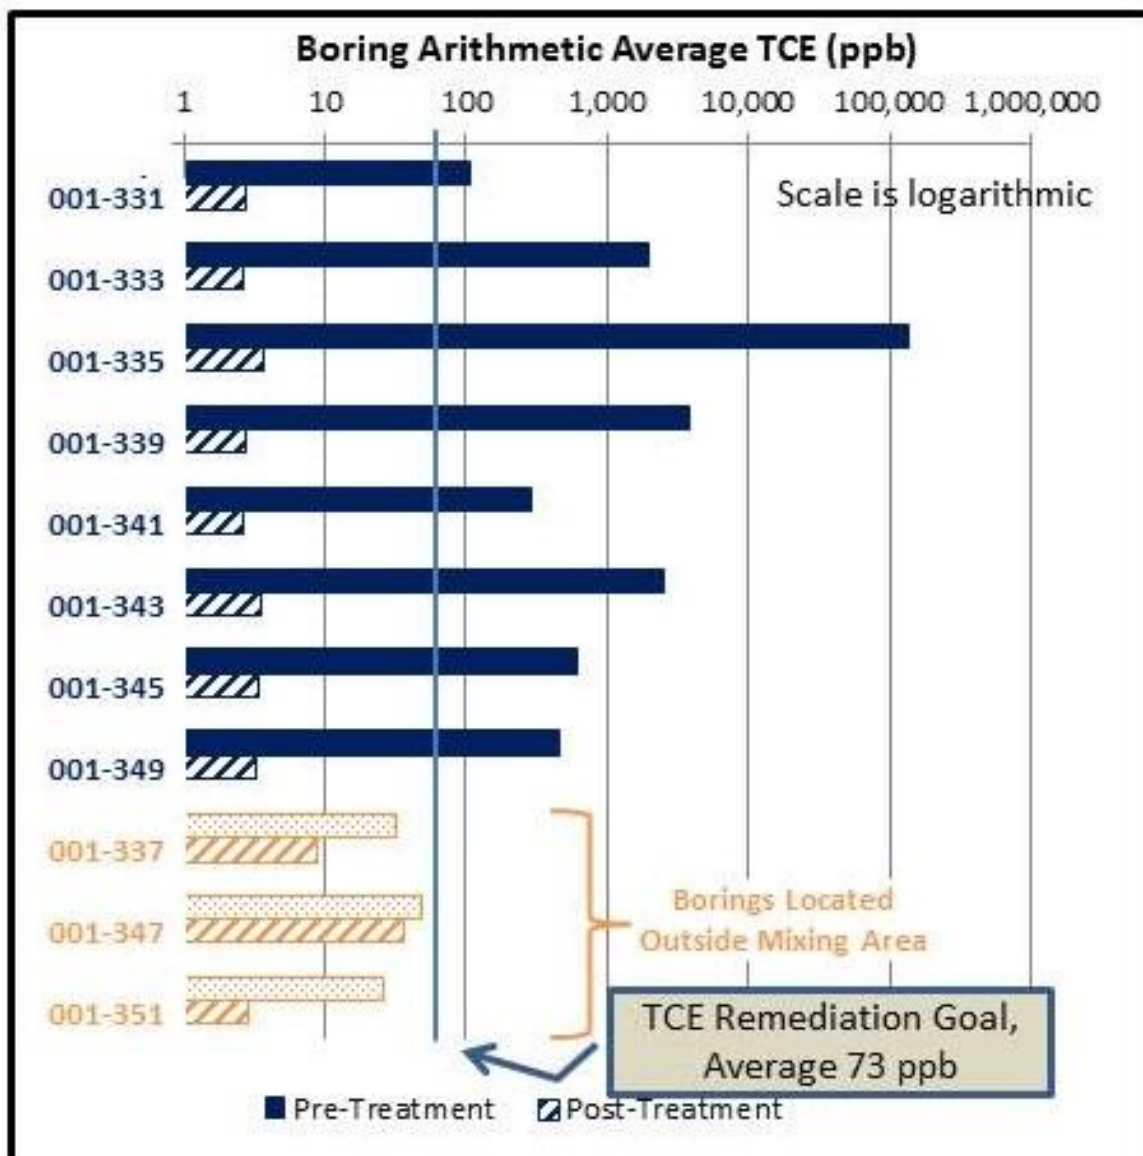
Figure 25. Arithmetic Average TCE Concentrations in Pre- and Post-Mixing Soil Borings

- Average post-treatment TCE soil contaminant concentrations were reduced by approximately 99% in the eight locations in the mixing area. compared to pre-mixing TCE contaminant concentrations.
- Average post-treatment TCE concentrations in those eight soil borings in the mixing area all were below the Upper Continental Recharge System soil TCE cleanup level of 73 ppb.
- Average TCE concentrations in the three soil borings drilled outside the soil mixing area showed that reductions in TCE contamination occurred; therefore, it is concluded that the soil mixing did not cause TCE contaminant migration outside of the mixing area.

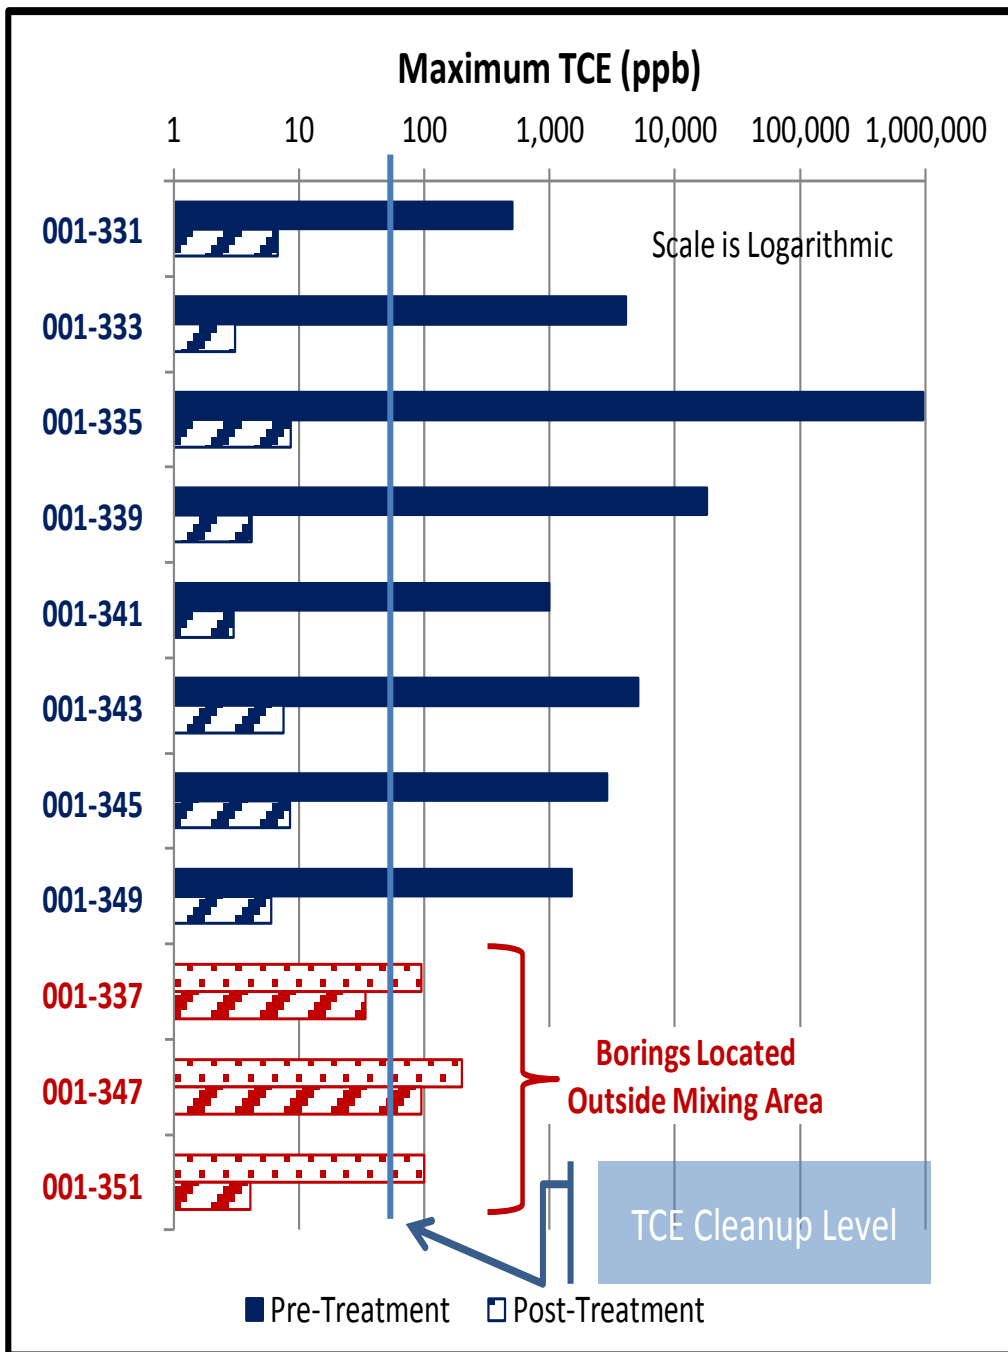
Figure 26. Maximum TCE Concentrations in Pre- and Post-Mixing Soil Borings
