**REMEDIAL ACTION COMPLETION REPORT FOR *IN SITU* SOURCE TREATMENT  
BY DEEP SOIL MIXING OF THE SOUTHWEST GROUNDWATER PLUME  
VOLATILE ORGANIC SOURCE AT THE C-747-C OIL LANDFARM (SOLID WASTE  
MANAGEMENT UNIT 1) AT THE PADUCAH GASEOUS DIFFUSION PLANT,  
PADUCAH, KENTUCKY, DOE/LX/07-2405&D2**

**Remedial Action Completion Report  
for *In Situ* Source Treatment by Deep Soil Mixing  
of the Southwest Groundwater Plume Volatile Organic  
Source at the C-747-C Oil Landfarm  
(Solid Waste Management Unit 1),  
at Paducah Gaseous Diffusion Plant,  
Paducah, Kentucky**

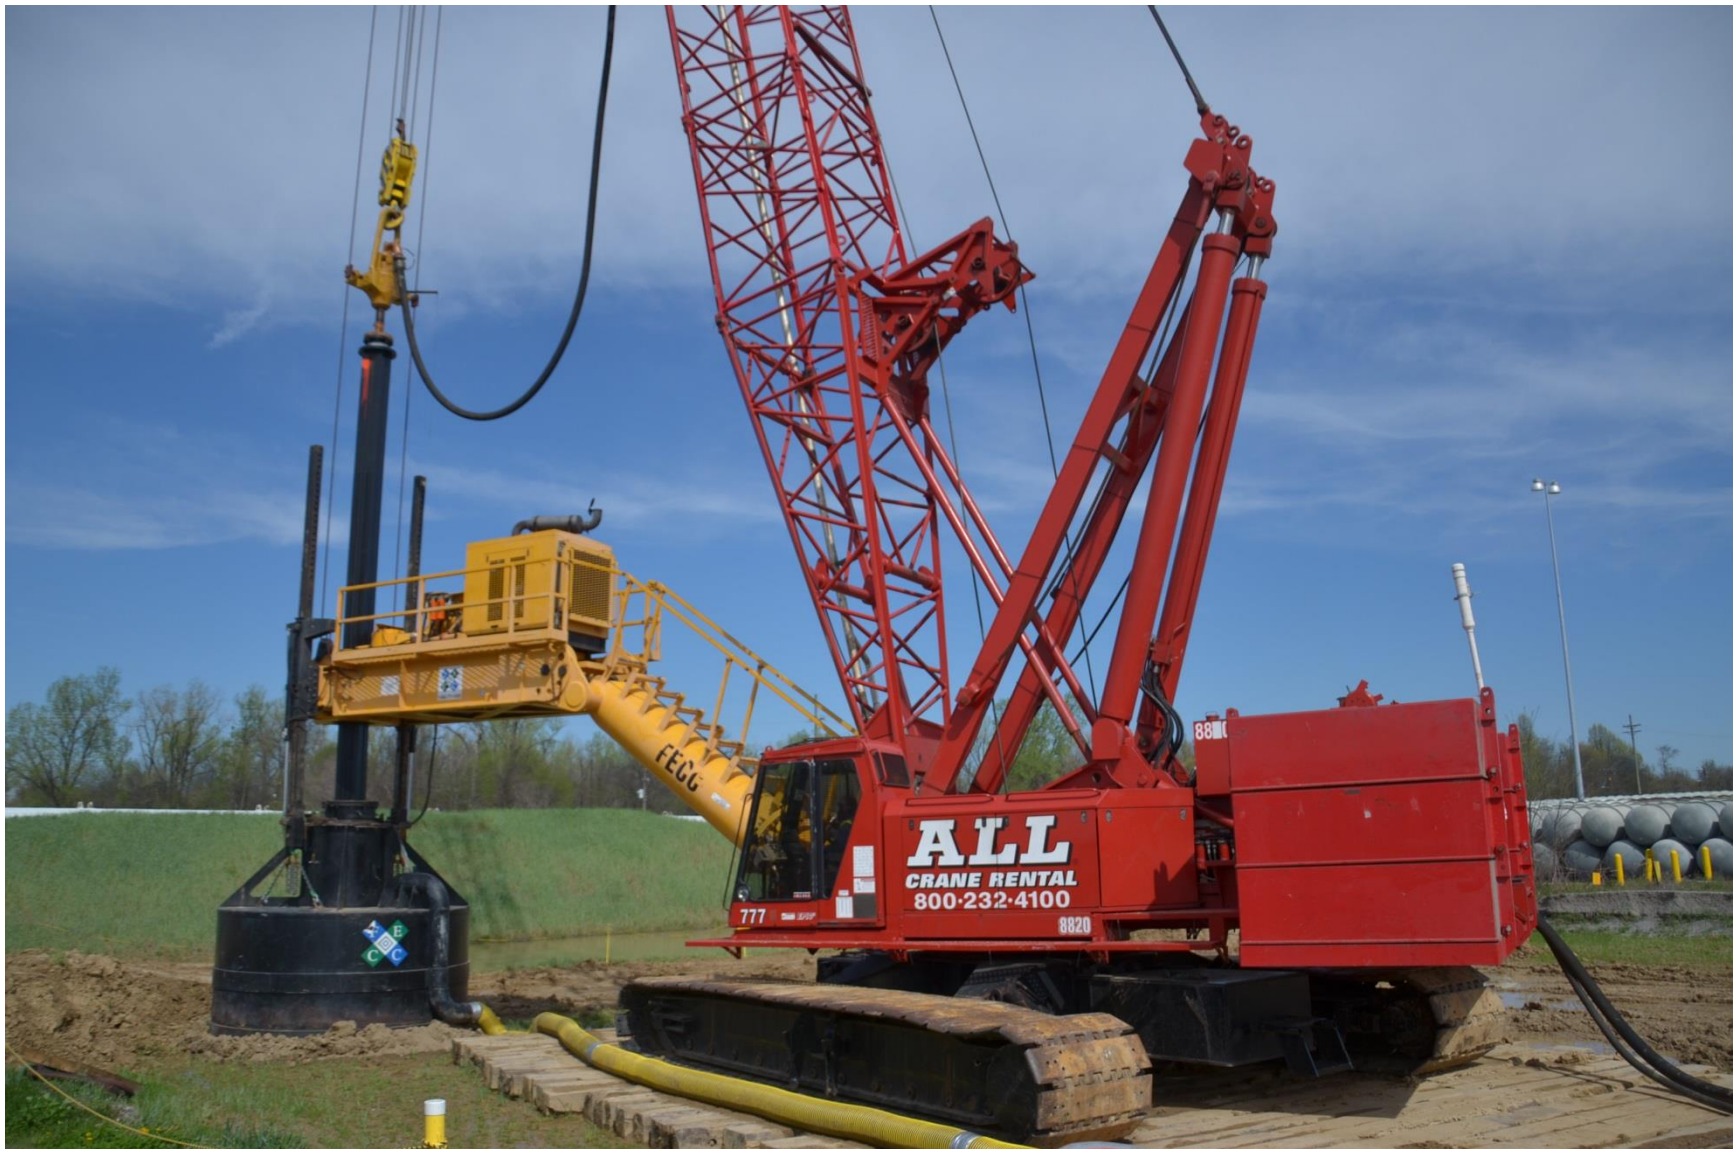
Figure 28. Manitowoc Crane and Soil Mixing Assembly (Looking Northwest on April 10, 2015)

**Major Equipment and Tools.** Major equipment and tools used for soil mixing included a crane, Stephen Haine LDA, Kelly bar, and drill platform. The soil mixing rig was comprised of a crawler-mounted lift crane (Manitowoc 777, 200-ton crane), with a 90-ft long by 13.5 inch diameter hollow drill stem (Kelly bar) driven by a high-torque transmission (Hain drilling platform and turn-table) capable of producing a range of torque of approximately 100,000 to 450,000 ft-lb of torque and capable of achieving a design soil mix depth of 60 ft bgs (62 ft below the original land surface elevation based upon the excavation of the upper 4 ft of soil in the mixing treatment area and placement/recompaction of 2 ft of the excavated soil prior to implementation), Figure 28. A swivel assembly attached to the end of the crane boom cables served as the connection point for the Kelly bar, allowing the bar to rotate freely for drilling. In addition, the swivel served as the injection point of material into the Kelly bar from flexible hosing connecting the hot air/steam and ZVI delivery system to the soil mixing equipment. A multi-blade rotating mixing/injection tool (auger) with a diameter of 8 ft was located at the base of the Kelly bar, which is capable of injecting the hot air, steam, and ZVI slurry into the soil to volatilize and treat VOCs. The mixing tool included injection ports every 8 to 10 inches along the back side of the mixing blade to achieve distribution of hot air/steam and injected ZVI throughout the mixed soil column. The mixing rig operated on wood crane mats that provided stability, maintained vertically plumb mixing, and reduced contamination of drill rig tracks. The mixing rig was capable of reaching outward from the toe of the crawler tracks (crane front) up to two rows of overlapped column locations. The Kelly bar vertical alignment was controlled by adjusting the crane mats, drill platform, or the cables that suspended the turntable and/or by slightly booming up or down as necessary.

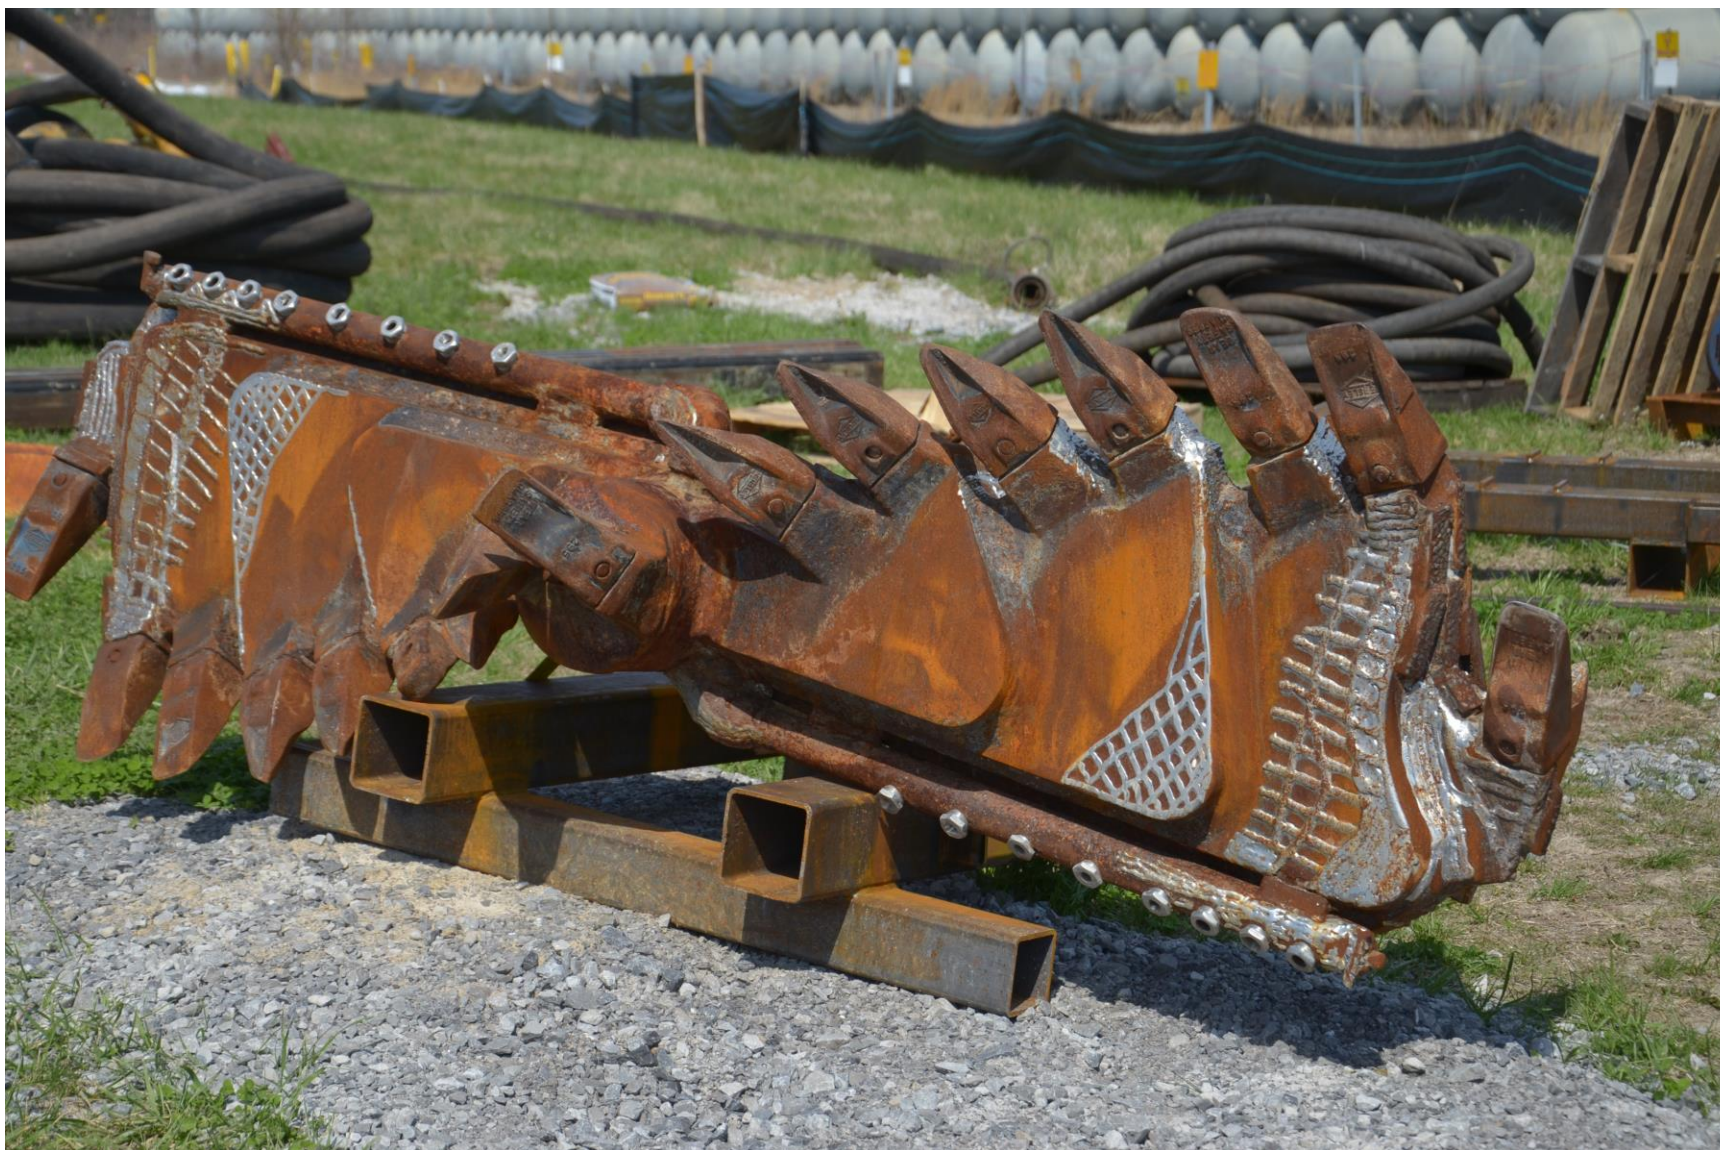
**Figure 29. Multi-Blade Rotating Mixing/Injection Tool (Looking Northwest on March 31, 2015)**
