PPPO-02-967898-11C

**REMOVAL ACTION REPORT FOR CONTAMINATED SEDIMENT ASSOCIATED WITH THE SURFACE WATER OPERABLE UNIT (ON-SITE) AT THE PADUCAH GASEOUS DIFFUSION PLANT, PADUCAH, KENTUCKY (DOE/LX/07-0357&D1)**

**REMOVAL ACTION REPORT FOR CONTAMINATED SEDIMENT  
ASSOCIATED WITH THE SURFACE WATER OPERABLE UNIT  
(ON-SITE) AT THE PADUCAH GASEOUS DIFFUSION PLANT,  
PADUCAH, KENTUCKY**

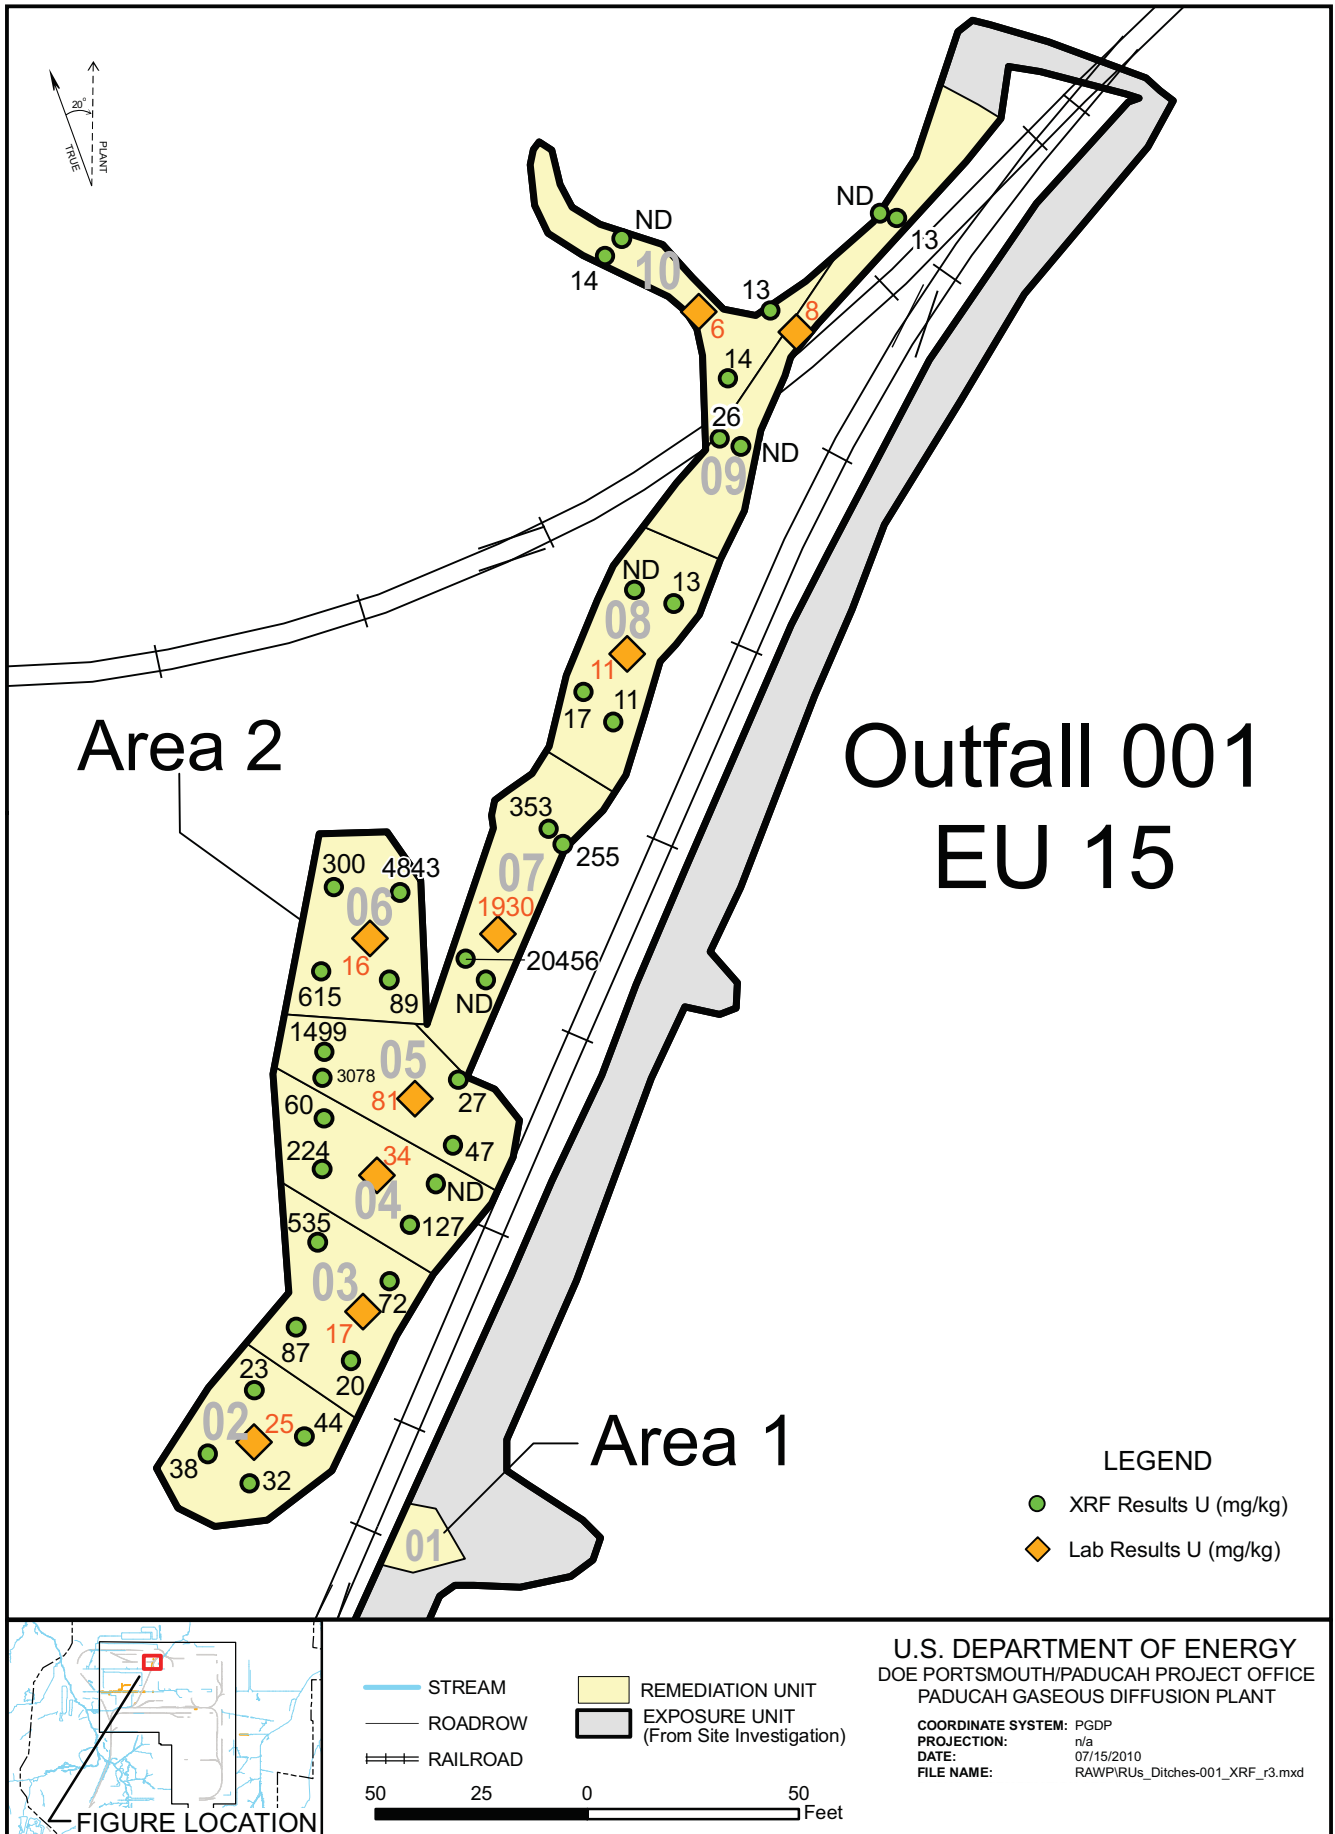
Figure A.3. Outfall 001 Preexcavation (5/18/10) Sample Results

Uranium was the surrogate COC at Outfall 001, EU 15, Area 2 [at Area 1, polychlorinated biphenyl (PCB) was the surrogate COC] and during the planning process, the extent of contamination in Area 2 had been established based on just two total uranium results, one elevated and one not elevated (642 mg/kg and 8 mg/kg, as compared to a cleanup criteria of 227 mg/kg). In an effort to define more clearly the horizontal extent of contamination at Area 2, sampling was undertaken in this area utilizing the postexcavation sampling protocol specified in the RAWP. The results of this sampling effort indicated that contamination above the total uranium action limit of 150 mg/kg was limited to the northern half of RU 03 and RUs 04–07. Verification sample results for uranium confirmed that RUs 02 and 08–10, as well as the southern half of RU 03, are not impacted above the cleanup level of 227 mg/kg total uranium. Additionally, sample results indicated that in all RUs within Area 2, all COCs, except uranium and uranium-238 (U-238), were below their respective cleanup levels. Appendix A contains a figure showing the results of this sampling effort, and Appendix B includes the data results in Tables B.1.1 and B.1.2.

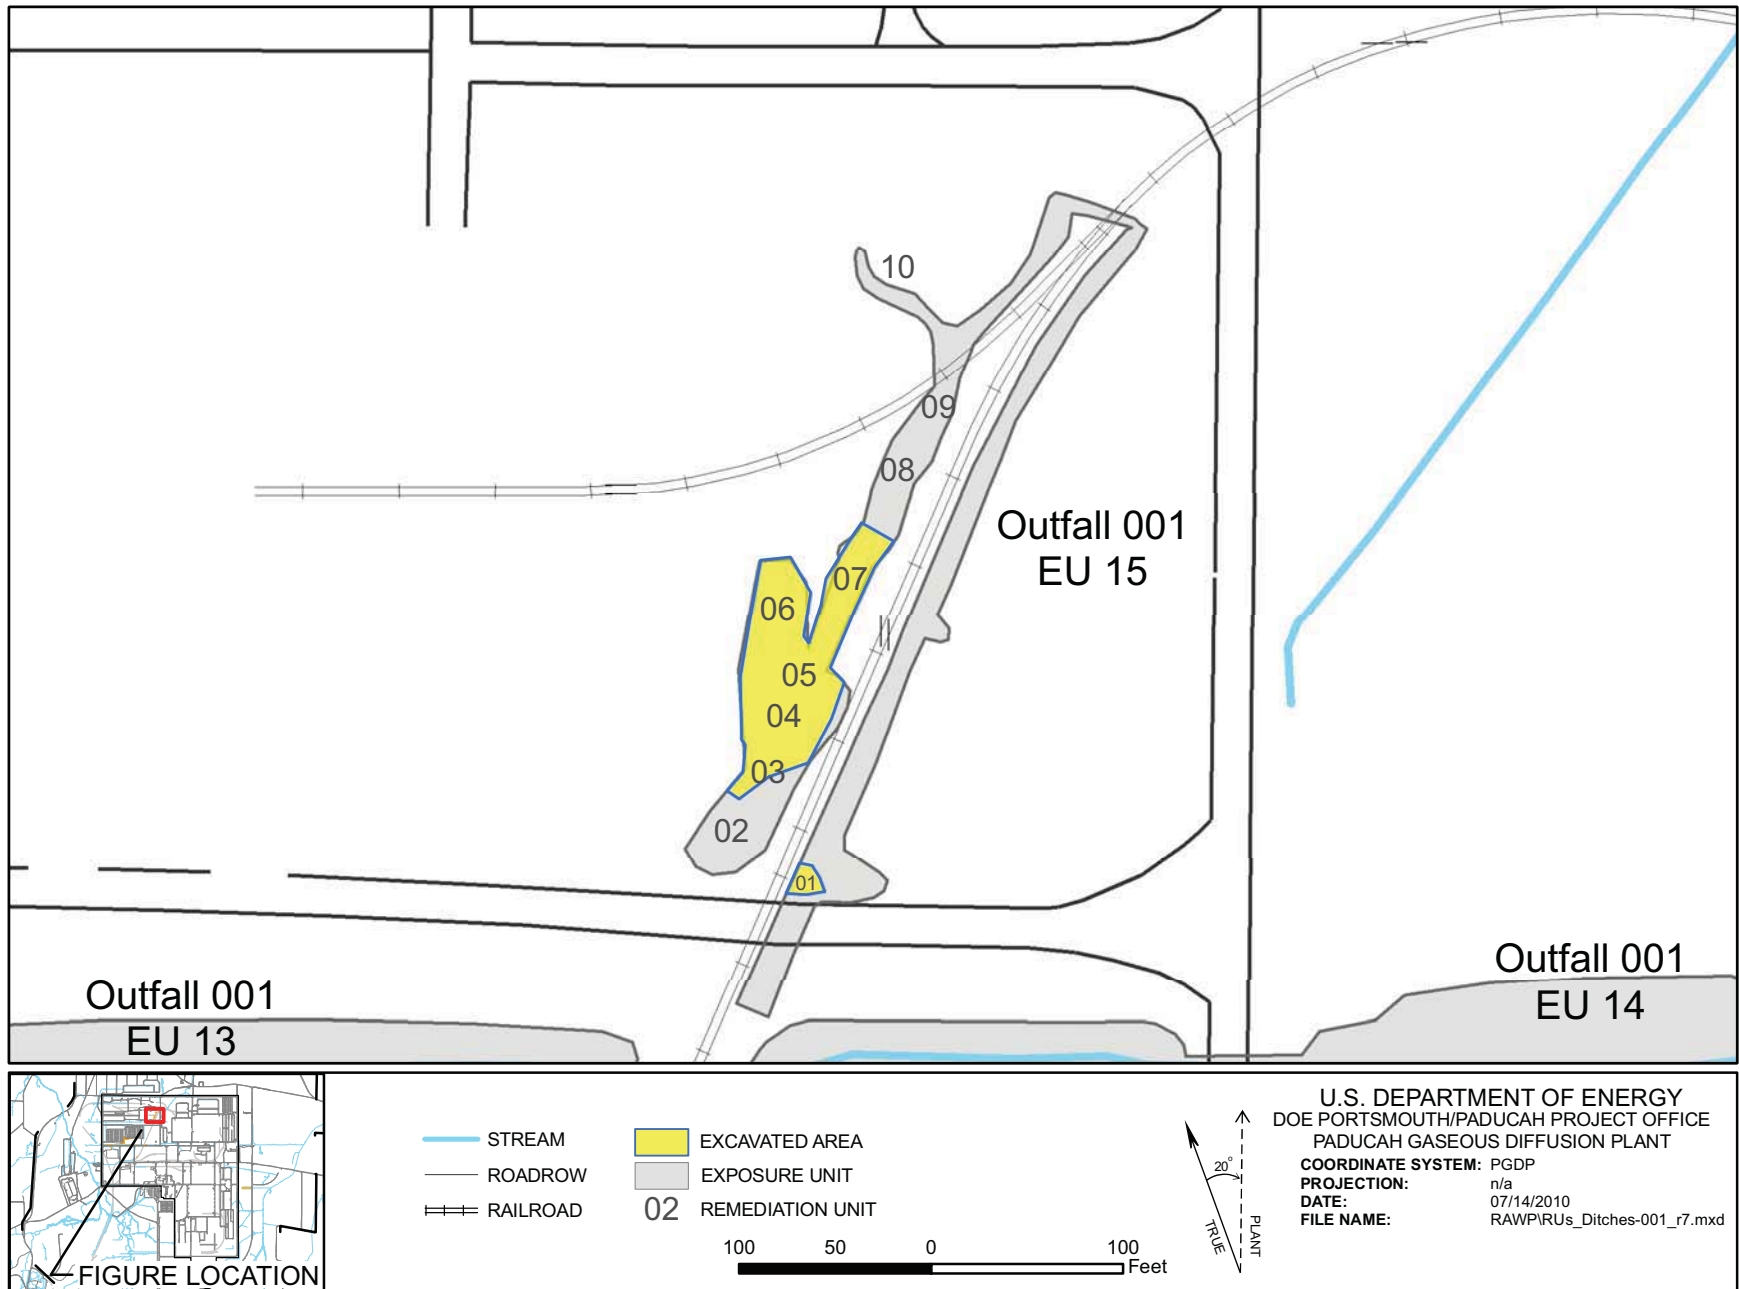
Figure A.4. Outfall 001 Actual Excavation Limits

At the five RUs addressed under this action, one RU was excavated to 2 ft. The remaining RUs were excavated to 3 ft at some SUs and 4 ft at other SUs. The walkover survey results and the field screening results indicate that all RUs were remediated to below their respective action levels (65 pCi/g for U-238, 5 pCi/g for Cs-137, 150 mg/kg for total uranium, and 10 mg/kg for PCBs), and verification sample results indicate that the cleanup levels have been achieved. Additionally, two field screen samples collected from the surface at the southern half of RU 03 (the portion not excavated) indicate that the surrogate COC concentrations are below the action levels. Appendix A includes a figure showing the final excavation limits, and the data results are included in Appendix B, Tables B.1.1 and B.1.2.

At Outfall 001, 926 yd<sup>3</sup> of soils were removed; 501 yd<sup>3</sup> were disposed of at *EnergySolutions* in Clive, Utah; and 425 yd<sup>3</sup> were disposed of at the C-746-U Landfill.

In light of the foregoing, a revised approach to Outfall 001, Area 2, was proposed and agreed to at the June 17, 2010, FFA Managers Meeting. Excavation would be limited to those RUs that were impacted above the action limit of 150 mg/kg for total uranium. This included the northern half of RU 03 and RUs 04, 05, 06, and 07. The southern half of RU 03 and RUs 02, 08, 09, and 10 were not excavated because the data show that these areas are not impacted above the action limits or the cleanup levels.

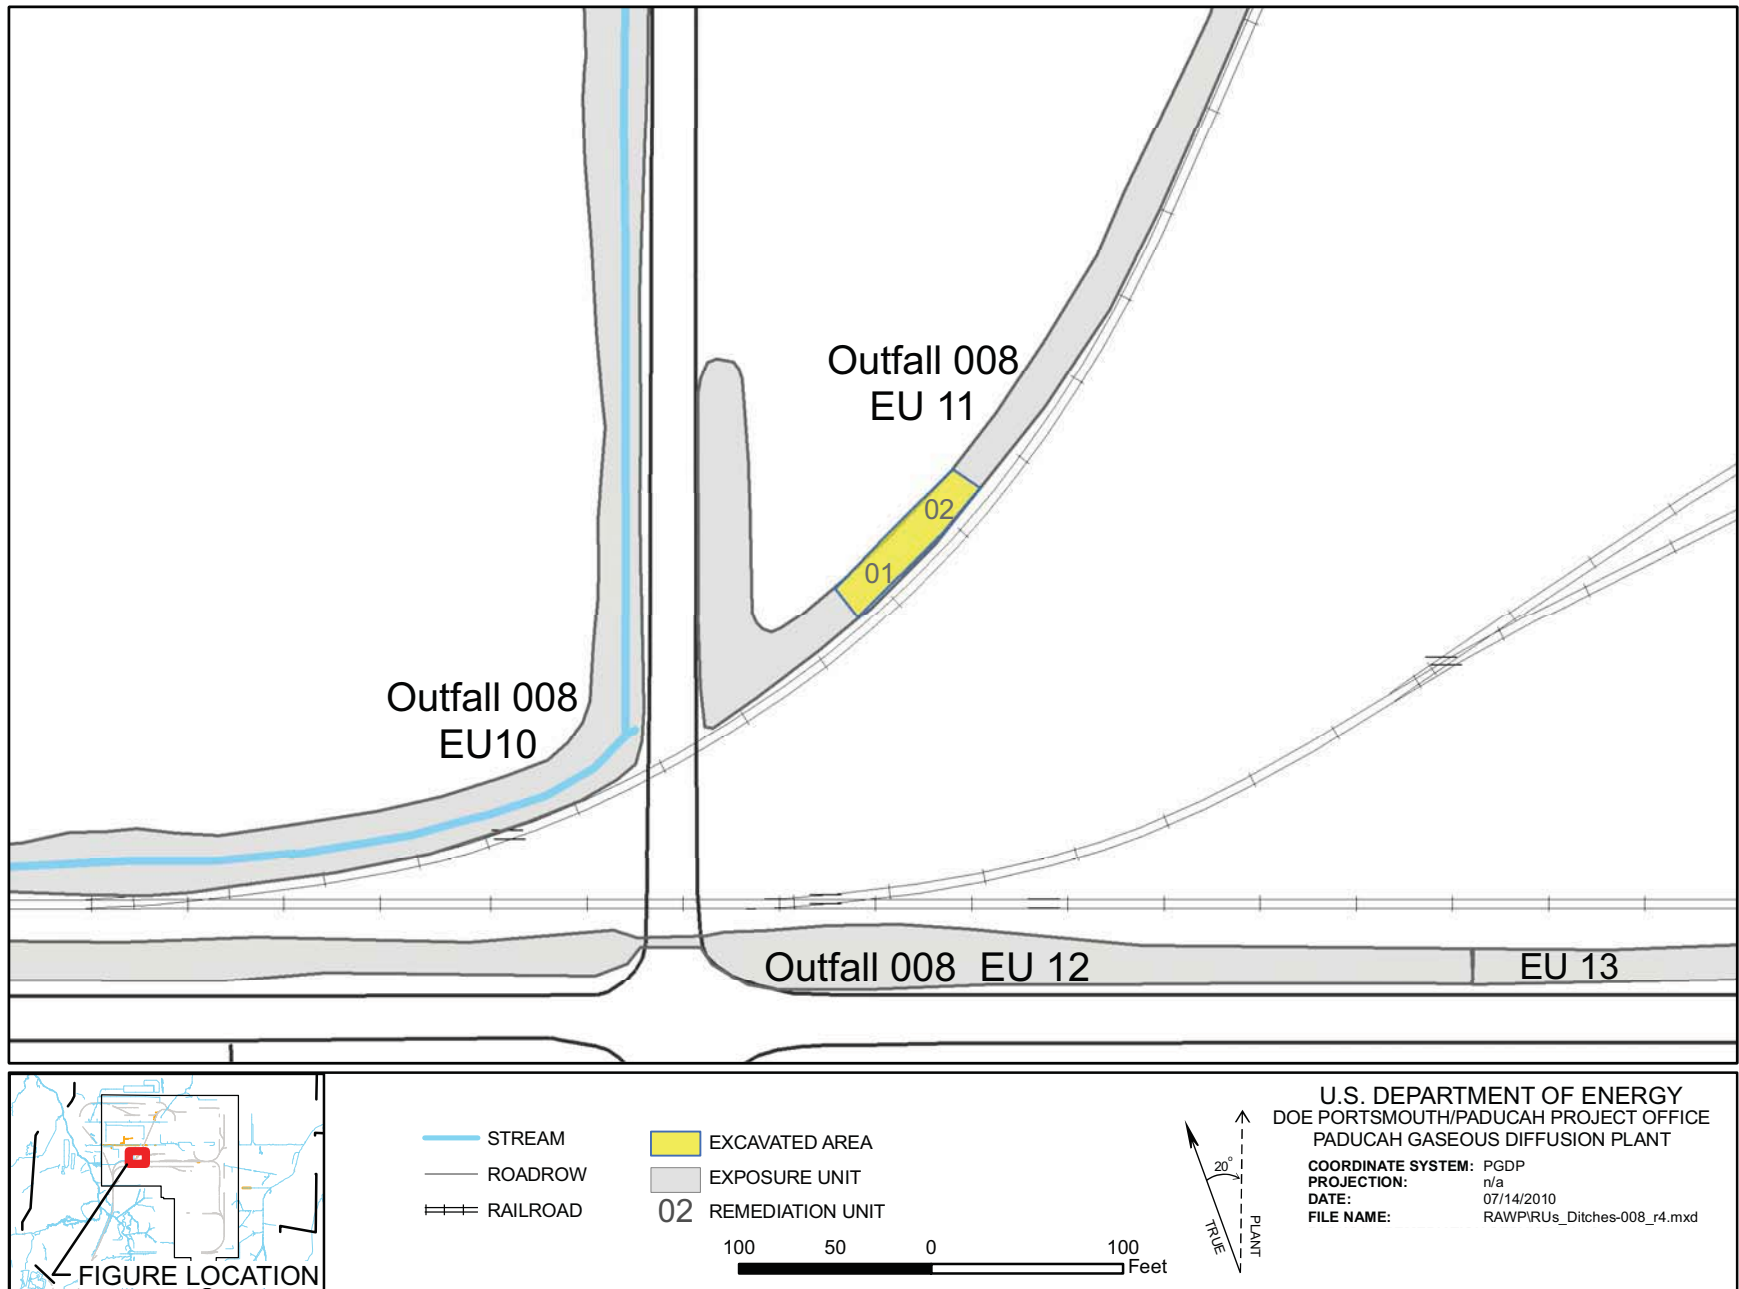
Figure A.5. Outfall 008 Actual Excavation Limits

At Outfall 008, one EU containing two RUs, over an area of approximately 200 yd<sup>2</sup>, was excavated. Soils were removed to a depth of 2 ft at this location.

At the two RUs excavated under this action, the walkover survey results and the field screening results indicate that all RUs were remediated to below their respective action limits, and verification sample results indicate that the cleanup levels have been achieved. Appendix A contains a figure showing the final excavation limits, and Appendix B includes the data results in Tables B.2.1 and B.2.2.

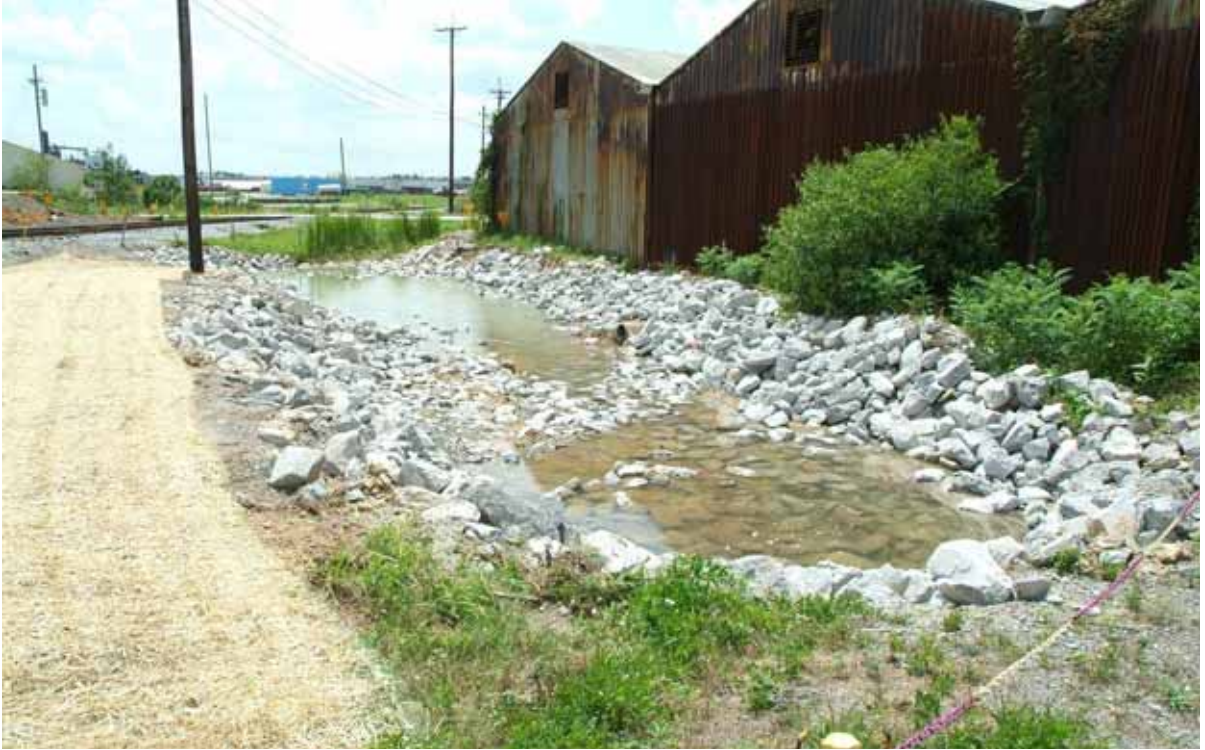
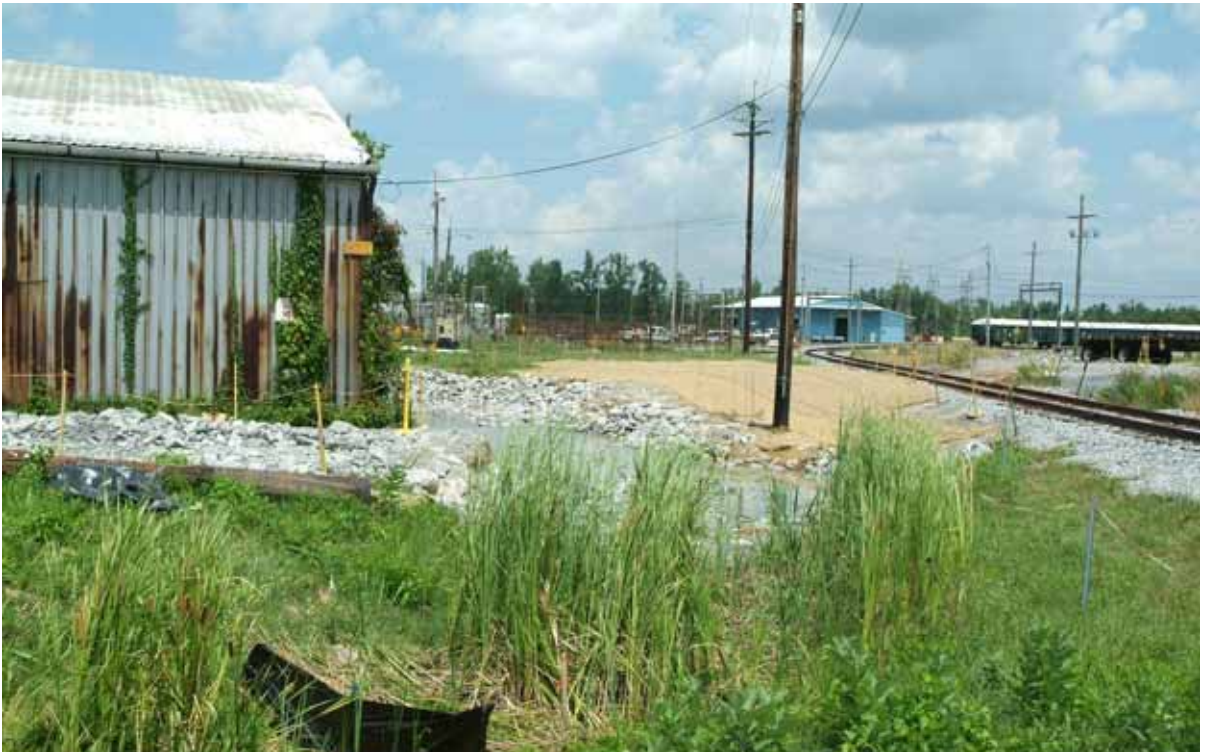
**Outfall 001 07-22-10 (After)**

Refer to Appendix E for photographs showing the condition of the excavation areas following restoration. Consistent with the RAWP, inspections and site maintenance will continue to control erosion until the affected areas are stable.
