C-637 Pumphouse and Cooling Tower (Solid Waste Management Unit 89)

Facility Overview Briefing

June 22, 2023

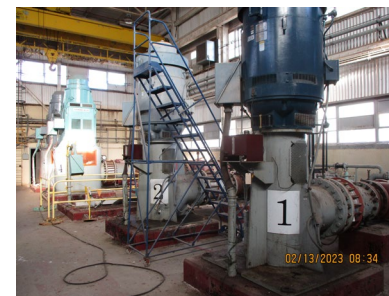
C-637-1 – Center Structure
RCW Pump #1

- In 1969, concrete walls were installed in between each of the transformers located outside of the west wing of C-637-1.
 - ❑ Walls were installed for fire protection.
- USEC leased the facility in the early 1990s and continued to use C-637-1 as a pump house until enrichment operations ceased at C-337 in 2013.
- In 1992, there was a polychlorinated biphenyl (PCB) leak from the drain associated with the 7PH6 transformer; < 5 ppm.
- In 1993, various PCB spills associated with the transformers occurred; all areas were addressed.
 - ❑ May - Leak from the 7PH1 transformer; approximately 5 gal.
 - ❑ August - Leak from the 7PH4 transformer; < 5 ppm.
- In November 1993, a cooling water line to the motor oil cooler at RCW pump #3 ruptured resulting in an RCW water and oil spill.
- In 2006, the #1 pump surge relief system developed an RCW leak from a small broken pipe; leak was addressed.

- Historical RCW leaks at #1 and #3 pumps (see slide 12).
- No known chemical spills except for the above noted chromated water leaks and RCW leaks.

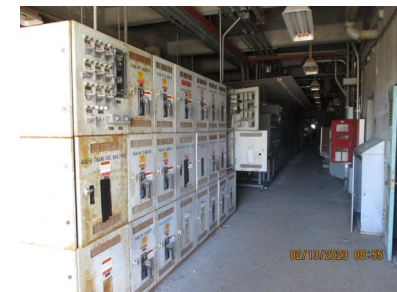
C-637-1 - East Wing
Interior Switchgear Room

- In 2013, an RCW leak associated with the blowdown header was discovered in the switchgear room.
 - North end where the header penetrates the wall and goes into an elbow.

- RCW leaked both inside and outside of the building.
 - As part of the corrective action the nearby storm drain was sealed off until the leak was repaired.

- No GSA or SAA.
- Both ACM and lead-based paints are known to be present.
- 2013 RCW leak associated with the blowdown header on the north end (see slide 13).

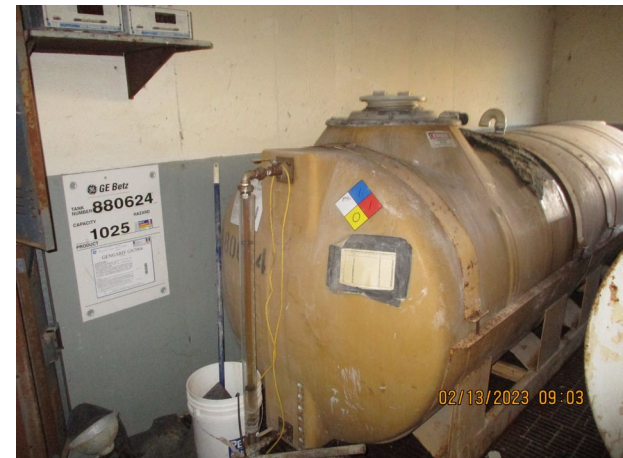
C-637-1 West Wing
Betz Chemical Feed Tank

- In 2012, there was a significant leak identified associated with the feed assembly.
 - Betz representatives replaced the feed assembly.
 - Area was cleaned and waste disposed.

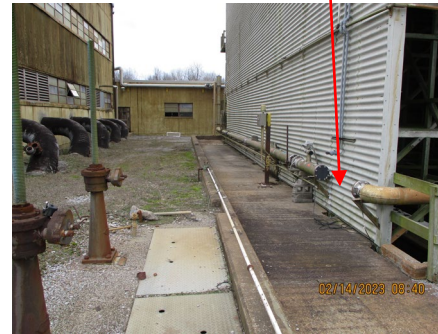
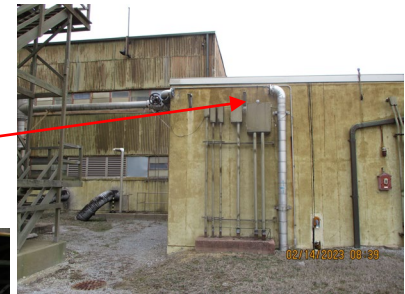
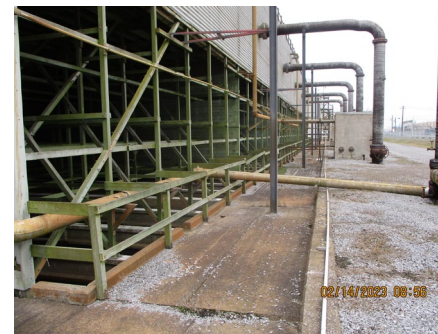
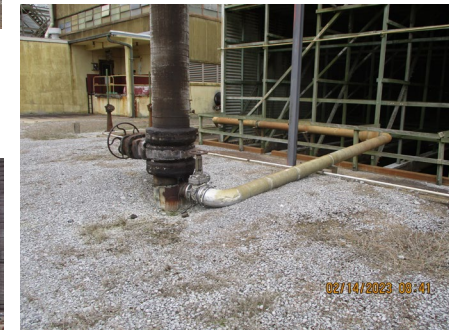
C-637-2A Cooling Tower
Northeast Plume Pump and Treat
Line to Riser No. 6

- Vault was pumped and leak repaired.
 - ❑ September - A water leak occurred below the #6 riser block valve where the NE Plume Containment piping tied into the riser between the riser and valve HV-184.

- Leak was minor and repaired immediately.
- In 2013, C-637-2A was shutdown, along with its associated pump house and blending towers.
 - ❑ The basin and influent flume have not been drained and remain full of water; draining has not occurred in order to prevent hydrostatic pressure changes that could cause collapse or floating of the subsurface structure. [Note: The basin has been lowered, filled with makeup water in order to decrease the amount of phosphate remaining in the basin (phosphate value of <1 ppm), and calcium hypochlorite tablets are added once a month to keep the water from becoming septic.]

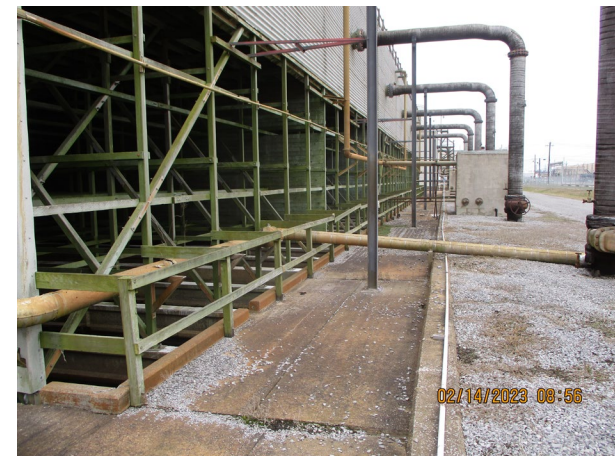
H-Loop Return to Blending Tower Vault

- In 2011, a leak associated with RCW H-Loop Return to Blending Tower valve was discovered; valve was replaced.
- In 2012, two system leaks occurred.
 - ❑ April - An RCW leak associated with RCW H-Loop Return to Blending Tower vault.

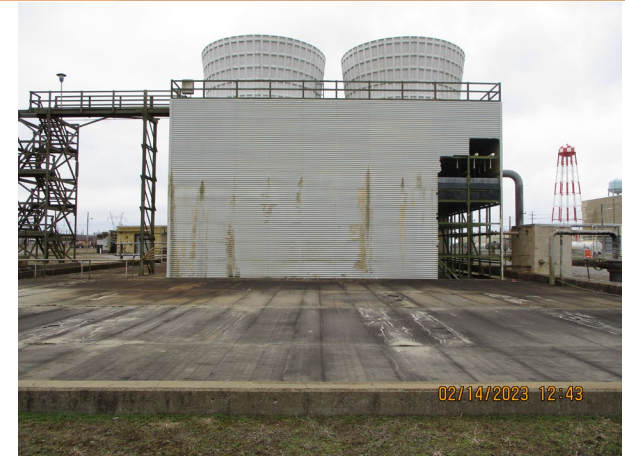
C-637-2B Cooling Tower – North Side

- ❑ Heated RCW from the C-337 process building, C-360, and the C-537 switchyard (synchronous condensers) and groundwater from the Northeast Plume (beginning in 1997) was distributed through various sections of the cooling tower and released via evaporation; cooled RCW was then collected into the cooling tower basin where it then flowed by gravity via an influent flume into the mixing flume and wet well located underneath the C-637-1 pump house.
- ❑ Tower was demolished down to the basin and rebuilt in the 1996-1997 timeframe.

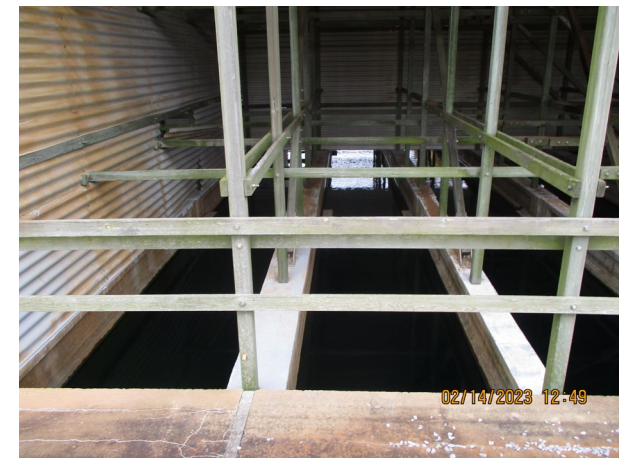
C-637-2B Cooling Tower – Interior View

➤ Brown rot fungi growth quickly became a problem for the cooling towers.

- ❑ In 1958, a program was initiated to combat fungus deterioration.
- ❑ Replaced infected wood with new pressure treated redwood.
 - Cooling tower structural members, fill, mist eliminators, outer wall, cell partitions, and deck were originally constructed of California redwood.
- ❑ Treated remaining wood with fungicide solutions (most susceptible areas only).
- ❑ All cell plenum chambers, tower deck, outer sidewalls, and tower tops were treated periodically with one of two types of fungicide solutions:
 - Sodium pentachlorophenate.
 - Double diffusion method – first spraying with a solution of zinc sulphate and arsenic acid followed by a second spraying with a solution of sodium bichromate.
- ❑ Fungicide treatment was discontinued in 1987.

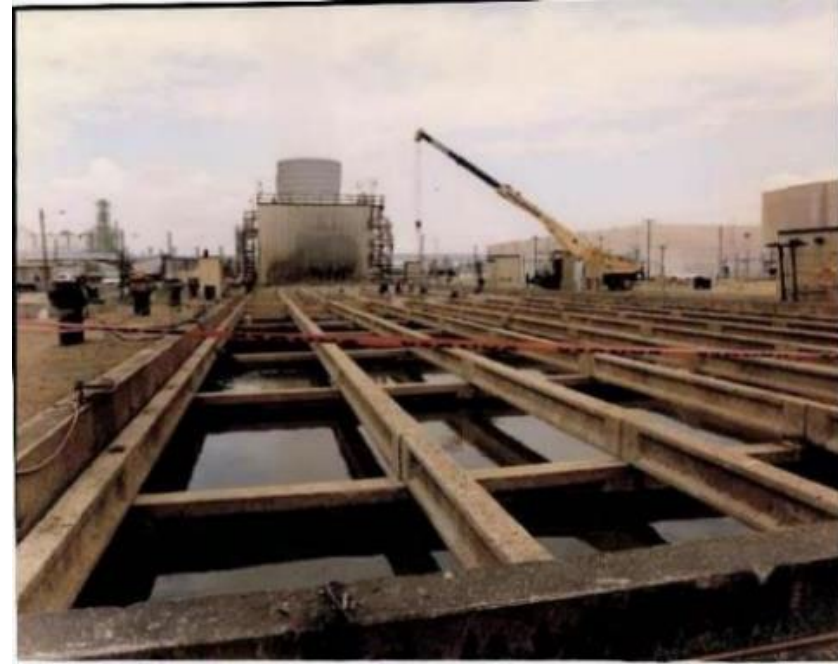
Historical photo of main cooling tower replacement project
(Photo of C-637 Main Cooling Tower)

- In 1996-1997, the main cooling tower was replaced down to the basin.
 - ❑ The overall footprint of the cooling tower was adjusted and the height, length, and width of the new cooling tower was reduced.
 - Height reduced from approximately 41 ft to approximately 31 ft.
 - Length reduced from approximately 252 ft to approximately 179 ft.
 - Width reduced from approximately 84 ft to approximately 59 ft.
 - Modified from 7 to 5 pairs of back-to-back cooling tower cells; total of 10 rather than 14 cooling tower cells.
 - Modified from 7 risers to 5 risers.
 - ❑ Downsized because the cooling tower load designed for in the 1950s was not required for C-337 and the new tower design was more efficient.

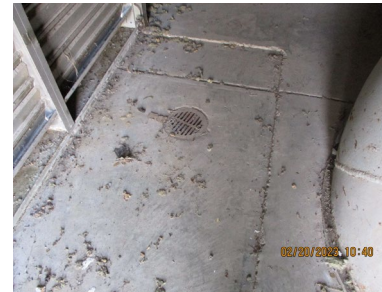
C-637-3 - Floor Drain

- Houses three blending pumps.
- Both ACM (e.g., corrugated transite siding) and lead-based paints are known to be present.
- Six 3-inch floor drains are present.
 - All drain back into the C-637-2B cooling tower basin.
- Not used for radiological storage; no radiological postings are present.
- No GSA or SAA.
- Minor oil staining around the blending pumps.
- Damage to building insulation (suspect animal infestation).
- No known chemical spills.

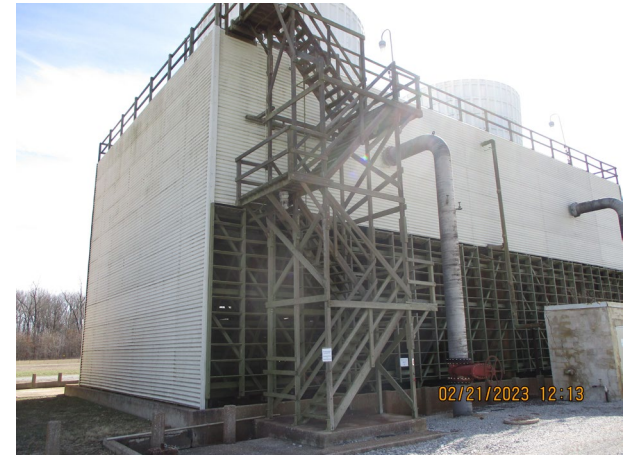
C-637-4 Northwest Corner – Stairs and Riser No. 9

- In 2010, a leak was discovered in the #9 riser between ground level and the isolation valve of the riser.
 - ❑ No water was released to KPDES outfall; leak was repaired.

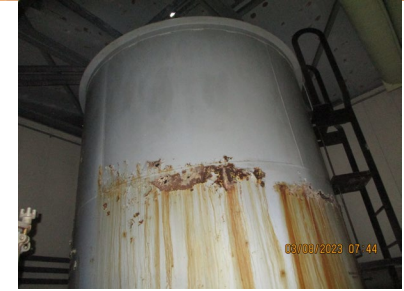
- In 2011, it was determined that the sand filter tank had a slow leak.
 - ❑ The sand filter bypass was opened to alleviate pressure on the tank; bypass sent water directly to the C-637-2A basin.

C-637-6 – Permutit® Sand Filter Tank

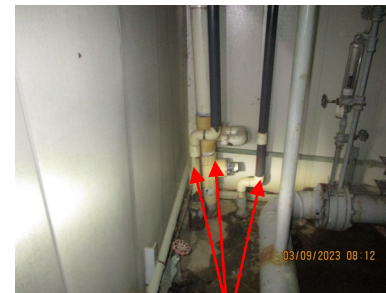
➤ In 1991, a sump pump in the cooling tower drift collection system was discovered to be inoperable.

- ❑ The sump filled and overflowed to the storm drain going to KPDES Outfall 002.
- ❑ Cr⁺⁶ measured 0.11 mg/L; did not exceed the discharge limit of 0.31 mg/L.
- ❑ A portable pump was used to pump water back to the C-637-2A basin until the pump was repaired.

C-637-6 – Inlets from Windage Collection Sumps

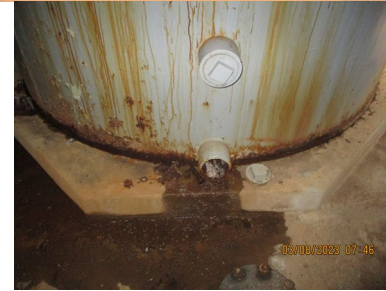
- In 2016, C-637-6 was no longer in service and electricity and water were isolated.
 - ❑ Permutit® sand filter tank was drained.
 - ❑ Sanitary water line was capped at both the incoming line and floor locations.

C-637-6 - Permutit® Sand Filter Tank Drain

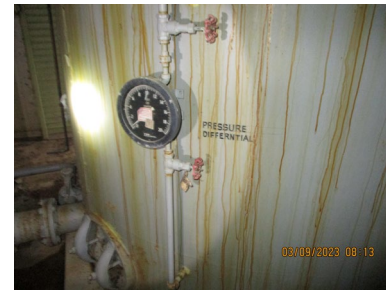
C-637-6 -Permutit® Sand Filter Tank (Pressure Differential Indicator)

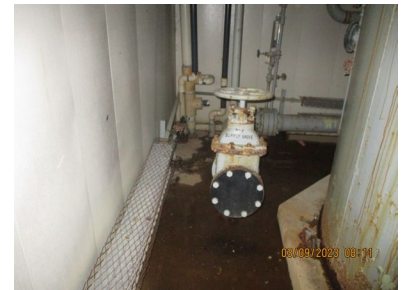
C-637-6 -Sanitary Water Line (Capped)

- In 2014, it was discovered that the valve to the sanitary water line had frozen and burst resulting in a large sanitary water leak.
 - ❑ Valve was repaired.
