PPPO-02-10037987-26

DE-EM0004895: APPROVAL OF DELIVERABLE NO. 11, URANIUM ENRICHMENT TOXIC SUBSTANCES CONTROL ACT QUARTERLY REPORT, APRIL 1 THROUGH JUNE 30, 2026, FRNP-RPT-0423

FRNP-RPT-0423

Uranium Enrichment Toxic Substances Control Act Quarterly Report for the Paducah Gaseous Diffusion Plant, Paducah, Kentucky, April 1 through June 30, 2026

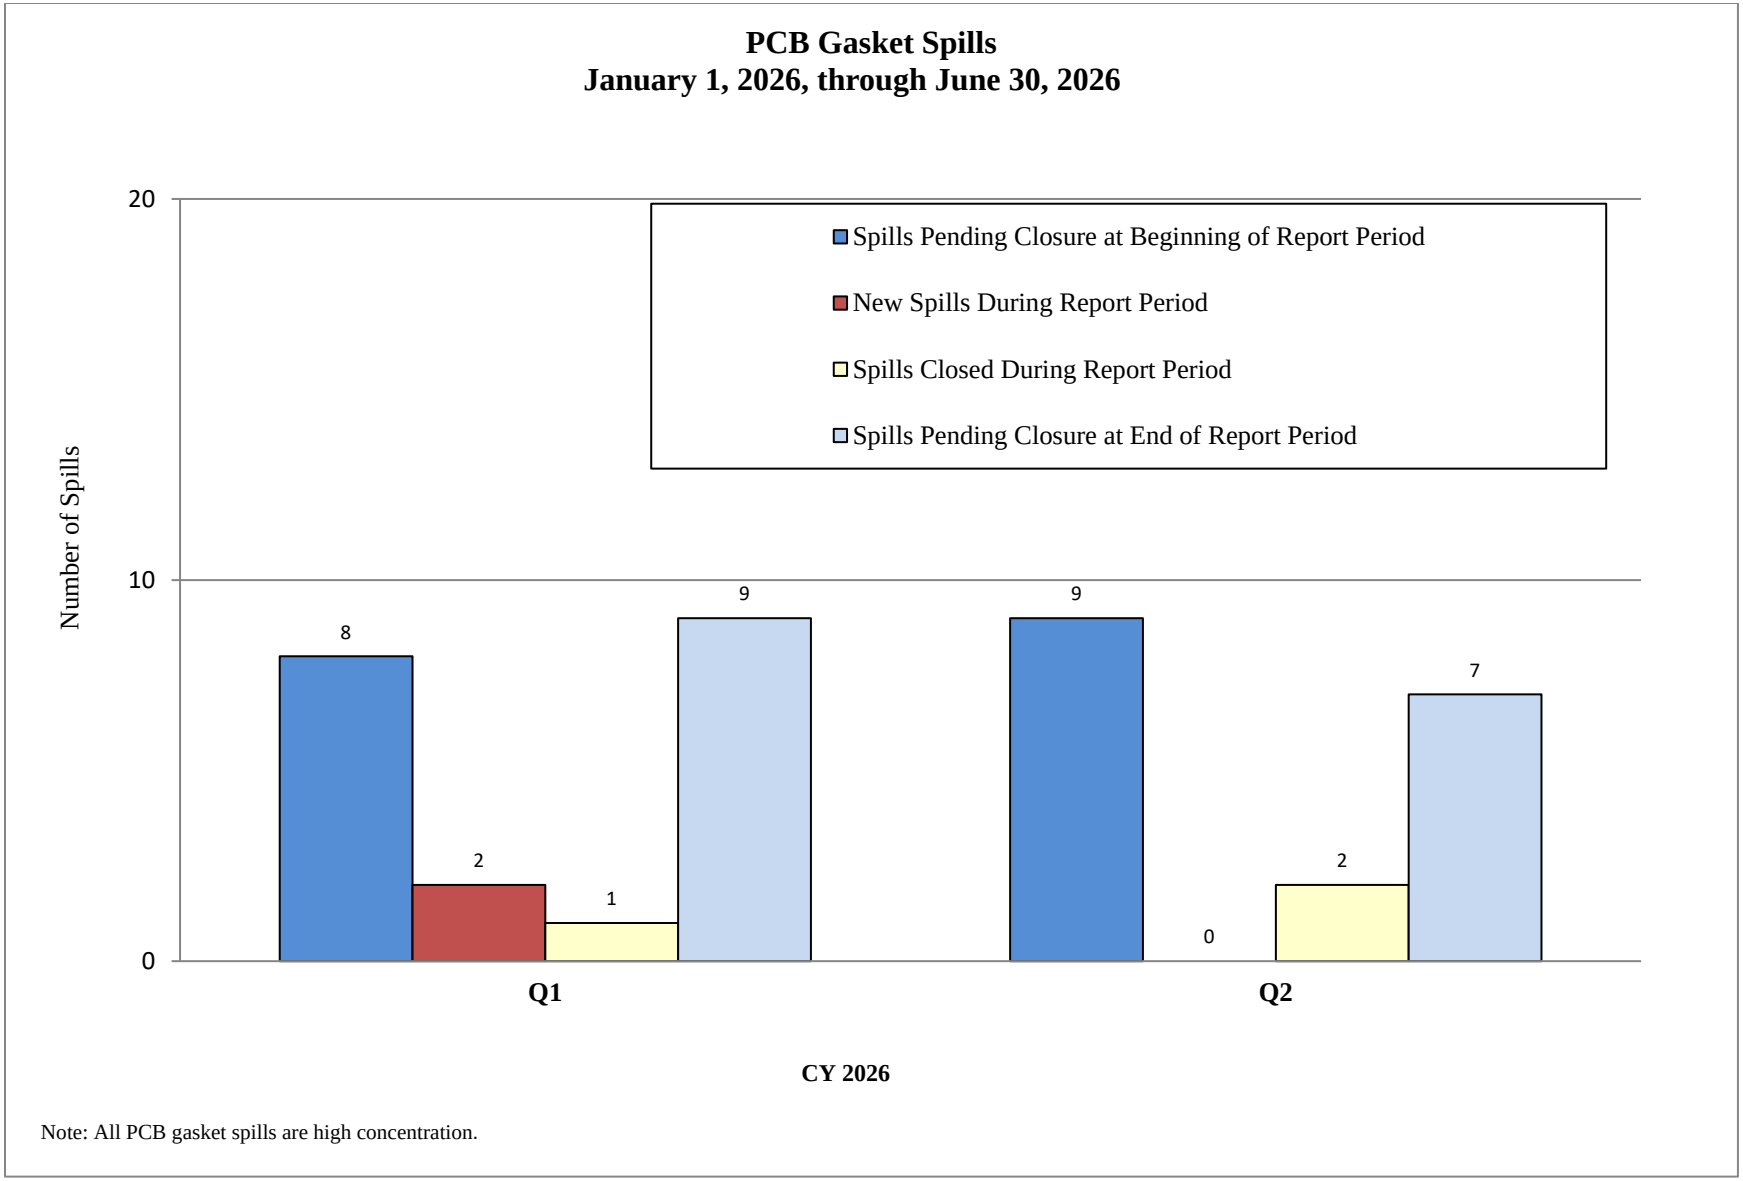
Figure 1. Quarterly Summary of PCB Gasket Spills

A quarterly breakdown of PCB gasket spill information can be found in Figure 1.

All PCB gasket spills identified were high-concentration PCB spills [i.e., from a source of 500 ppm or greater in PCB concentration]. Cleanup of each identified spill site was initiated within 24 hours, in accordance with Attachment 1 of the TSCA CA. Clearly visible signs have been posted at each spill site advising personnel to avoid the area in order to minimize the spread of contamination and the potential for human exposure. The cleanup documentation and the records are available for inspection.

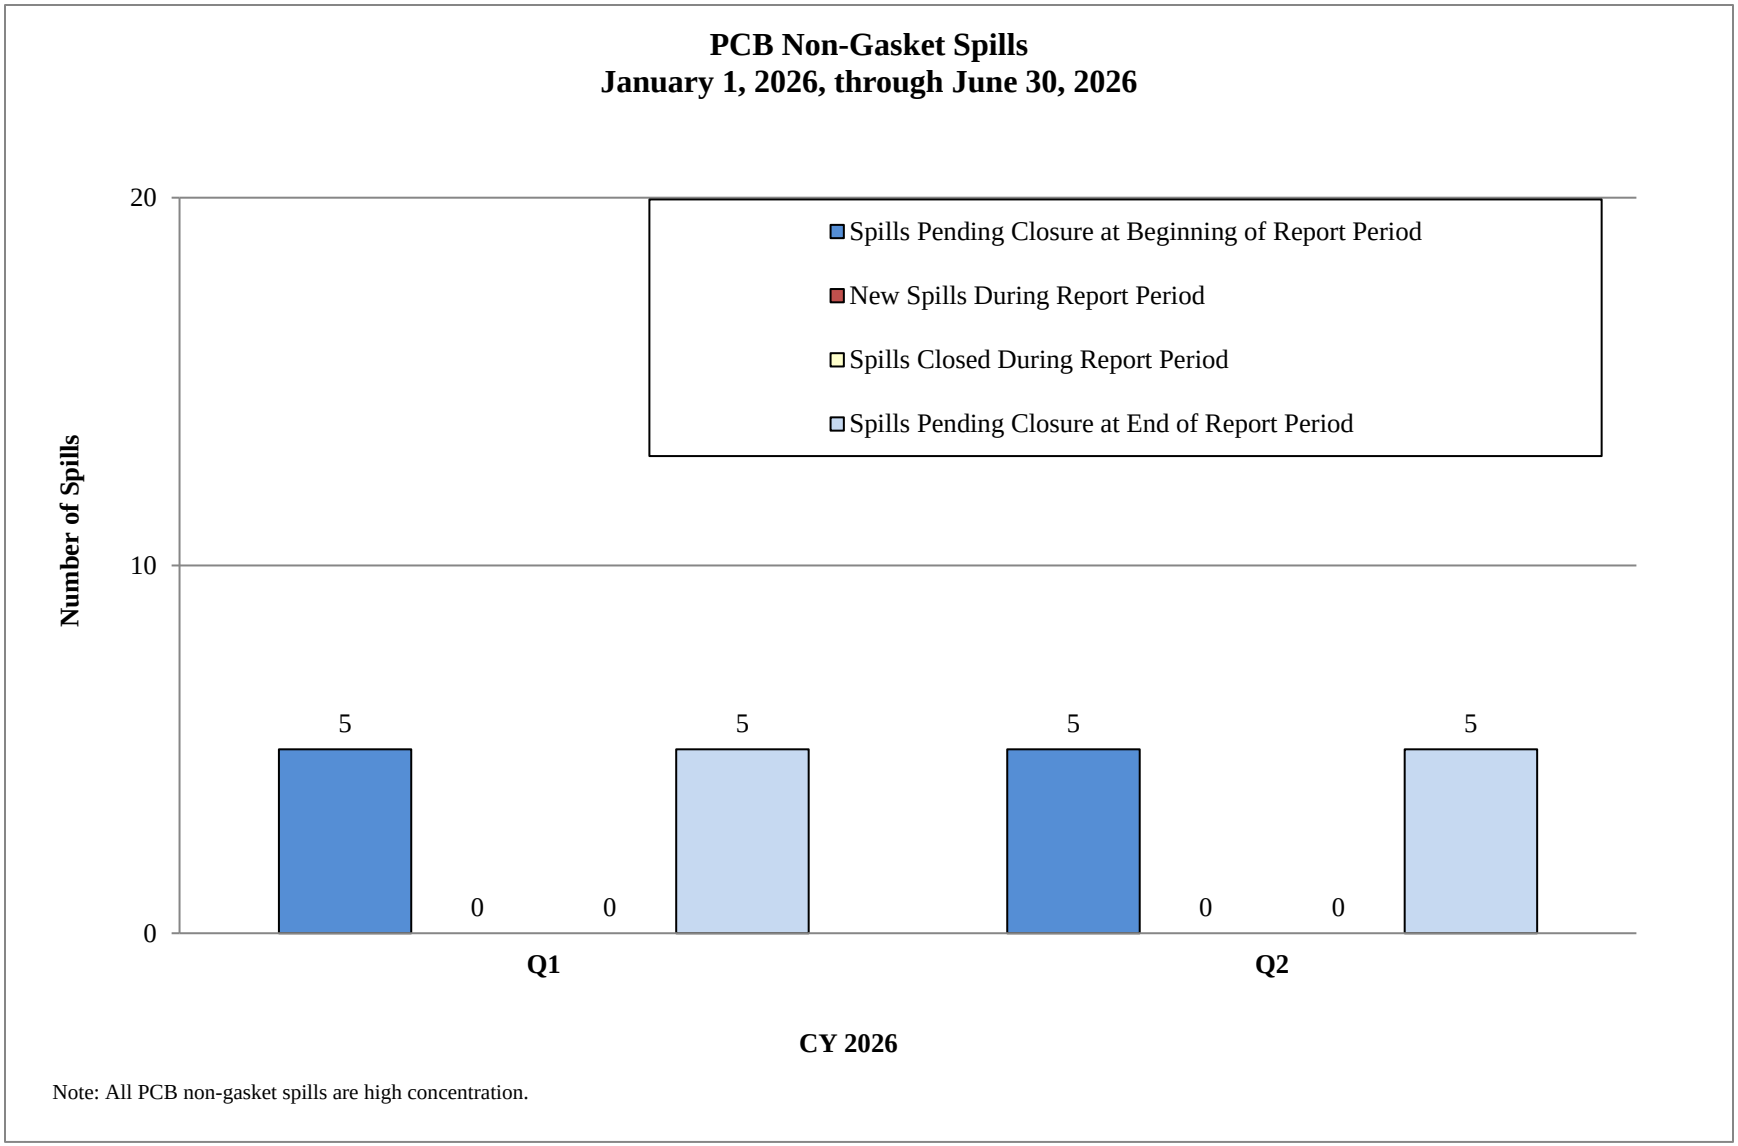
Figure 2. Quarterly Summary of PCB Non-Gasket Spills

A quarterly breakdown of PCB non-gasket spill information can be found in Figure 2.

All PCB non-gasket spills identified were high-concentration PCB spills (i.e., from a source of 500 ppm or greater in PCB concentration). Cleanup of each identified spill site was initiated within 24 hours, in accordance with Attachment 1 of the TSCA CA. Clearly visible signs were posted at each spill site advising personnel to avoid the area in order to minimize the spread of contamination and the potential for human exposure. The cleanup documentation and the records are available for inspection.
