REMEDIAL ACTION COMPLETION REPORT FOR THE INTERIM REMEDIAL ACTION FOR THE GROUNDWATER OPERABLE UNIT FOR THE VOLATILE ORGANIC COMPOUND CONTAMINATION AT THE C-400 CLEANING BUILDING AT THE PADUCAH GASEOUS DIFFUSION PLANT, PADUCAH, KENTUCKY, DOE/LX/07-2417&D1

**Remedial Action Completion Report
for the Interim Remedial Action
for the Groundwater Operable Unit for the
Volatile Organic Compound Contamination at the
C-400 Cleaning Building at the
Paducah Gaseous Diffusion Plant,
Paducah, Kentucky**

**DOE/LX/07-2417&D1
Primary Document**

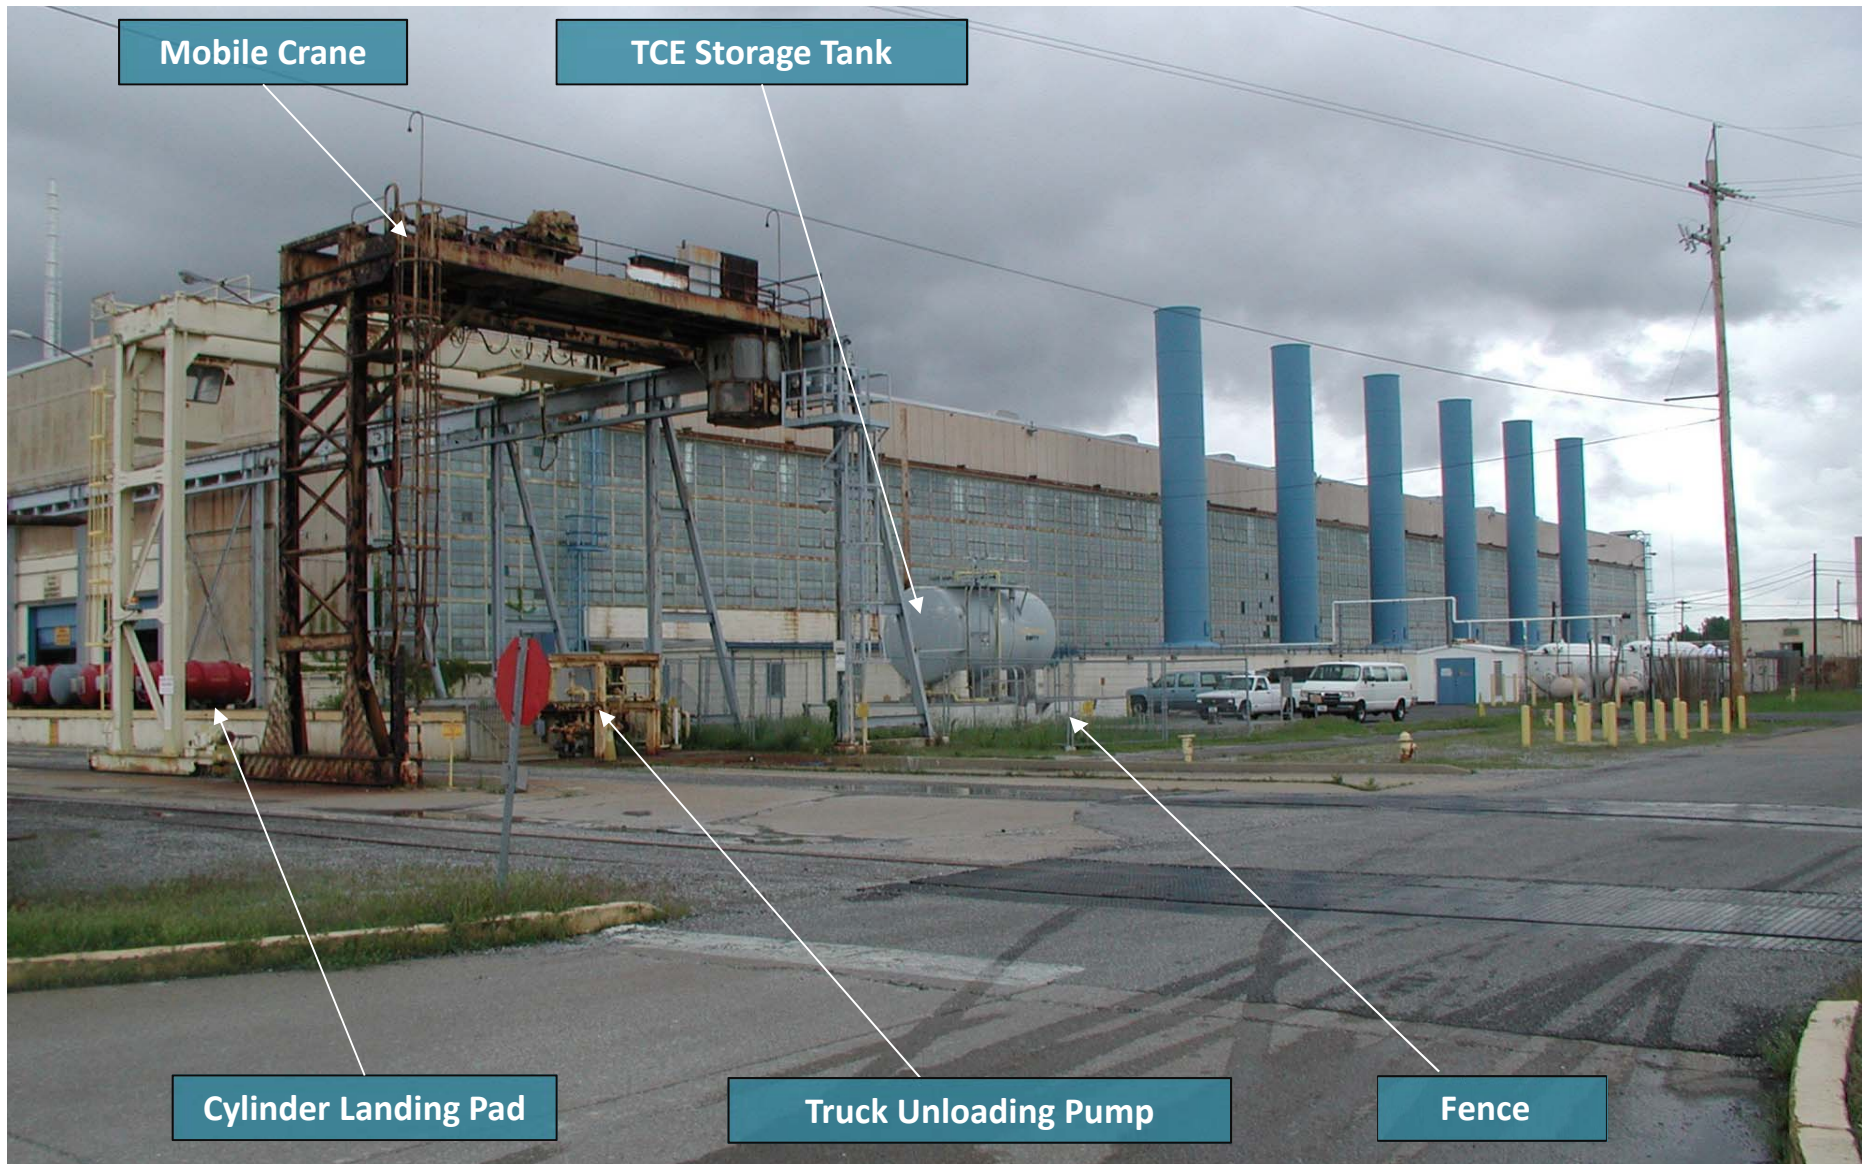
Figure 4.1. Infrastructure Equipment Removal

In addition to removing some existing equipment, it was necessary to construct some new foundations and pads for IRA equipment, including electrical power transformers, tanks and other required equipment.

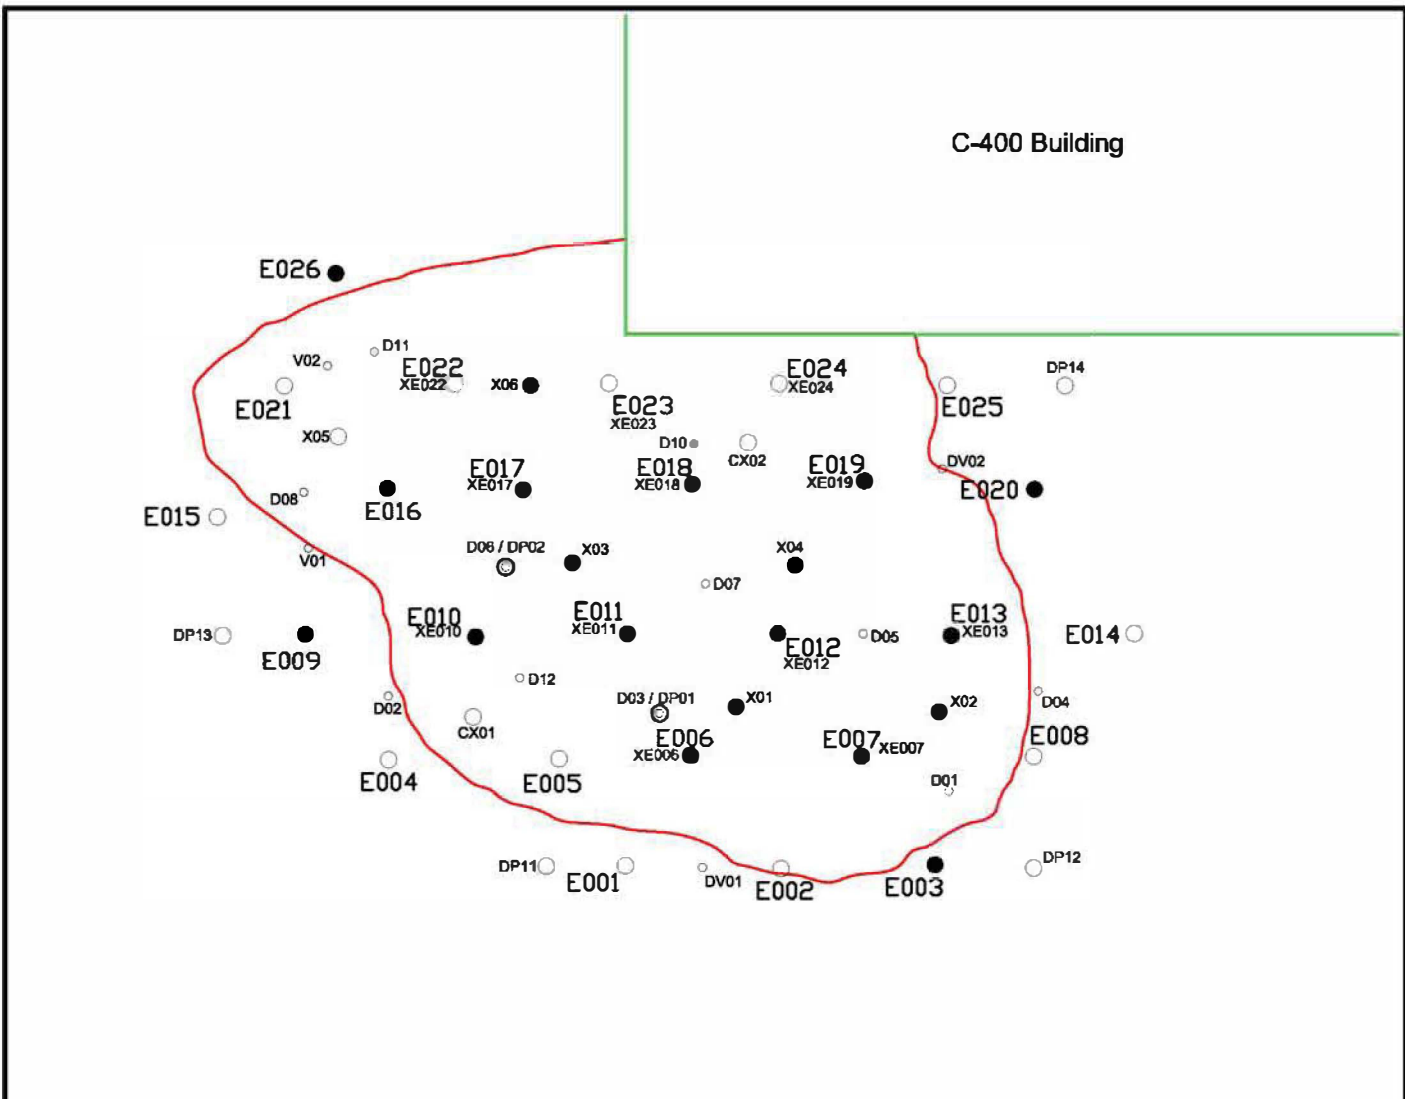
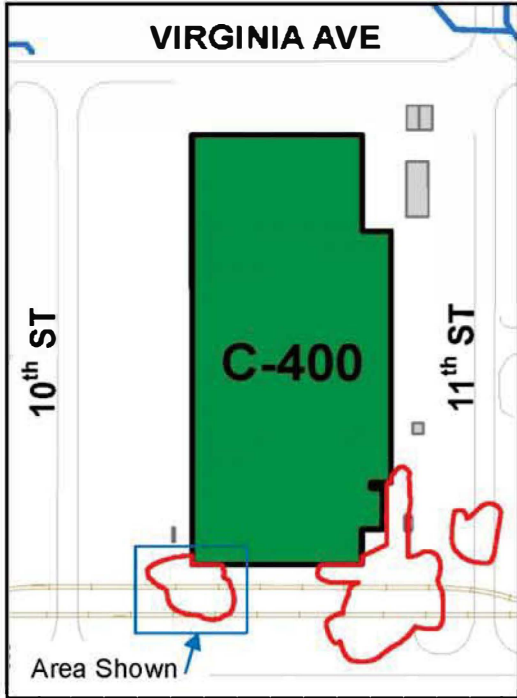
Figure 4.3. Southwest Treatment Area Subsurface Equipment Layout

Construction for Phase I activities was initiated in December 2008. The layout of the subsurface components for the Southwest and East Treatment Areas is shown in Figures 4.3 and 4.4. Installation of the subsurface ERH equipment involved rotonic drilling of borings within which the electrodes, multiphase extraction wells, temperature monitoring strings, vacuum piezometers, and water level monitoring instruments were installed. The system drilled and installed in both the Southwest and East Treatment Areas consisted of the specific components as shown in Table 4.2.

Six multiphase extraction wells were installed and equipped with pumps (X01, X02, X03, X04, X05, and X06) in the Southwest Treatment Area, and three multiphase extraction wells were installed and equipped with pumps (X26, X27, and X28) in the East Treatment Area (see Figures 4.3 and 4.4 for well locations). Groundwater was extracted via these submersible pneumatic pumps during system operations to maintain hydraulic control, dewater the treatment area, and aid in the transport of VOCs to the multiphase extraction wells. Lower RGA groundwater extraction wells in the Southwest Treatment Area were installed with the bottom of the well screen set at the RGA/McNairy interface and included a 2-ft sump extending into the McNairy Formation to maximize potential direct DNAPL recovery. Table 4.10 provides a summary of groundwater extraction data from Phase I operations. For the southwest wellfield, 1.7 times more water was extracted from the southwest wellfield as was injected. In the east, the ratio was 1.6. The average extraction rate for individual Southwest Treatment Area wells was 2.0 gpm, for a total of 11.8 gpm. The average extraction rate for individual wells in the East Treatment Area was 2.6 gpm, for a total of 7.9 gpm.

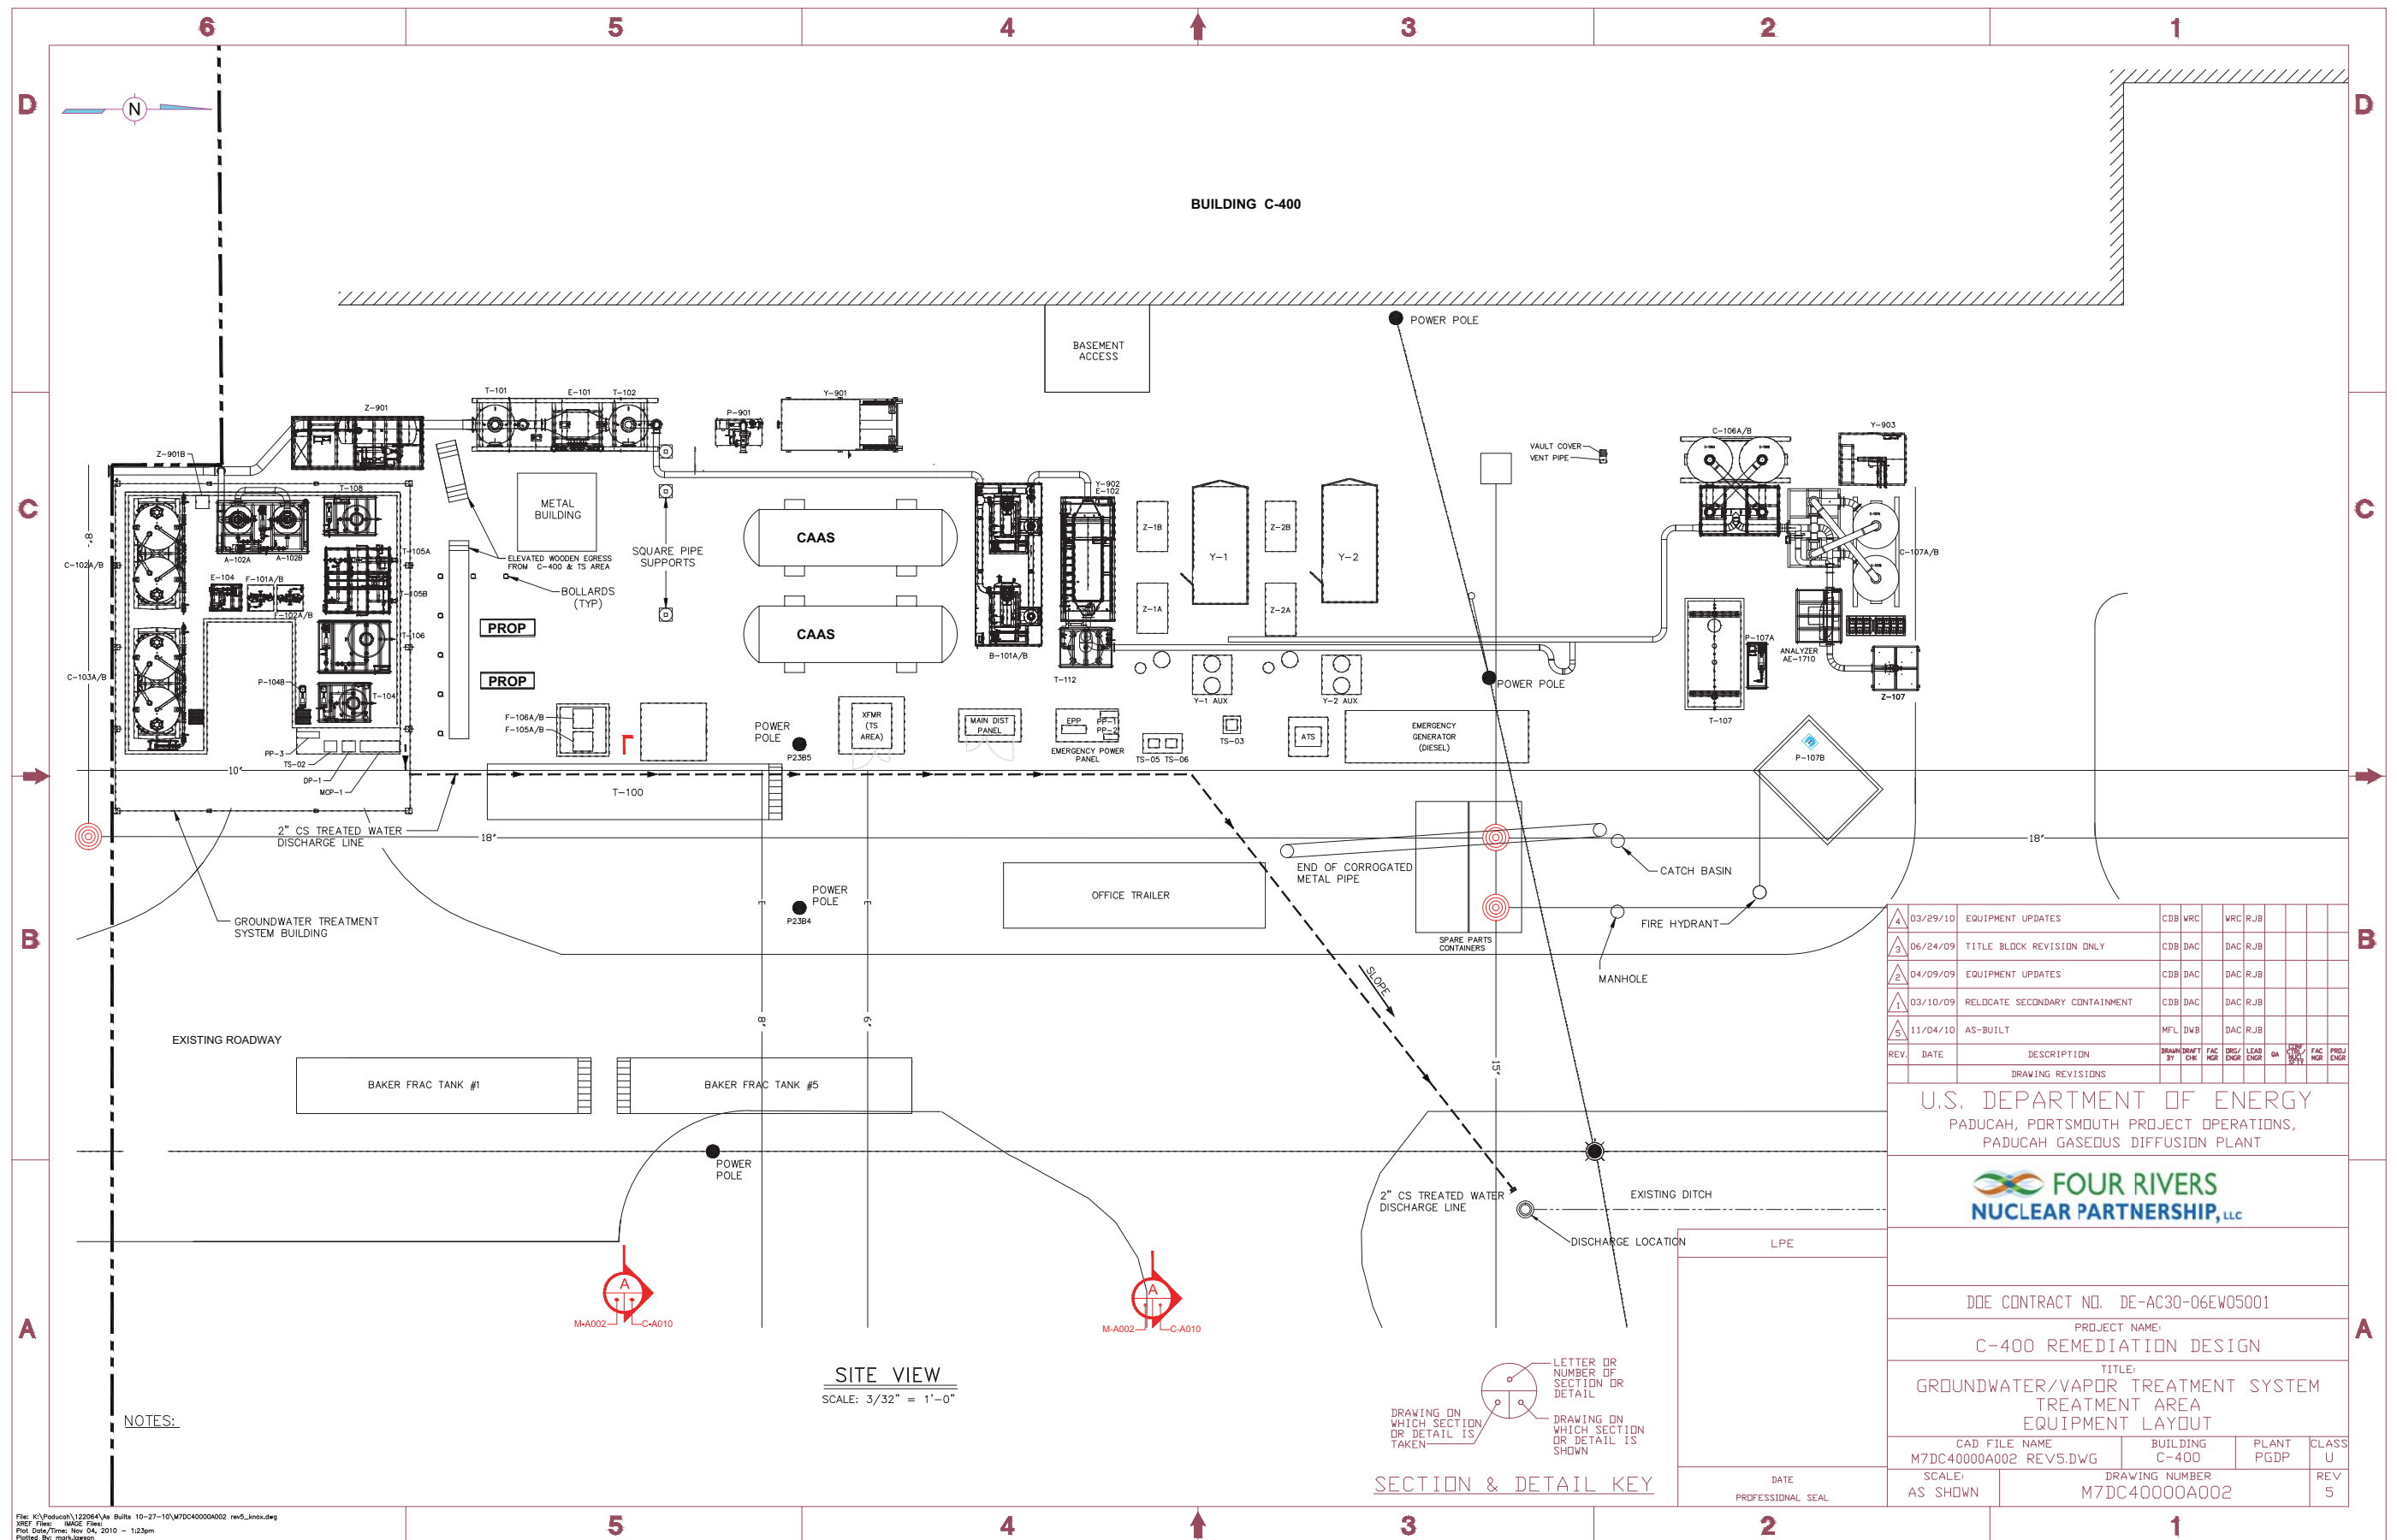
Figure 4.5. Groundwater/Vapor Treatment System Equipment Layout

The SVGTS to remove the contaminants from the soil vapor and groundwater extracted was constructed on the east side of the C-400 Cleaning Building. Figure 4.5 provides a figure showing the arrangement of the aboveground treatment equipment; while Figure 4.6 shows a picture of the aboveground treatment system at the time of Phase I. The major components of the SVGTS included the following:

- Power Delivery System
- Liquid Treatment System
- Vapor Treatment System
- System Controller
- Backup generator

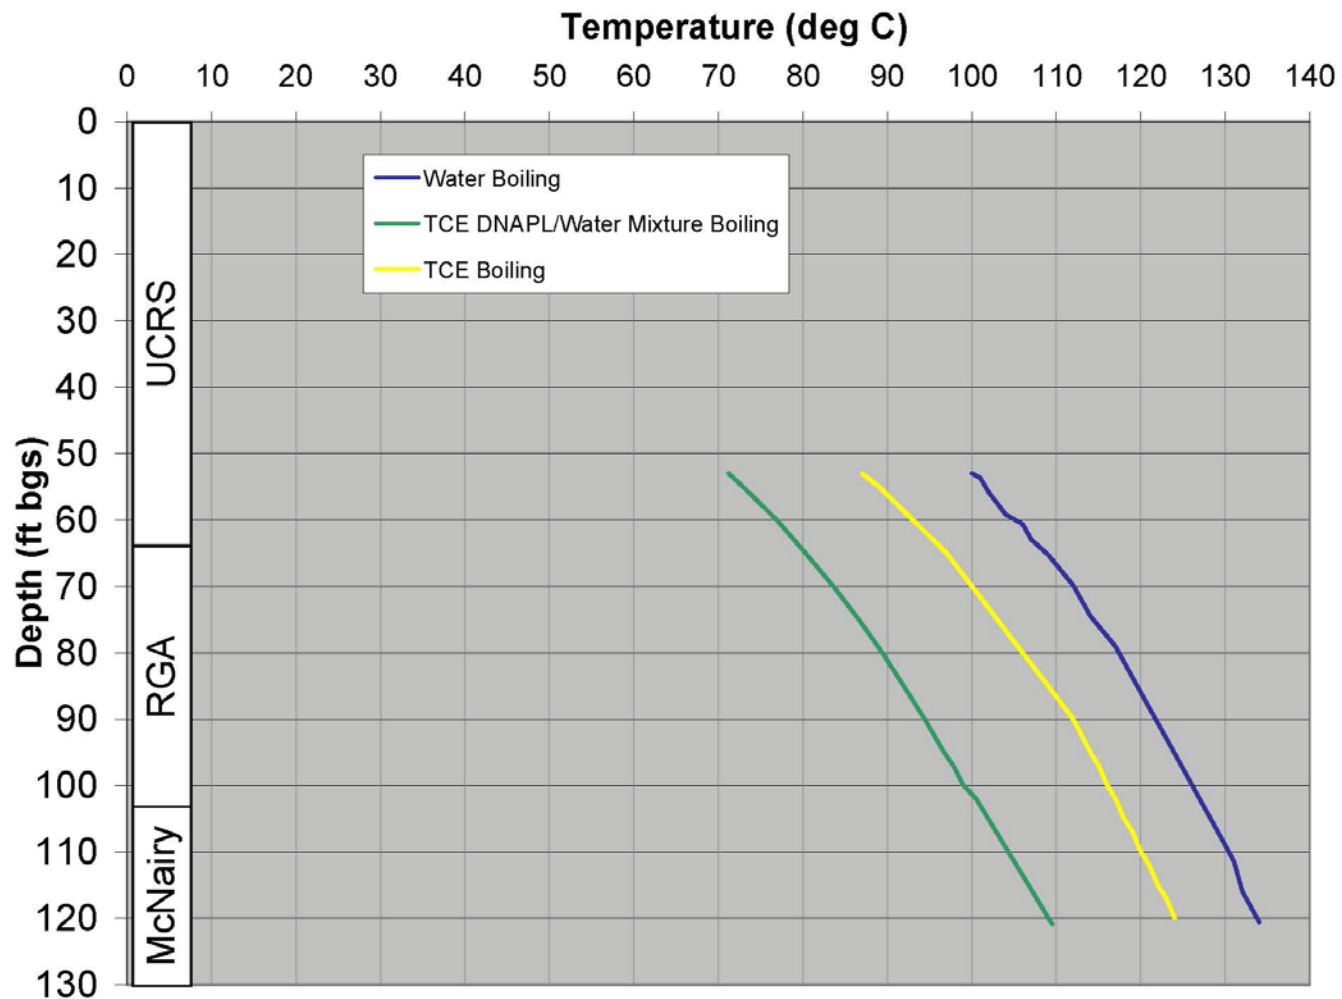
Figure 4.8. Boiling Temperature versus Depth

A critical factor in the success of an *in situ* ERH project is the attainment of target temperatures that are at or above the boiling point of the target VOC(s). The target temperature requirements for the C-400 ERH project were developed to be depth specific for reasons described below. TCE, the target VOC at C-400, has a boiling point of approximately 189°F (87°C) at normal atmospheric pressure conditions. A TCE/water mixture will boil at a lower temperature than that of either TCE or water. The boiling point of a TCE/water mixture is approximately 163°F (73°C). The boiling temperature of TCE and that of a TCE/water mixture increases with depth below the water level (potentiometric surface) due to increasing hydrostatic pressures. These factors were considered in defining the C-400 IRA target temperatures. Figure 4.8 shows the relationship between boiling temperature and depth below the potentiometric surface for a TCE/water mixture, for free-phase TCE, and for groundwater (DOE 2011b).

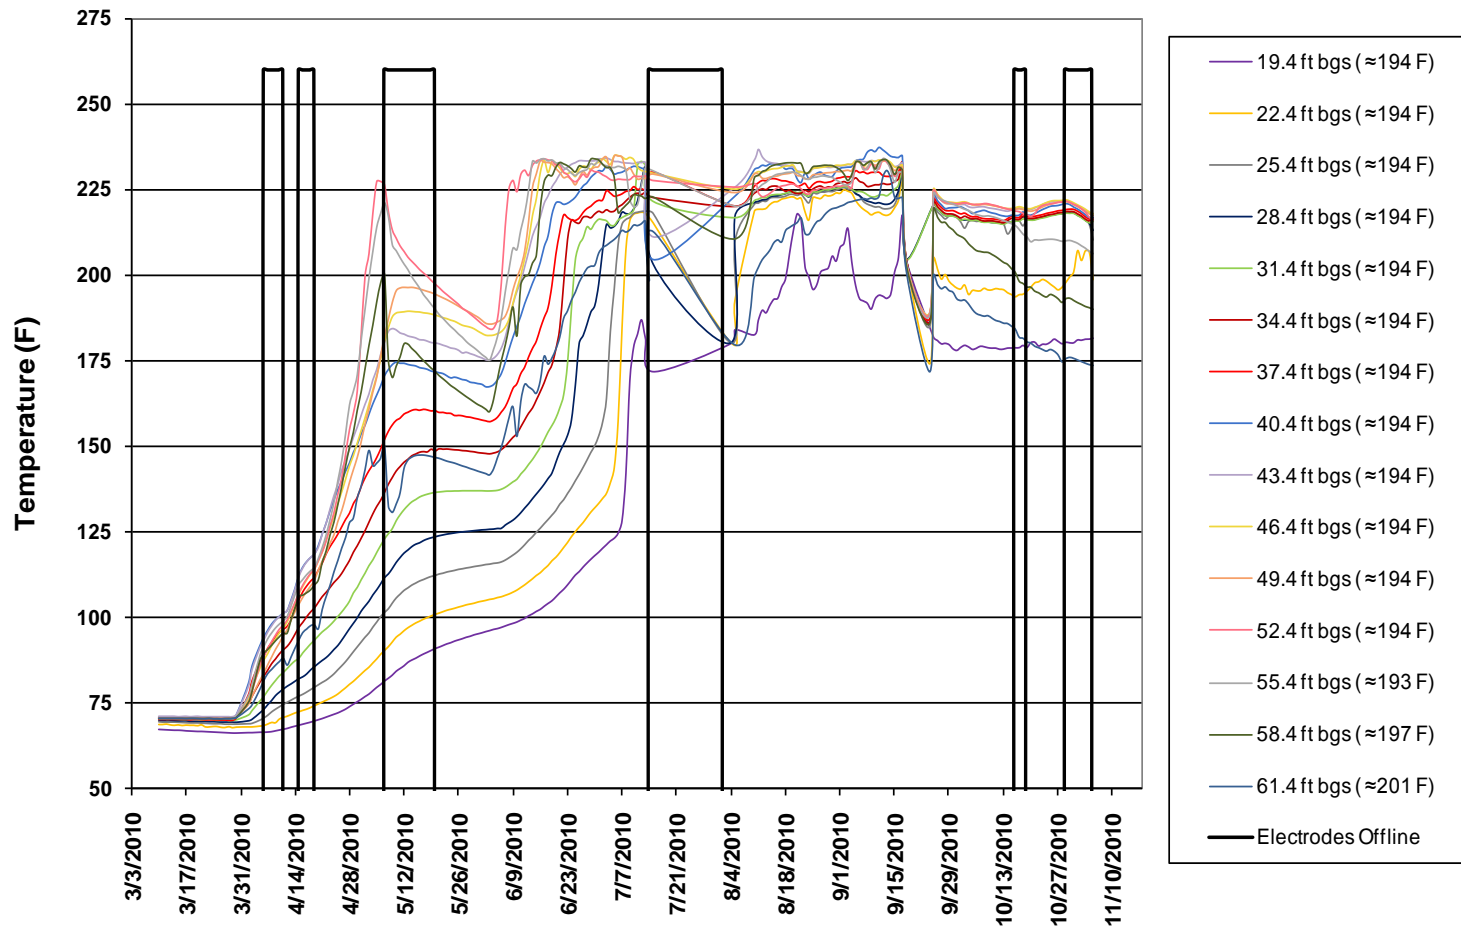
Figure 4.9. East Treatment Area Average Daily digiTAM™ D44 Readings, 18-62 ft bgs

Figures 4.9, 4.10, and 4.11 present temperature monitoring results from the East Treatment Area at digiTAM™ locations D44, D43, and D46, respectively (DOE 2011b). D44 was centrally located in the east area where the target heated depth interval was 40 to 60 ft bgs (Figure 4.4). DigiTAMs™ D43 and D46 were located on the west side of the East Treatment Area where the target heated depth interval was 20–60 ft bgs. Figure 4.12 presents temperature monitoring results at digiTAM™ D44 from approximately 62–71 ft bgs. Geologic setting and electrode placement are important for understanding the heating performance. In the East Treatment Area, the UCRS extends to an average depth of 51 ft bgs. The Upper RGA (HU 4 unit) extends from 51 ft to 57 ft bgs. The Lower RGA extends from 57 ft bgs to the top of the McNairy Formation at 91 ft bgs. Heating performance discussed below also tied into the aquifer being addressed. Due to the lower hydraulic conductivity (resulting in lower groundwater inflow) and lower electrical resistivity, the UCRS is more conducive to heating than the RGA. The heating electrodes in the East Treatment Area consisted of typical two interval electrodes placed from 36–46 ft and 53–63 ft bgs. The western borings contained a third electrode placed from 18–26 ft bgs. The discussion that follows compares heating performance based on geologic formation, water table, and electrode depth.

*Data spikes which exceed 20% of the adjacent values have been removed from the data set for presentation.

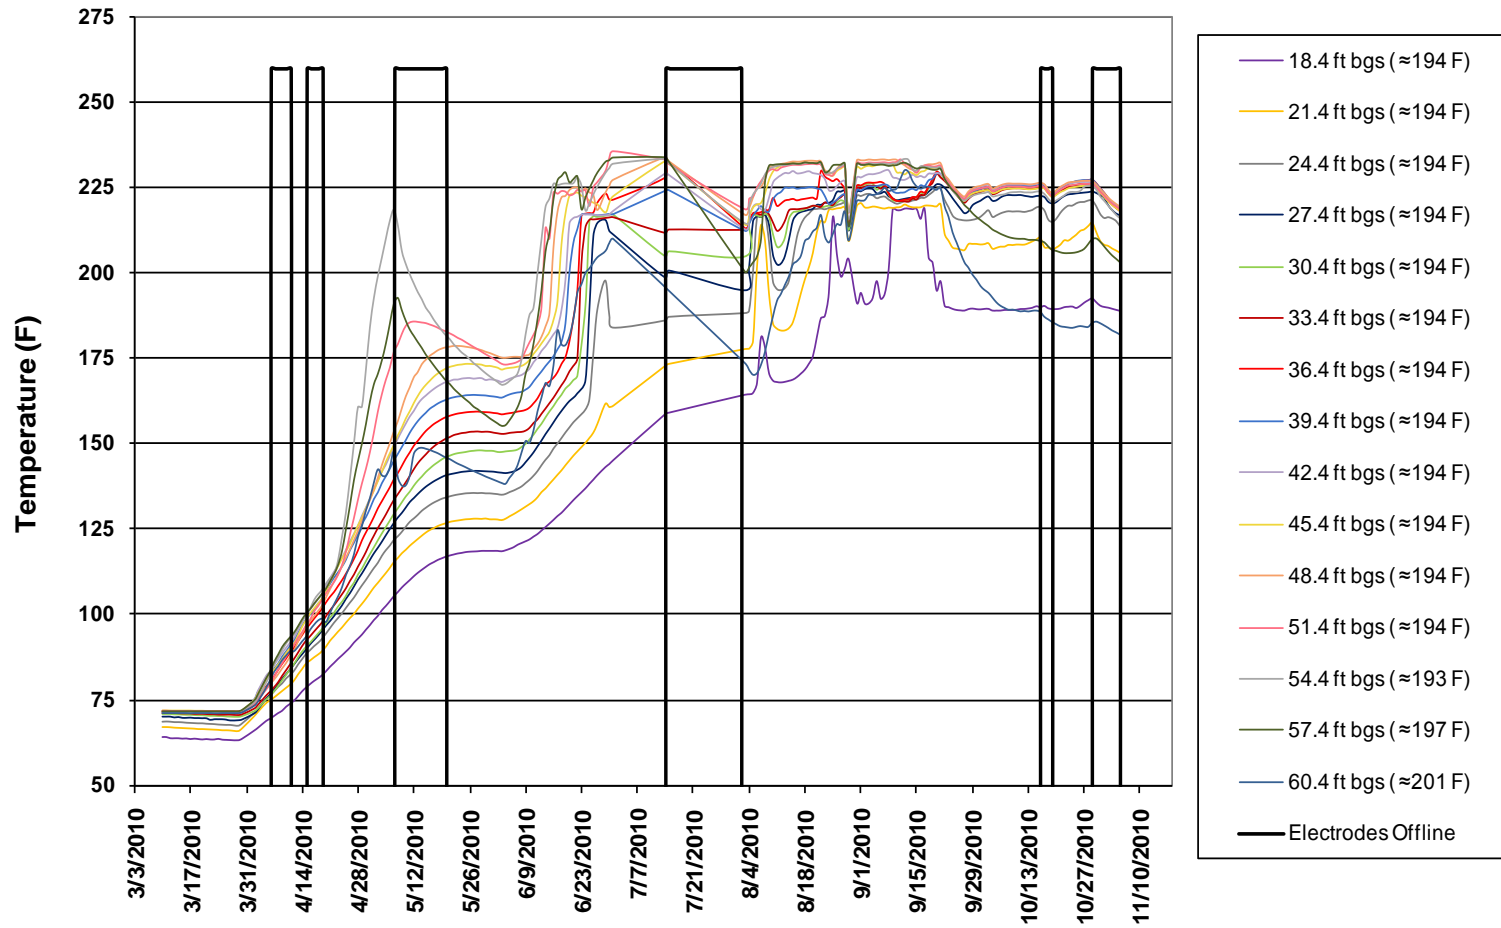
Figure 4.10. East Treatment Area Average Daily digiTAM™ D43 Readings, 18-62 ft bgs

*Data spikes which exceed 20% of the adjacent values have been removed from the data set for presentation.

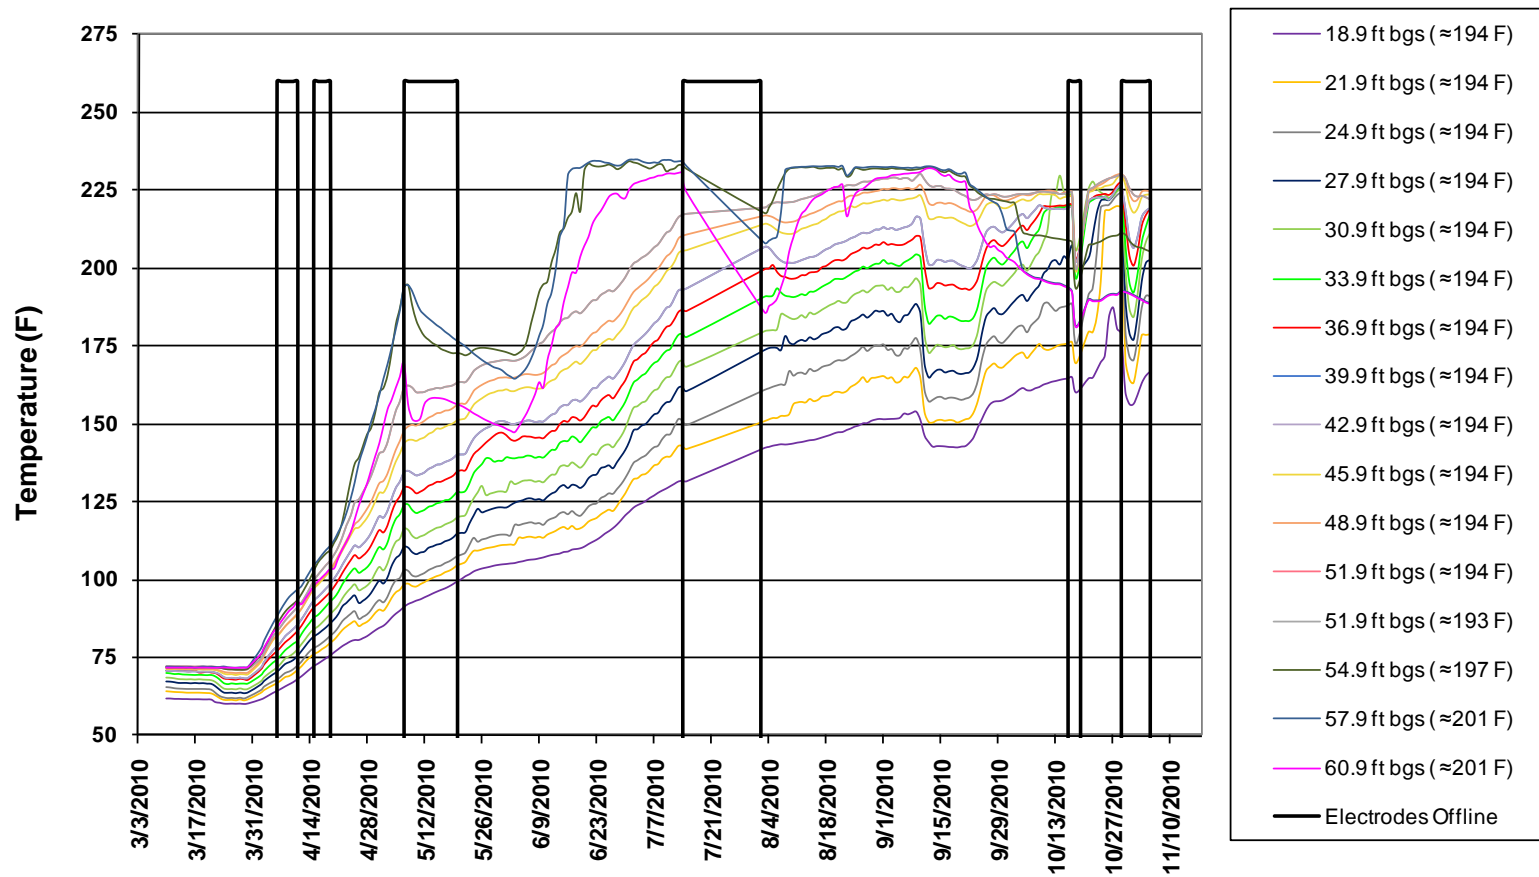
Figure 4.11. East Treatment Area Average Daily digiTAM™ D46 Readings, 18-62 ft bgs

*Data spikes which exceed 20% of the adjacent values have been removed from the data set for presentation.

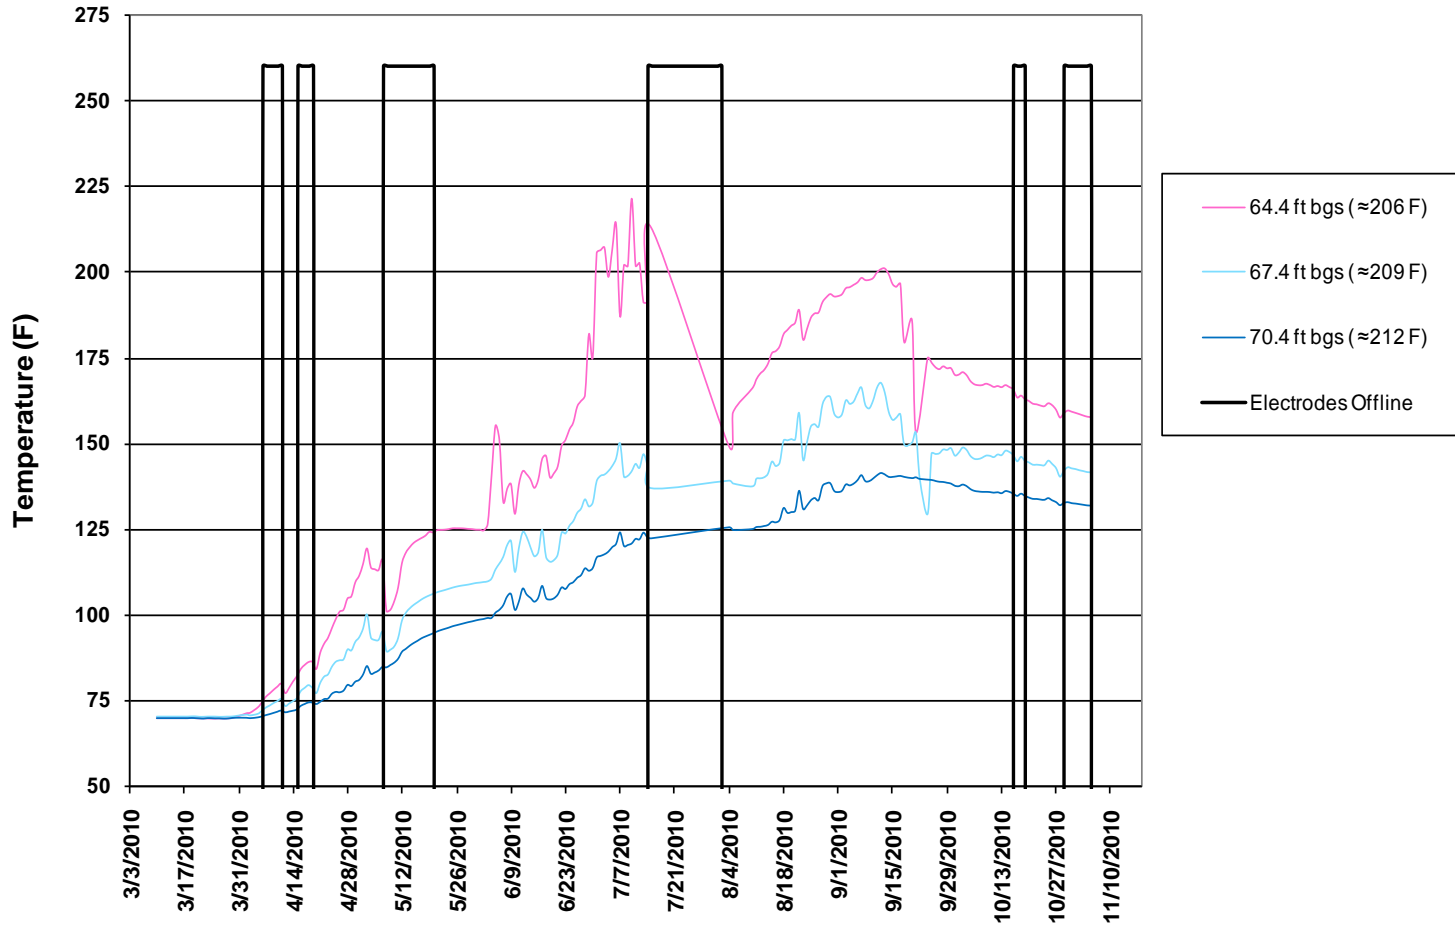
Figure 4.12. East Treatment Area Average Daily digiTAM™ D44 Readings, RGA 62-71 ft bgs

*Data spikes which exceed 20% of the adjacent values have been removed from the data set for presentation.

- Based on this observed response in the East Treatment Area, it is clear that, without benefit of additional deeper electrodes, the 60 to 70 ft bgs interval would not have been heated adequately in the Southwest Treatment Area.

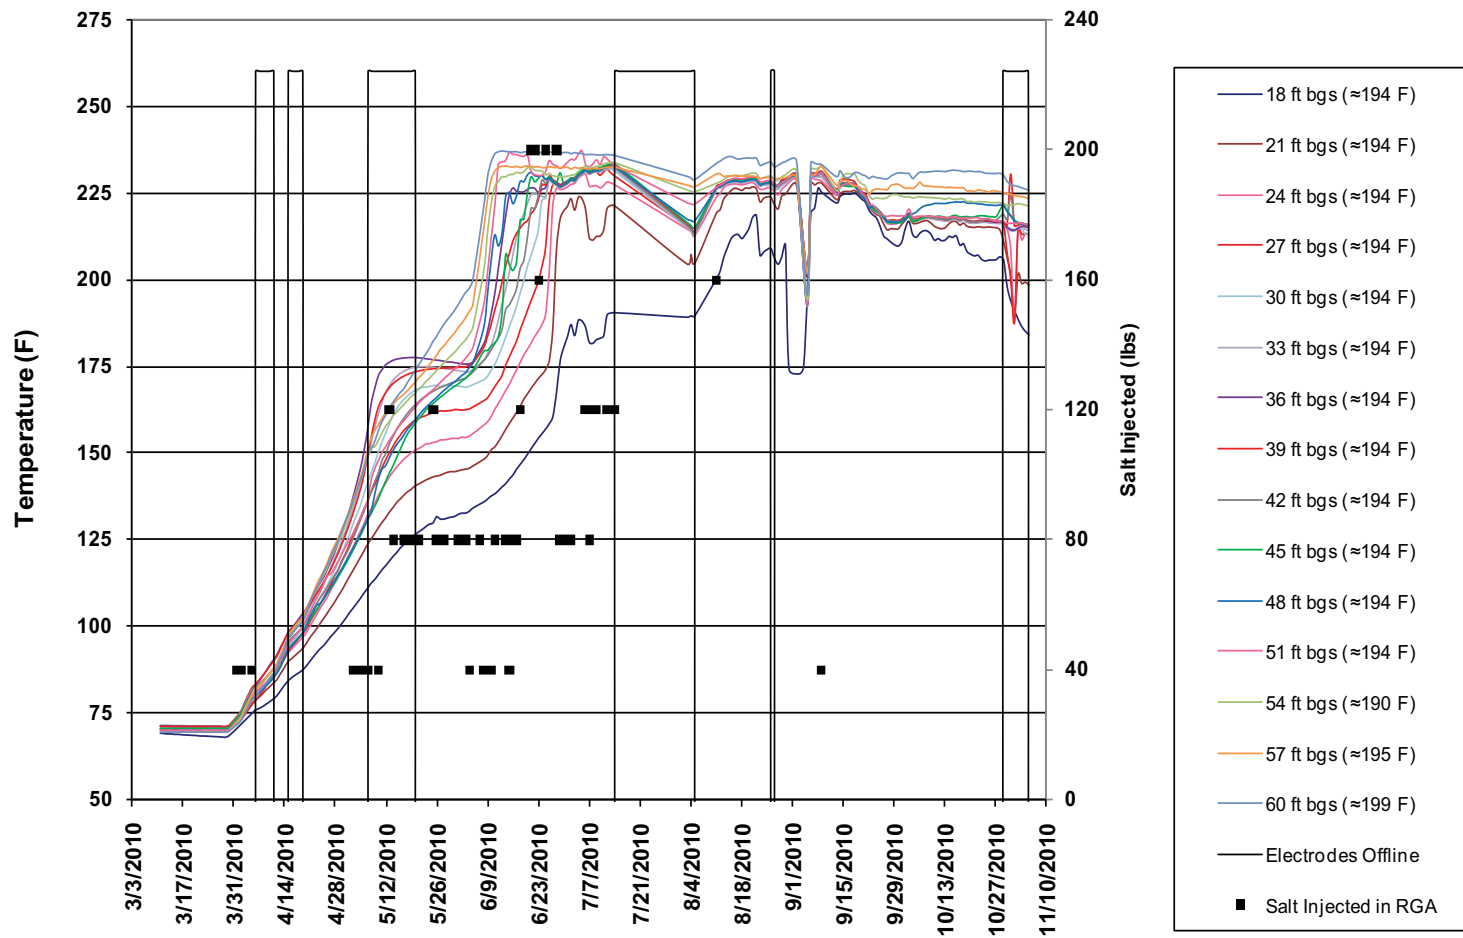
Figure 4.13. Southwest Treatment Area Average Daily digiTAM™ D07 Readings, UCRS 18-62 ft bgs

Heating performance discussed below also tied into the aquifer being addressed. Recall that the lower hydraulic conductivity (resulting in lower groundwater inflow) and lower electrical resistivity makes the UCRS more conducive to heating than the RGA. The heating electrodes in the Southwest Treatment Area typically consist of 3 interval electrodes, with electrodes placed from 18–28 ft, 36–46 ft, and 53–63 ft. For those borings surrounding D07, two additional electrodes were placed in the boreholes from 71–81 ft and 88–98 ft bgs.

*Data spikes which exceed 20% of the adjacent values have been removed from the data set for presentation.

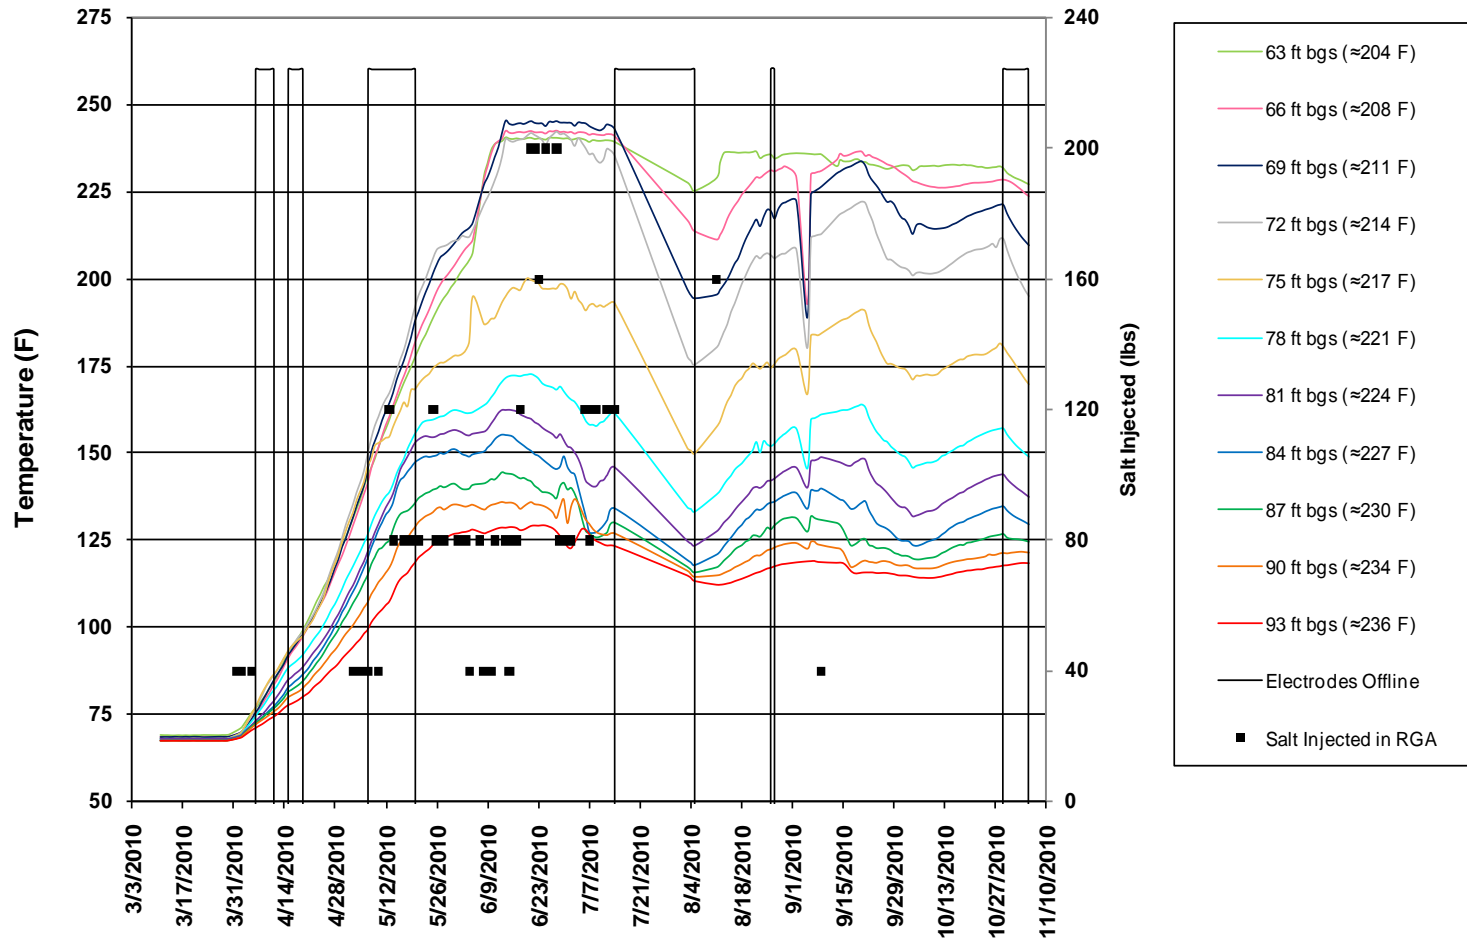
Figure 4.14. Southwest Treatment Area Average Daily digiTAM™ D07 Readings, 62-100 ft bgs

*Data spikes which exceed 20% of the adjacent values have been removed from the data set for presentation.

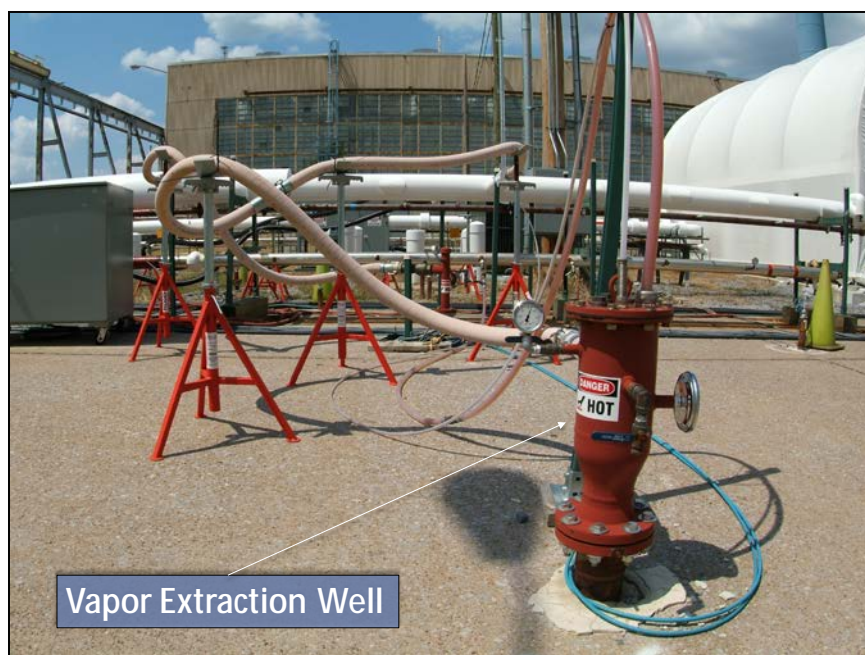
Figure 4.15. Vapor Extraction Well

Soil vapor extraction (SVE) as a component of ERH is a technology that is used to extract volatile compounds from unsaturated soil. During SVE, a vacuum is applied to an extraction well to lower the vapor pressure in the vicinity of the well. Lowering the pressure at the extraction well induces an advective flow of soil vapors and flow of groundwater containing VOCs (primarily TCE and its breakdown products) from regions of higher pressure to the extraction point. This process enhances the volatilization of contaminants from within grains of soil and promotes the diffusion of sorbed contaminants into soil pores where they can be swept and extracted along with soil vapors. Vapor extraction performance is assessed by monitoring mass removal and ensuring that all areas within the treatment area had sufficient induced vacuum to recover the vapors generated by ERH. The radius of influence (ROI) generated by a vapor extraction well was assessed by measuring the vacuum induced at adjacent monitoring points. Vapor extraction well locations are shown on Figures 4.3 and 4.4 for the East and Southwest Treatment Areas. Vapor extraction wells were designated on the figure by the letter “X” followed by a number (e.g., X27). A picture of a vapor extraction well is shown in Figure 4.15. Wellfield vacuum pressure was monitored at vacuum piezometers installed near the perimeter of the treatment areas. These are designated on the Figures 4.3 and 4.4 by the letter “V” followed by a number (e.g., V06) or by the letters “DV” followed by a number (e.g., DV07).

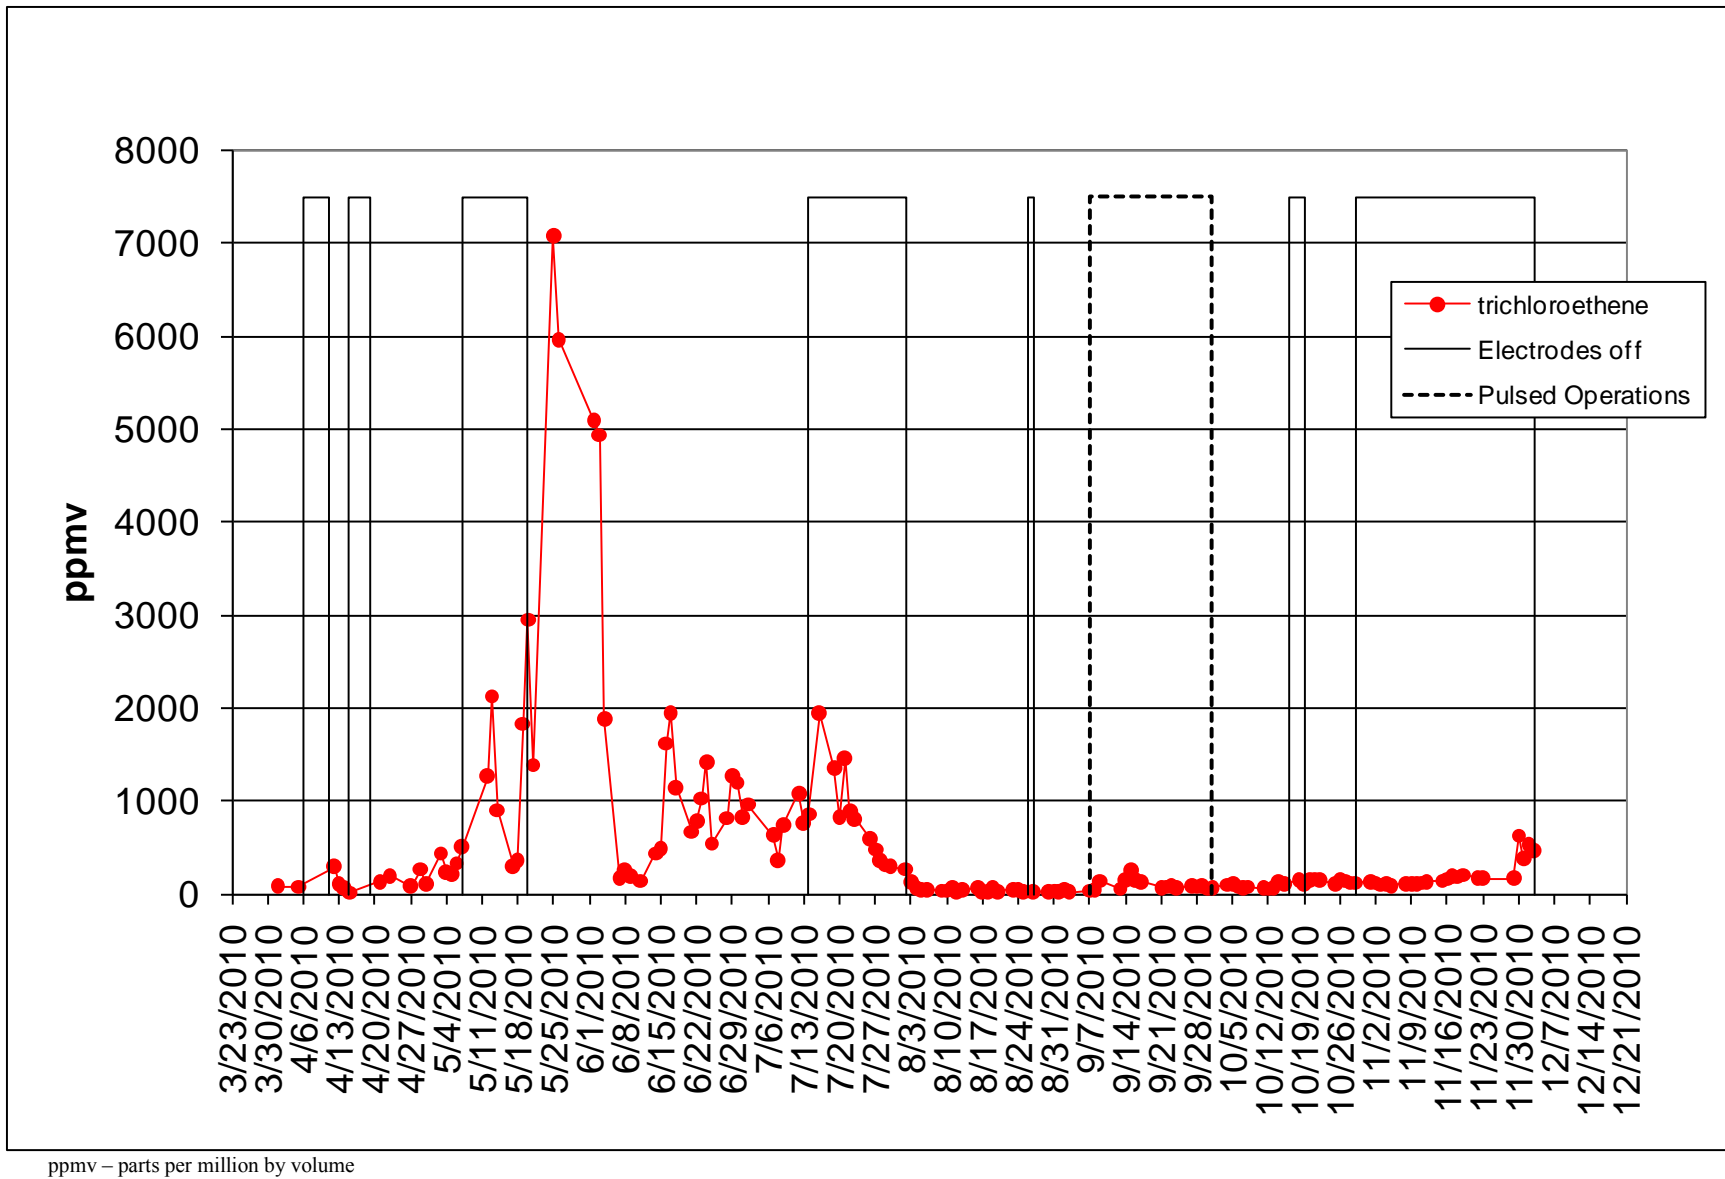
TCE concentrations in the vapor extraction header were monitored throughout operations using photoacoustic analyses. Figure 4.16 shows the East Treatment Area header photoacoustic readings (DOE 2011b). These data indicate that asymptotic levels were achieved in the wellfield during August 2010. Pulsed operations commenced in early September 2010 and were stopped at the end of
