REMEDIAL ACTION COMPLETION REPORT FOR THE INTERIM REMEDIAL ACTION FOR THE GROUNDWATER OPERABLE UNIT FOR THE VOLATILE ORGANIC COMPOUND CONTAMINATION AT THE C-400 CLEANING BUILDING AT THE PADUCAH GASEOUS DIFFUSION PLANT, PADUCAH, KENTUCKY, DOE/LX/07-2417&D1

**Remedial Action Completion Report
for the Interim Remedial Action
for the Groundwater Operable Unit for the
Volatile Organic Compound Contamination at the
C-400 Cleaning Building at the
Paducah Gaseous Diffusion Plant,
Paducah, Kentucky**

**DOE/LX/07-2417&D1
Primary Document**

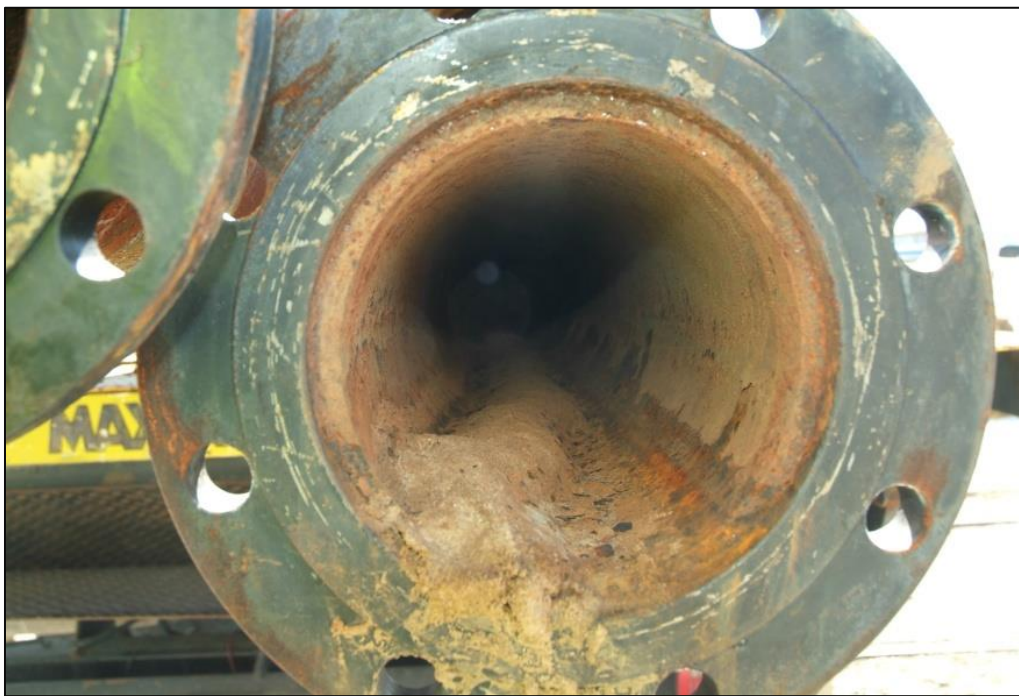
Figure 4.22. Sediment in the Vapor Extraction Header

During Phase I operations, sand and sediment infiltrated the six groundwater extraction wells located in the Southwest Treatment Area. Those extraction wells extended through the RGA to the McNairy interface. The infiltration is believed to have been caused by a combination of the wells being underdeveloped and the well screen slot size being too large. On a few occasions, the buildup of sand and sediment was significant enough to incapacitate the pumps. The pumps had to be removed to be serviced and the wells flushed to remove the sediment build up. The solids also negatively impacted operations at the SVGTS by plugging and filling the filter bags. This resulted in additional system downtime for replacement of the filter bags. The East Treatment Area extraction wells were not affected by the infiltration of solids as they did not penetrate the RGA. The design of future groundwater extraction wells should specify a smaller well screen slot size and require a more rigorous well development technique. Figure 4.22 shows a picture of sediment accumulation in the vapor extraction header pipe during Phase I operations.

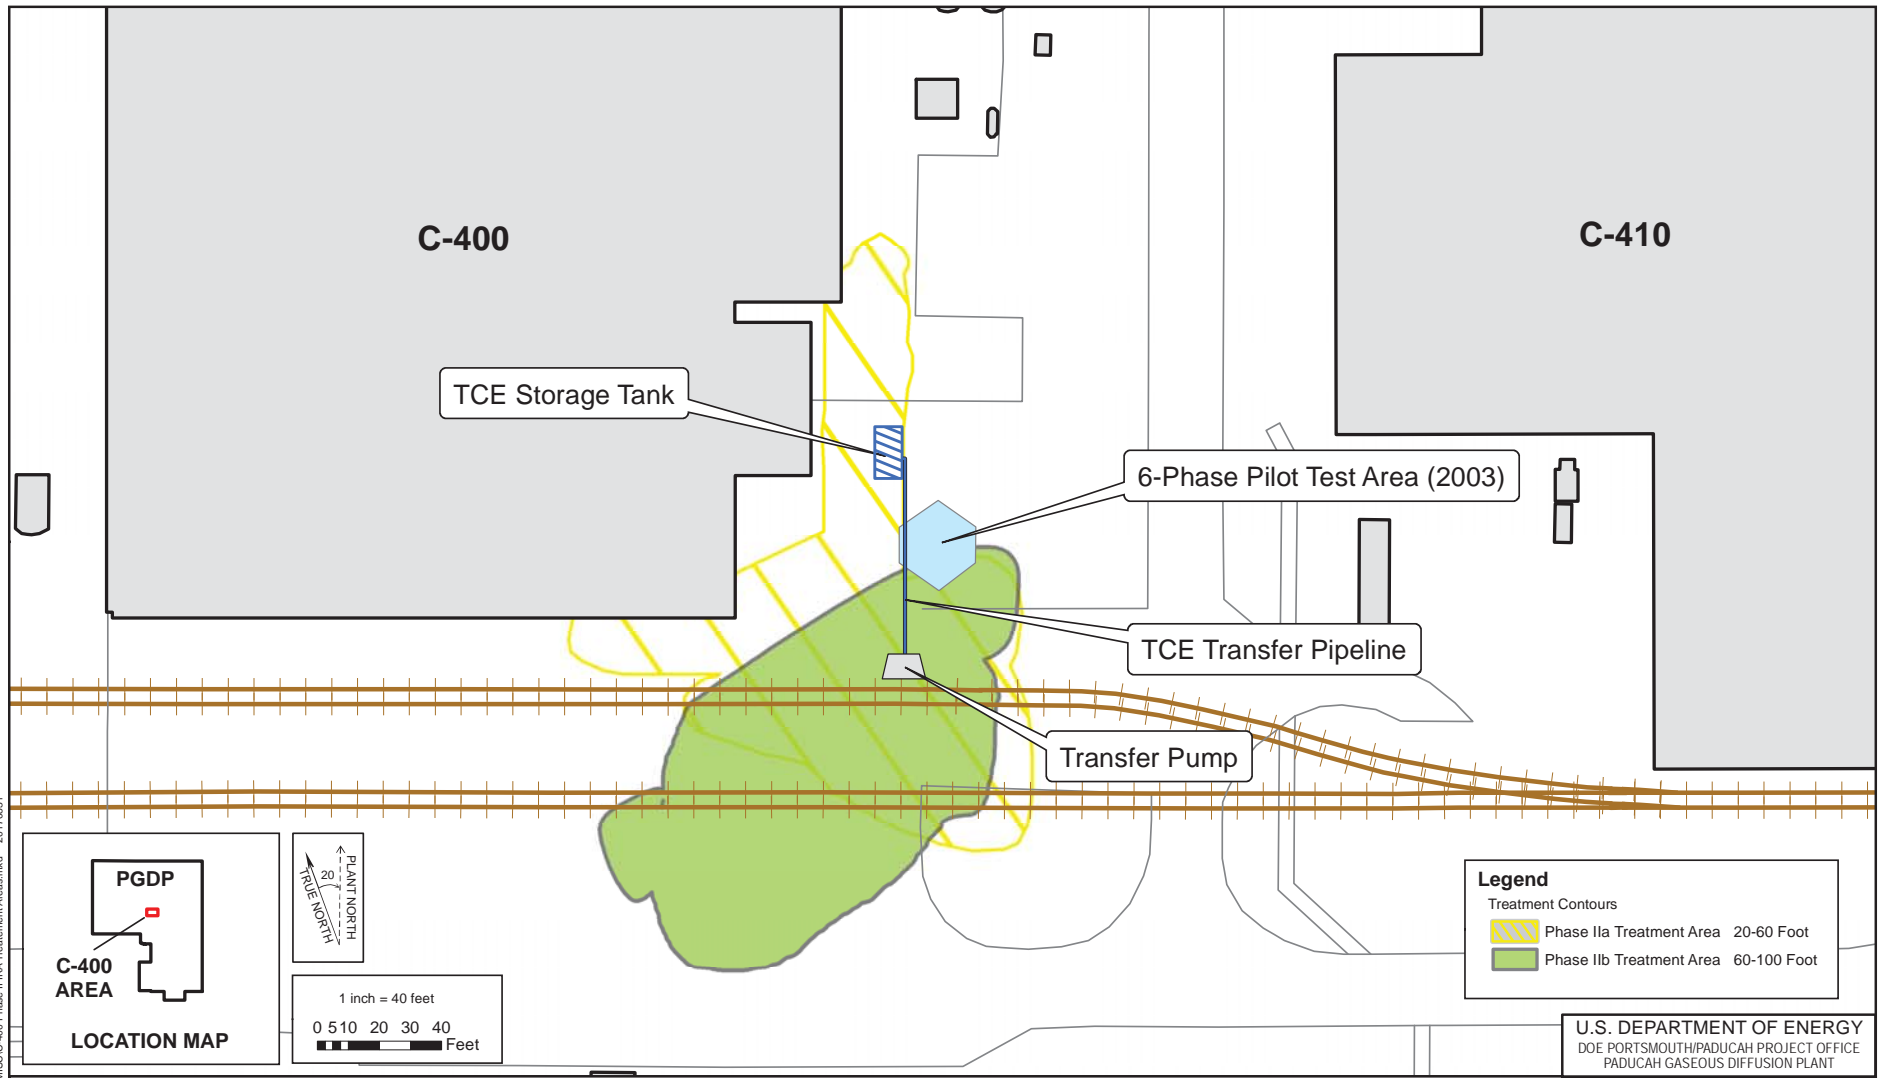
Figure 5.1. C-400 Phase II IRA Treatment Areas

Lower than anticipated vacuum levels were observed during Phase I in the wellfield without a surface seal, suggesting possible short circuiting to the atmosphere. Based on this observation, a vapor cap was installed to prevent short-circuiting of vacuum to atmosphere in areas without concrete/asphalt surfaces and consisted of 30-mil plastic sheeting covered with 4 inches of stone. Figure 5.2 shows the vapor cap locations in relationship to the Phase IIa well locations.

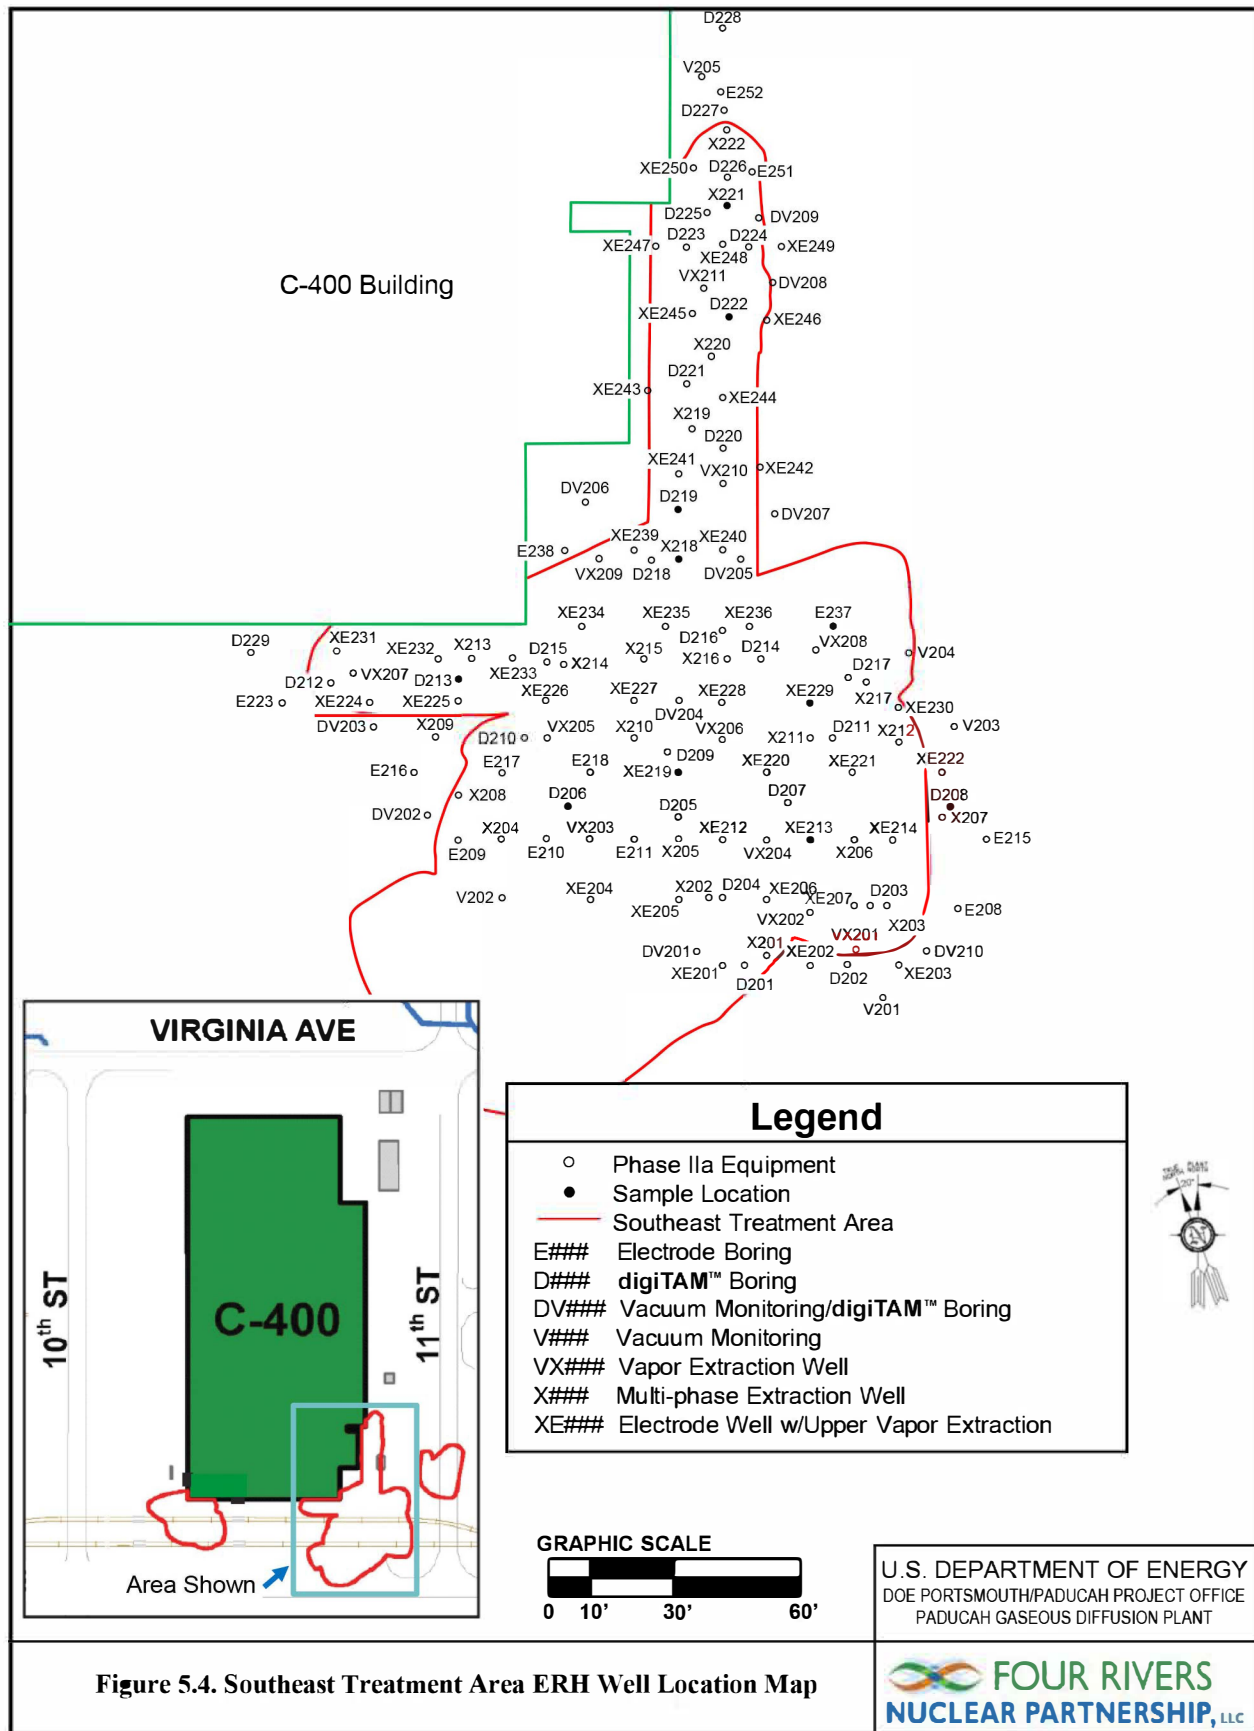
Figure 5.4. Southeast Treatment Area ERH Well Location Map

ERH Well Type	Southeast Treatment Area	Notes
Electrode Wells (E-XXX)	13	Configured with 3 Electrodes
Upper Vapor Extraction/Electrode Wells (XE-XXX)	39	Configured with 3 Electrodes
Multiphase Extraction Wells (X-XXX)	22	Vapor and Groundwater Extraction Well
digiTAM™ Wells (D-XXX)	29	Temperature Sensor Well
digiTAM™/Vacuum Monitoring Well (DV-XXX)	10	Temperature Sensor and Vacuum Monitoring Well
Vacuum Monitoring Well (V-XXX)	5	
Vapor Extraction Well (VX-XXX)	11	
Total Wells	129

Twenty-two multiphase extraction wells were installed and equipped with pumps (X201 through X222), in the Southeast Treatment Area (see Figure 5.4 for well locations). Groundwater was extracted via these submersible pneumatic pumps during system operations to maintain hydraulic control and dewater the treatment area and to aid in the transport of VOCs to the multiphase extraction wells. Upper RGA groundwater extraction wells in the Southeast Treatment Area were installed with the bottom of the well screen including a 2-ft sump extending approximately 68 ft bgs. Table 5.5 provides a summary of groundwater extraction data from Phase IIa operations. For the southeast wellfield, three times more water was extracted from the southeast wellfield as was injected. The average extraction rate for individual Southeast Treatment Area wells was 2.0 gpm, for a total of 45.0 gpm. Sample ports installed at each groundwater extraction wellhead allowed groundwater samples to be obtained.

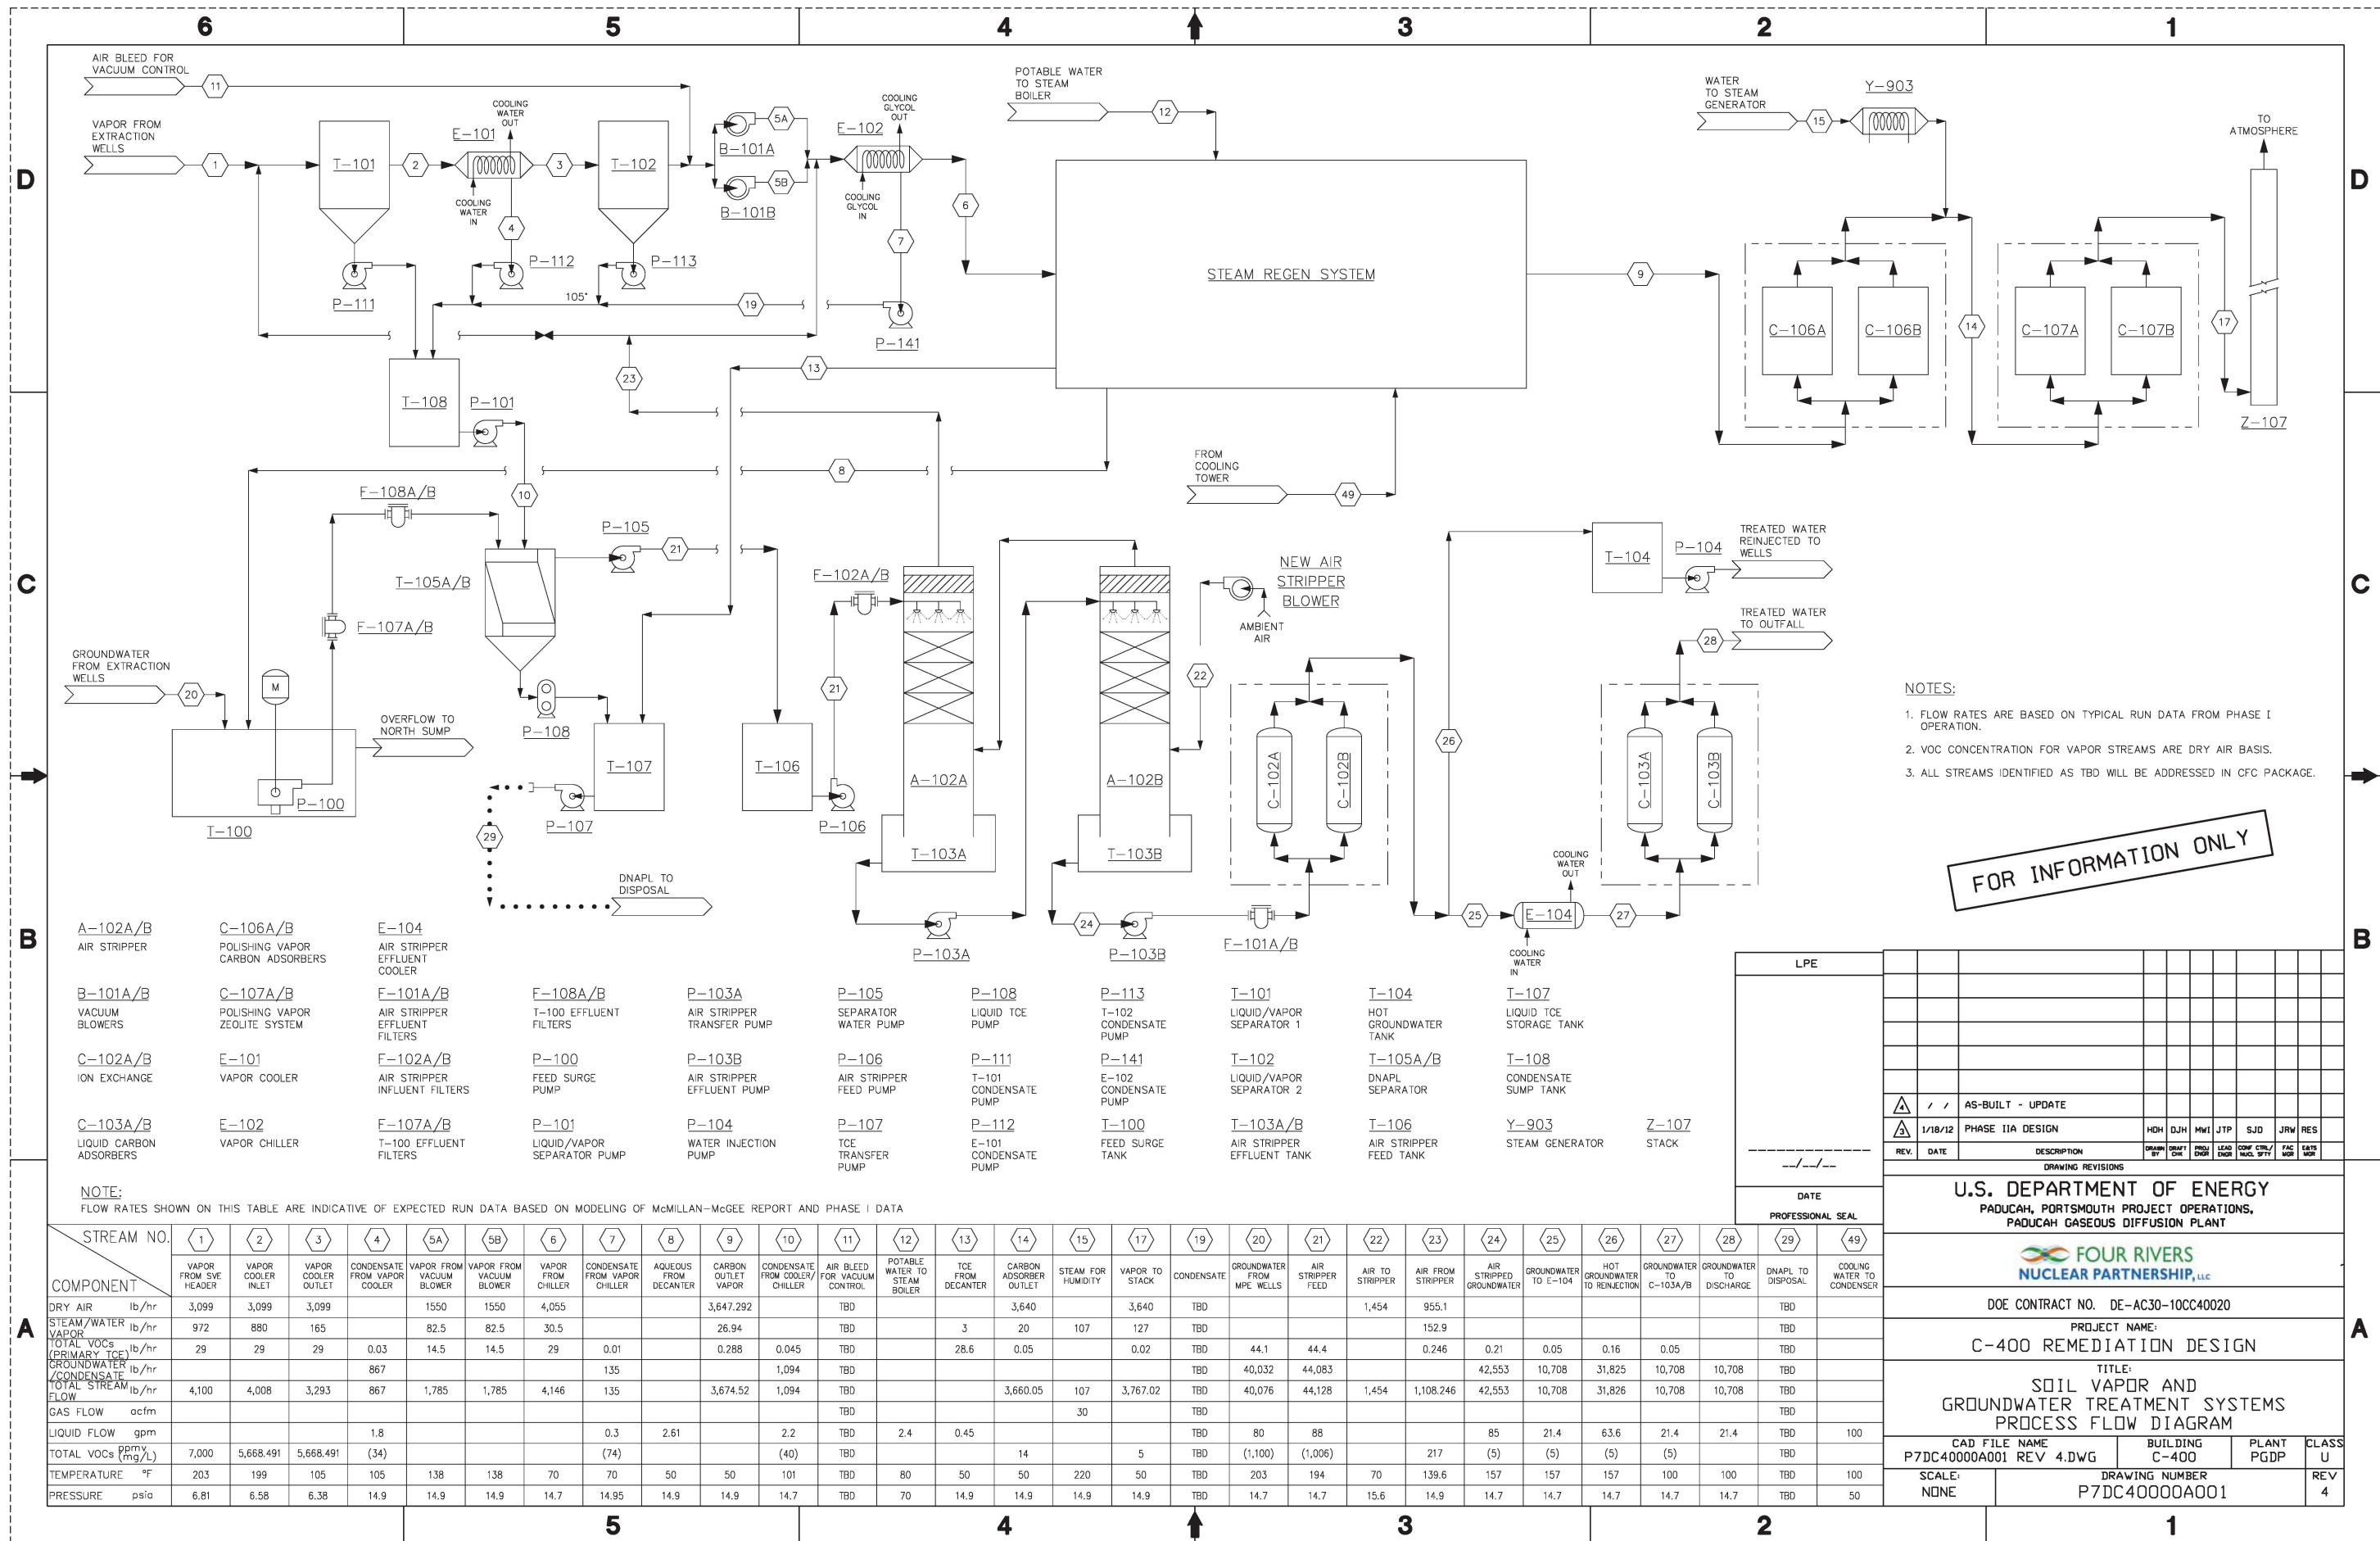
- NOTES:
1. FLOW RATES ARE BASED ON TYPICAL RUN DATA FROM PHASE I OPERATION.
 2. VOC CONCENTRATION FOR VAPOR STREAMS ARE DRY AIR BASIS.
 3. ALL STREAMS IDENTIFIED AS TBD WILL BE ADDRESSED IN CFC PACKAGE.

STREAM NO.	1	2	3	4	5A	5B	6	7	8	9	10	11	12	13	14	15	17	19	20	21	22	23	24	25	26	27	28	29	49	
COMPONENT	VAPOR FROM SVE HEADER	VAPOR COOLER INLET	VAPOR COOLER OUTLET	CONDENSATE FROM VAPOR COOLER	VAPOR FROM VACUUM BLOWER	VAPOR FROM VACUUM BLOWER	VAPOR FROM CHILLER	CONDENSATE FROM CHILLER	AQUEOUS FROM DECANTER	CARBON OUTLET VAPOR	CONDENSATE FROM COOLER/CHILLER	AIR BLEED FOR VACUUM CONTROL	POTABLE WATER TO STEAM BOILER	TCE FROM DECANTER	CARBON ADSORBER OUTLET	STEAM FOR HUMIDITY	VAPOR TO STACK	CONDENSATE	GROUNDWATER FROM MPE WELLS	AIR STRIPPER FEED	AIR TO STRIPPER	AIR FROM STRIPPER	AIR STRIPPED GROUNDWATER	GROUNDWATER TO E-104	HOT GROUNDWATER TO REINJECTION	GROUNDWATER TO C-103A/B	GROUNDWATER TO DISCHARGE	DNAPL TO DISPOSAL	COOLING WATER TO CONDENSER	
DRY AIR	3,099	3,099	3,099		1550	1550	4,055			3,647.292		TBD		3,640		3,640	TBD				1,454	955.1							TBD	
STEAM/WATER VAPOR	972	880	165		82.5	82.5	30.5			26.94		TBD		3	20	107	127	TBD				152.9							TBD

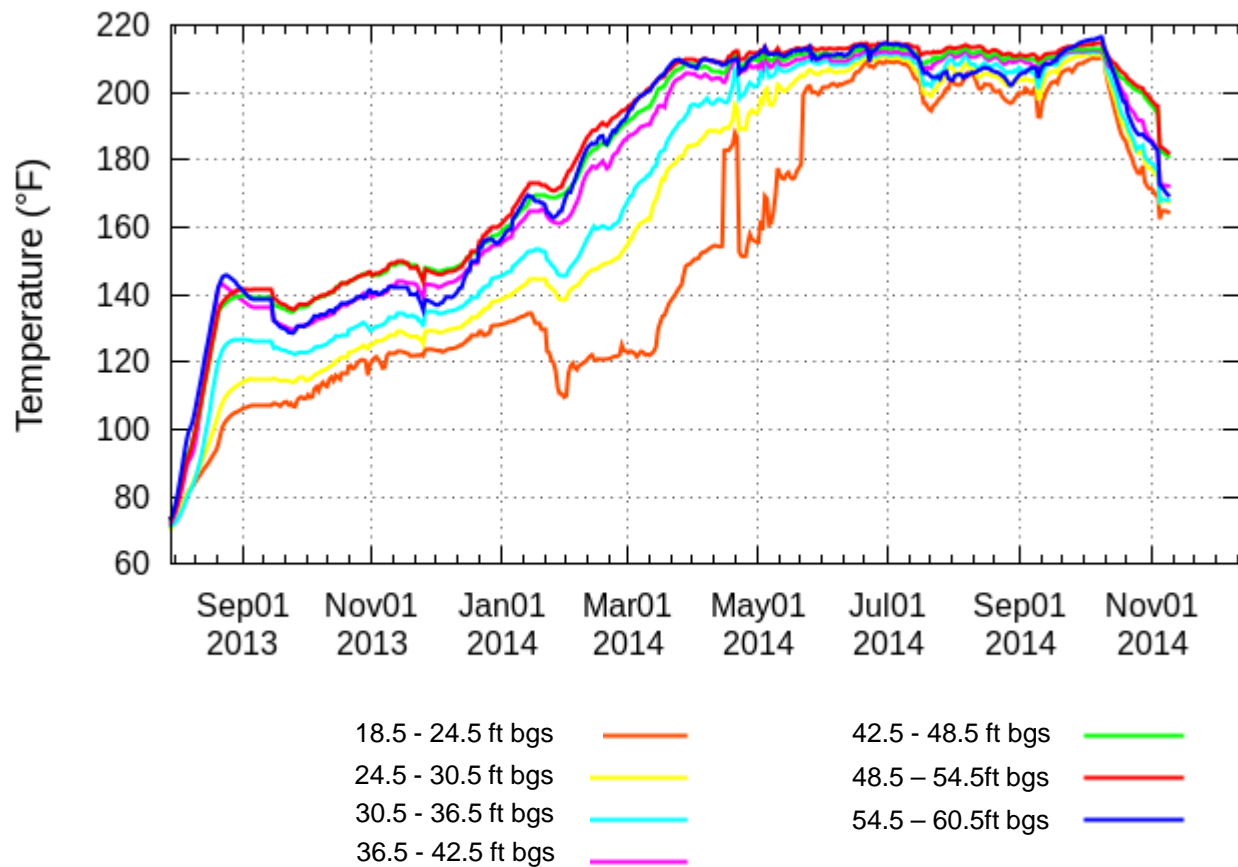
Figure 5.7. C-400 Phase IIa – Average digiTAM™ Temperature by Depth

Figures 5.7 and 5.8 present average digiTAM™ temperatures by depth and area results from the Southeast Treatment Area. Figure 5.7 depicts digiTAM™ sensor readings various depths bgs. The groundwater potentiometric surface typically was encountered at approximately 53 ft bgs.

DigiTAM™ temperature sensors above the potentiometric surface were these:

- Sensors staged between 18.5–24.5 ft bgs achieved and maintained target temperatures ($194^{\circ}\text{F}/90^{\circ}\text{C}$) from late-May through mid-October 2014.
- Sensors staged between 24.5–30.5 ft bgs achieved and maintained target temperatures ($194^{\circ}\text{F}/90^{\circ}\text{C}$) from late-April through mid-October 2014.
- Sensors staged between 30.5–36.5 ft bgs achieved and maintained target temperatures ($194^{\circ}\text{F}/90^{\circ}\text{C}$) from late-March through mid-October 2014.
- Sensors staged between 36.5–42.5 ft bgs achieved and maintained target temperatures ($194^{\circ}\text{F}/90^{\circ}\text{C}$) from mid-March through late-October 2014.
- Sensors staged between 42.5–48.5 ft bgs achieved and maintained target temperatures ($194^{\circ}\text{F}/90^{\circ}\text{C}$) from early-March through late-October 2014.

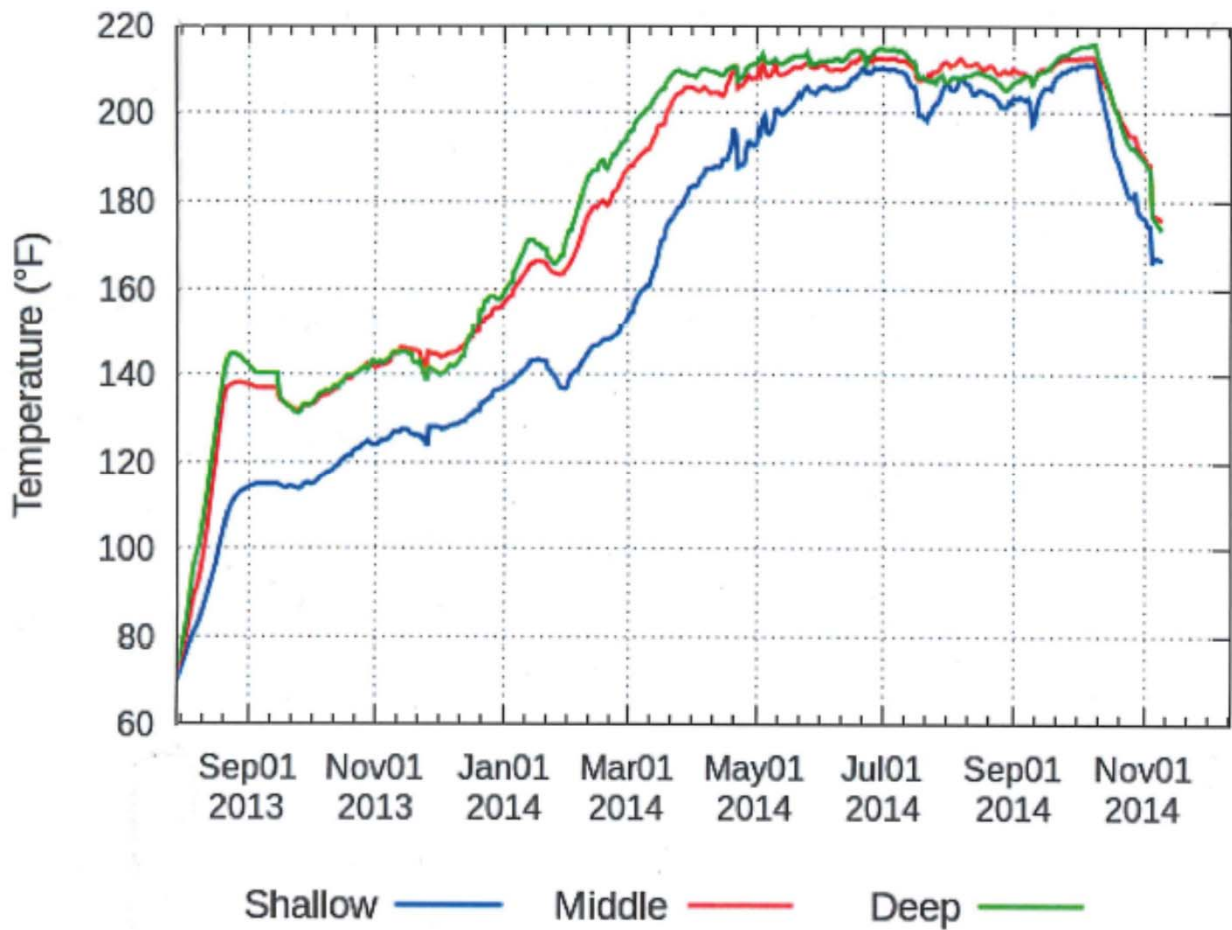
Figure 5.8. C-400 Phase IIa – Average digiTAM™ Temperature by Electrode Area

Figure 5.8 shows data based by area temperatures for shallow, middle, and deep interval electrodes.

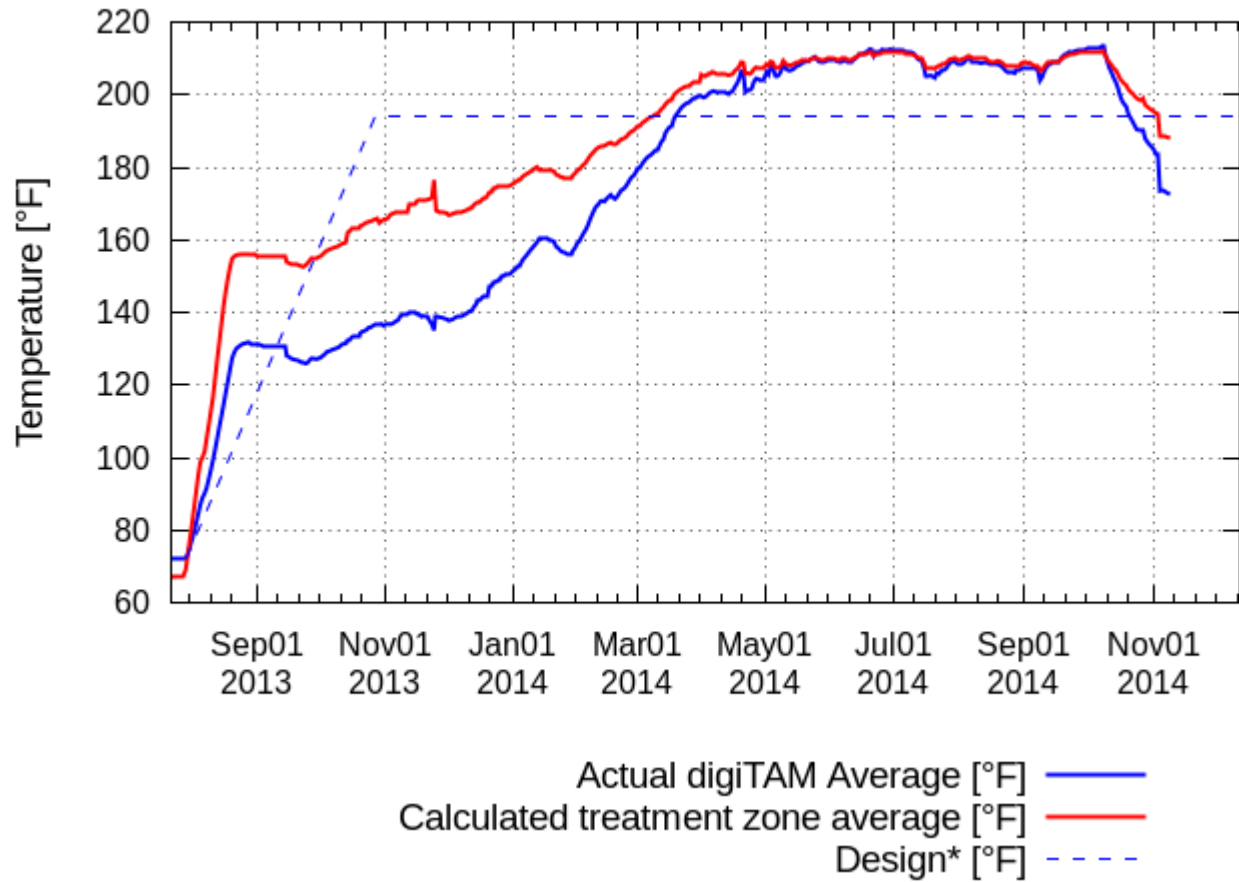
Figure 5.9. C-400 Phase IIa Actual and Design Temperature Curves

Figure 5.9 graphically illustrates the rapid temperature increase in subsurface temperatures during August 2013 when electrodes were powered up and the subsequent leveling off of temperature. The SVGTS was shut down in late November through mid-January to troubleshoot weather-related system issues and problems with the carbon regeneration unit. The ERH electrode system was operated as necessary during the periods of treatment system downtime to minimize the loss of subsurface heat as reflected on the temperature curves. After the SVGTS issues were resolved, power to the wellfield electrodes was resumed January 14, 2014. For the remainder of January 2014, the SVGTS system was subjected to levels of VOCs higher than anticipated, requiring additional fine-tuning of the SVGTS to address the VOC spikes. In turn, the power to the wellfield electrodes was lowered to reduce VOC concentrations at the SVGTS intake. Full power to the wellfield electrodes resumed in early February 2014 and the ERH and SVGTS systems ran without any significant incidents. The ERH system was shut down in early October 2014, as depicted by the sharp decline in energy on Figure 5.10. The SVGTS system was shutdown November 5, 2014.
