**Groundwater Assessment Report  
for the C-746-U Landfill at the  
Paducah Gaseous Diffusion Plant,  
Paducah, Kentucky**

Date Issued—May 2013

Prepared for the  
U.S. DEPARTMENT OF ENERGY  
Office of Environmental Management

Prepared by  
LATA ENVIRONMENTAL SERVICES OF KENTUCKY, LLC  
managing the  
Environmental Remediation Activities at the  
Paducah Gaseous Diffusion Plant  
under contract DE-AC30-10CC40020

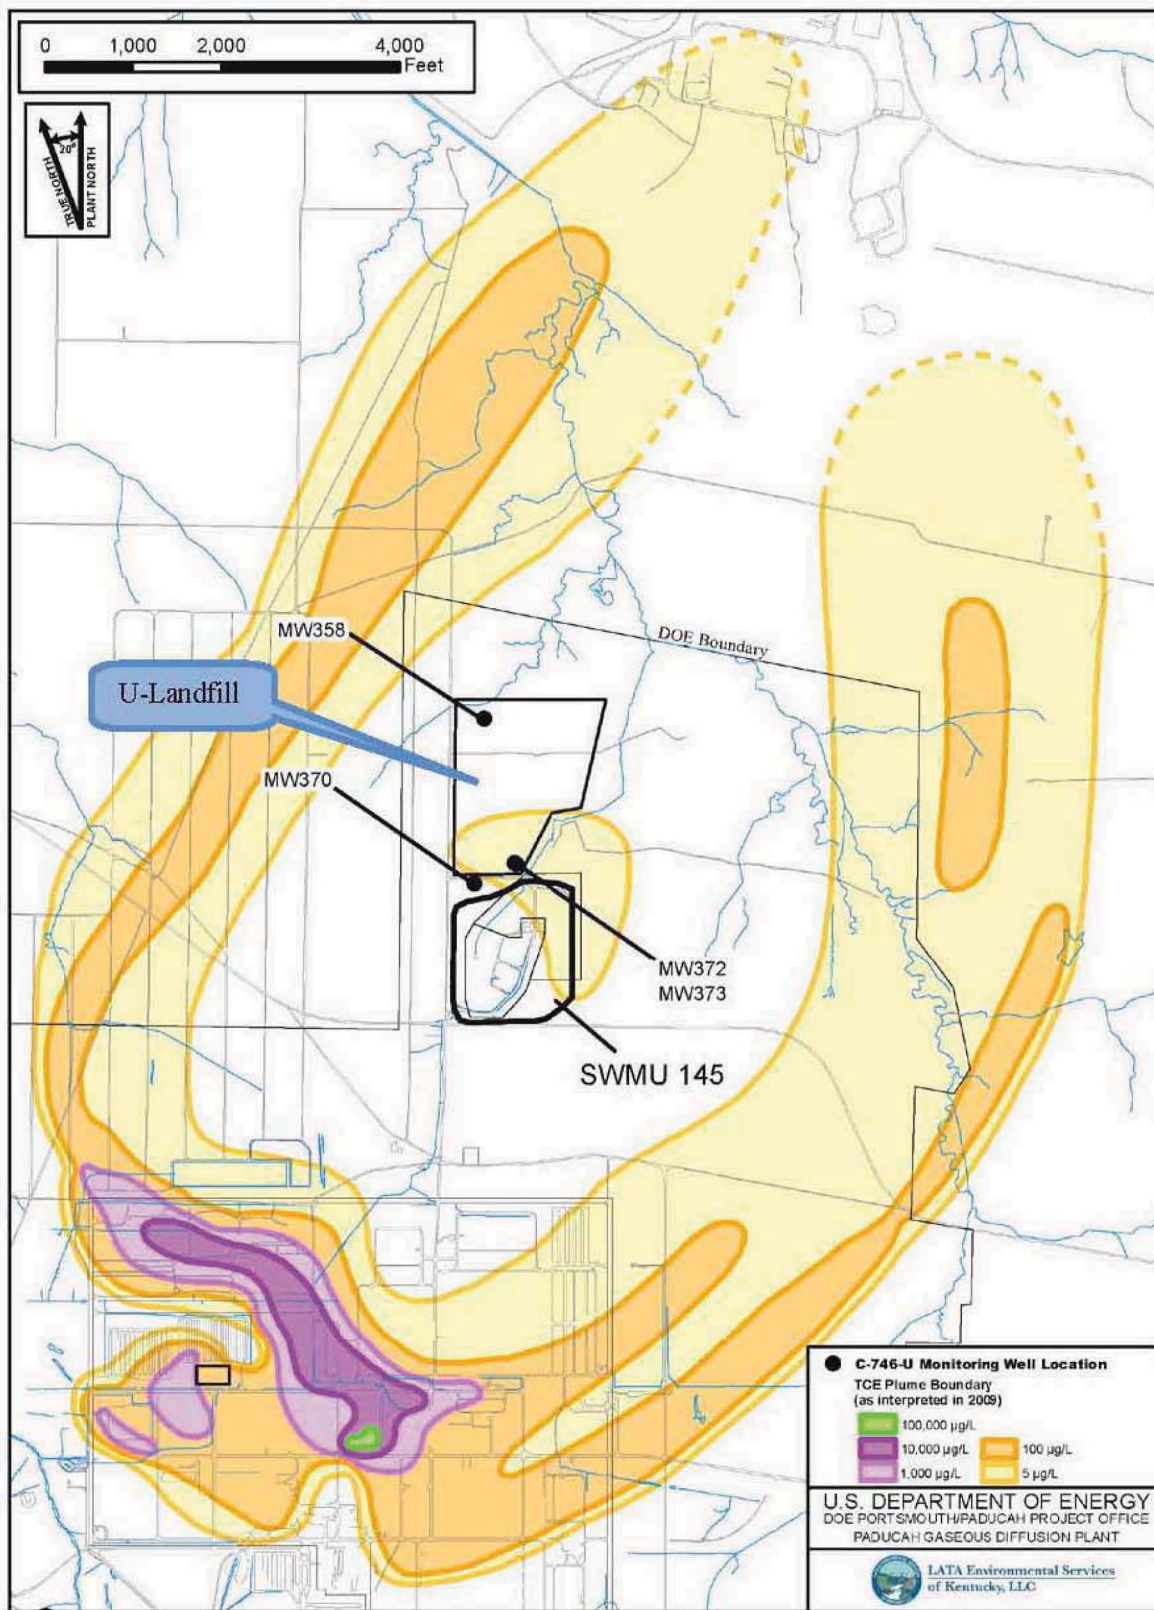
Figure 1. Location of the U-Landfill Depicted Relative to 2009 RGA TCE Plume Map

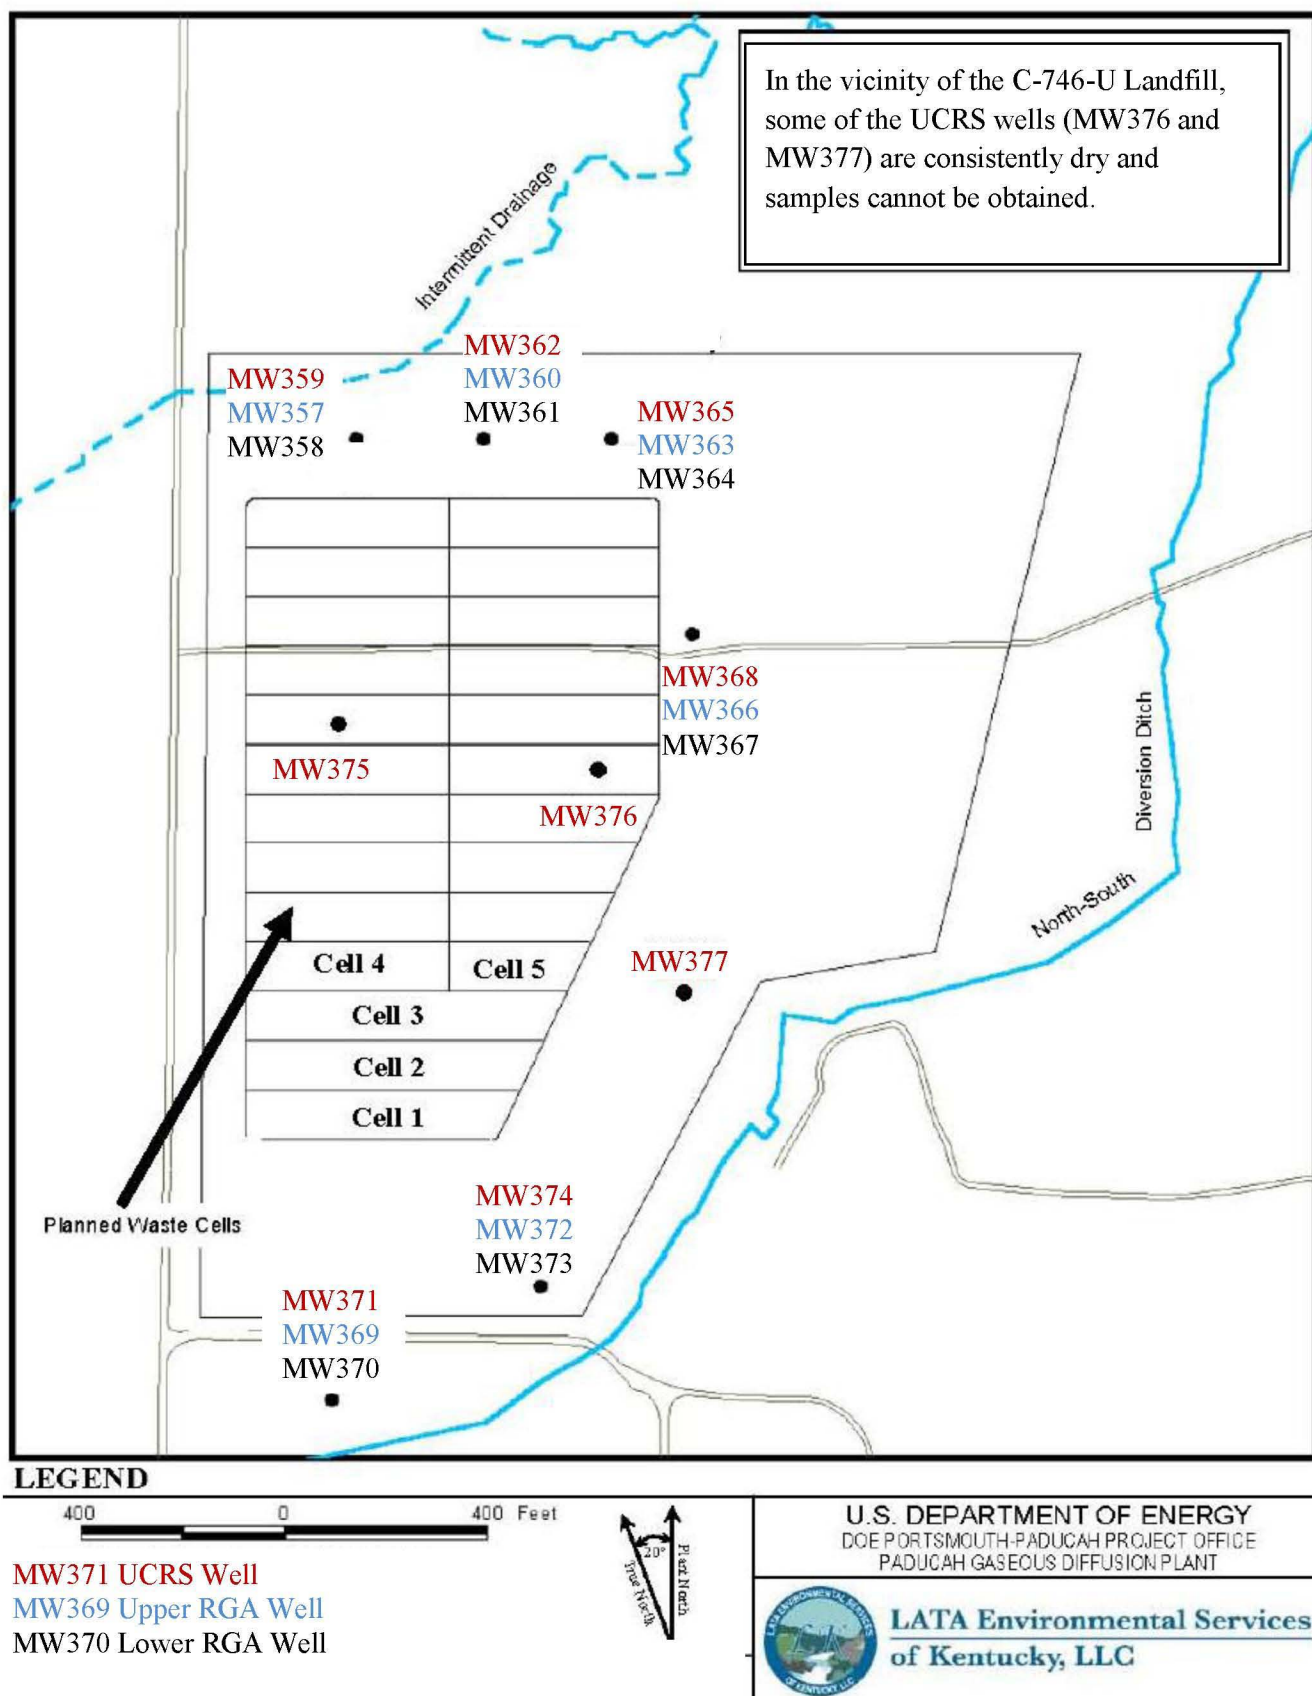
Figure 2 is a map of the C-746-U Landfill and the MWs located in the vicinity of the C-746-U Landfill. Soil boring logs, MW and piezometer water level records, soil geotechnical tests, and groundwater flow models of the area of the C-746-U Landfill provide sufficient data for the development of a Conceptual Site Model (CSM), described in Section 5. In general, groundwater flow is downward through the silts, clays, and fine sands of the Upper Continental Recharge System (UCRS). In contrast, the underlying Regional Gravel Aquifer (RGA) is conductive and provides the main conduit for lateral groundwater flow. Groundwater flow is in a north-northeasterly direction in the vicinity of the C-746-U Landfill. The Ohio River and lower reaches of Little Bayou and Bayou Creeks are the discharge areas for the RGA flow system.

Figure 2. C-746U Landfill and Wells Located in the Vicinity

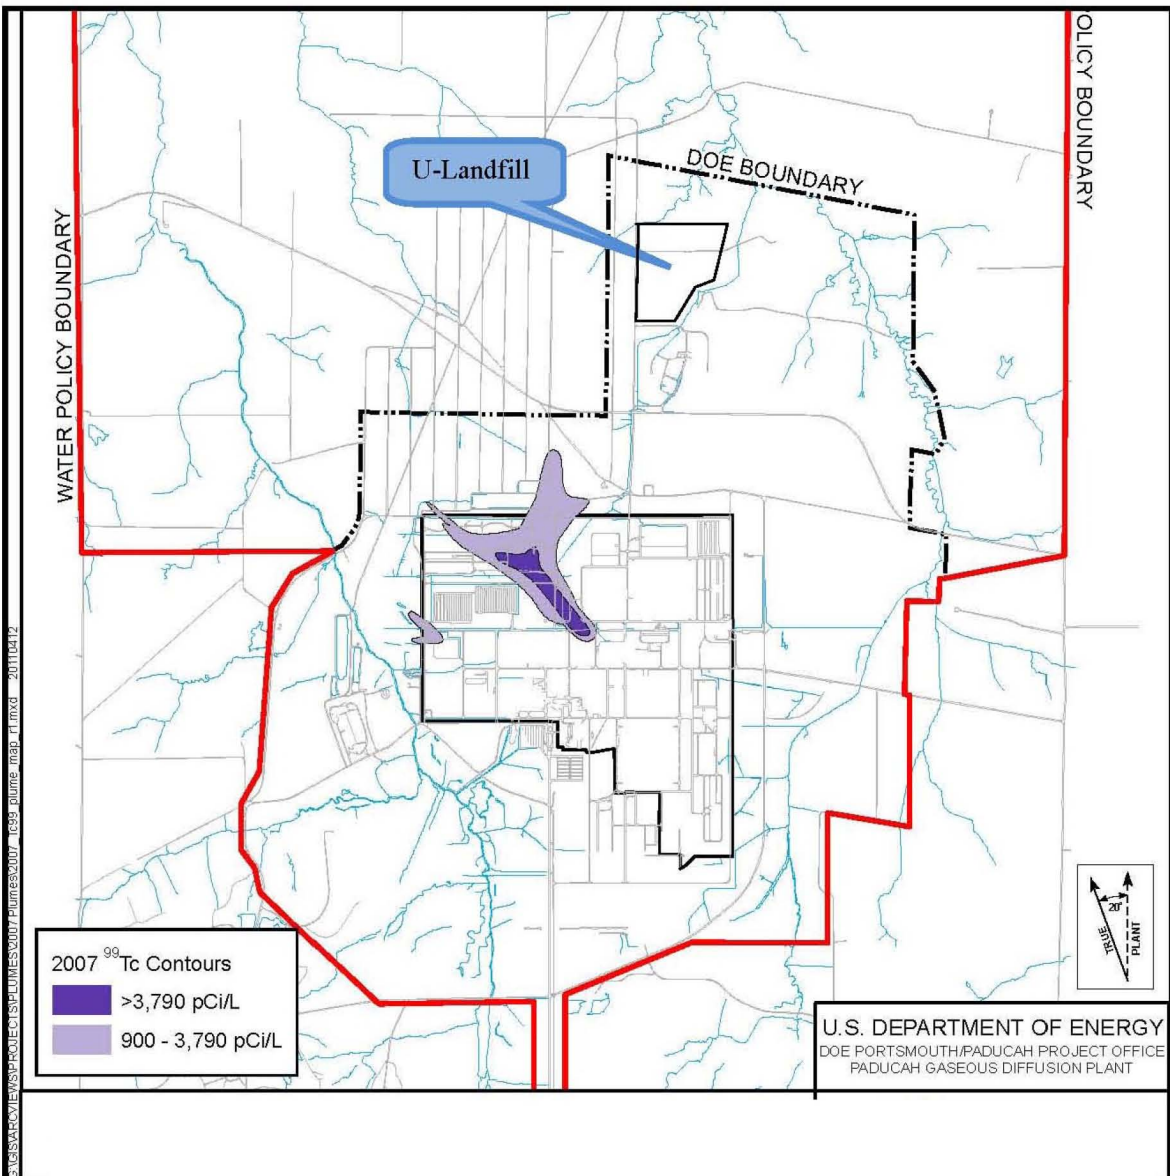
Tc-99 is a beta emitter. There is Tc-99 present in RGA groundwater at the PGDP site, as shown in Figure 3 (plume map established relative to the derived EPA MCL of 900 pCi/L). NOTE: Figure 3 also demonstrates that the C-746-U Landfill is located well within the boundaries of the Water Policy Box.

**Figure 3. Location of C-746-U Landfill Relative to 2009 Tc-99 RGA Plume Map and Water Policy Boundary**

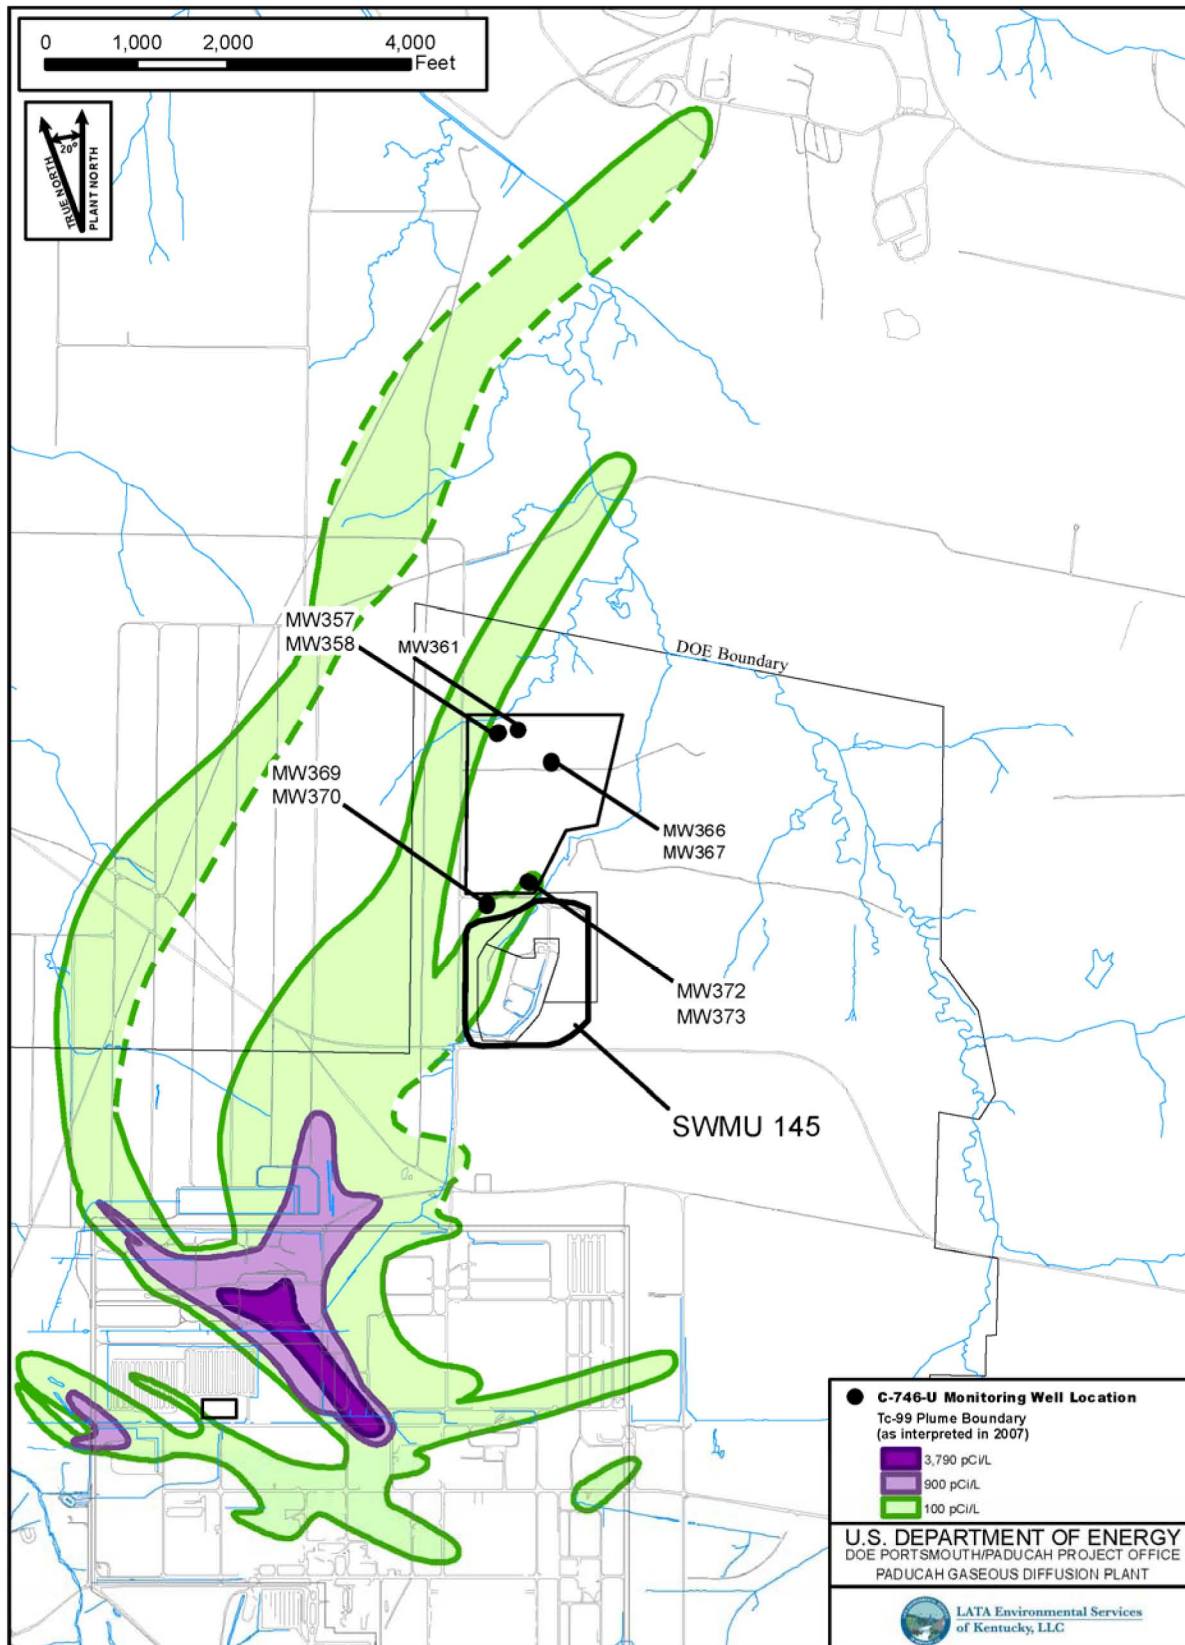
FIGURE No. C746U/20110628\_746U\_Tc99\_R1.mxd  
DATE 06-28-2011

Because Tc-99 can contribute to beta activity and also is measured in pCi/L, Figure 4 shows the Tc-99 plume contours to 100 pCi/L.

Figure 4. Technetium-99 Contours for the RGA

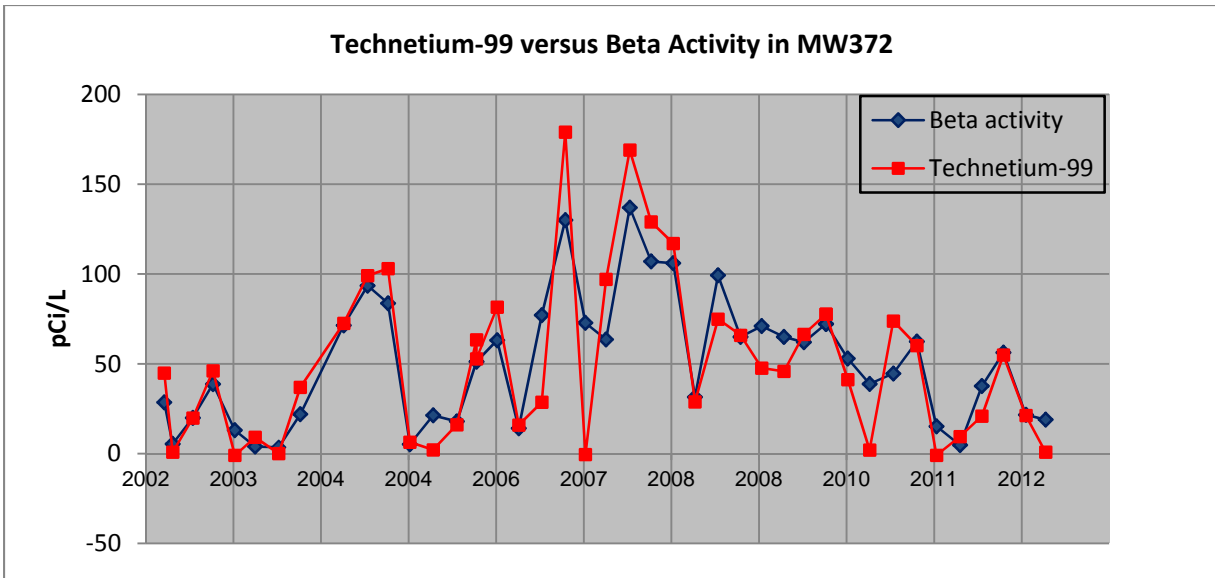
**Figure 5. Technetium-99 versus Beta Activity in MW372 at the C-746-U Landfill**

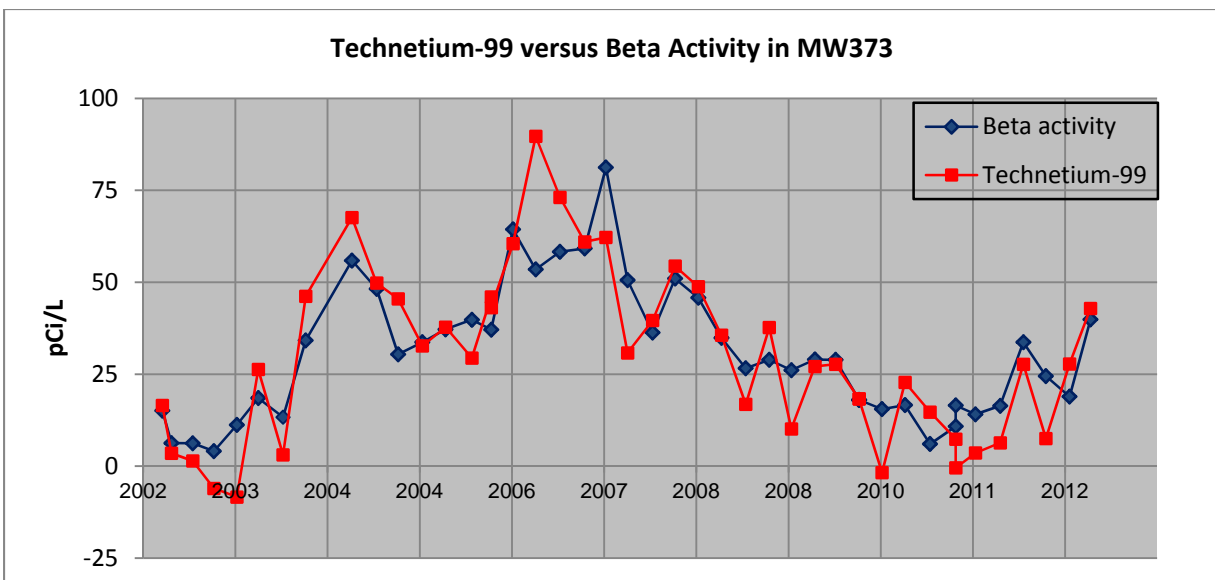
**Figure 6. Technetium-99 versus Beta Activity in MW373 at the C-746-U Landfill**

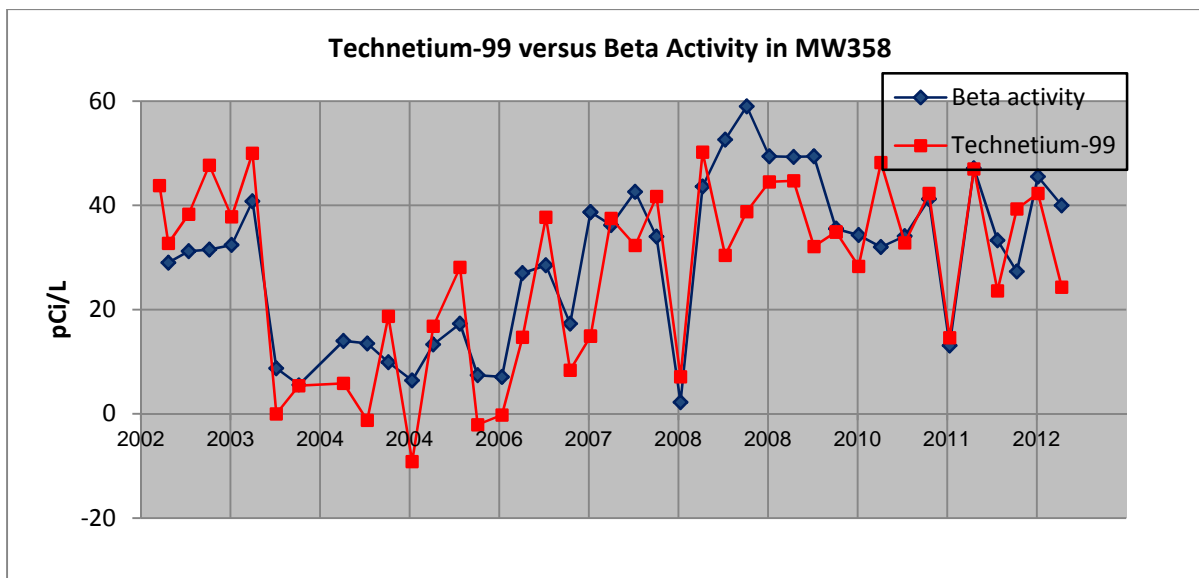
**Figure 7. Technetium-99 versus Beta Activity in MW358 at the C-746-U Landfill**

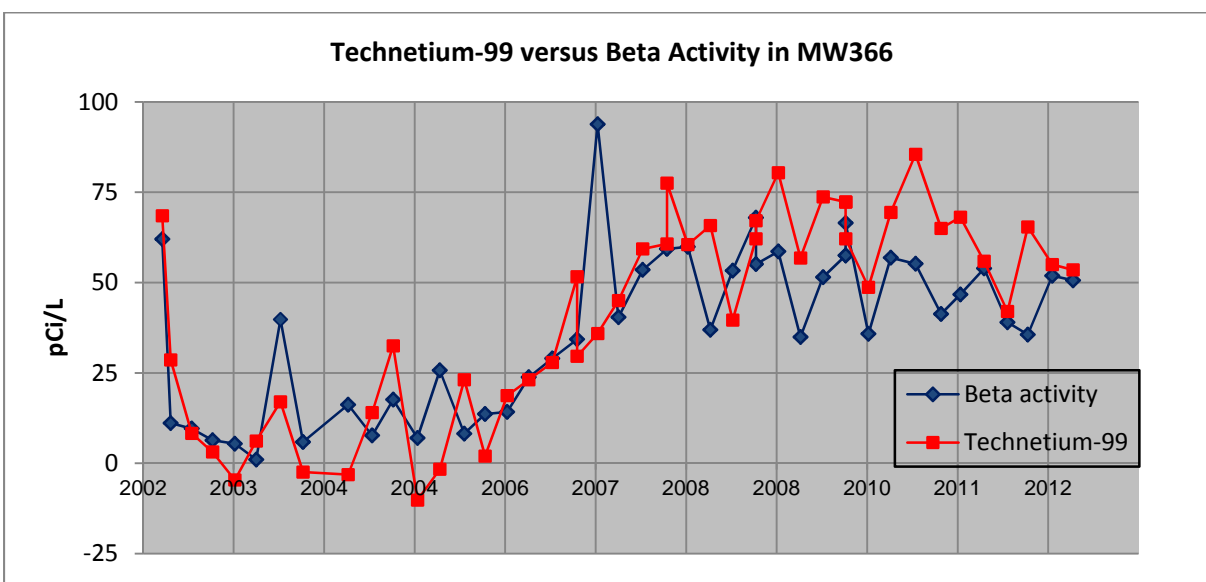
**Figure 8. Technetium-99 versus Beta Activity in MW366 at the C-746-U Landfill**

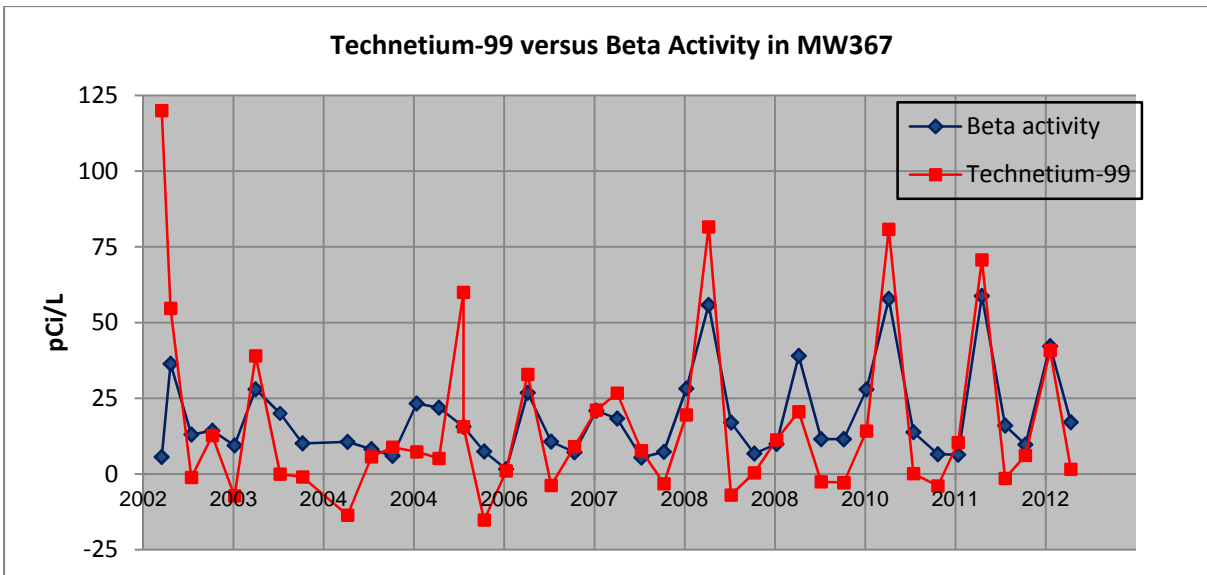
**Figure 9. Technetium-99 versus Beta Activity in MW367 at the C-746-U Landfill**

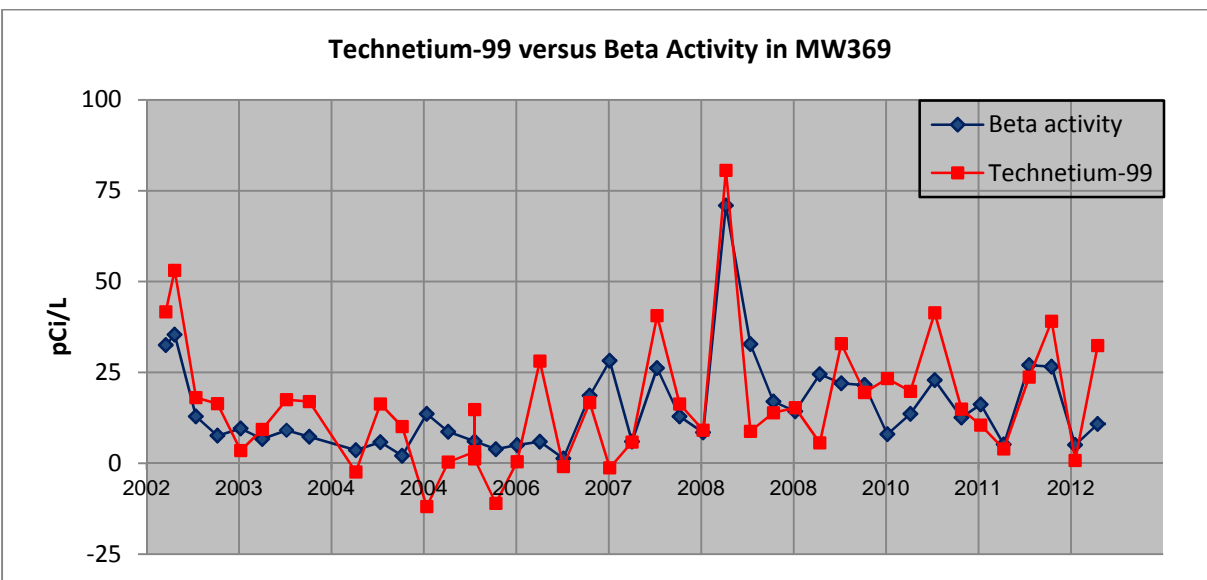
**Figure 10. Technetium-99 versus Beta Activity in MW369 at the C-746-U Landfill**

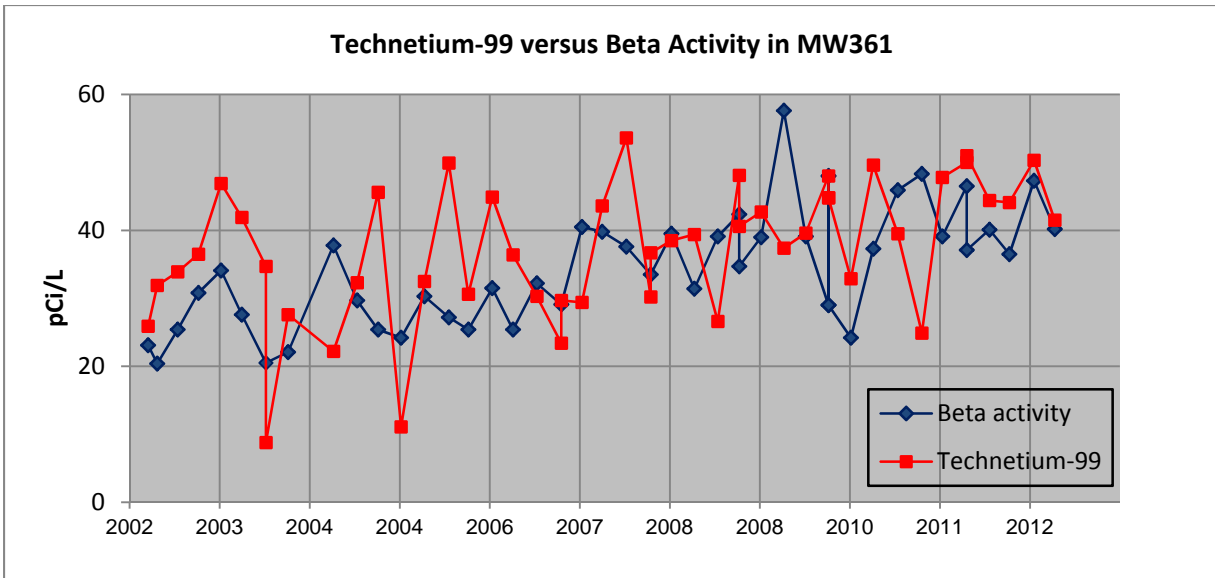
**Figure 11. Technetium-99 versus Beta Activity in MW361 at the C-746-U Landfill**

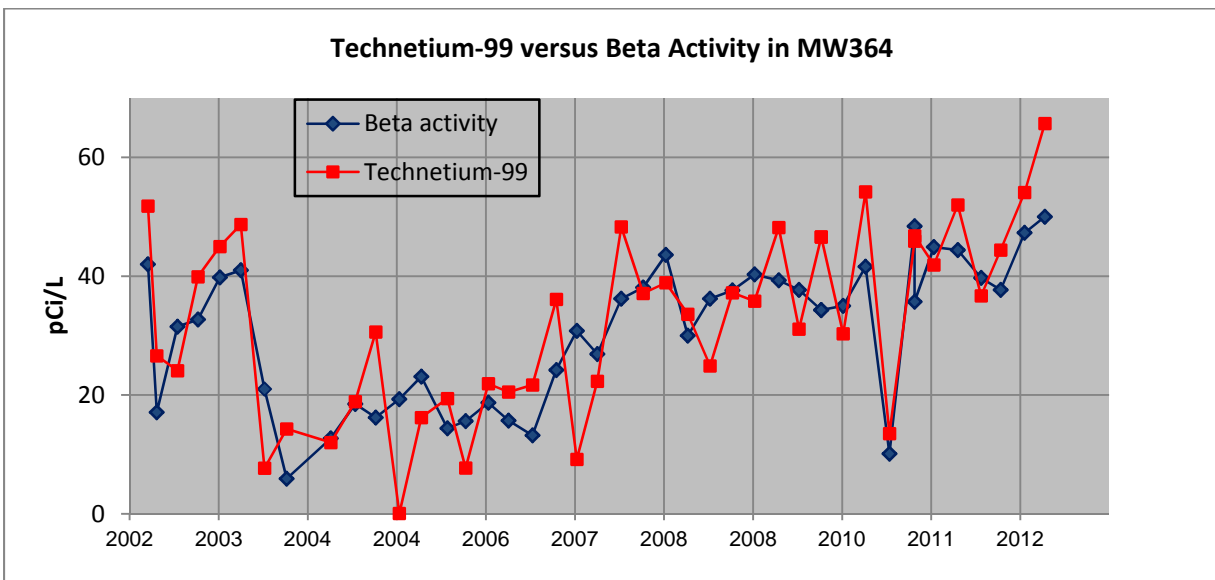
**Figure 12. Technetium-99 versus Beta Activity in MW364 at the C-746-U Landfill**

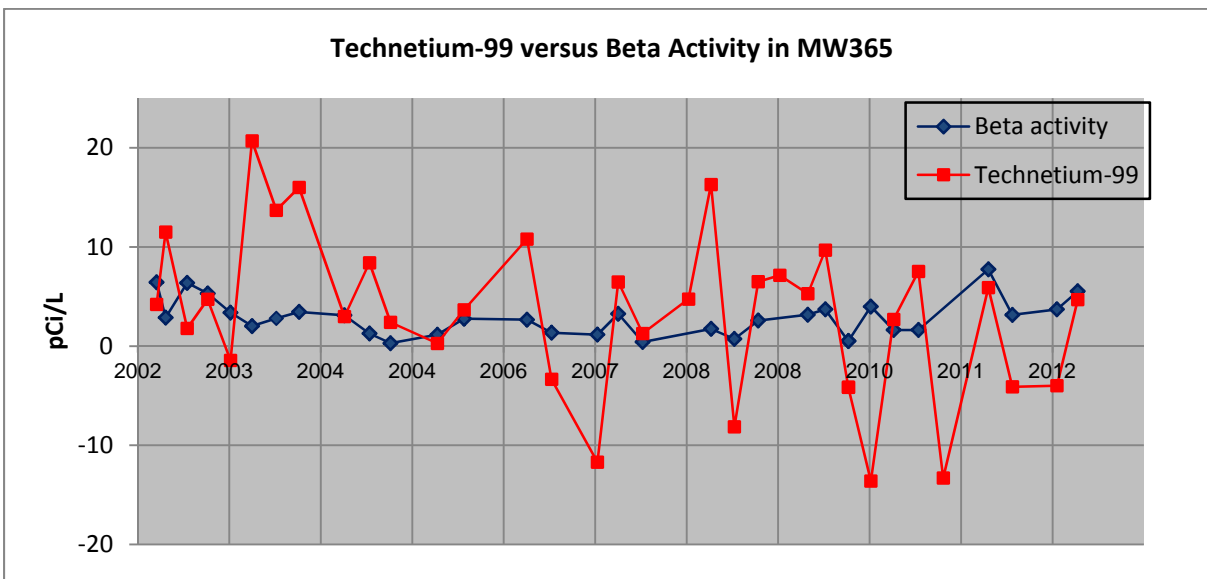
**Figure 13. Technetium-99 versus Beta Activity in MW365 at the C-746-U Landfill**

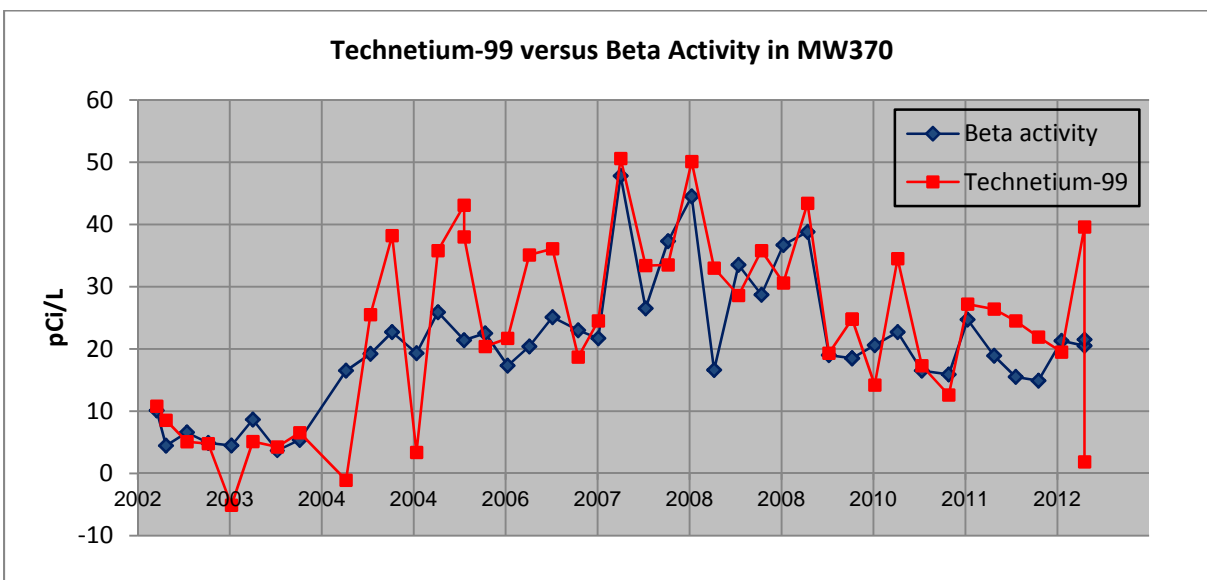
**Figure 14. Technetium-99 versus Beta Activity in MW370 at the C-746-U Landfill**

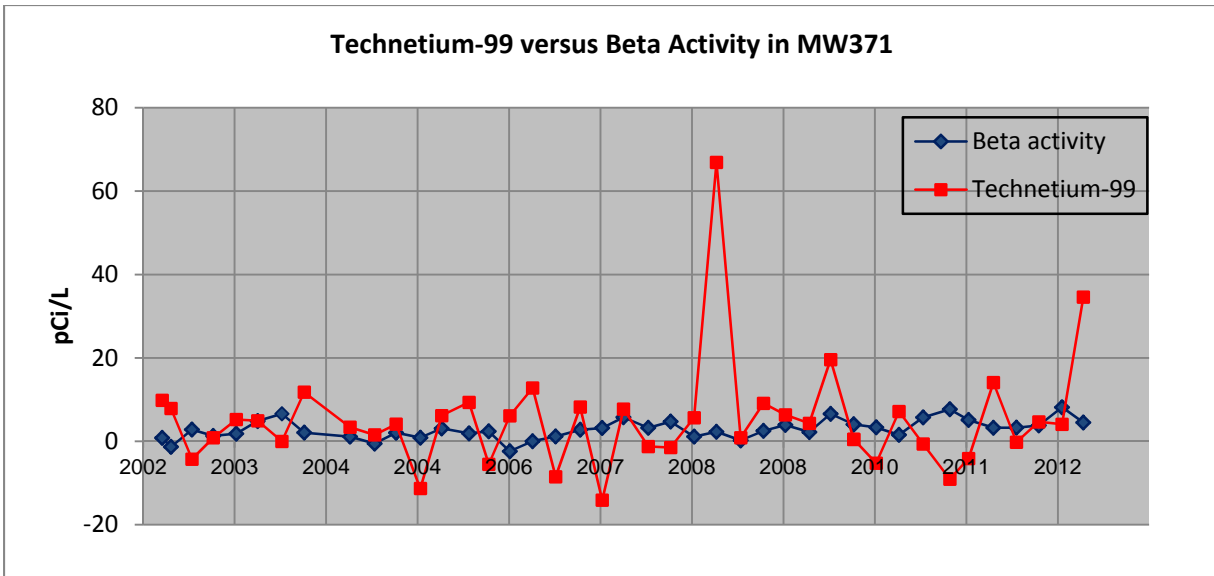
**Figure 15. Technetium-99 versus Beta Activity in MW371 at the C-746-U Landfill**

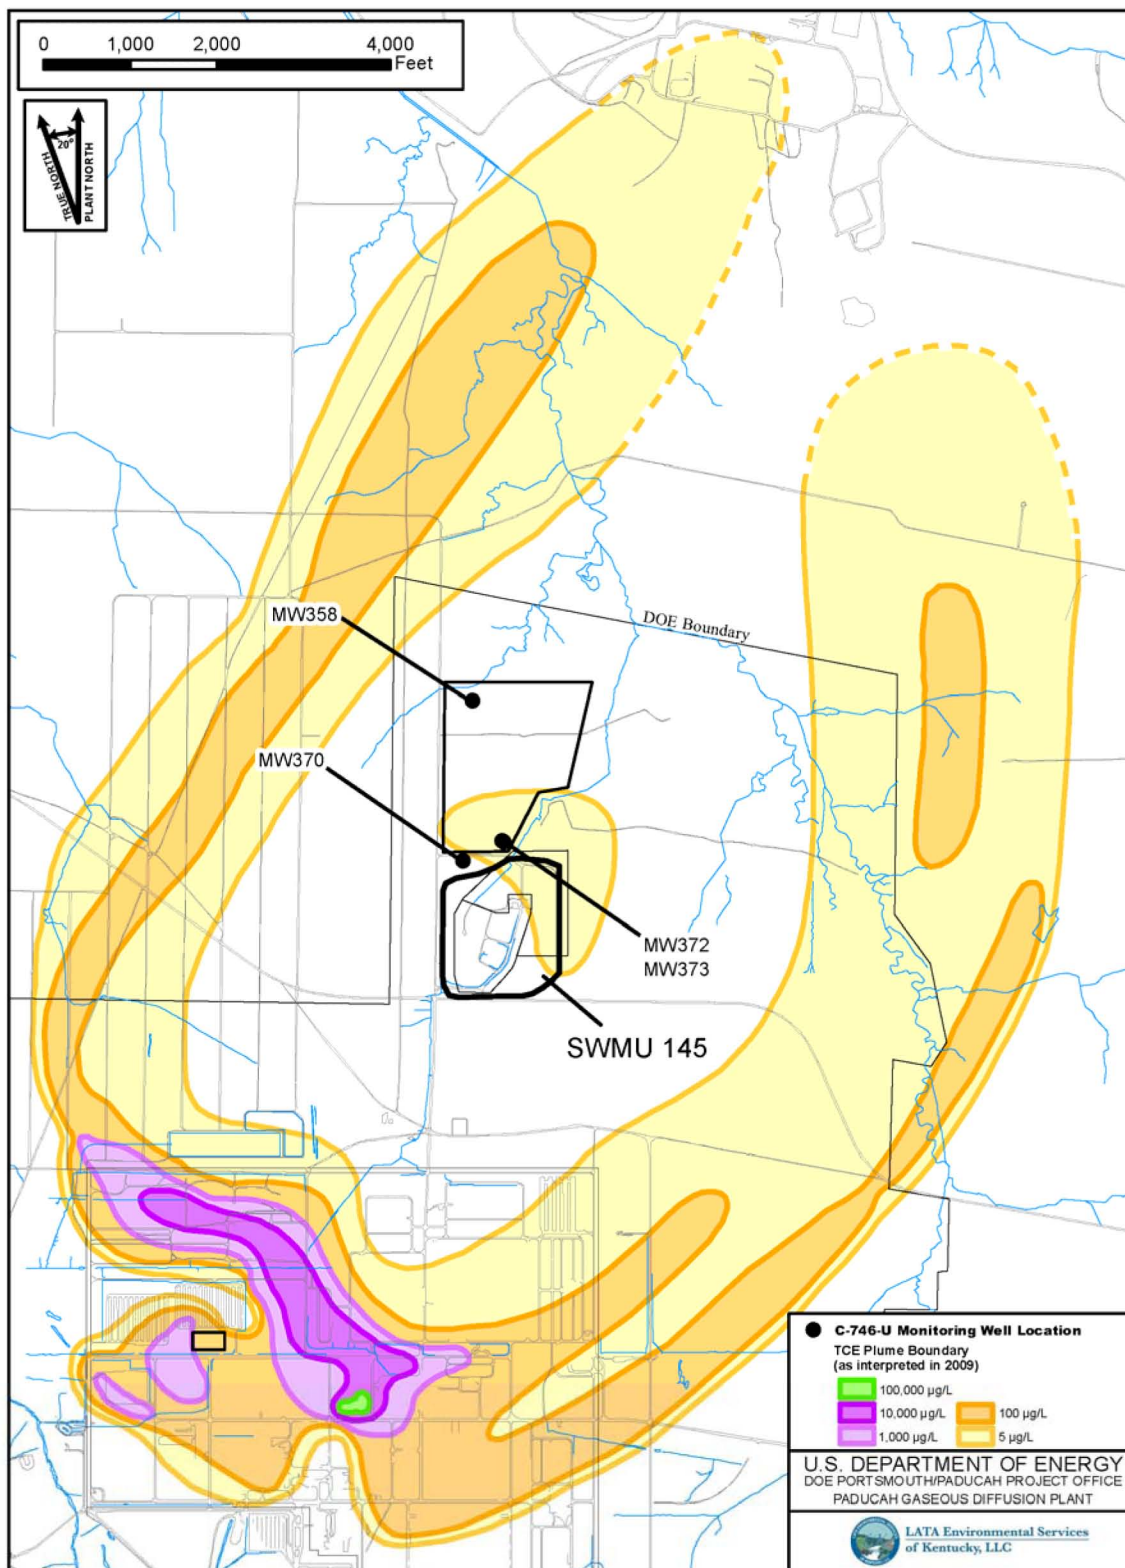
Figure 16. Composite Trichloroethene Contours for the RGA for Calendar Year 2009

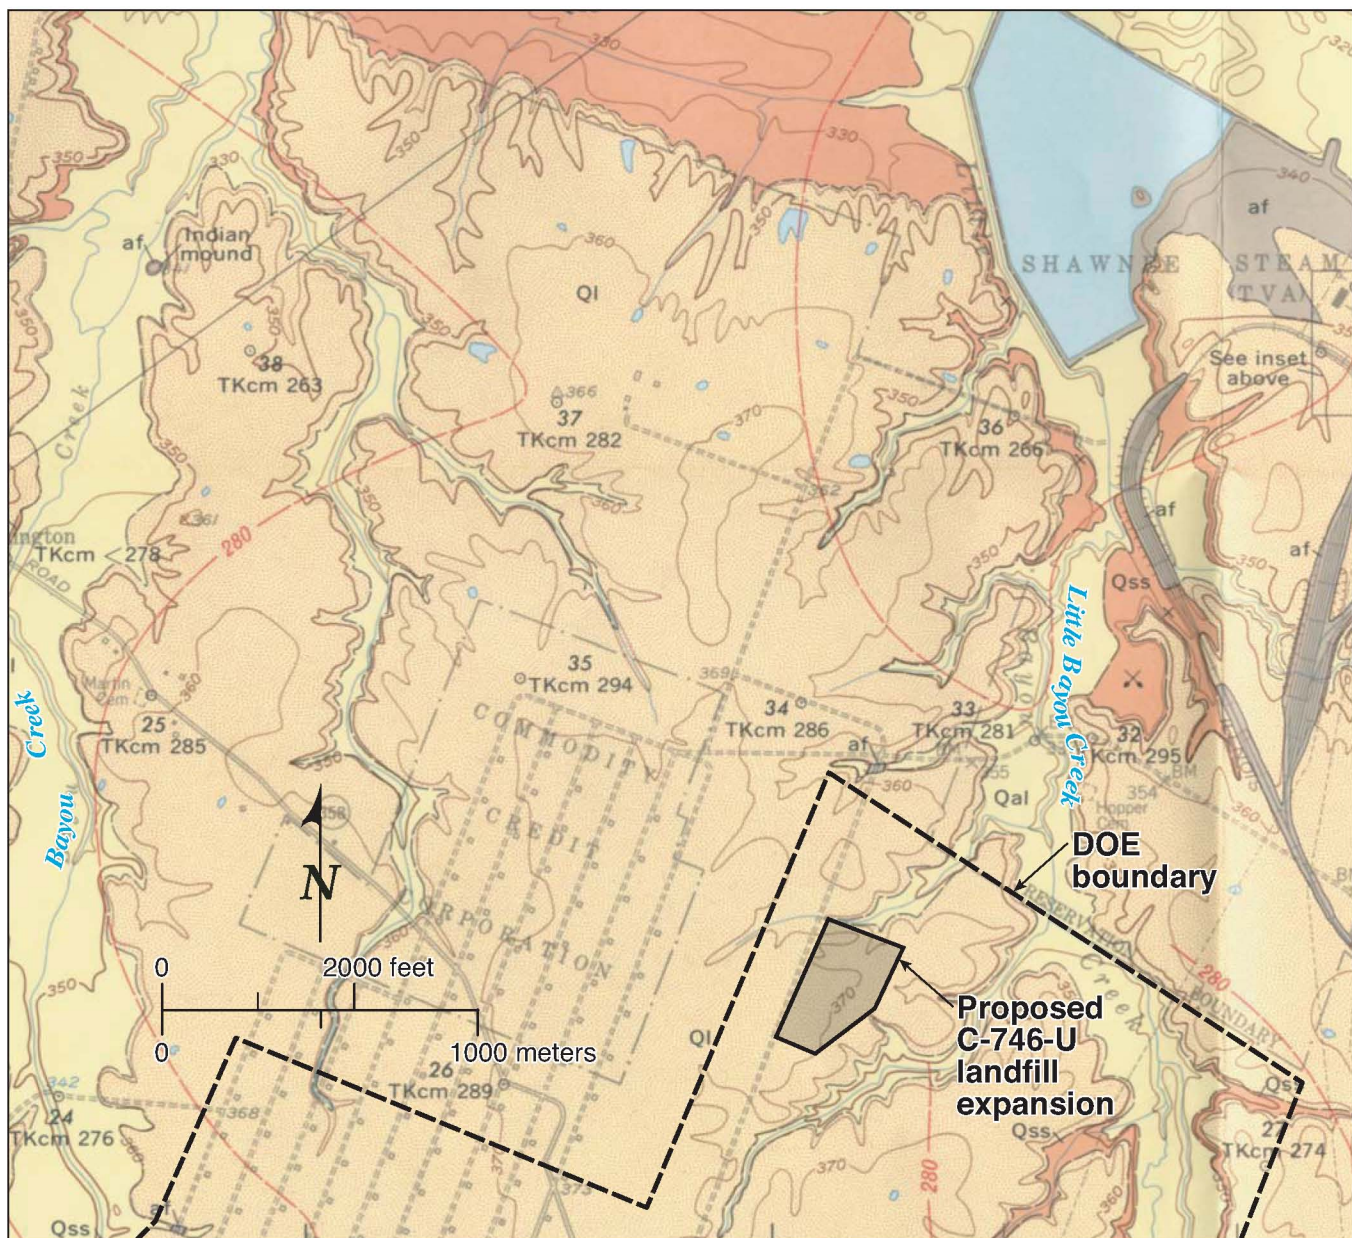
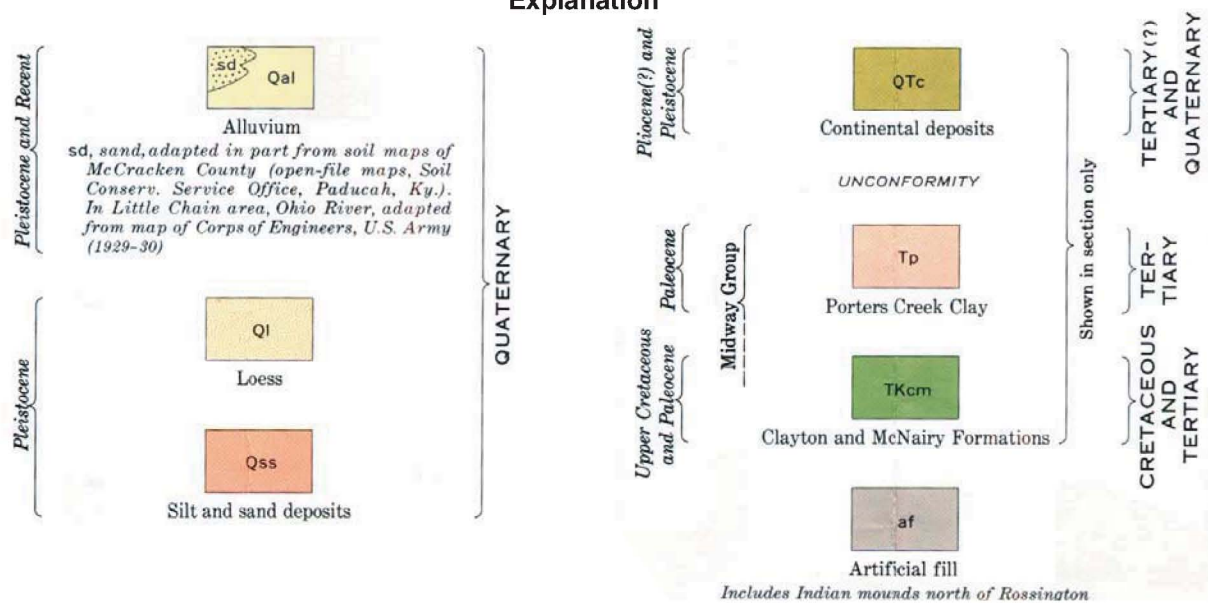
Figure 18. Regional Geologic Map (Modified from Finch 1967)

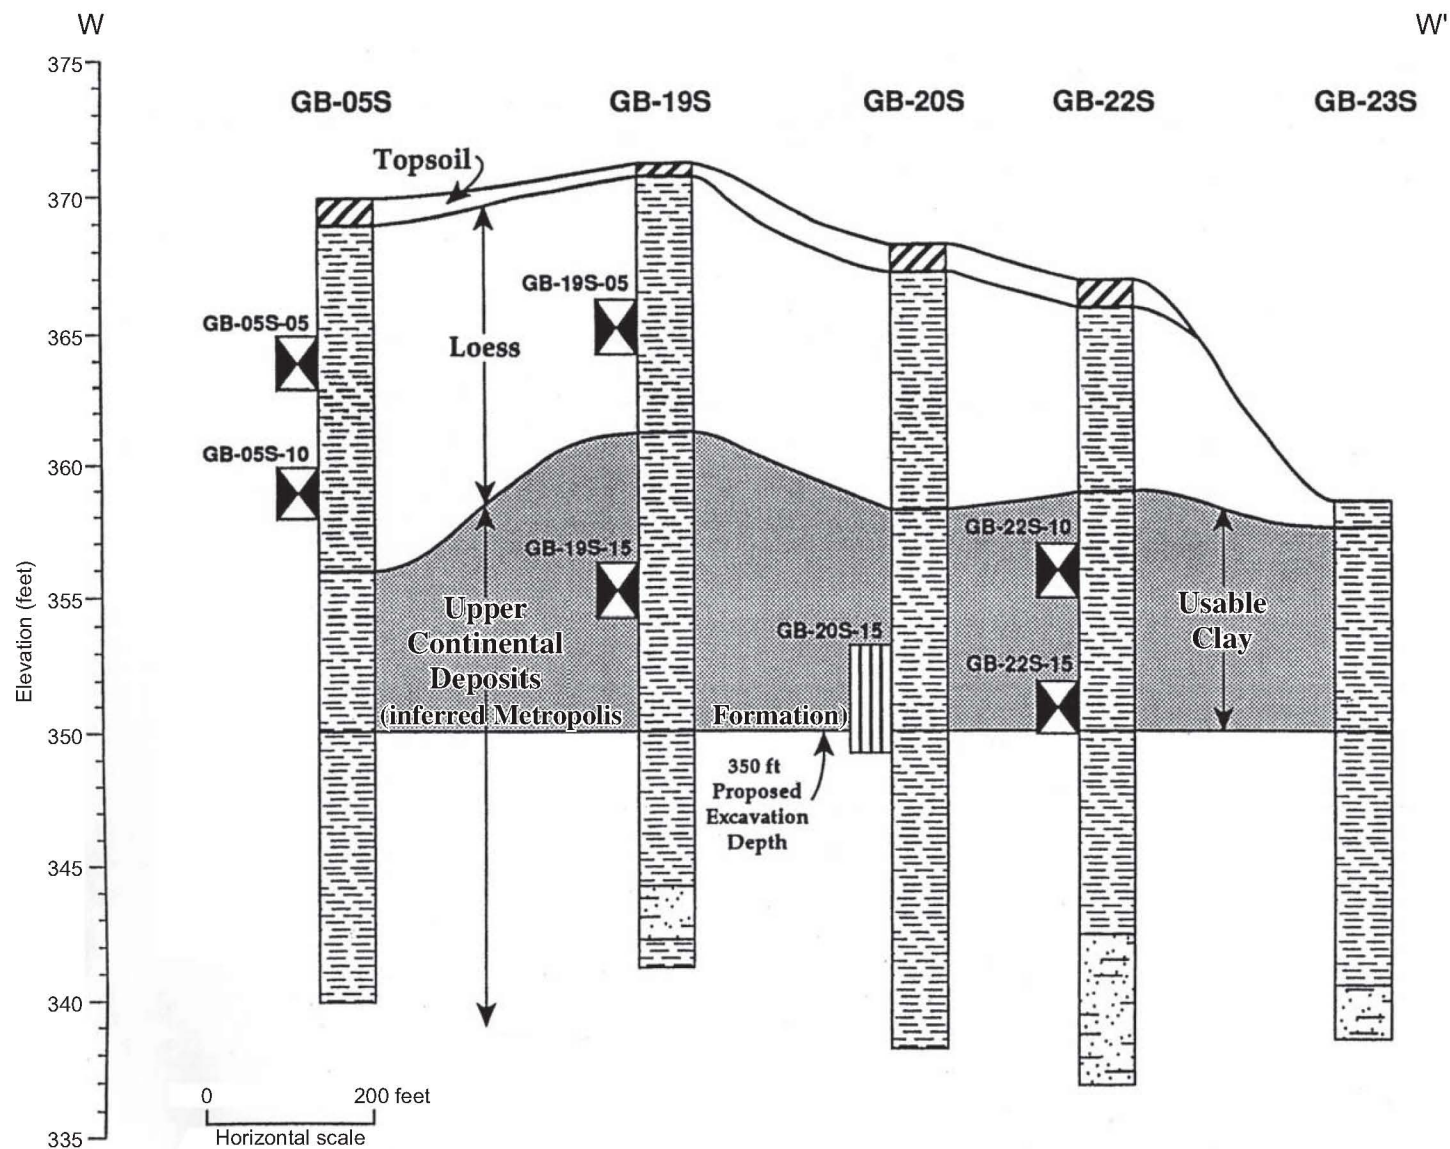
Figure 20. Geologic Section Depicting Generalized Stratigraphy Underlying C-764-U Landfill (from SAIC 1994)
