**Groundwater Assessment Report  
for the C-746-U Landfill at the  
Paducah Gaseous Diffusion Plant,  
Paducah, Kentucky**

Date Issued—May 2013

Prepared for the  
U.S. DEPARTMENT OF ENERGY  
Office of Environmental Management

Prepared by  
LATA ENVIRONMENTAL SERVICES OF KENTUCKY, LLC  
managing the  
Environmental Remediation Activities at the  
Paducah Gaseous Diffusion Plant  
under contract DE-AC30-10CC40020

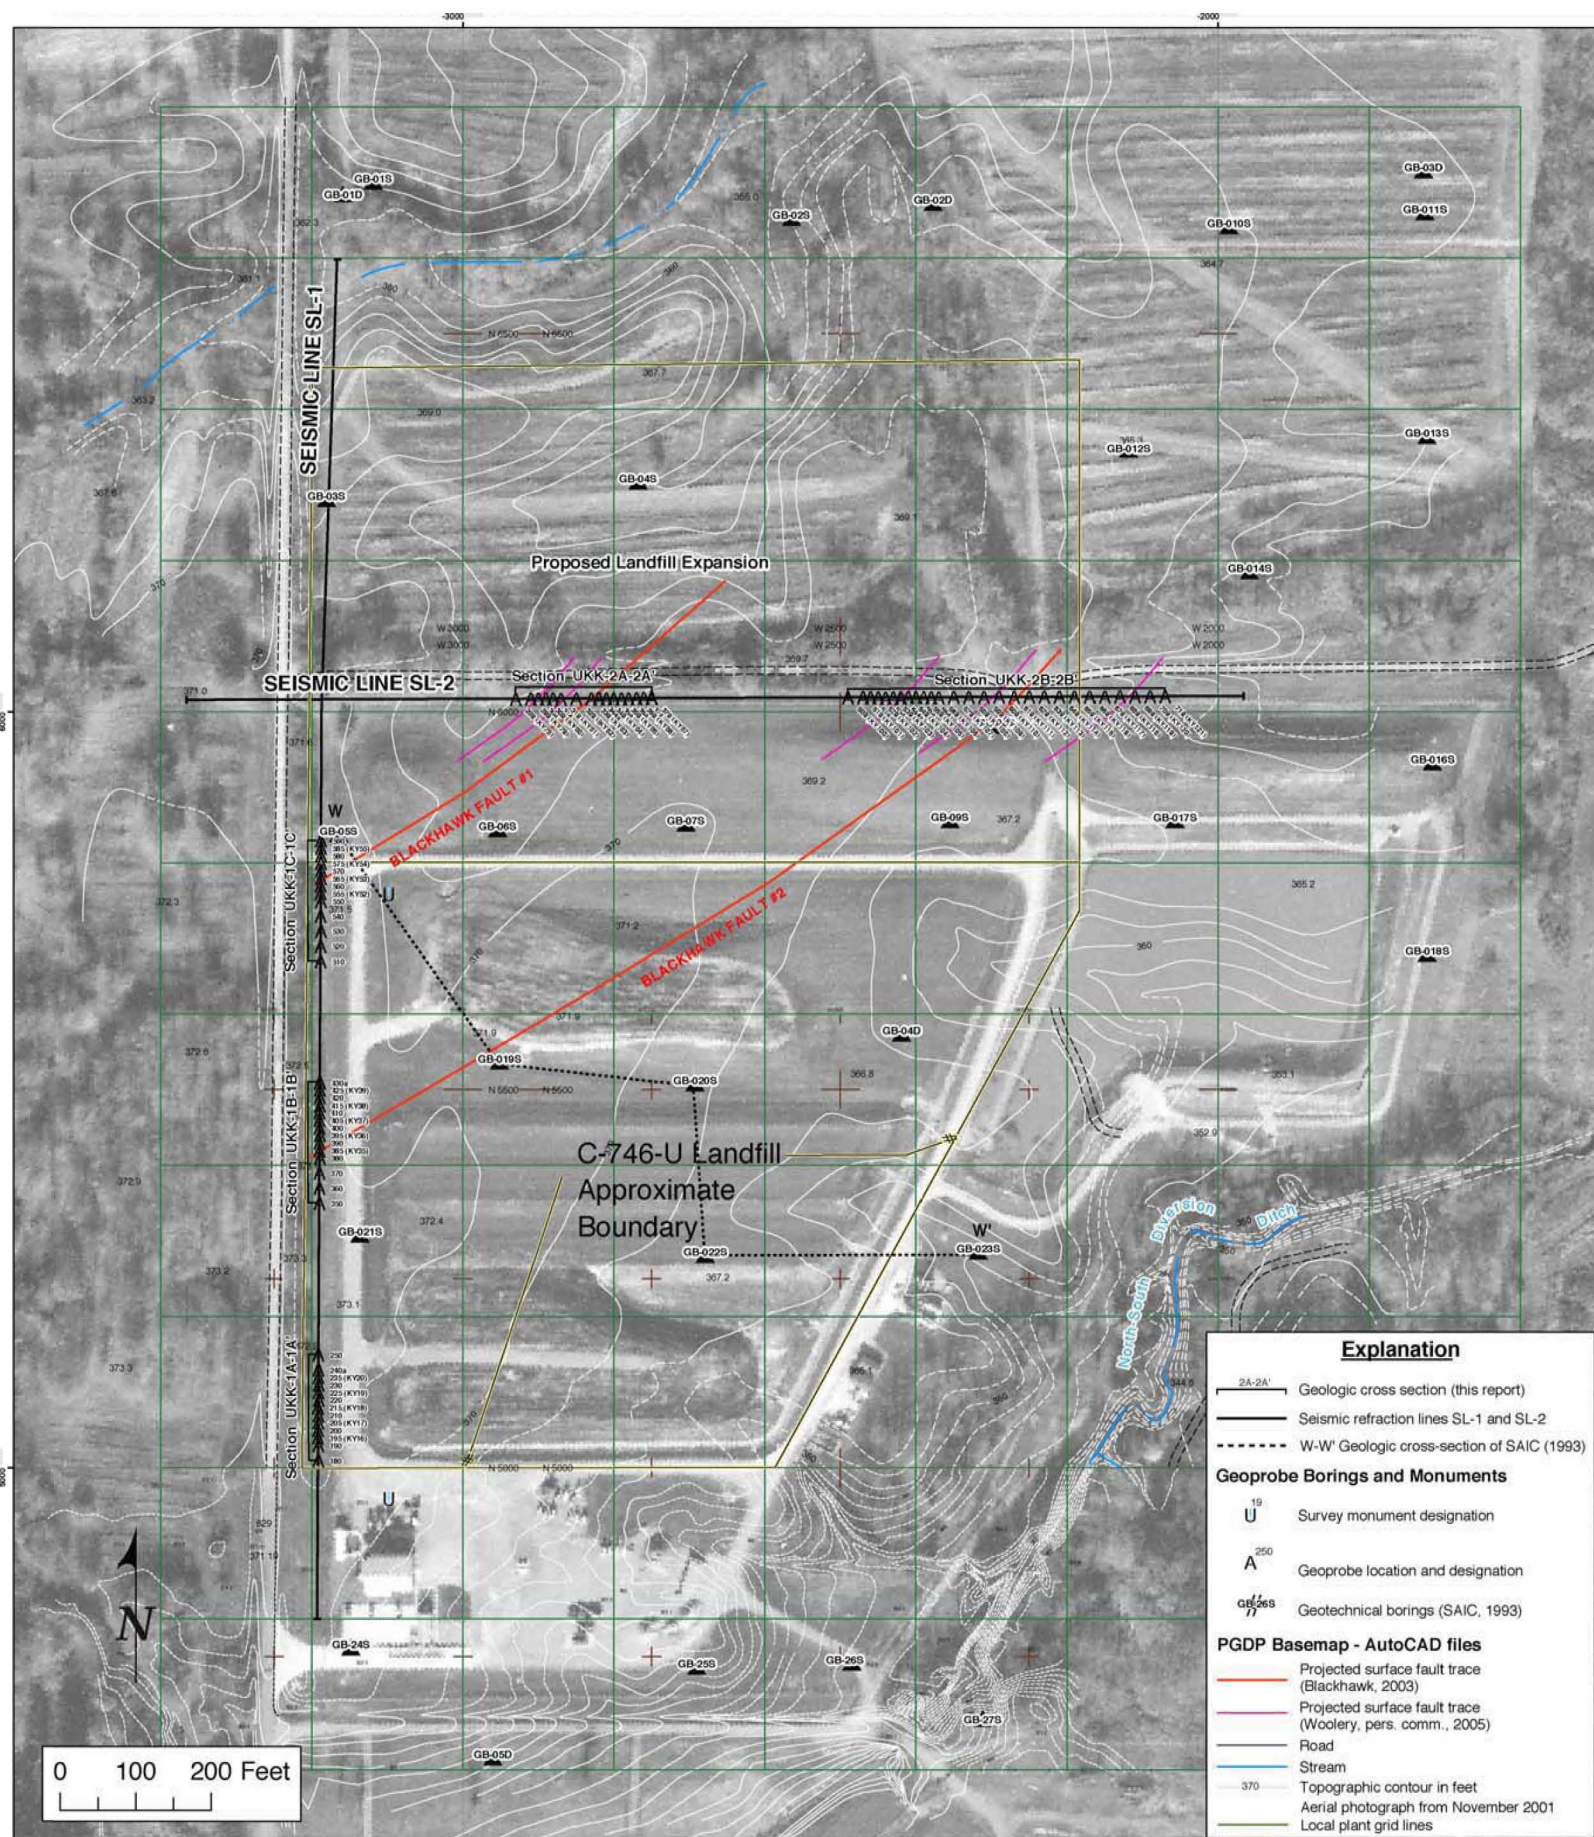
Figure 21. Topographic Map of the Paducah Gaseous Diffusion Plant C-746-U Landfill Expansion

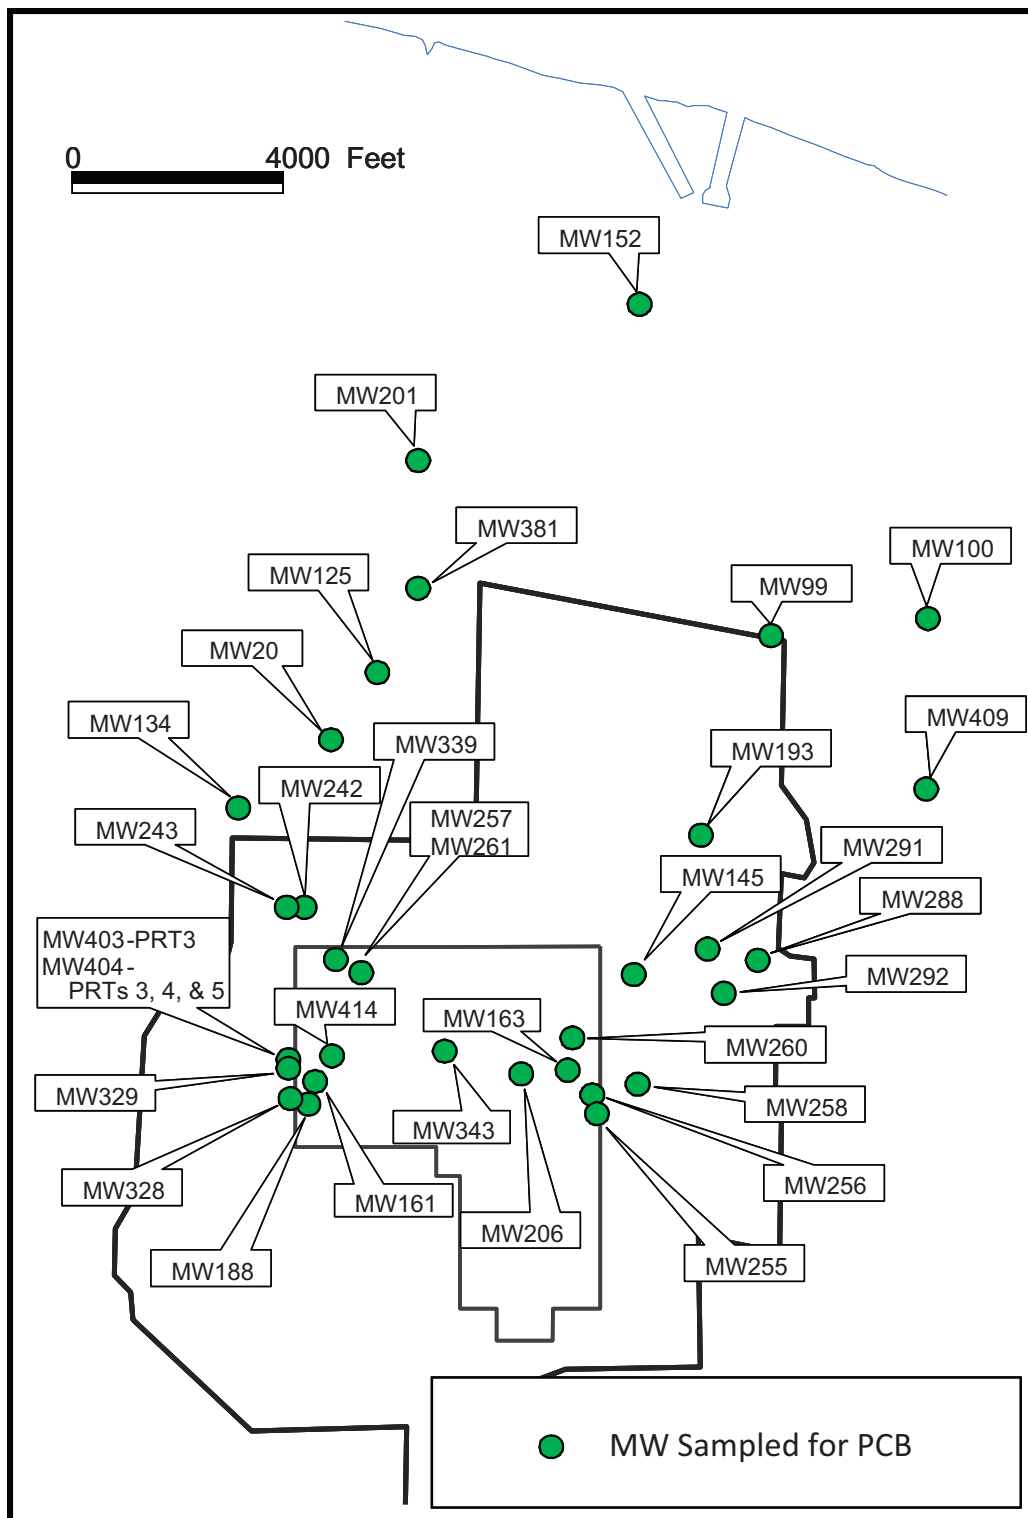
**Figure 22. Location of RGA Wells with PCB Analyses to the C-746-S&T and C-746-U Landfill Wells**

- Figure 22 and Table 9 shows that PCBs have not been an issue in other RGA wells at PGDP. This is consistent with the fact that PCBs are not soluble in water; thus, though PCBs were historically used at PGDP, they are not found in RGA groundwater at locations across the site.

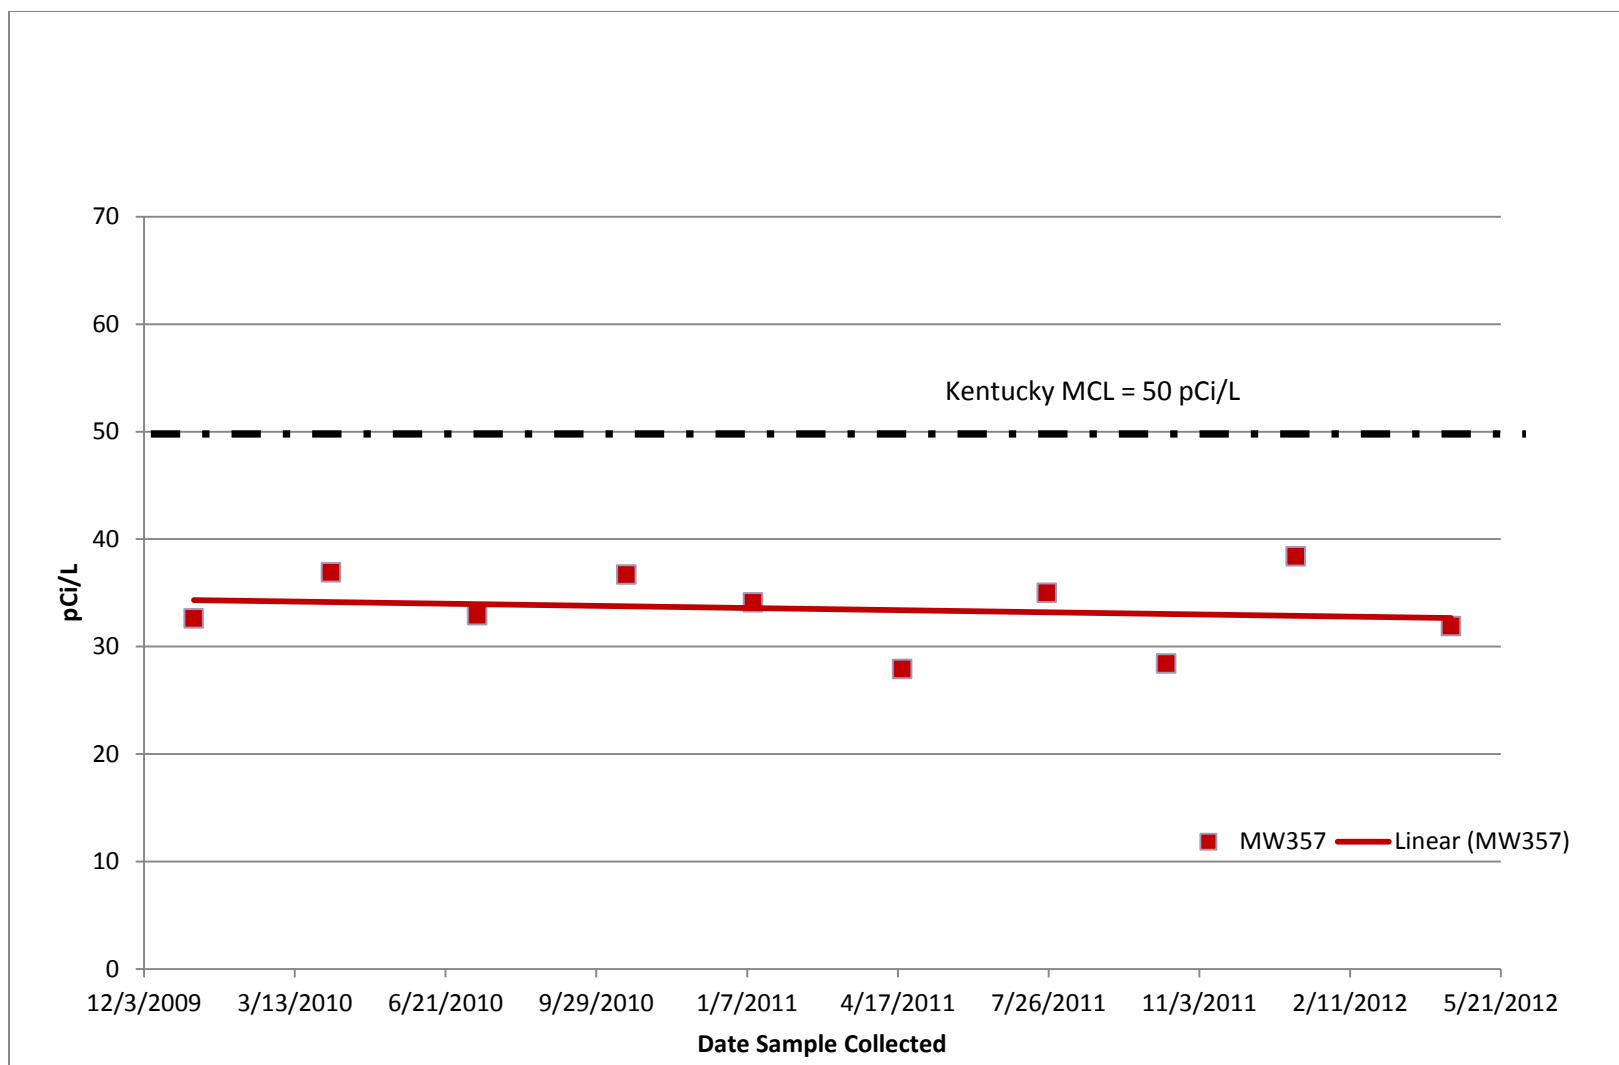
Figure B.3. MW357 Beta Activity since 2010

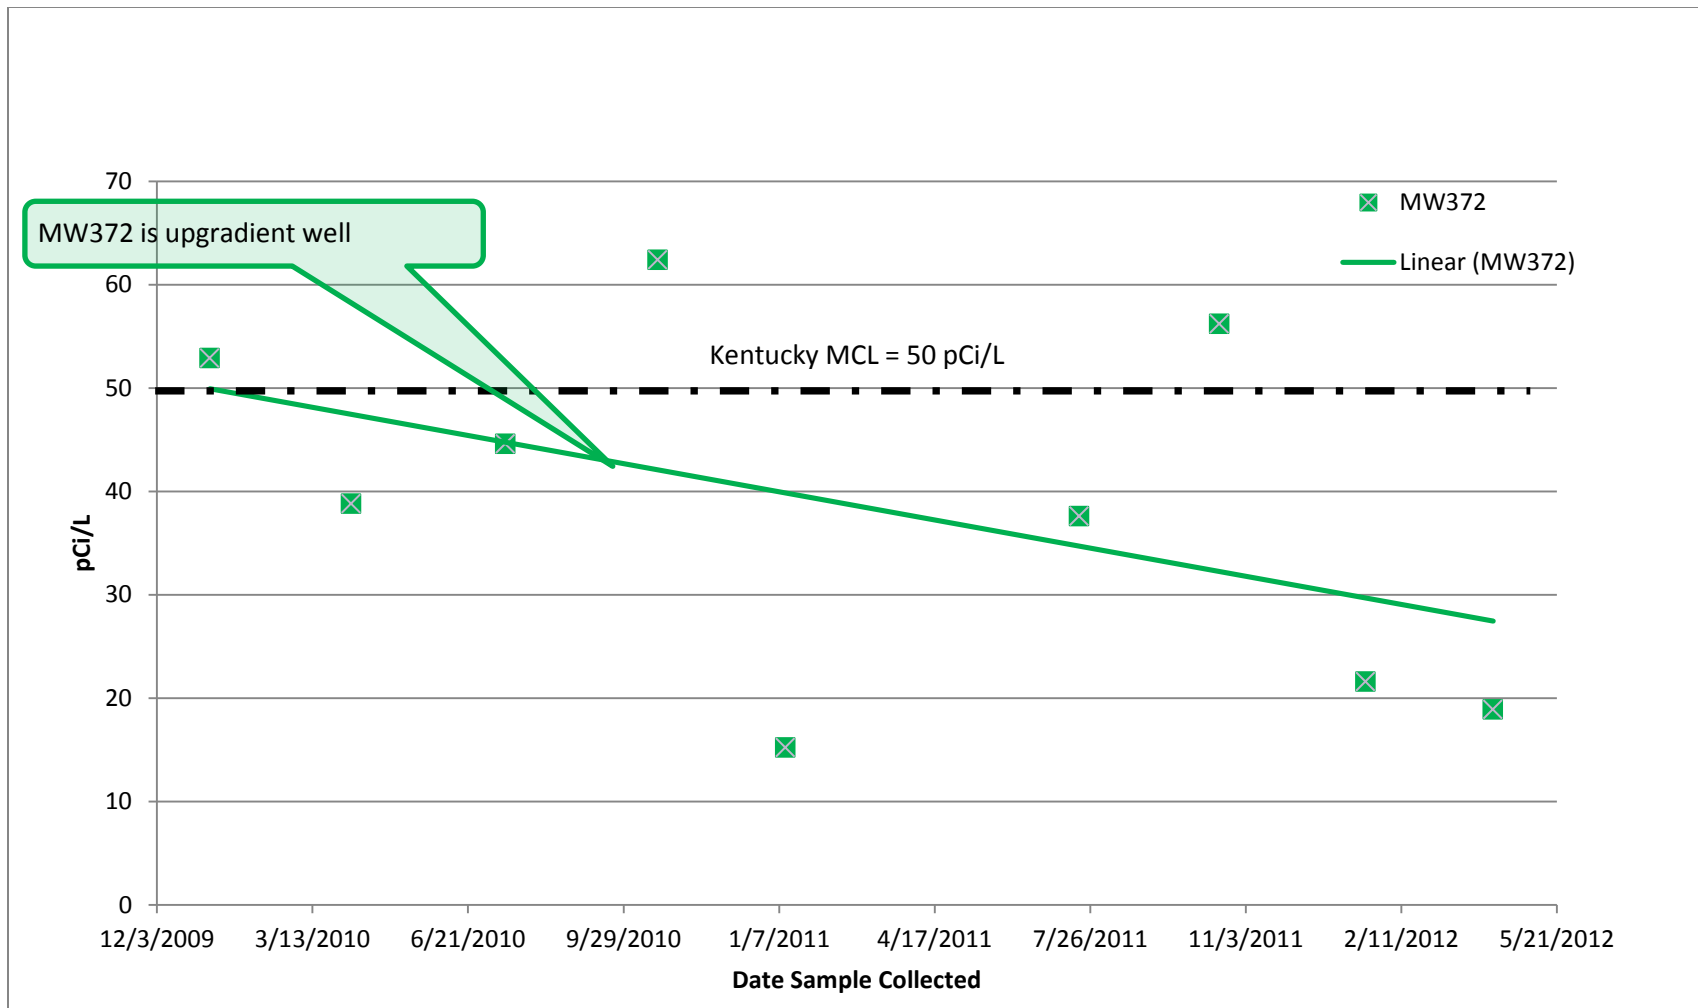
**Figure B.4. Beta Activity since 2010 Upgradient Well Exceeds 50 pCi/L**

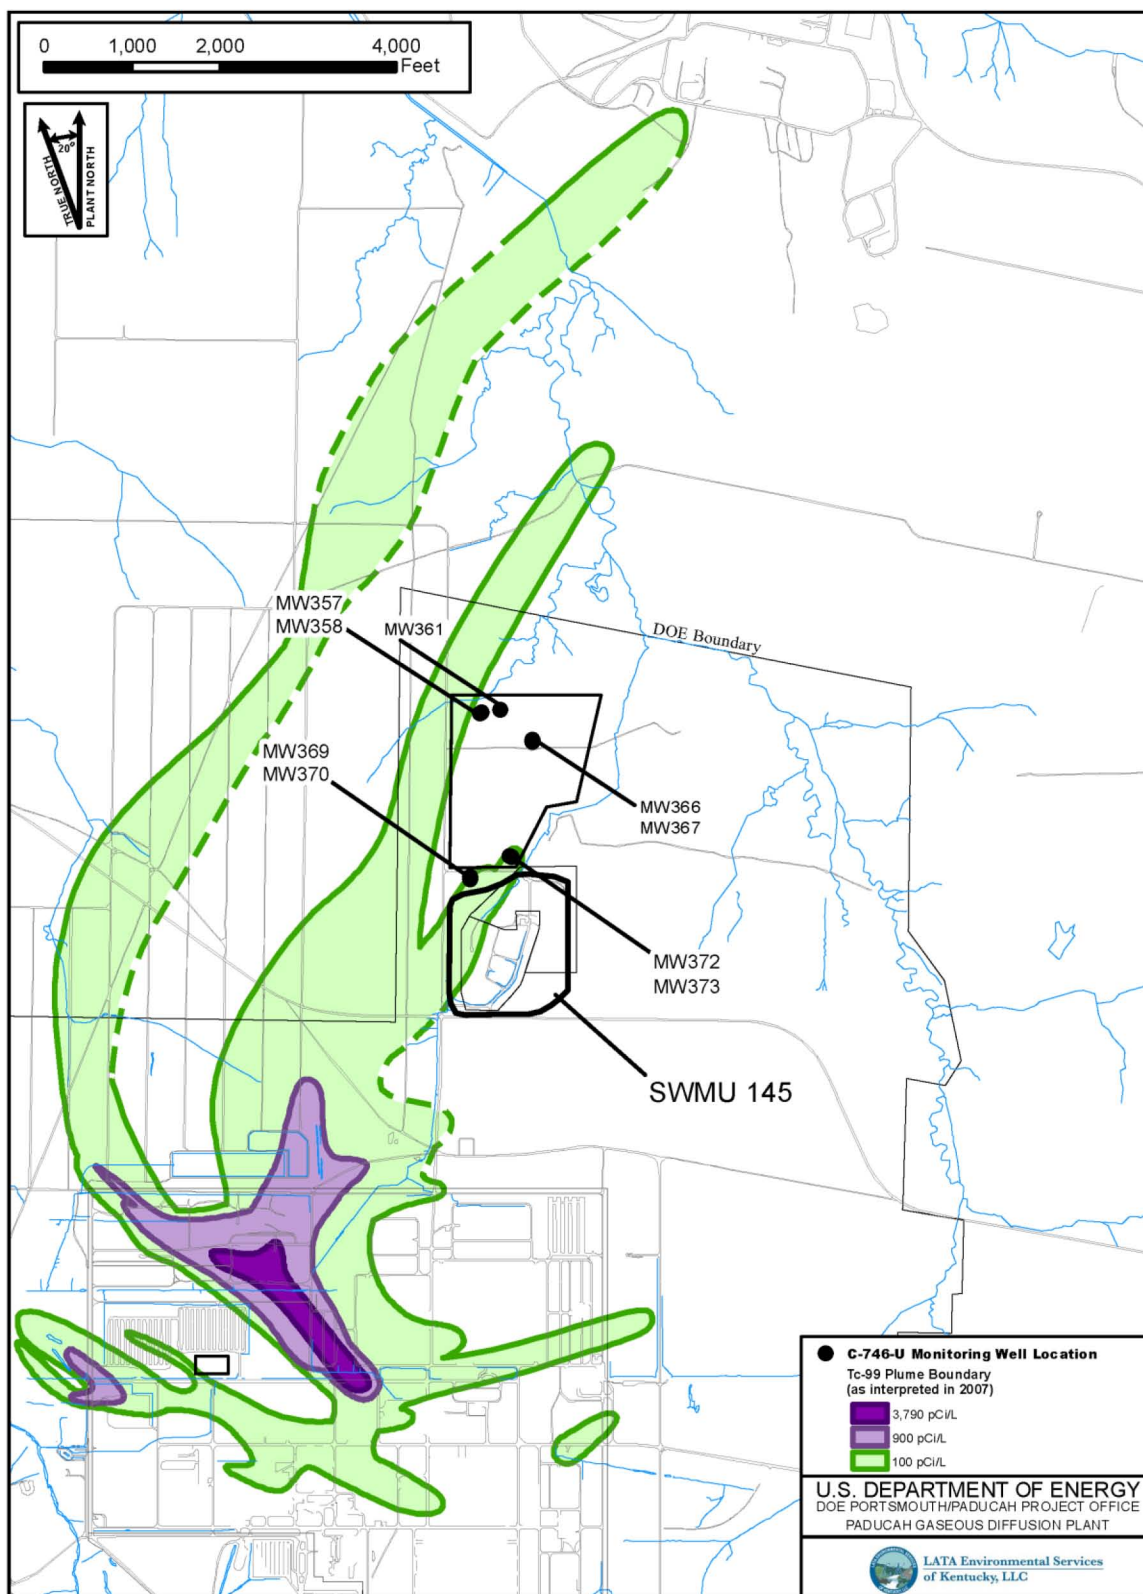
FIGURE No. C746U/20110628\_746U\_Tc99\_R1.mxd  
DATE 06-28-2011

Figure B.5. Technetium-99 Contours for the RGA

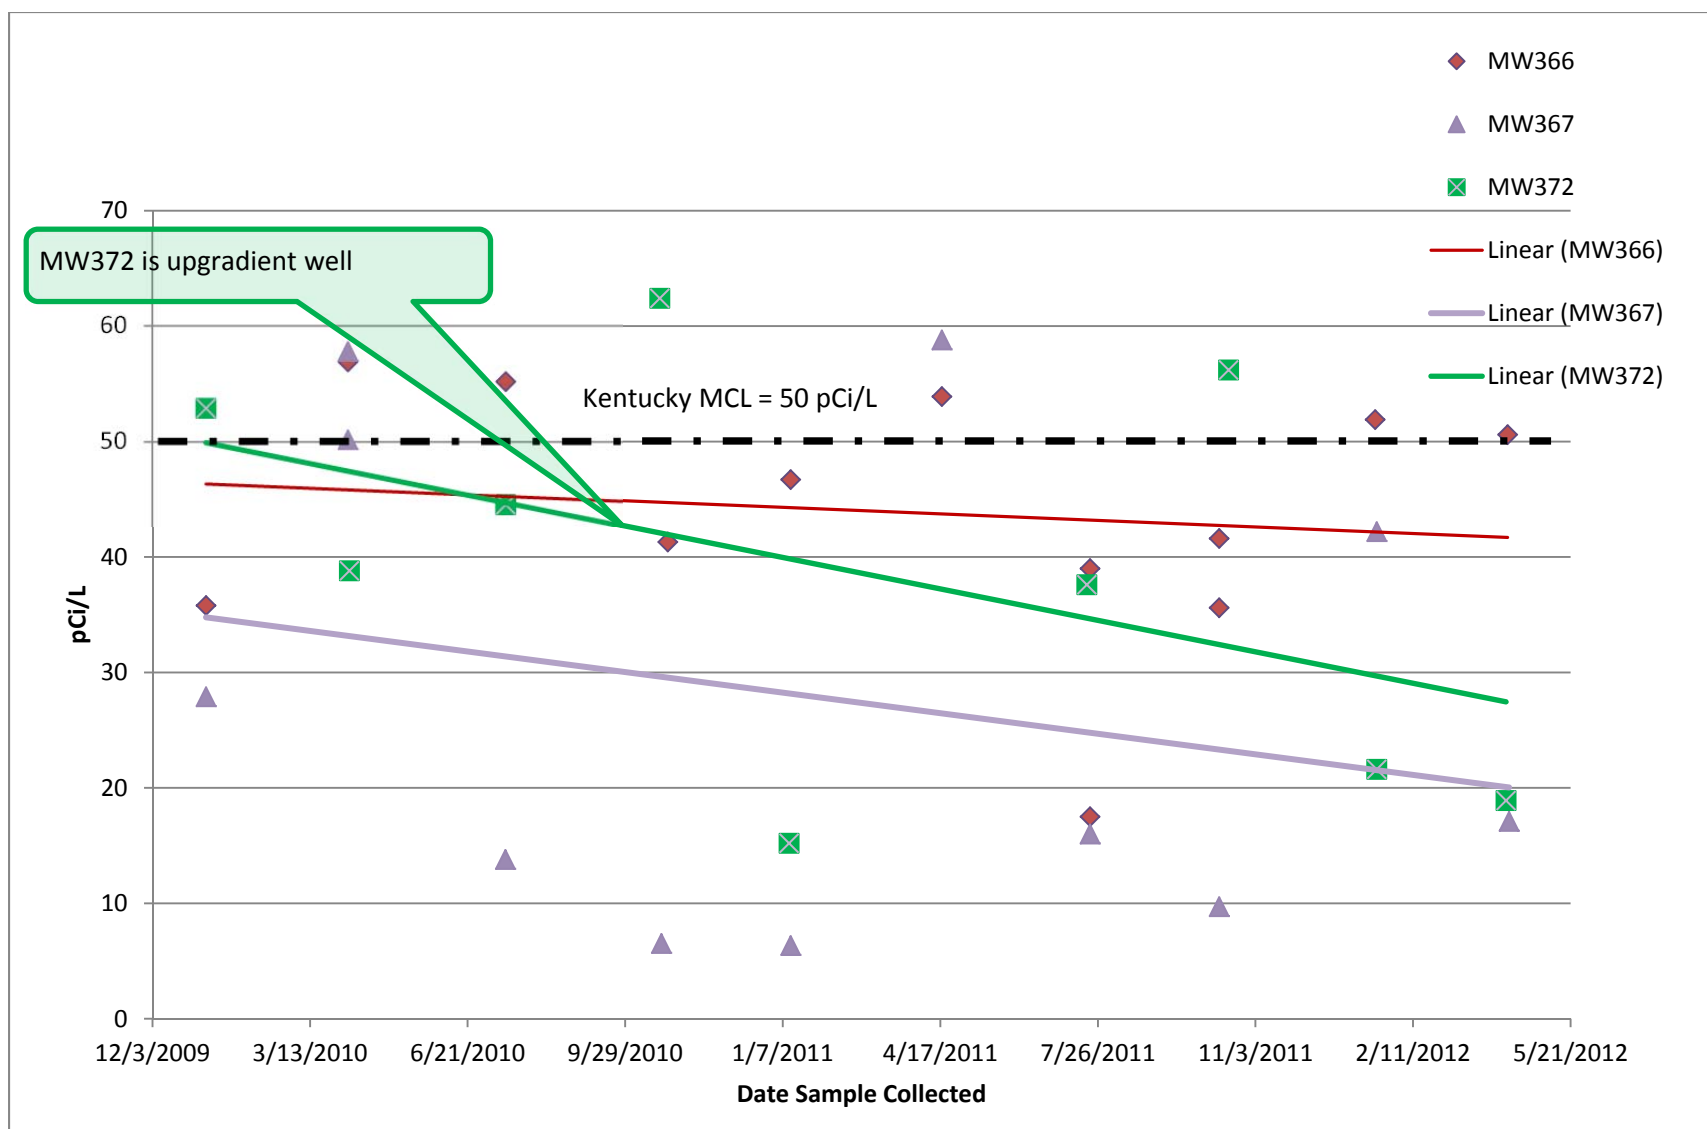
Figure B.6 is a graph of beta activity concentrations for the three RGA wells with beta activity greater than the MCL over the past two years. MW366 and MW367 are on the same flow path as water passing through MW372. Concentrations in MW366 and MW367 are lower than in upgradient well MW372 and also are decreasing; thus, the concentrations in the downgradient wells are well-explained

Figure B.6. Beta Activity since 2010 Wells with Any Exceedance of 50 pCi/L

by the upgradient source (that accounts for the MW372 concentrations). Consequently, the C-746-U Landfill is not contributing a measurable amount of beta activity to the RGA groundwater.

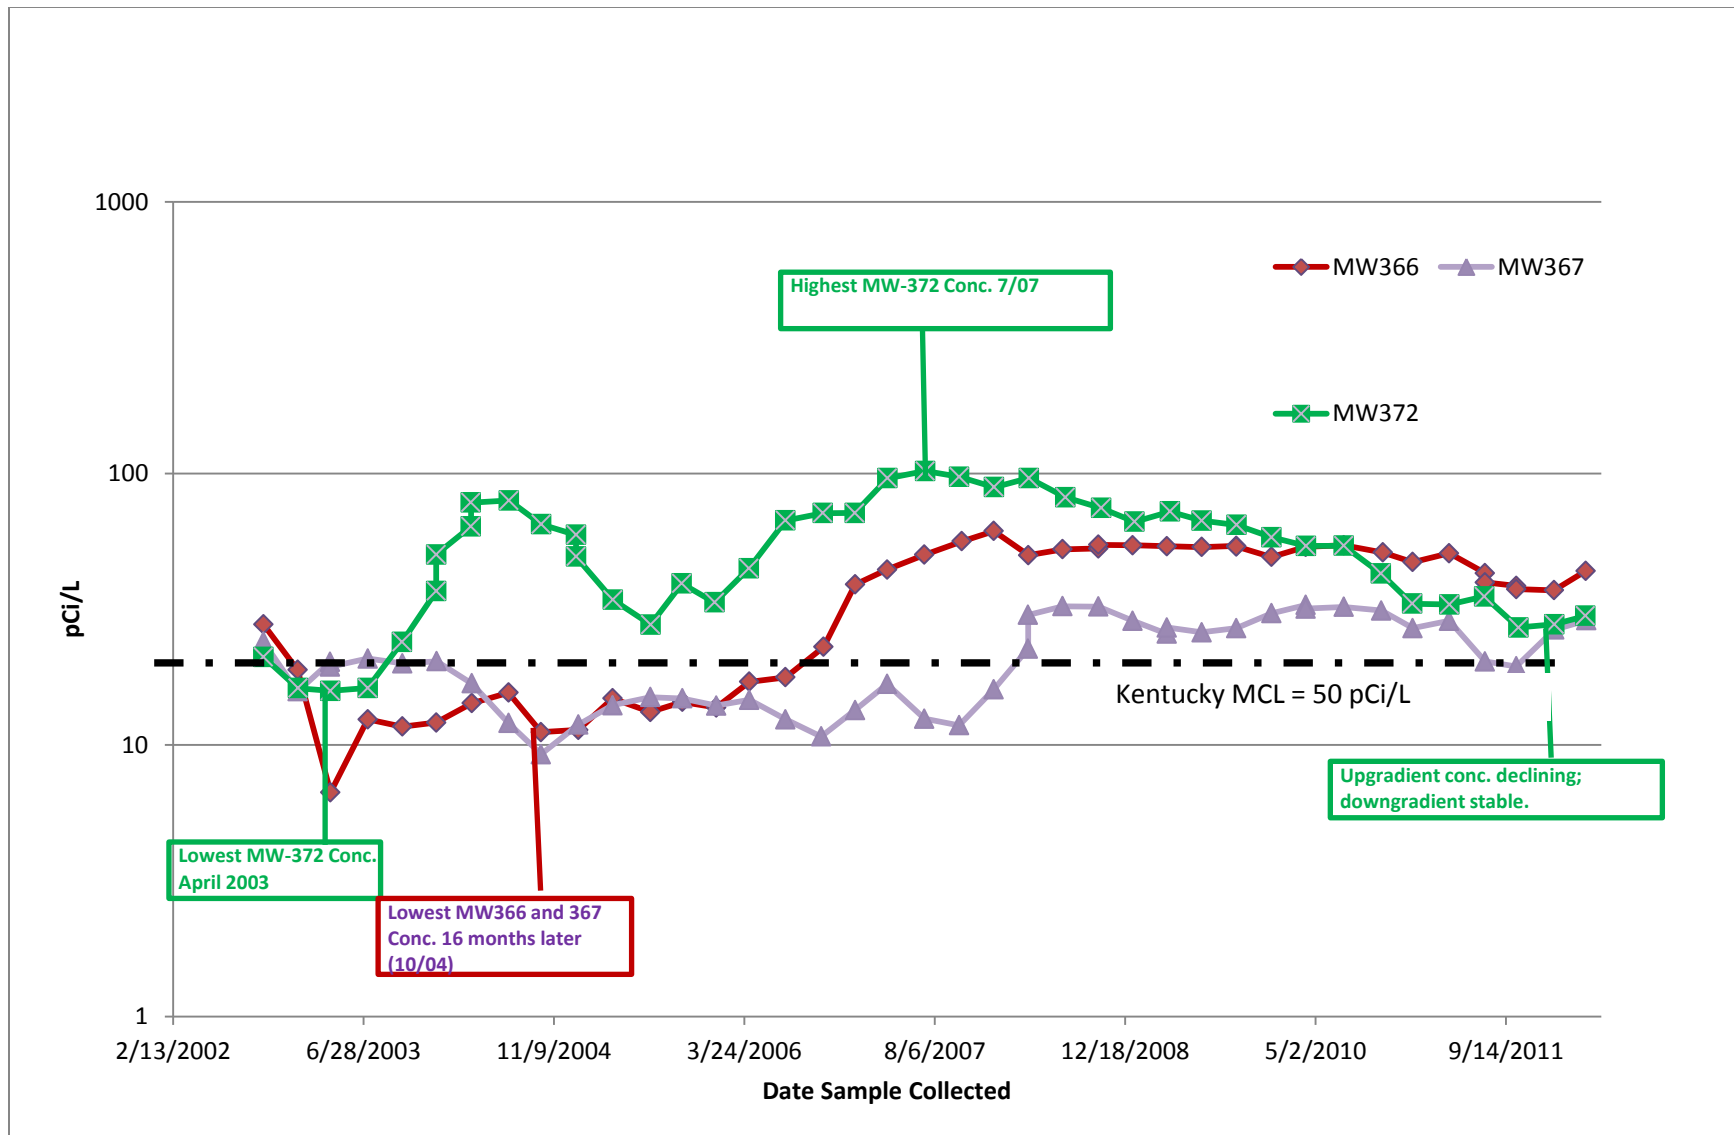
Figure B.7. Beta Activity 4 Event Rolling Average, Log Scale

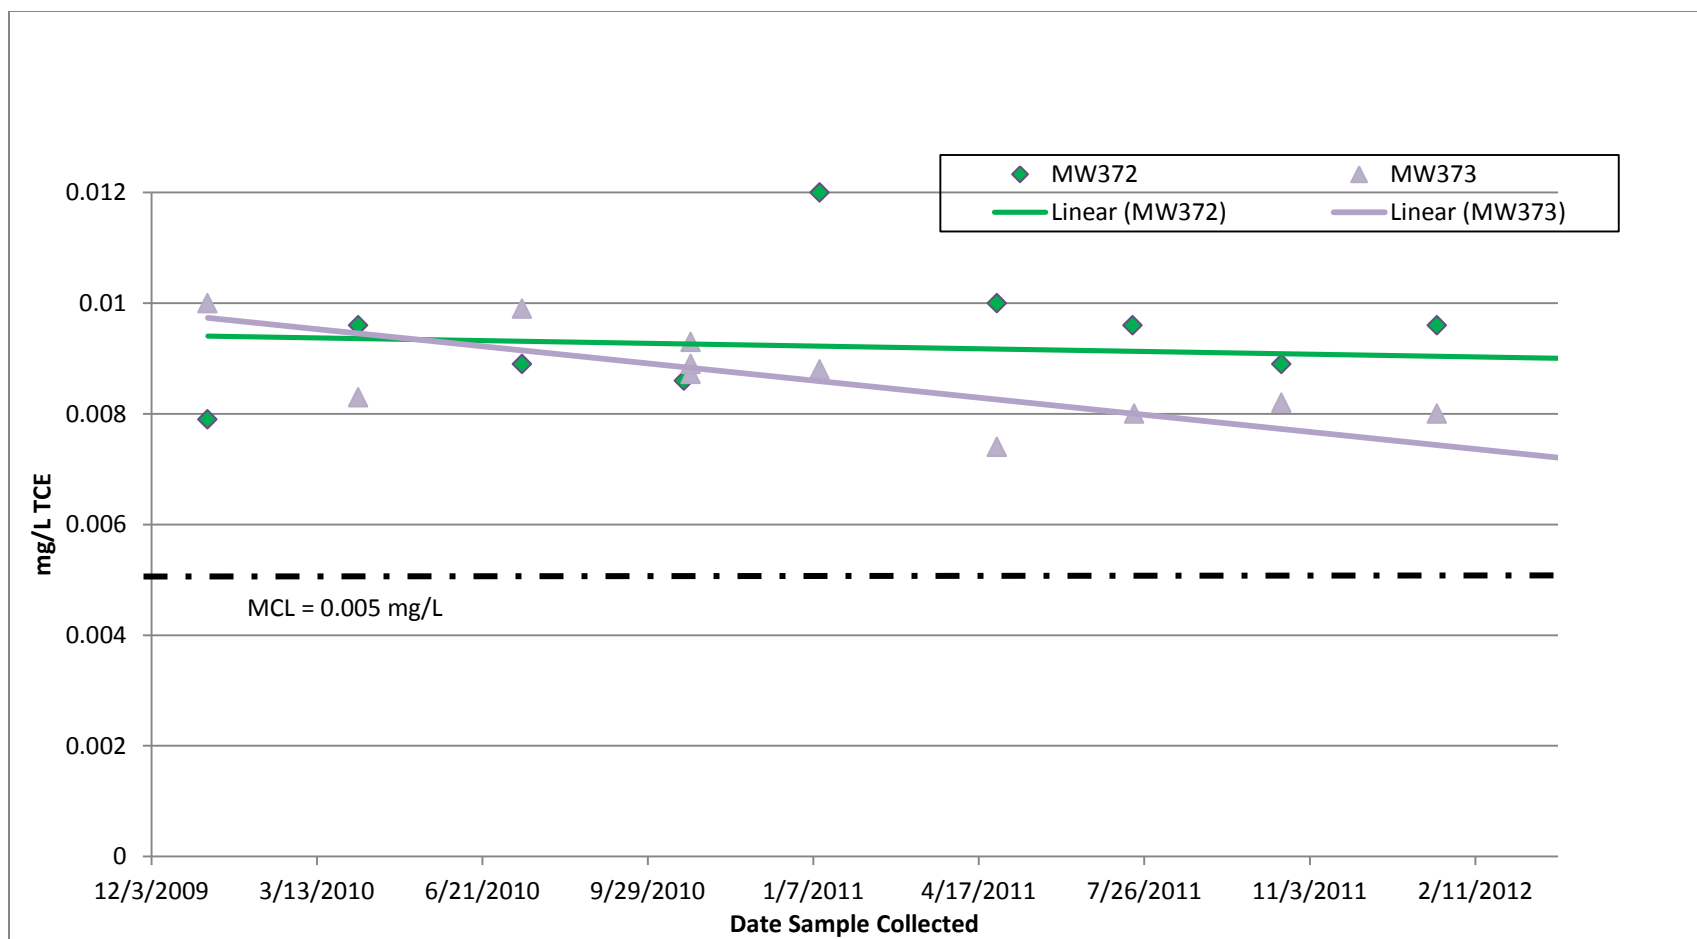
Figure B.8. TCE Concentration, Upgradient Wells

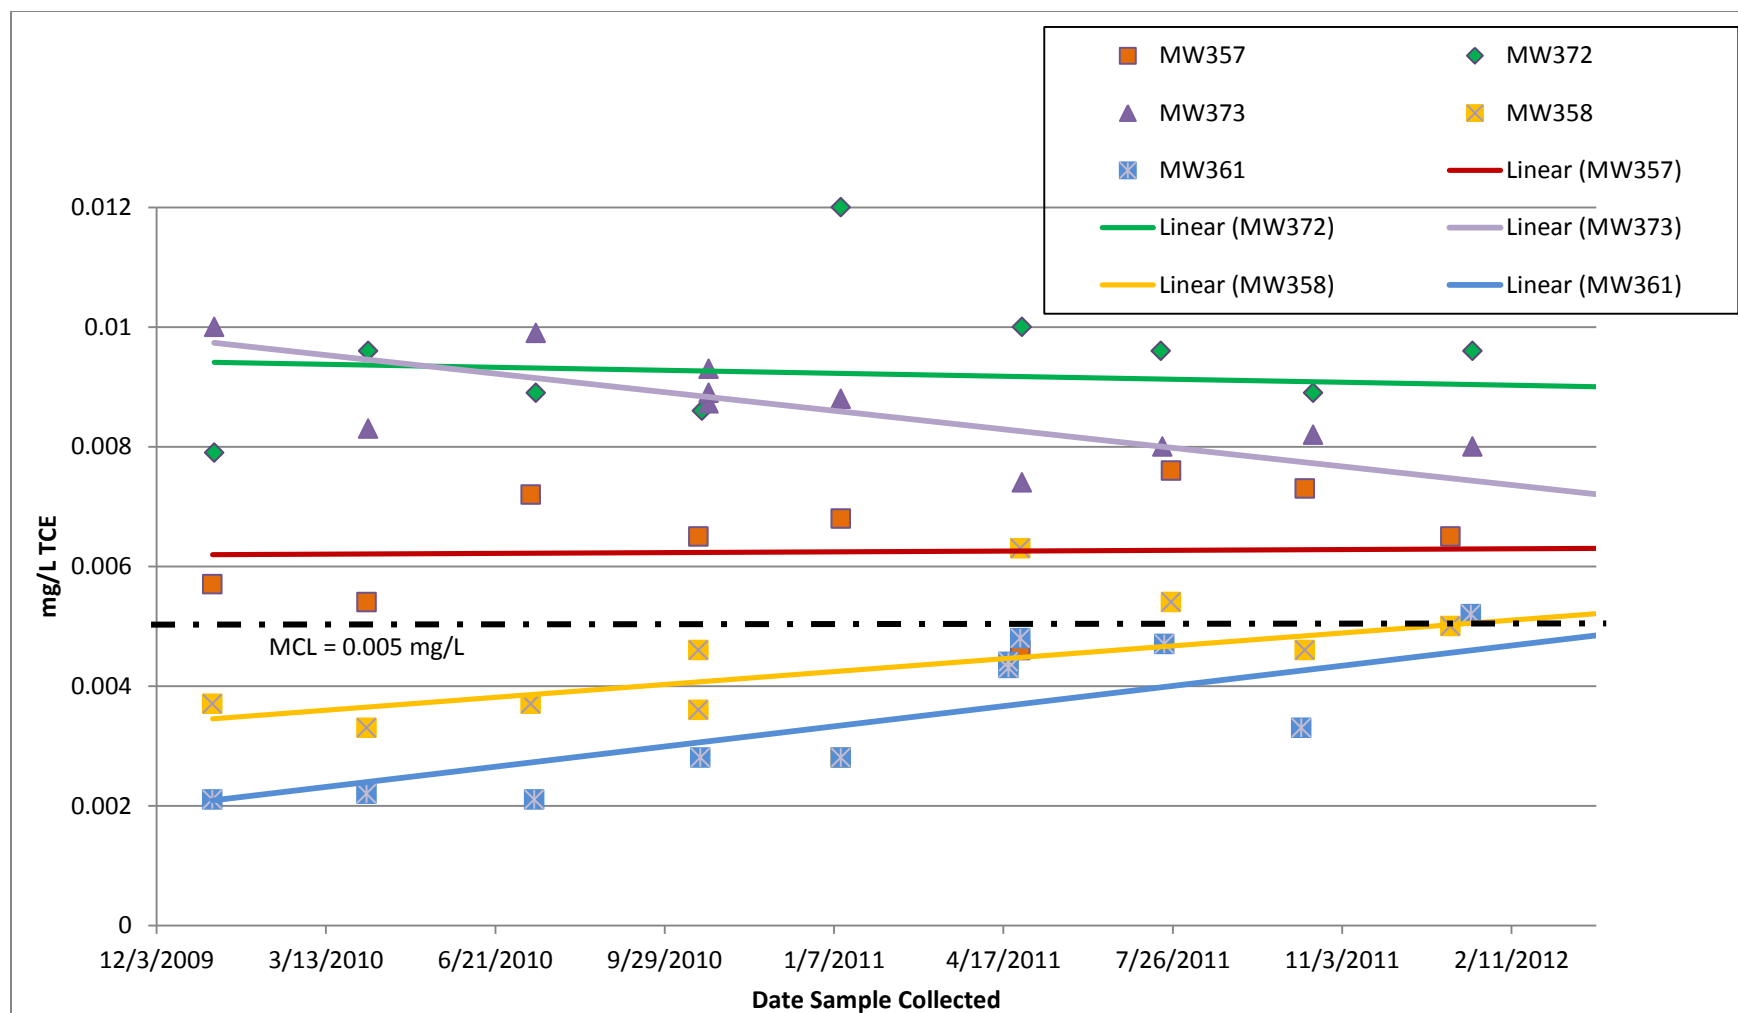
**Figure B.9. TCE Concentration, All Wells w/TCE > 0.005**

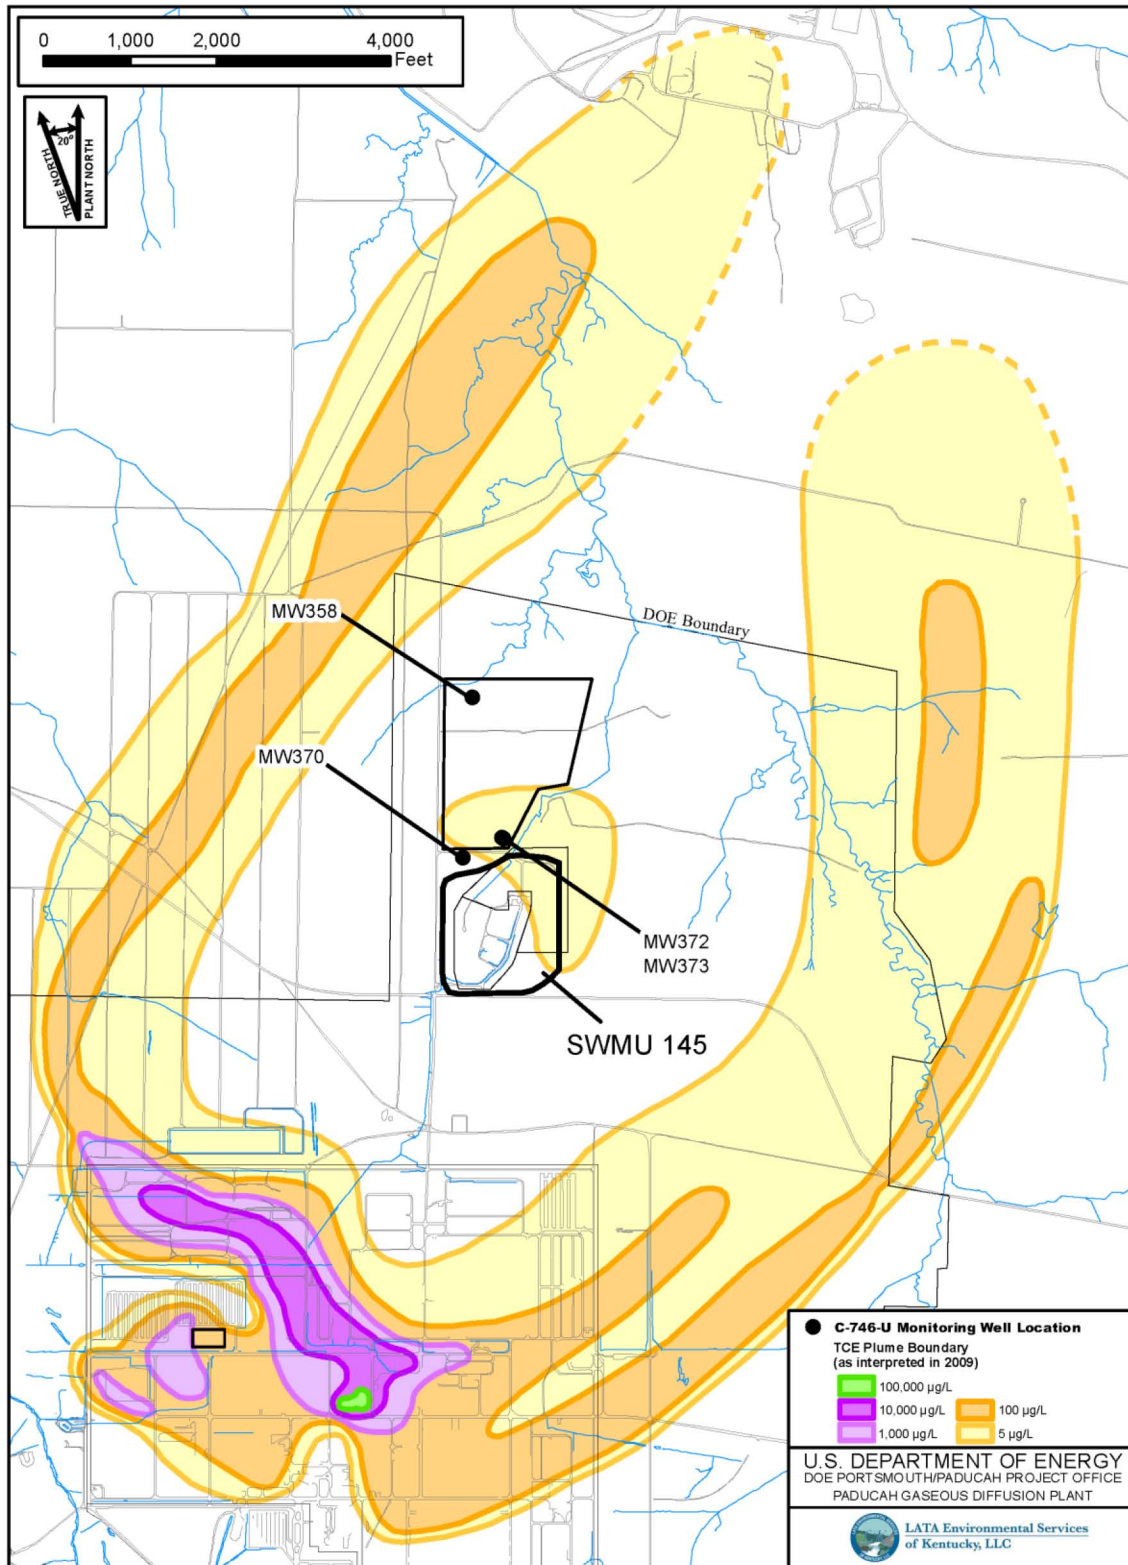
FIGURE No. C746U\20110628\_746U\_TCE.mxd  
DATE 06-28-2011

**Figure B.10. Composite Trichloroethene Contours for the RGA for Calendar Year 2009**

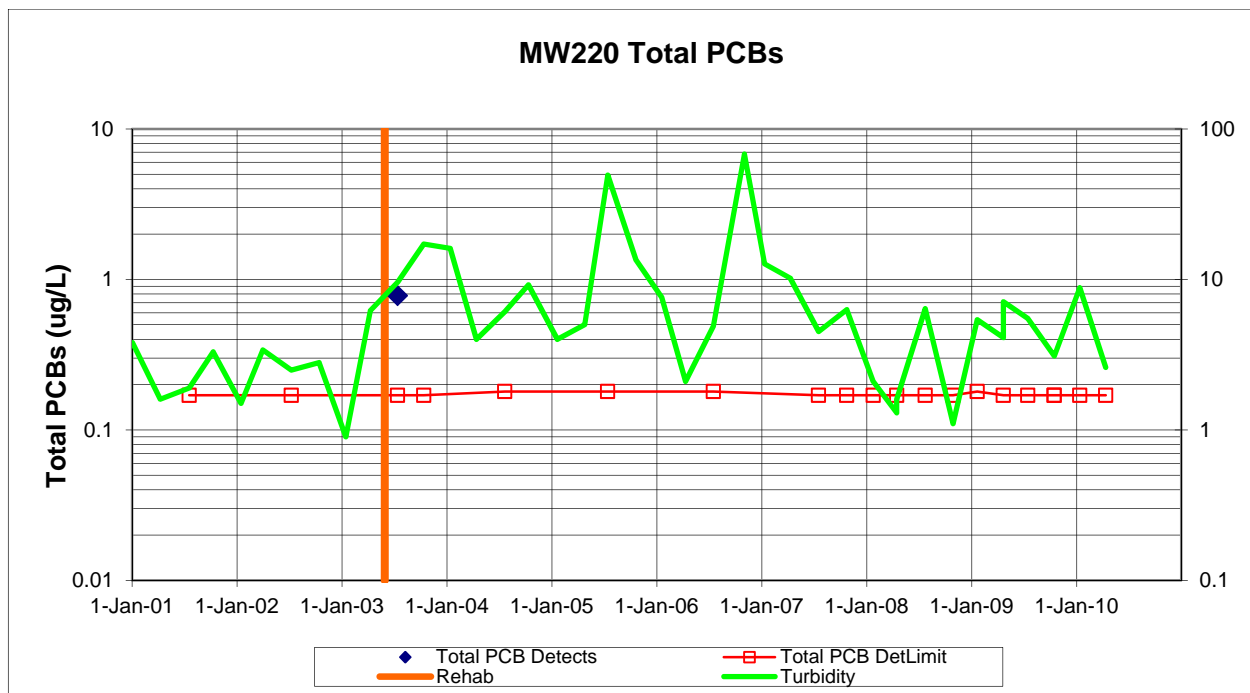
Figures E.1 through E.18 illustrate the relationship of the PCB occurrences to well rehabilitation events for the 18 wells with PCB detections. Where the first detection of PCBs is delayed after well rehabilitation, plots of turbidity support the association of PCBs with suspended solids in the wells.

**Figure E.1. PCB Analyses and Well Rehabilitation in MW220**

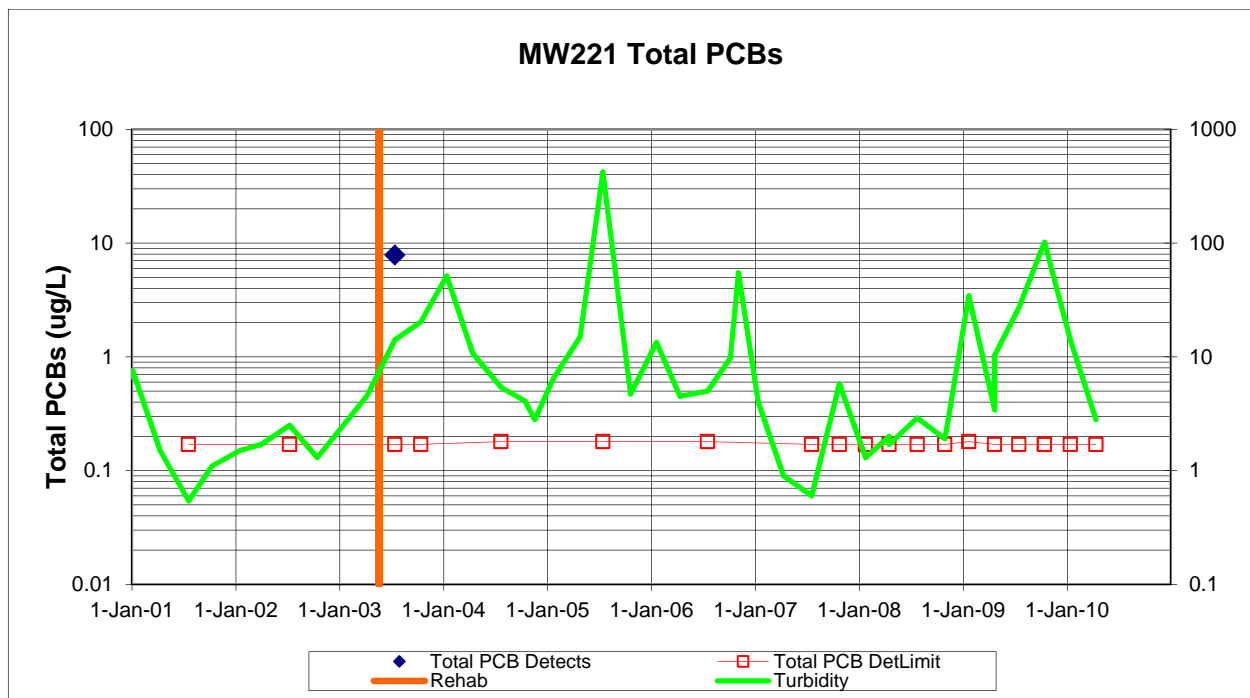
**Figure E.2. PCB Analyses and Well Rehabilitation in MW221**

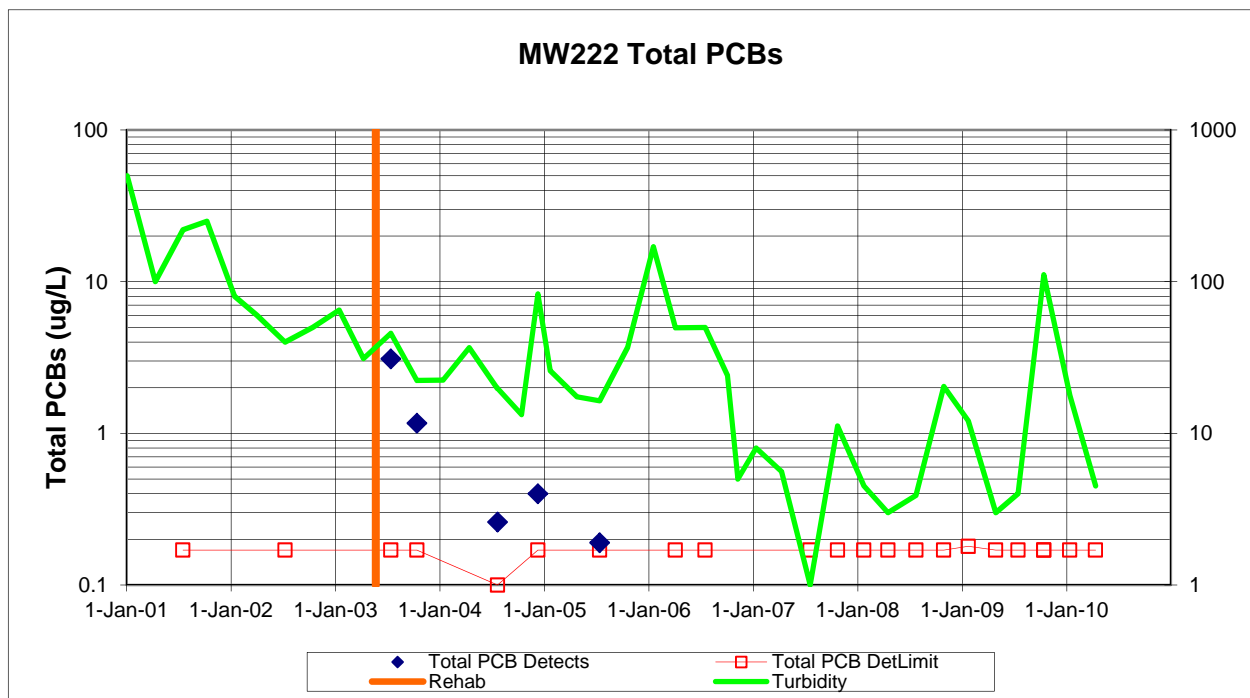
**Figure E.3. PCB Analyses and Well Rehabilitation in MW222**

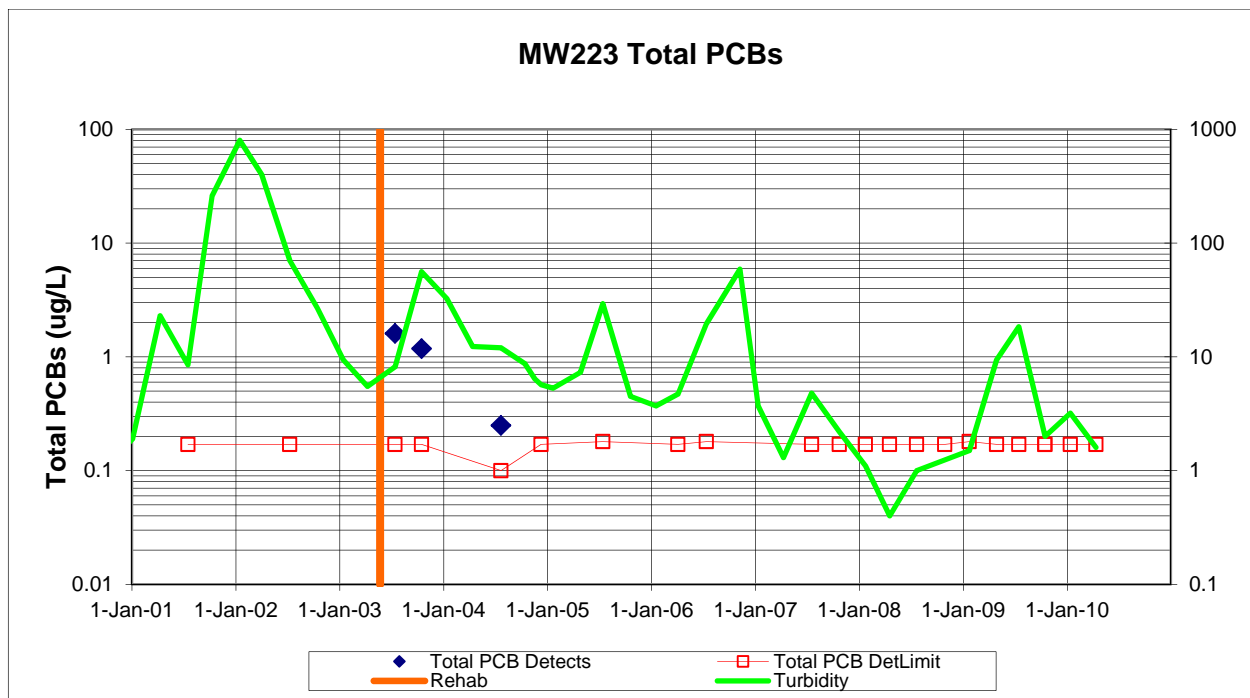
**Figure E.4. PCB Analyses and Well Rehabilitation in MW223**
