**Groundwater Assessment Report  
for the C-746-U Landfill at the  
Paducah Gaseous Diffusion Plant,  
Paducah, Kentucky**

Date Issued—May 2013

Prepared for the  
U.S. DEPARTMENT OF ENERGY  
Office of Environmental Management

Prepared by  
LATA ENVIRONMENTAL SERVICES OF KENTUCKY, LLC  
managing the  
Environmental Remediation Activities at the  
Paducah Gaseous Diffusion Plant  
under contract DE-AC30-10CC40020

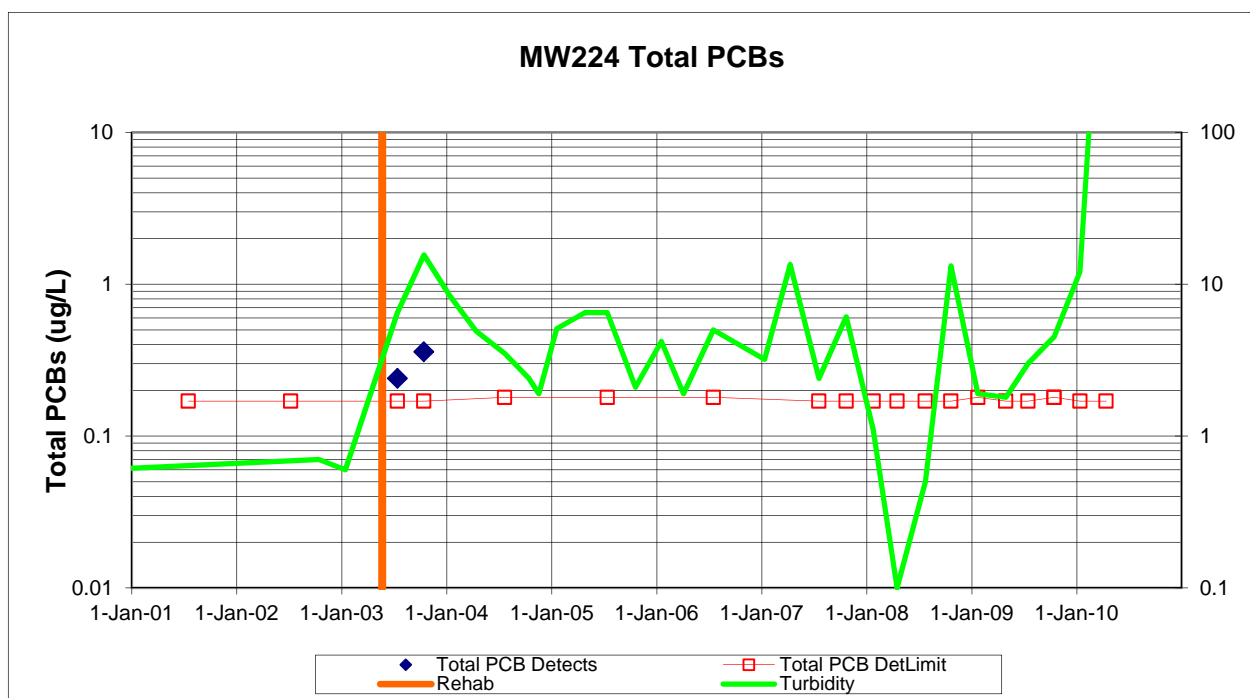
**Figure E.5. PCB Analyses and Well Rehabilitation in MW224**

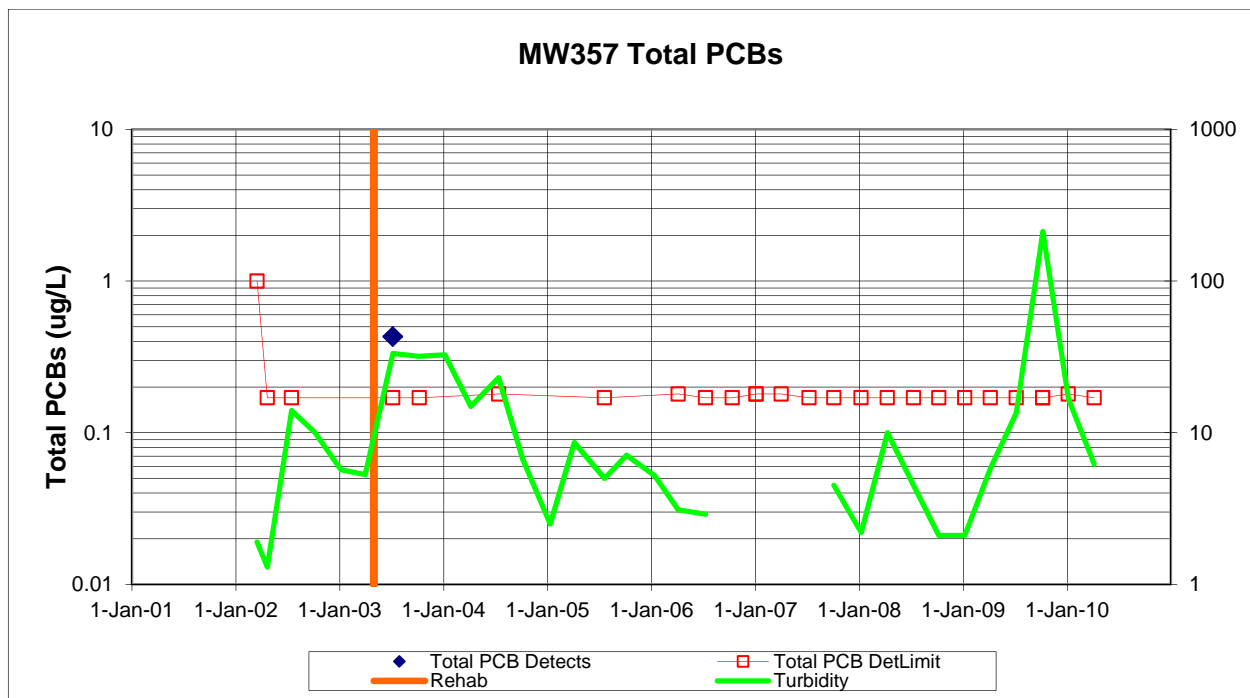
**Figure E.6. PCB Analyses and Well Rehabilitation in MW357**

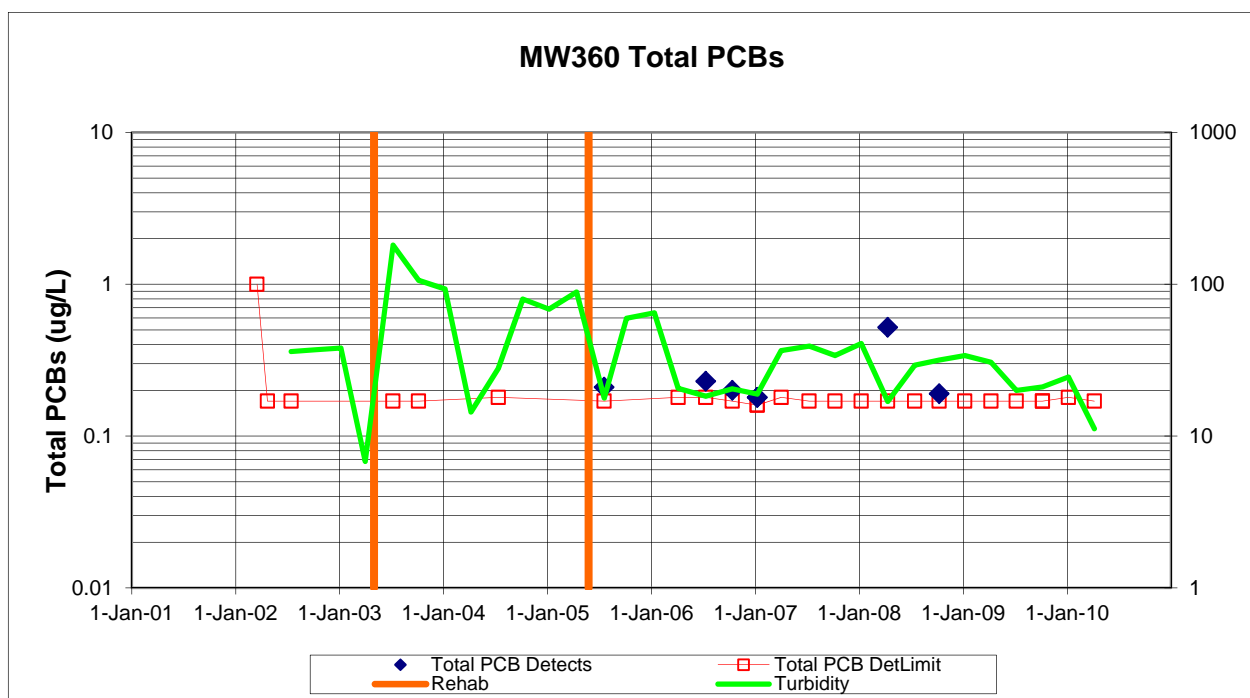
**Figure E.7. PCB Analyses and Well Rehabilitation in MW360**

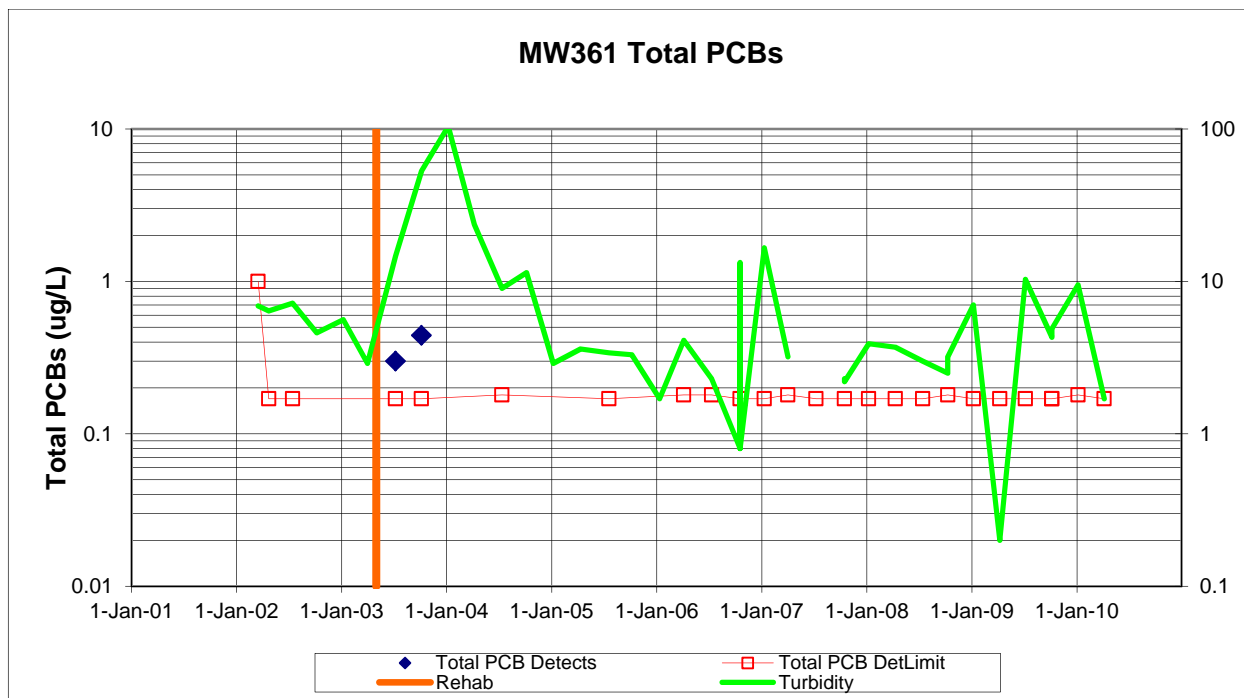
Figure E.8. PCB Analyses and Well Rehabilitation in MW361

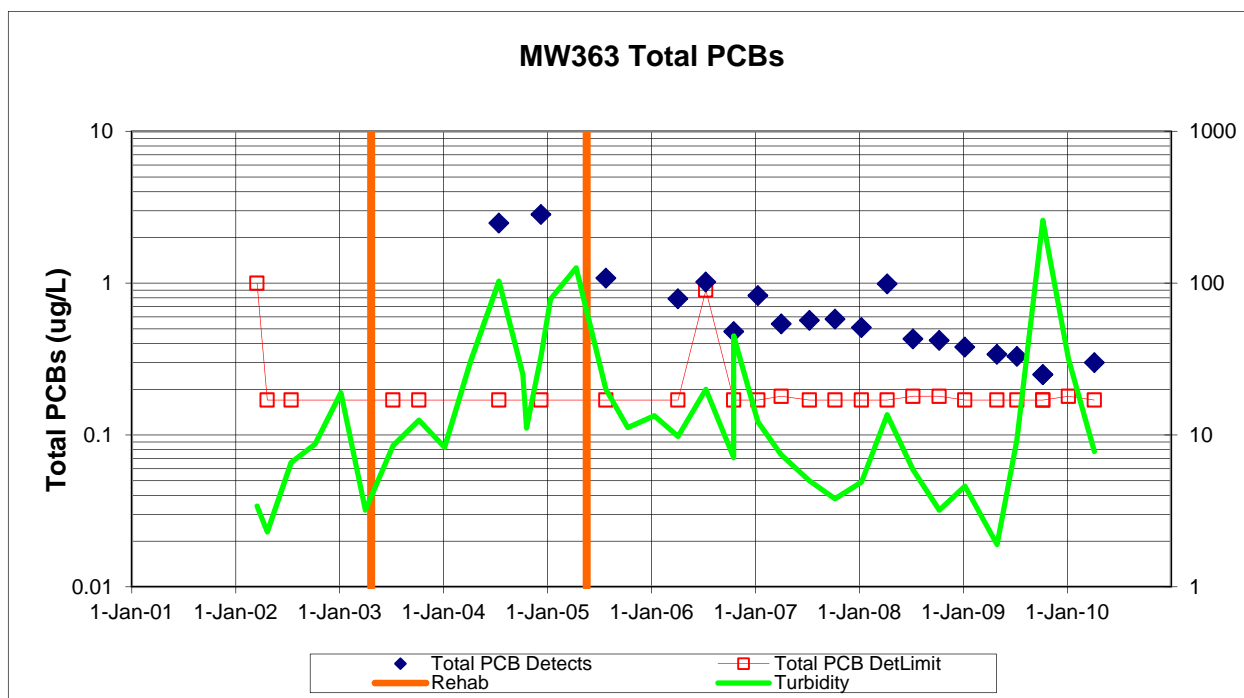
Figure E.9. PCB Analyses and Well Rehabilitation in MW363

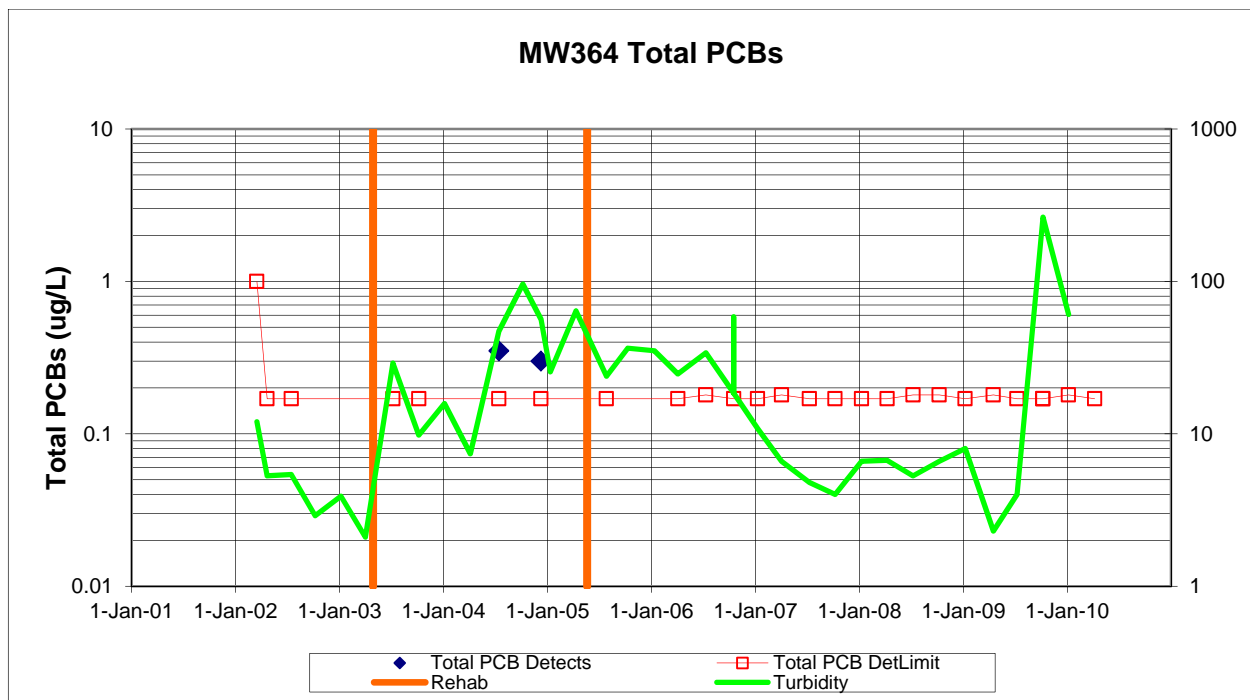
**Figure E.10. PCB Analyses and Well Rehabilitation in MW364**

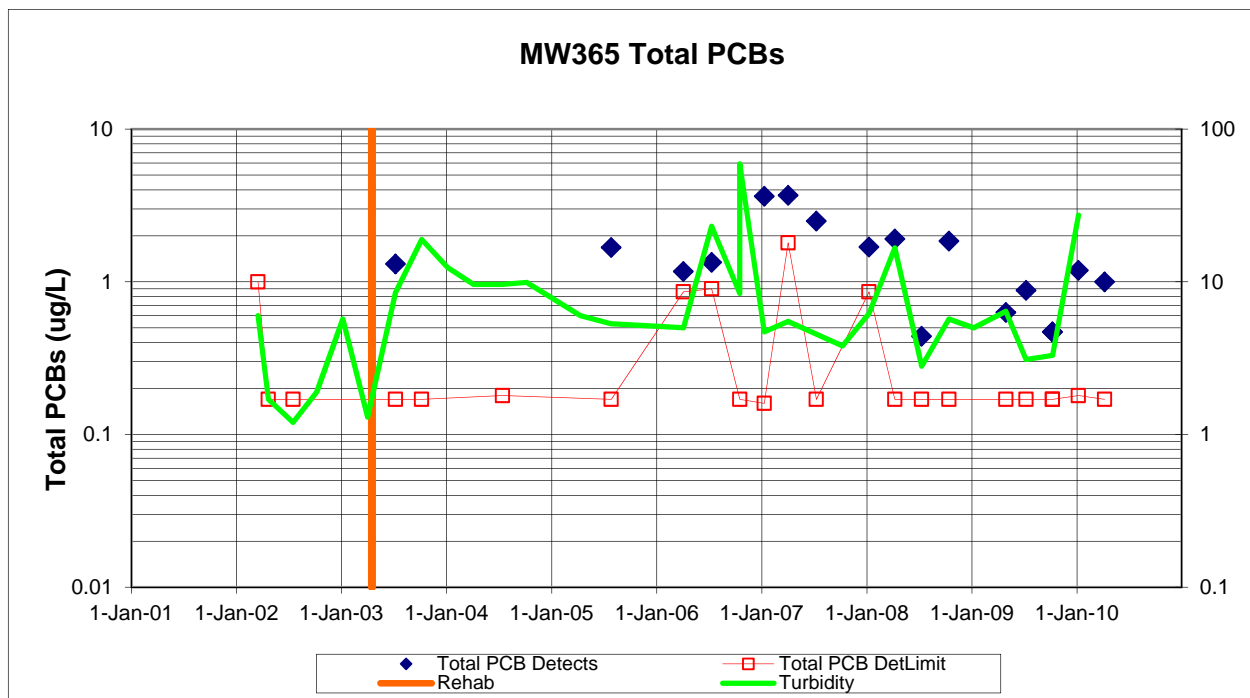
**Figure E.11. PCB Analyses and Well Rehabilitation in MW365**

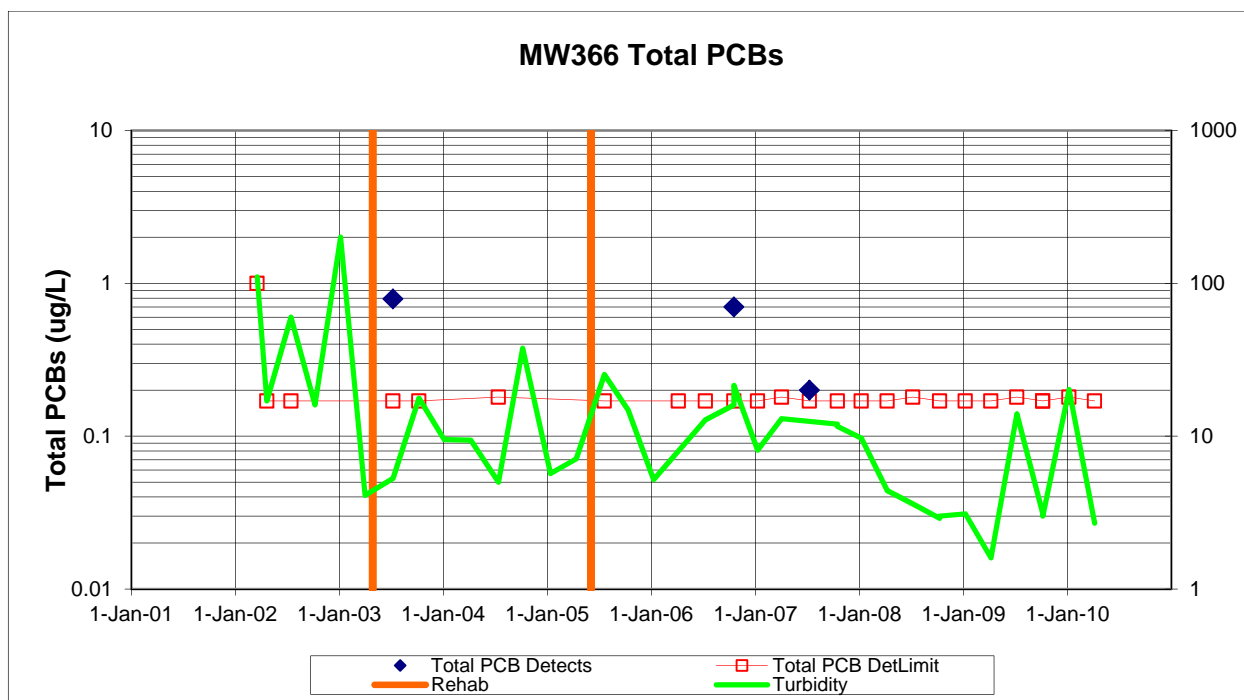
**Figure E.12. PCB Analyses and Well Rehabilitation in MW366**

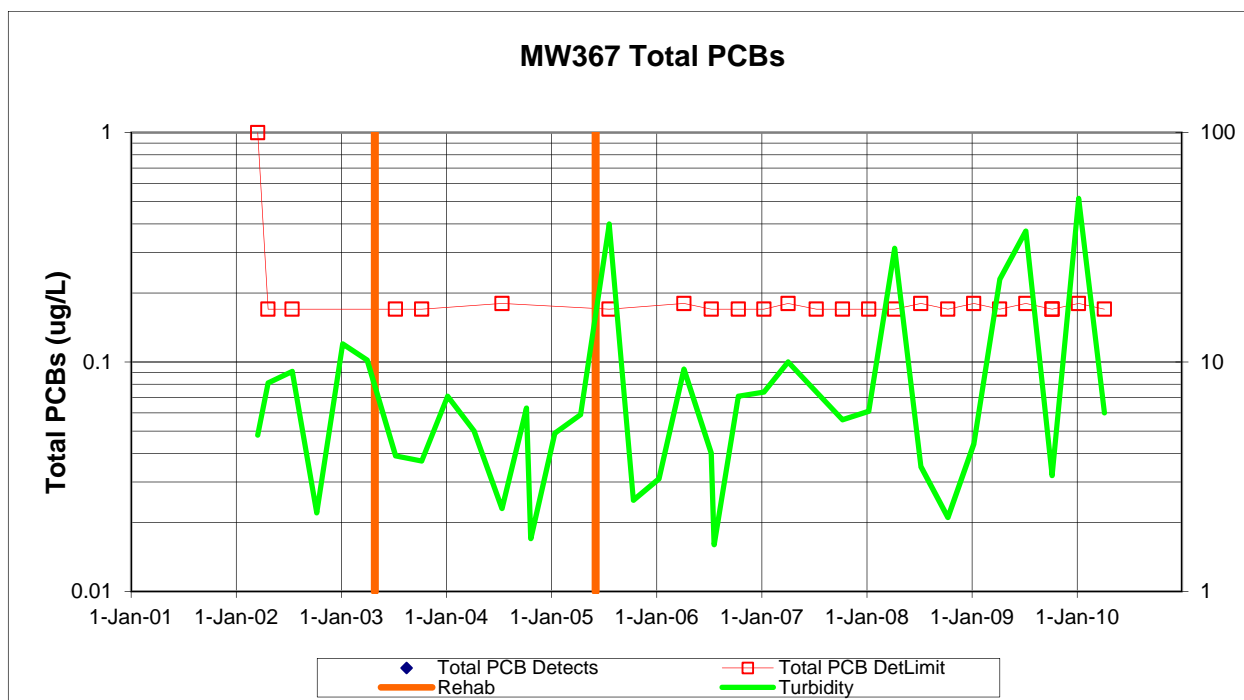
**Figure E.13. PCB Analyses and Well Rehabilitation in MW367**

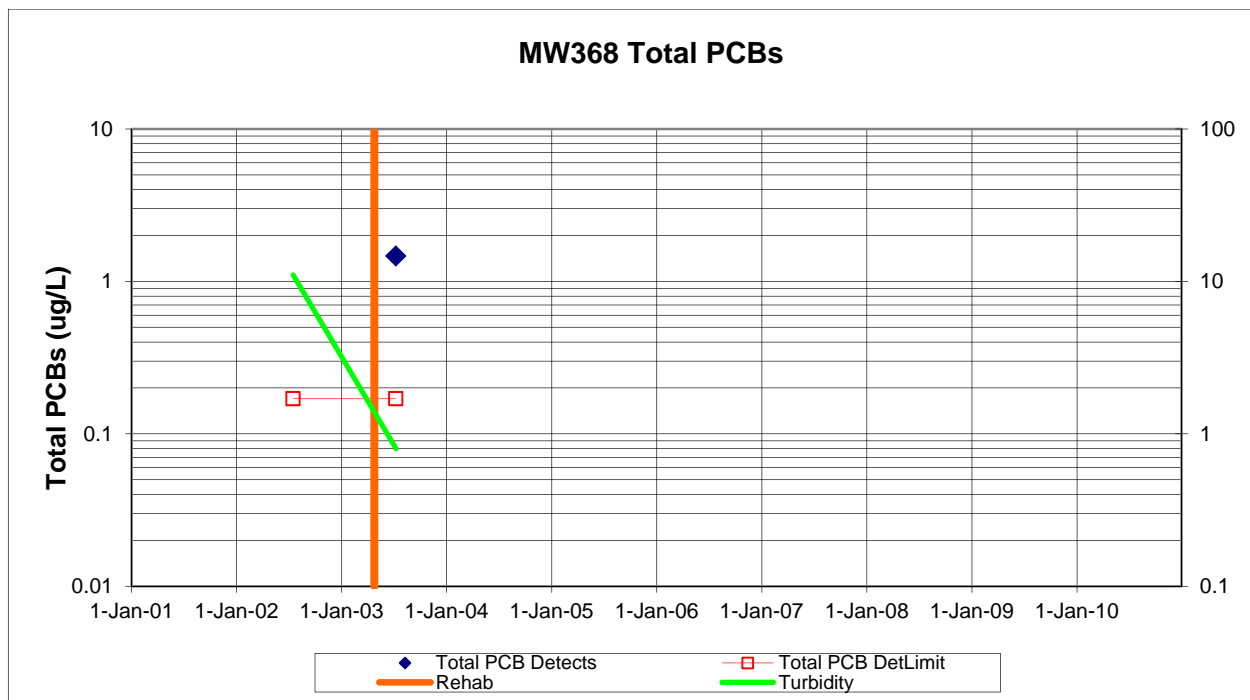
**Figure E.14. PCB Analyses and Well Rehabilitation in MW368**

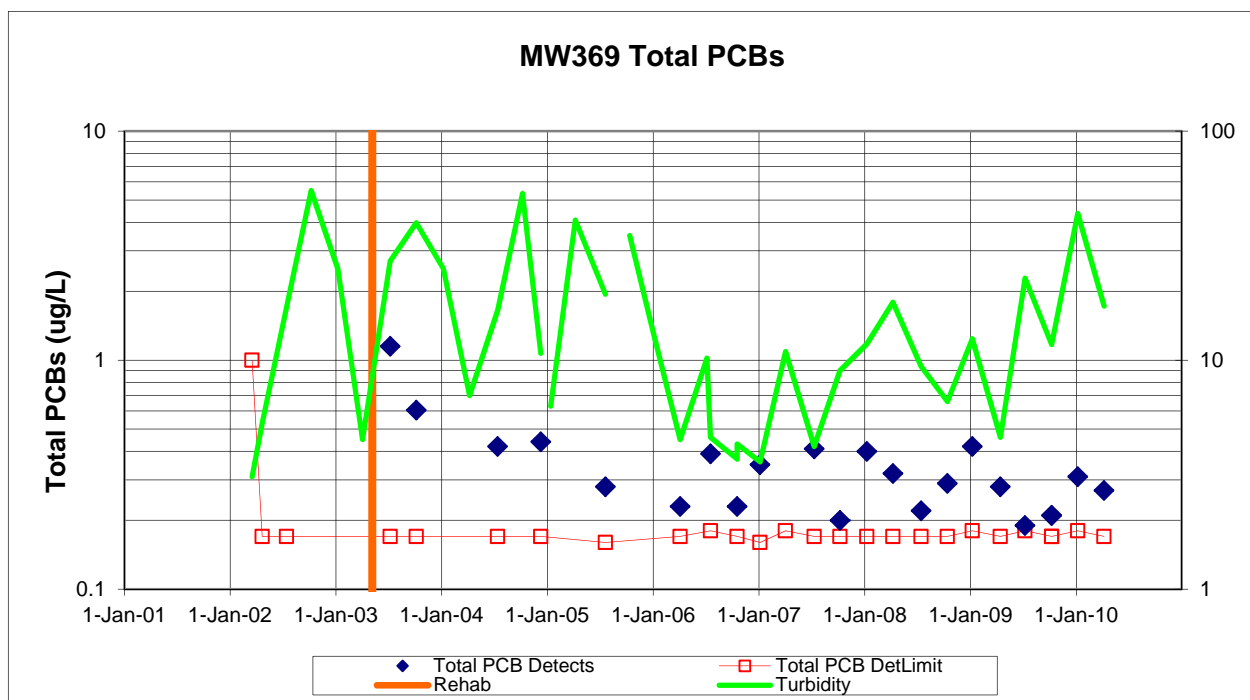
**Figure E.15. PCB Analyses and Well Rehabilitation in MW369**

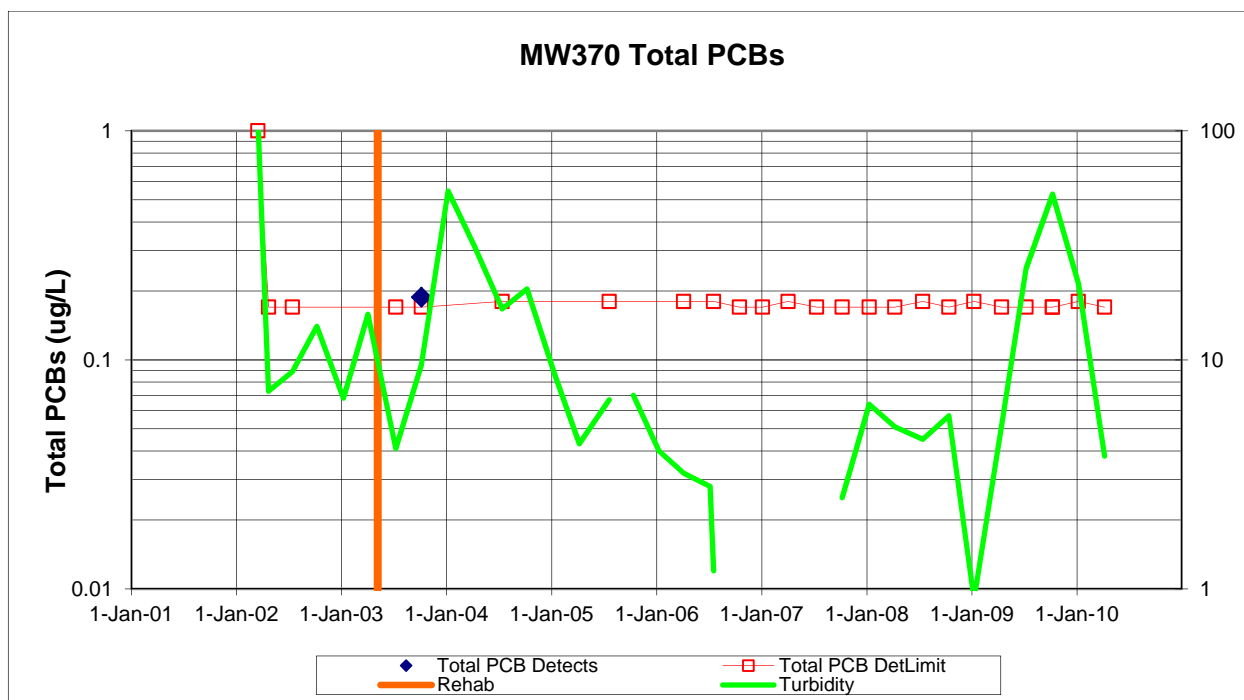
**Figure E.16. PCB Analyses and Well Rehabilitation in MW370**

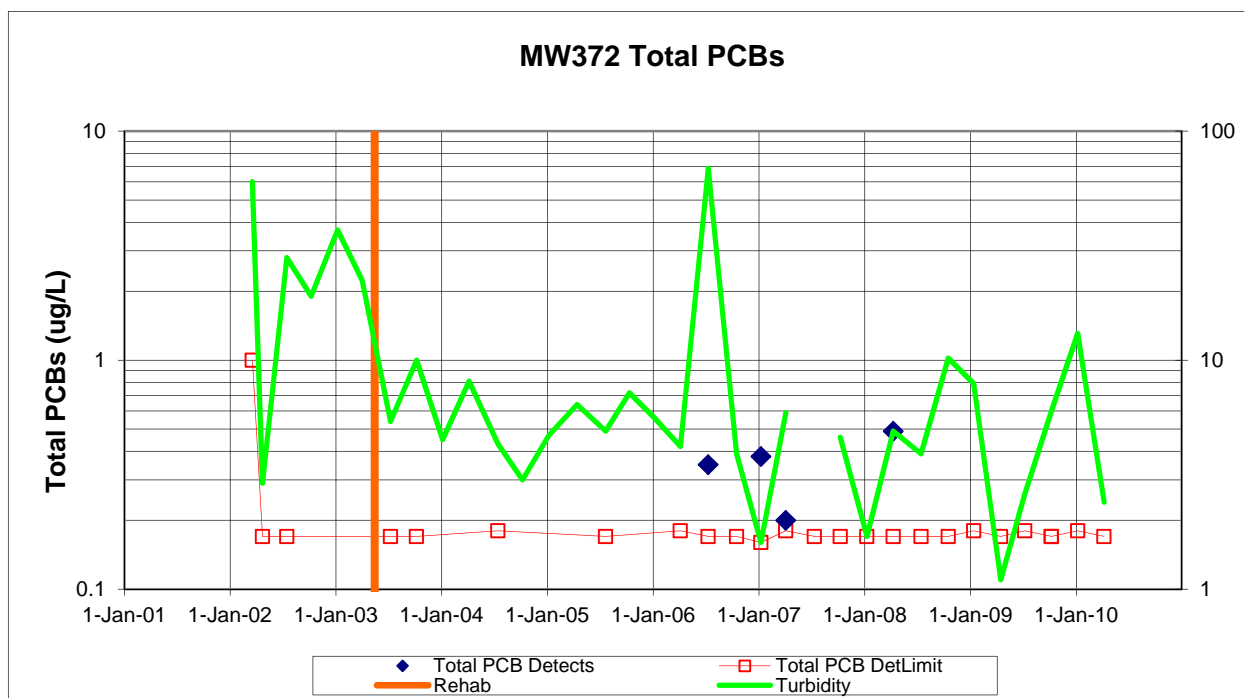
**Figure E.17. PCB Analyses and Well Rehabilitation in MW372**

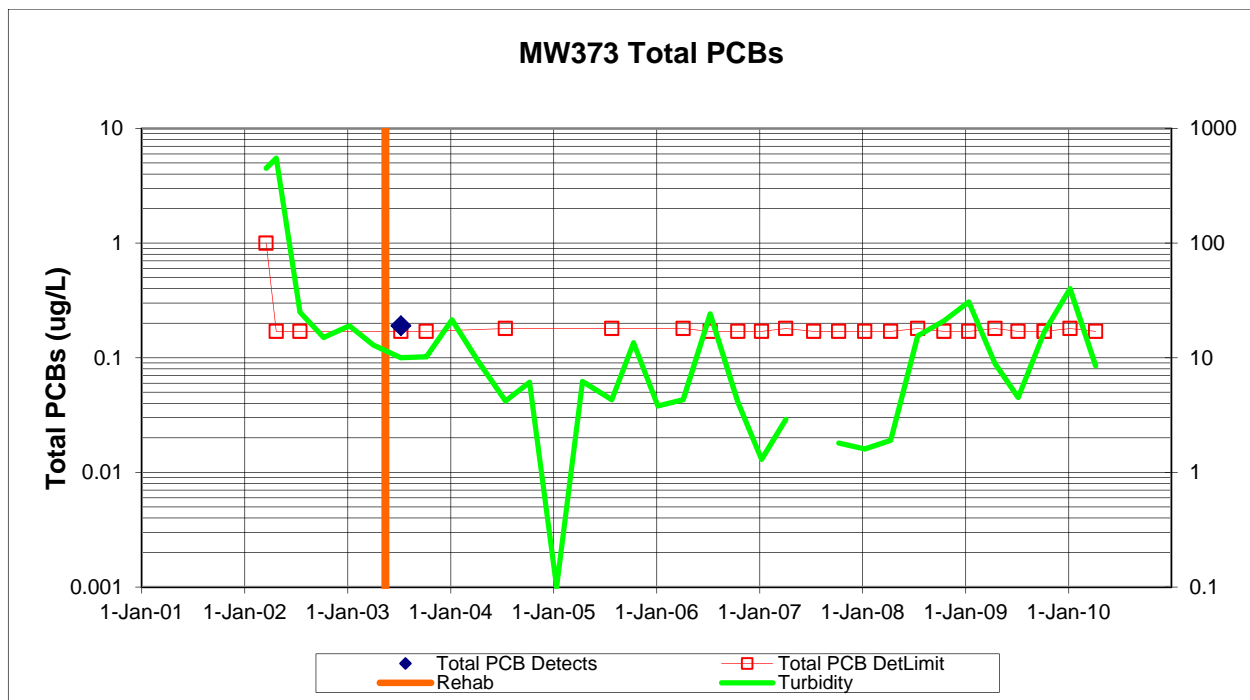
**Figure E.18. PCB Analyses and Well Rehabilitation in MW373**

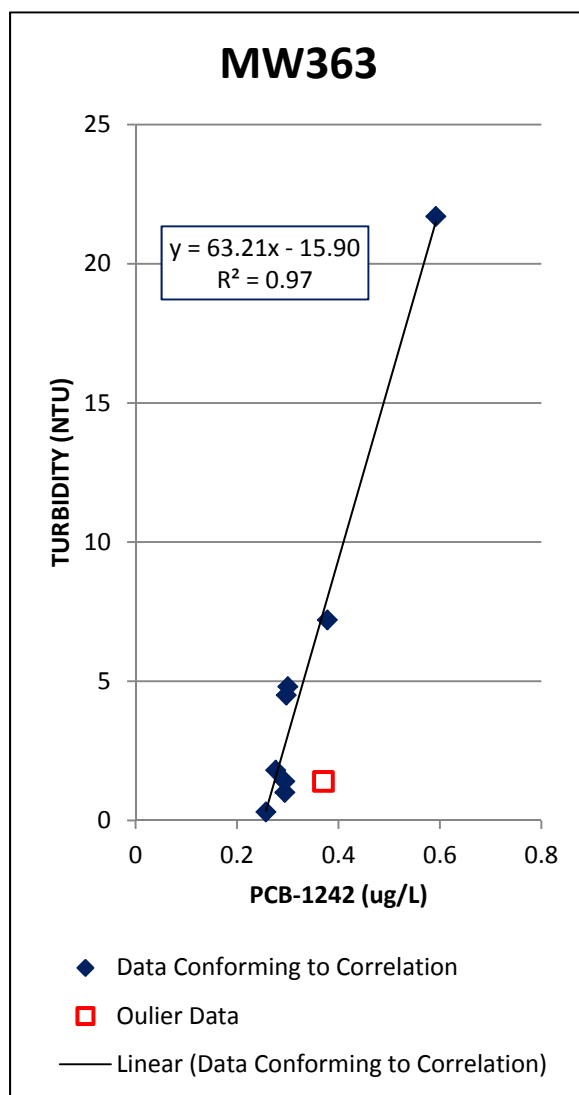
Analyses of the overpumping test documents the presence of PCB-1242 in 9 of 10 samples (and in the 2 duplicate samples), at estimated levels of 0.257–0.592 µg/L. With the exception of 1 outlier, the PCB-1242 levels closely relate to turbidity of the samples (Figure F.1).

Figure F.1. PCB-1242 versus Turbidity in MW363

Except for the one sample with a concentration of 0.592 µg/L (collected in early April 2011), none of the other samples had concentrations that exceed the EPA MCL of 0.5 µg/L. Thus, the overpumping reduced concentrations of PCBs to less than the EPA MCL where they have remained since. The finding that there no longer are concentrations of PCBs in groundwater at MW363 that exceed the EPA MCL is consistent with the established PCBs trend, indicating that PCBs no longer are a problem in MW363. This finding indicates that there is no continuing source of PCBs to the water in this well.

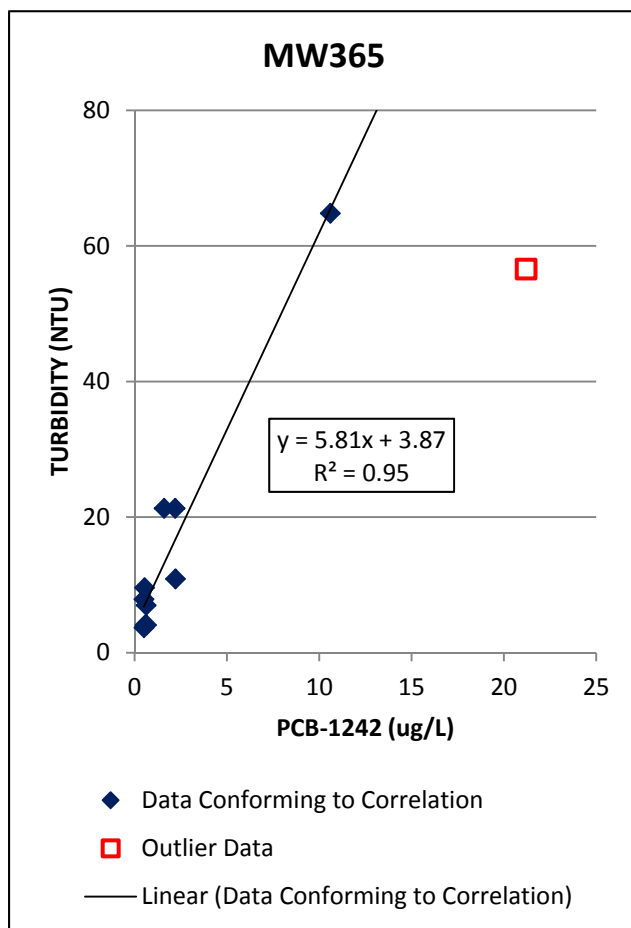
The 24 previous analyses of MW365 groundwater samples include 18 detections of PCBs (3.63—0.44 µg/L). PCB-1242 was detected in all 10 of the overpumping test samples and in the two duplicate samples (ranging from 0.50–21.2 µg/L). As in MW363, PCB-1242 levels closely relate to the turbidity of the groundwater in all but one sample (Figure F.2).

Figure F.2. PCB-1242 versus Turbidity in MW365

Sample concentrations continue to exceed the EPA MCL of 0.5 µg/L in this UCRS well. Except as noted above, none of the RGA wells has PCB concentrations that exceed the EPA MCL. Concentrations of PCBs in MW365 have decreased in response to the overpumping but remain above the EPA MCL. MW365 is located approximately 1,000 ft north of the C-746-U Landfill. This area was subjected to the soils investigation summarized in Appendix D.

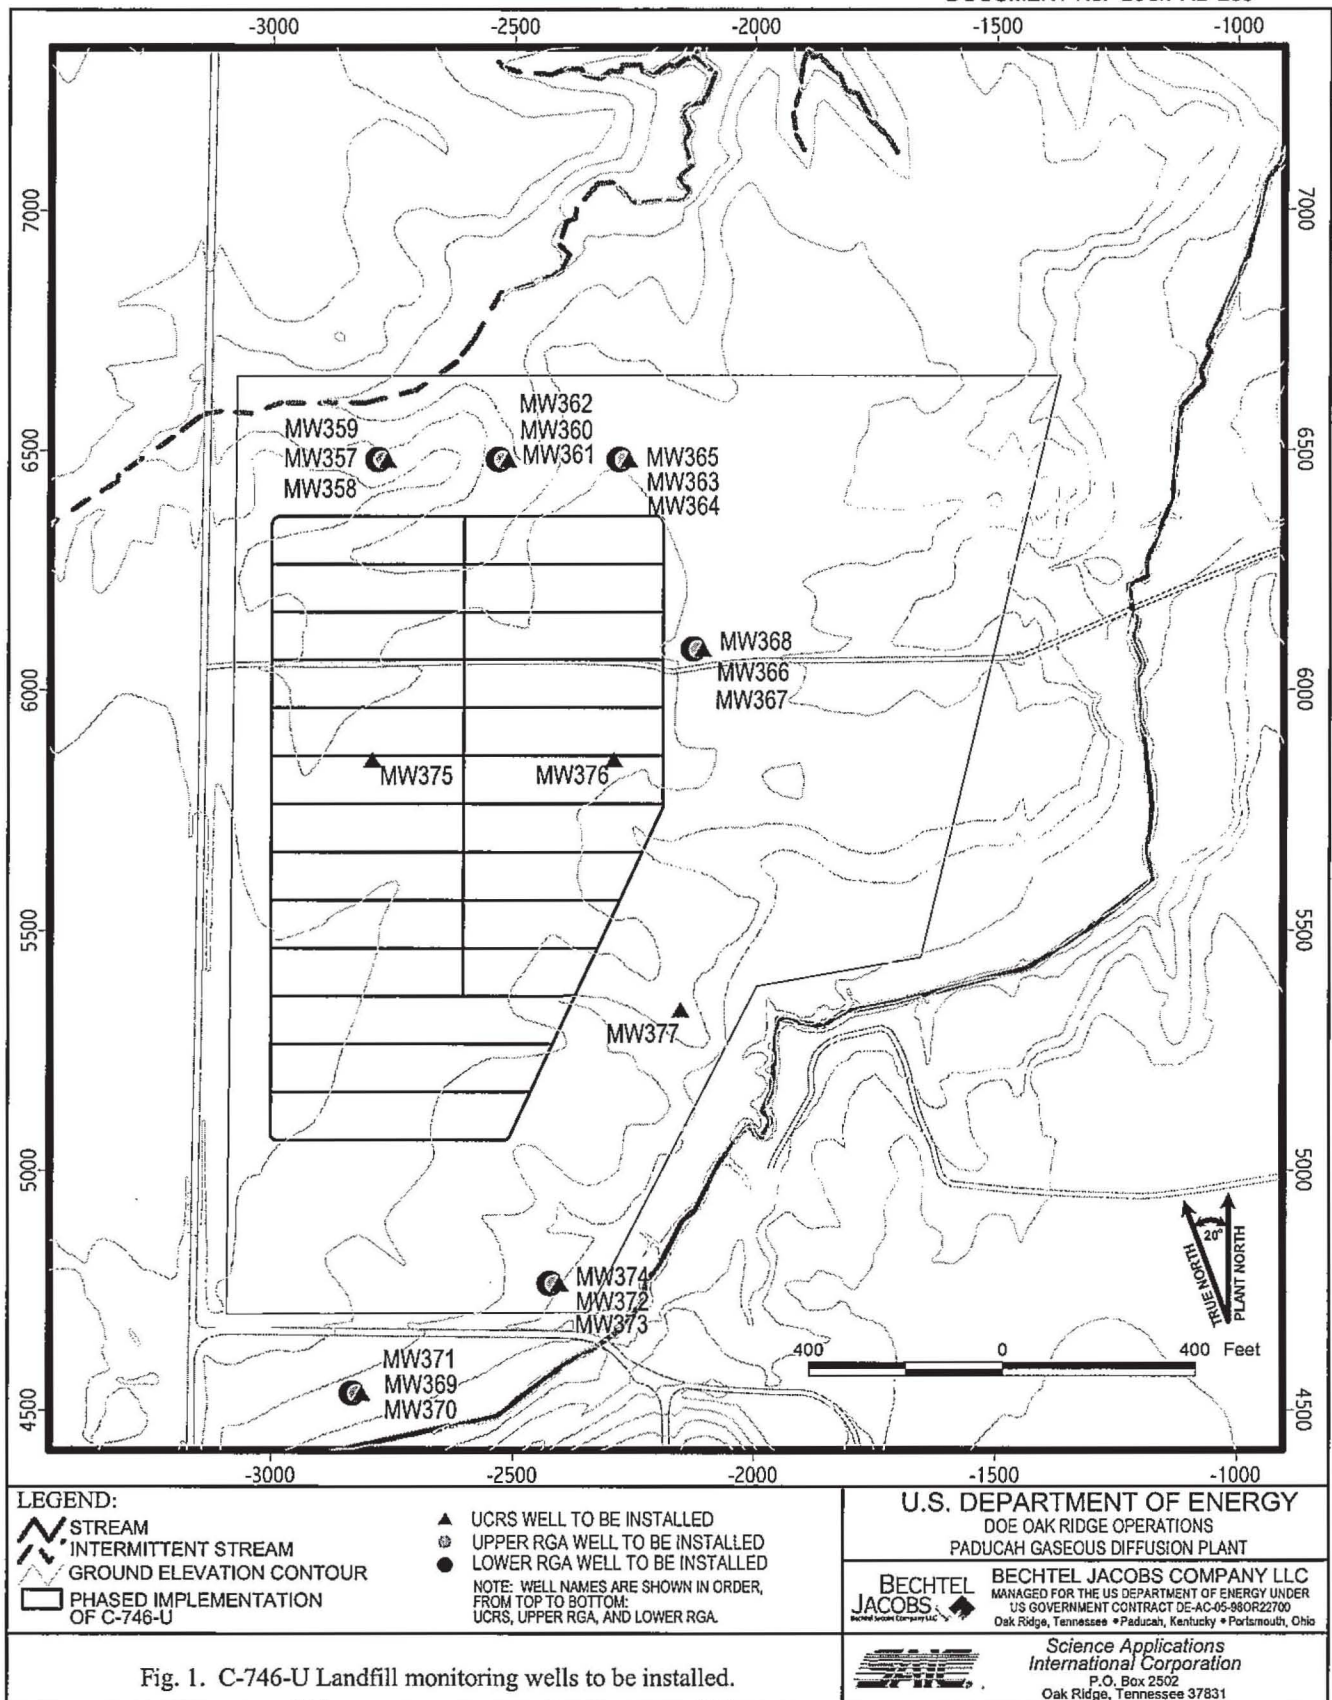
Fig. 1. C-746-U Landfill monitoring wells to be installed.

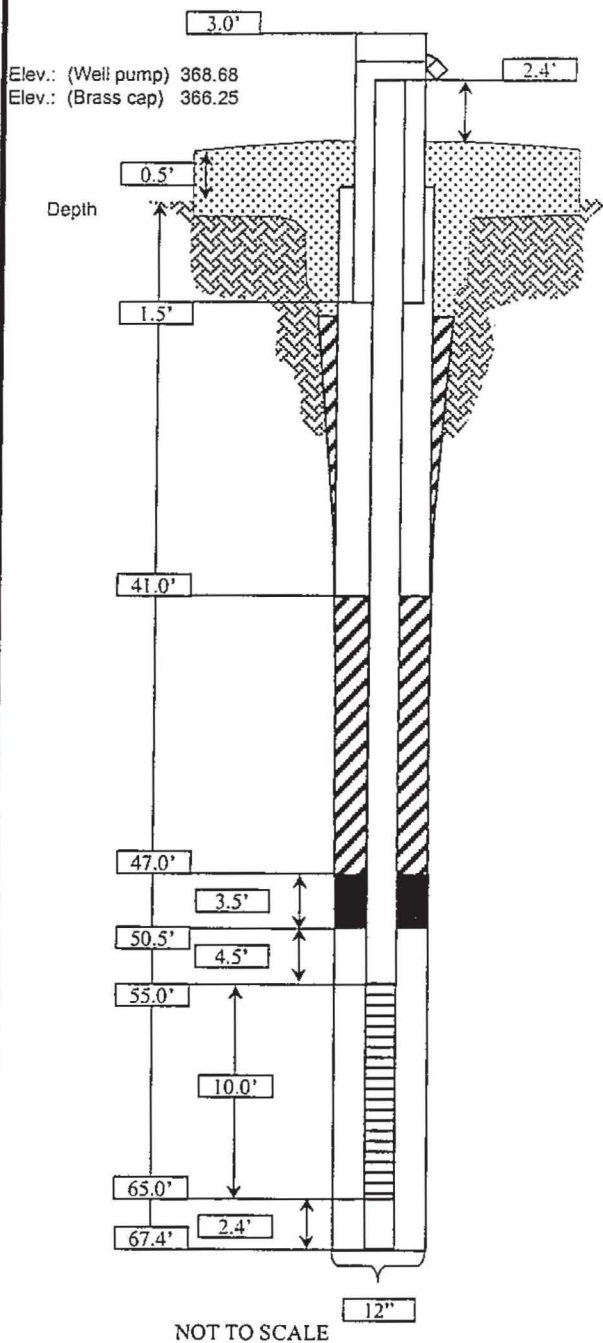
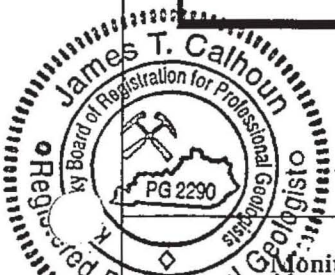
Monitoring Well 363 Construction Log

<b>Filter Pack</b> Graduation Designation: #1 Grain Size: Project File Type: DSI #1 Filter Sand Amt. Used: 750 lb Tremied (Y / N): Yes Source: Project File Grain Size Dist: Project File		
<b>Screen</b> Type: SCH 40 PVC Diameter: 4-in. Length: 10-ft Slot Size and Type: 0.010 Horizontal Slot Interval BGS: 55.0' - 65.0'		
<b>Isolation Casing (Y / N): Yes</b> Type: Steel Diameter: 14-in Total Length: 41.0'		
<b>Sump (Y / N): Yes</b> Interval BGS: 65.0' - 67.0' Bottom Cap (Y / N): Yes - 0.4-ft		
<b>Backfill Plug</b> Material: N/A Setup/Hydration Time: N/A Tremied (Y / N): N/A

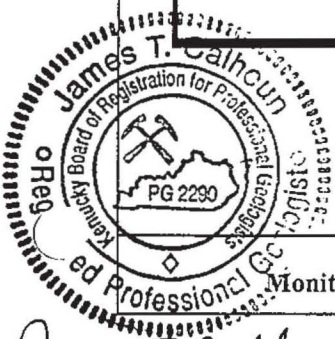
Monitoring Well 364 Construction Log

Well No. MW 364		Installation: N/A	
Project No.		Client/Project: BJC/C-746-U Well Abandonment/Replacement	
Contractor: SAIC		Drill Contractor: Miller Government Services	
Start Date: 2/21/2002		End Date: 3/5/2002	
(1025 M)		(1035 M)	
Well Coord: N 6535.89		W 2373.54	
<p>Elev.: (Well pump) 367.63 Elev.: (Brass cap) 365.95</p> <p>NOT TO SCALE</p>		<p><b>Protective Casing</b> Material Type: Steel Diameter: 10-in. Depth BGS: 1.6' Guard Posts (Y / N): Yes No: 4 Type: Steel</p> <p><b>Surface Pad</b> Composition and Size: 4-ft x 4-ft Concrete Pad</p> <p><b>Riser Pipe</b> Type: SCH 40 PVC Diameter: 4-in. Total Depth (TOR to TOS): 75.2' Ventilated Cap (Y / N): Yes</p> <p><b>Grout</b> Composition &amp; Proportions: High Solids Bentonite Grout Type: Pure Gold Weight (lbs/gal.): 10.0 % Solids: 30 Tremied (Y / N): Yes Interval BGS: 0.0' - 65.5'</p> <p><b>Centralizers (Y / N): Yes</b> Depth(s): 84.0'</p> <p><b>Seal</b> Type: 3/8-inch TR 30 Bentonite Pellets Source: Pel-Plug Setup/Hydration Time: 17 hr Tremied (Y / N): Yes Vol. Fluid Added: N/A</p> <p><b>Filter Pack</b> Graduation Designation: #1 Grain Size: Project File Type: DSI #1 Filter Sand Amt. Used: 750 lb Tremied (Y / N): Yes Source: Project File Grain Size Dist: Project File</p> <p><b>Screen</b> Type: SCH 40 PVC Diameter: 4-in. Length: 10-ft Slot Size and Type: 0.010 Horizontal Slot Interval BGS: 73.0' - 83.0'</p> <p><b>Isolation Casing (Y / N): Yes</b> Type: Steel Diameter: 14-in Total Length: 41.0'</p> <p><b>Sump (Y / N): Yes</b> Interval BGS: 83.0' - 85.0' Bottom Cap (Y / N): Yes - 0.4-ft</p> <p><b>Backfill Plug</b> Material: N/A Setup/Hydration Time: N/A Tremied (Y / N): N/A</p>

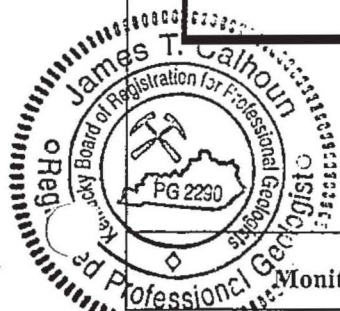
Monitoring Well 365 Construction Log

<b>Filter Pack</b> Graduation Designation: #1 Grain Size: Project File Type: DSI #1 Filter Sand Amt. Used: 1000 lb Tremied (Y / N): No Source: Project File Grain Size Dist: Project File		
<b>Screen</b> Type: SCH 40 PVC Diameter: 4-in. Length: 10-ft Slot Size and Type: 0.010 Horizontal Slot Interval BGS: 32.0' - 42.0'		
<b>Isolation Casing (Y / N): No</b> Type: N/A Diameter: N/A Total Length: N/A		
<b>Sump (Y / N): Yes</b> Interval BGS: 42.0' - 44.0' Bottom Cap (Y / N): Yes - 0.4-ft		
<b>Backfill Plug</b> Material: Pel-Plug 3/8-inch TR30 Bentonite Pellets Setup/Hydration Time: 17.5 hr Tremied (Y / N): No
