PPPO-02-4381974-17A

**TRANSMITTAL OF ERRATA PAGES AND COMPLETE CORRECTED DOCUMENT
FOR THE C-400 VAPOR INTRUSION STUDY WORK PLAN TO SUPPORT THE
ADDITIONAL ACTIONS FOR THE COMPREHENSIVE ENVIRONMENTAL
RESPONSE, COMPENSATION, AND LIABILITY ACT FIVE-YEAR REVIEW AT
THE PADUCAH GASEOUS DIFFUSION PLANT, PADUCAH, KENTUCKY
(DOE/LX/07-2403&D2/R1)**

**C-400 Vapor Intrusion Study Work Plan to Support the
Additional Actions for the
CERCLA Five-Year Review
at the Paducah Gaseous Diffusion Plant,
Paducah, Kentucky**

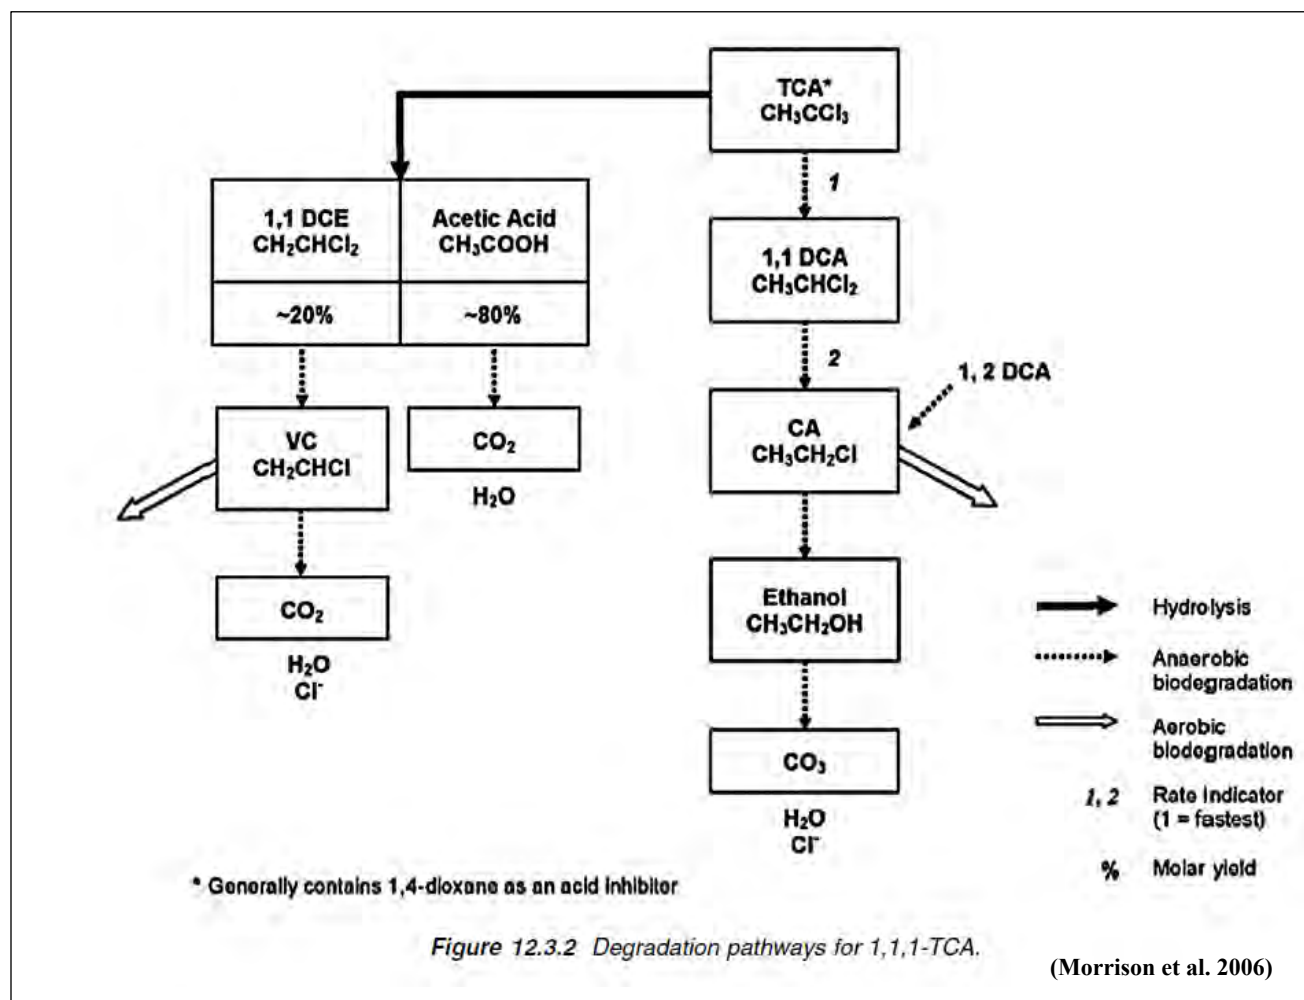
Figure 6. Degradation Pathways for TCA

TCA degradation also is well understood [see Figure 6 (Figure 12.3.2 from Morrison et al. 2006), http://announce.exponent.com/practice/environmental/ef/morrison_murphy.pdf] and occurs much more rapidly in the environment than TCE degradation. TCA degradation products also degrade rapidly. Often, the only evidence of TCA migration to the environment is the detection of the presence of 1,4-dioxane. 1,4-dioxane is miscible with water and thus provides an essentially unattenuated plume front indicator of historical TCA contamination. However, its miscibility also allows effective transport downward and away from the source via a groundwater pathway.

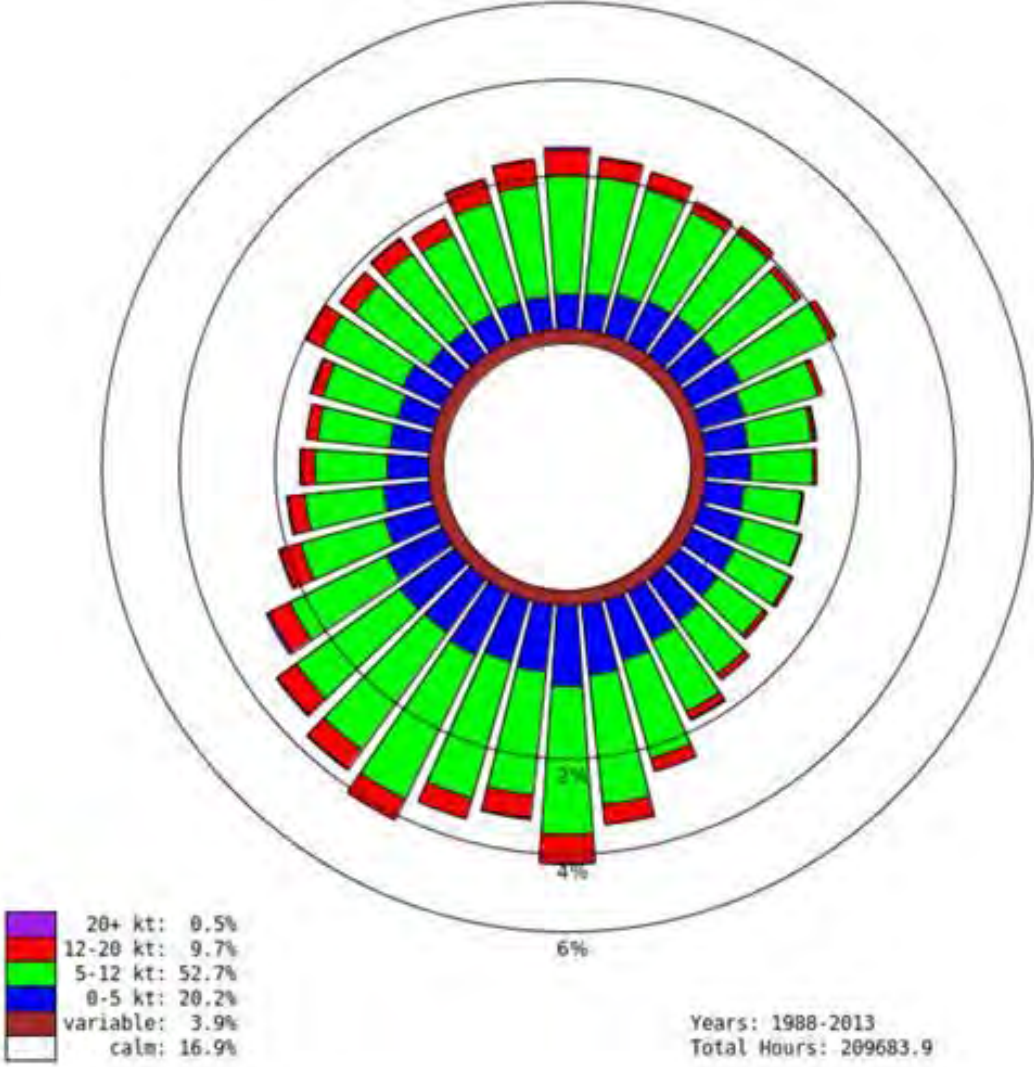
Figure 15. Wind Rose for the Barkley Airport, Paducah, Kentucky

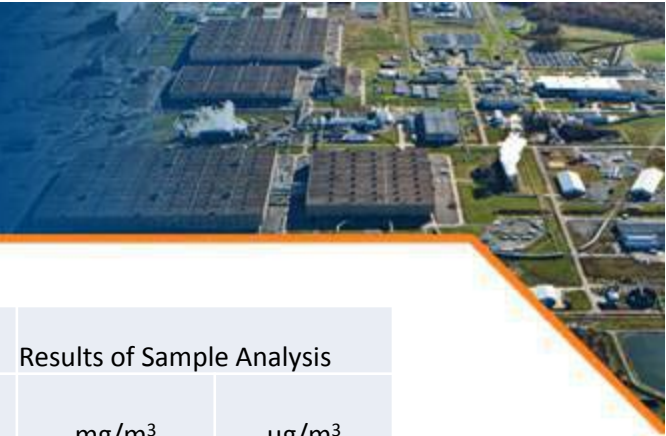
Location of Sample	Mass of TCE	Volume of Sample	Results of Sample Analysis	
	mg	m ³	mg/m ³	µg/m ³
Laundry Break Area	<0.010	0.01855	<0.539	<539
South East Corner of Office	<0.010	0.018304	<0.546	<546
Boundry Control Station Near Cylinder Wash	<0.010	0.017791	<0.562	<562
Basement Fan Room Catwalk	<0.010	0.016442	<0.608	<608

- ❑ All results non-detect but MDLs higher than Adjusted VISL Values
- ❑ Adapted from National Institute of Occupational Safety and Health (NIOSH) Method 1022
 - ❑ Measured volume of breathing zone air pulled through charcoal tube
 - ❑ TCE extracted into solvent and injected into Gas Chromatograph

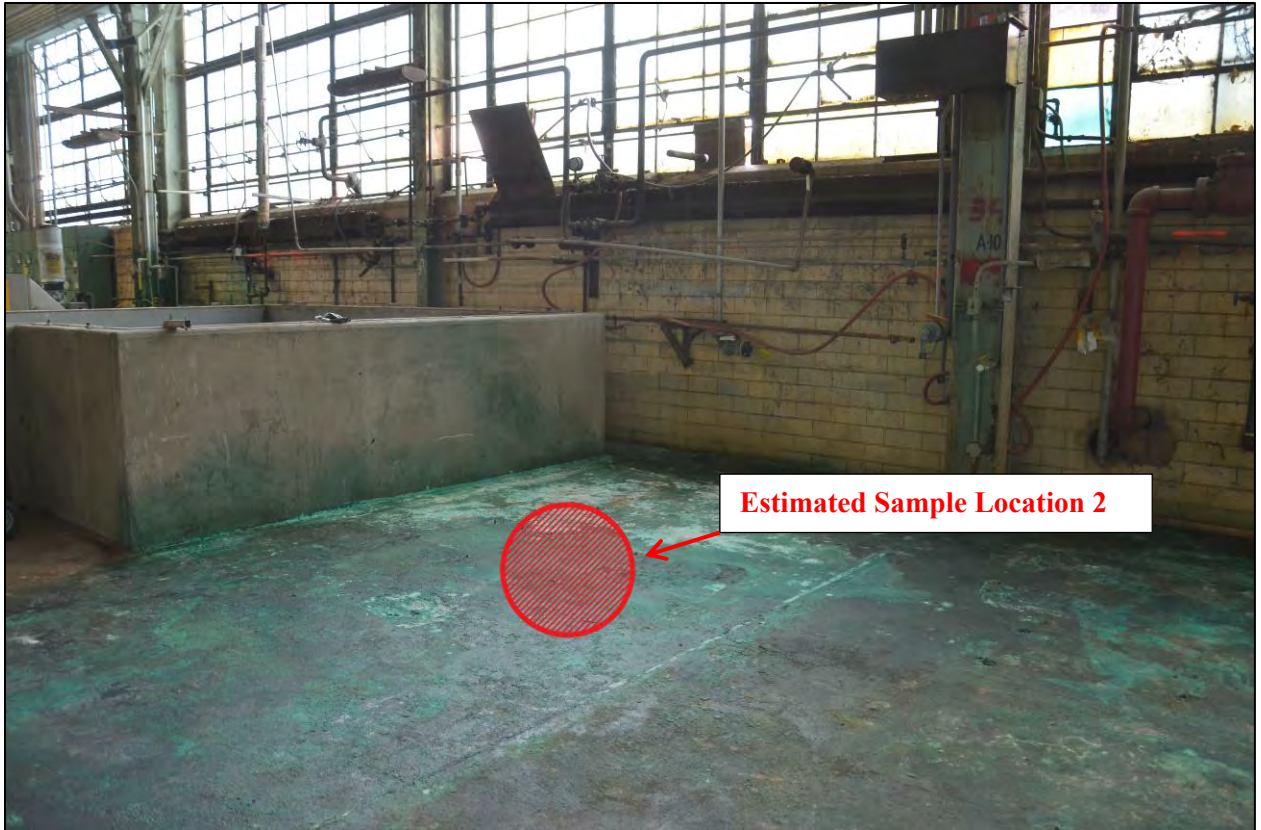
Figure D.2. Sample Location 2, Deteriorated Concrete near Column A10

Recent walkthroughs of C-400 indicate the integrity of the floor slab appears to be generally good, but did identify deteriorated concrete in the central west portion of the building that may serve as a conduit to subsurface vapors. Due to the size (approximately $144,000 \text{ ft}^2$) and complexity of C-400, identifying the specific locations of other potential VI conduits is not practicable. Instead, DOE assumes that both a subsurface source of TCE and preferential pathways for VI exist at C-400, and, for risk assessment and risk management purposes, assumes that any measured indoor air exceedances of the TCE VISL value are attributable to VI.
