TRANSMITTAL OF C-400 VAPOR INTRUSION STUDY WORK PLAN TO SUPPORT THE ADDITIONAL ACTIONS FOR THE COMPREHENSIVE ENVIRONMENTAL RESPONSE, COMPENSATION, AND LIABILITY ACT FIVE-YEAR REVIEW AT THE PADUCAH GASEOUS DIFFUSION PLANT, PADUCAH, KENTUCKY (DOE/LX/07-2403&D2/R1)

DOE/LX/07-2403&D2/R1
Secondary Document

**C-400 Vapor Intrusion Study Work Plan to Support the
Additional Actions for the
CERCLA Five-Year Review
at the Paducah Gaseous Diffusion Plant,
Paducah, Kentucky**

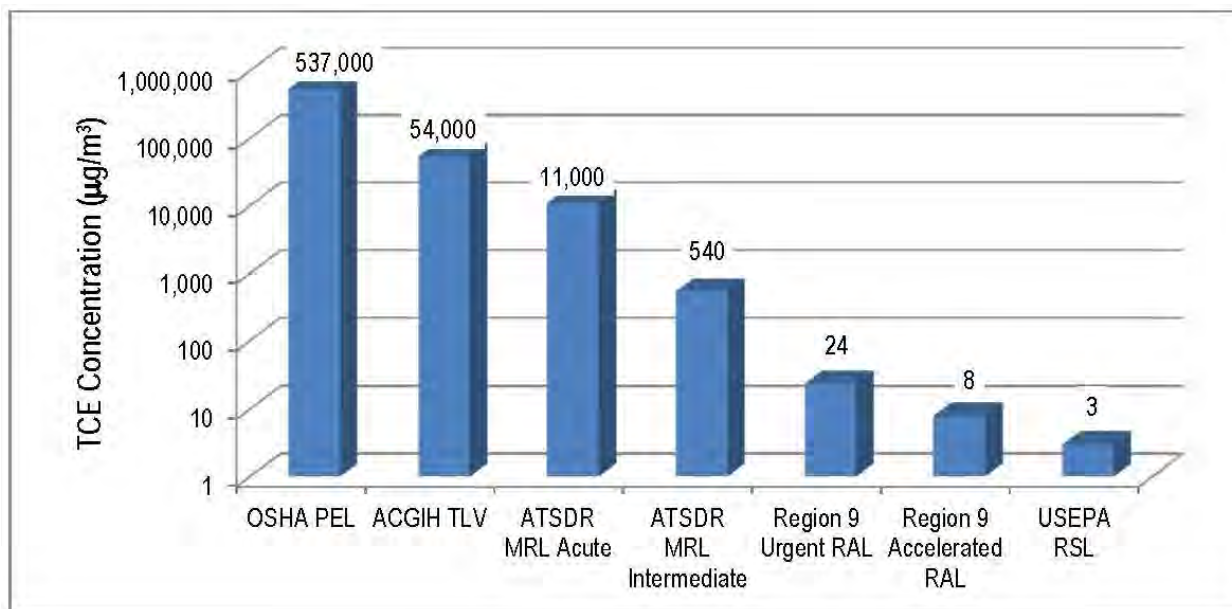
Figure 16. TCE Regulatory Levels for Commercial Industrial Scenarios (SERDP-ESTCP 2016)
 (Note: EPA RSL = EPA VISL for commercial settings)

The results will also be compared to other benchmarks if the VI pathway is determined to be complete. As described in a recent Strategic Environmental Research and Development Program-Environmental Security Technology Certification Program VI seminar (SERDP-ESTCP 2016), a number of commercial/industrial screening levels are available for TCE (Figure 16), including those intended for industrial hygiene applications such as Occupational Safety and Health Administration permissible exposure limits (PELs) of 537,000 $\mu\text{g}/\text{m}^3$ and the ACGIH threshold limit value of 54,000 $\mu\text{g}/\text{m}^3$. EPA's commercial indoor air VISL of 3.0 $\mu\text{g}/\text{m}^3$ is the same as EPA's commercial regional screening level of 3.0 $\mu\text{g}/\text{m}^3$. Both are based on default commercial worker exposure conditions and correspond to a 1×10^{-6} carcinogenic risk (for a 25-year exposure duration, 250 days per year exposure frequency, and 8 hour per day exposure time) which is less than the level corresponding to a hazard quotient of 1.0. Under differing site-specific conditions, where workers may be subject to different exposure durations, other target levels may be applicable. EPA's toxicity values and the CERCLA risk range will be used to make risk evaluation and risk management decisions using the data generated from this approved Work Plan.

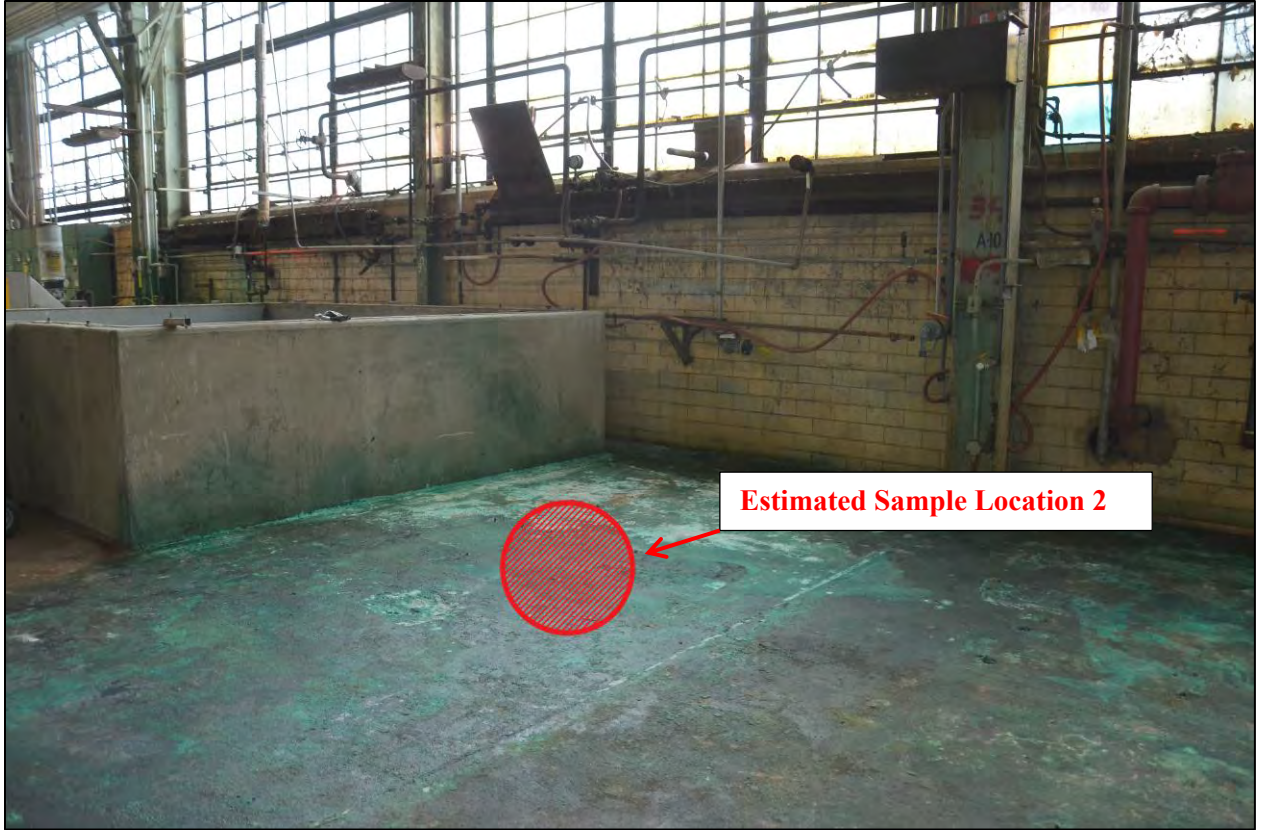
Figure D.2. Sample Location 2, Deteriorated Concrete near Column A10

Recent walkthroughs of C-400 indicate the integrity of the floor slab appears to be generally good, but did identify deteriorated concrete in the central west portion of the building that may serve as a conduit to subsurface vapors. Due to the size (approximately $144,000 \text{ ft}^2$) and complexity of C-400, identifying the specific locations of other potential VI conduits is not practicable. Instead, DOE assumes that both a subsurface source of TCE and preferential pathways for VI exist at C-400, and, for risk assessment and risk management purposes, assumes that any measured indoor air exceedances of the TCE VISL value are attributable to VI.

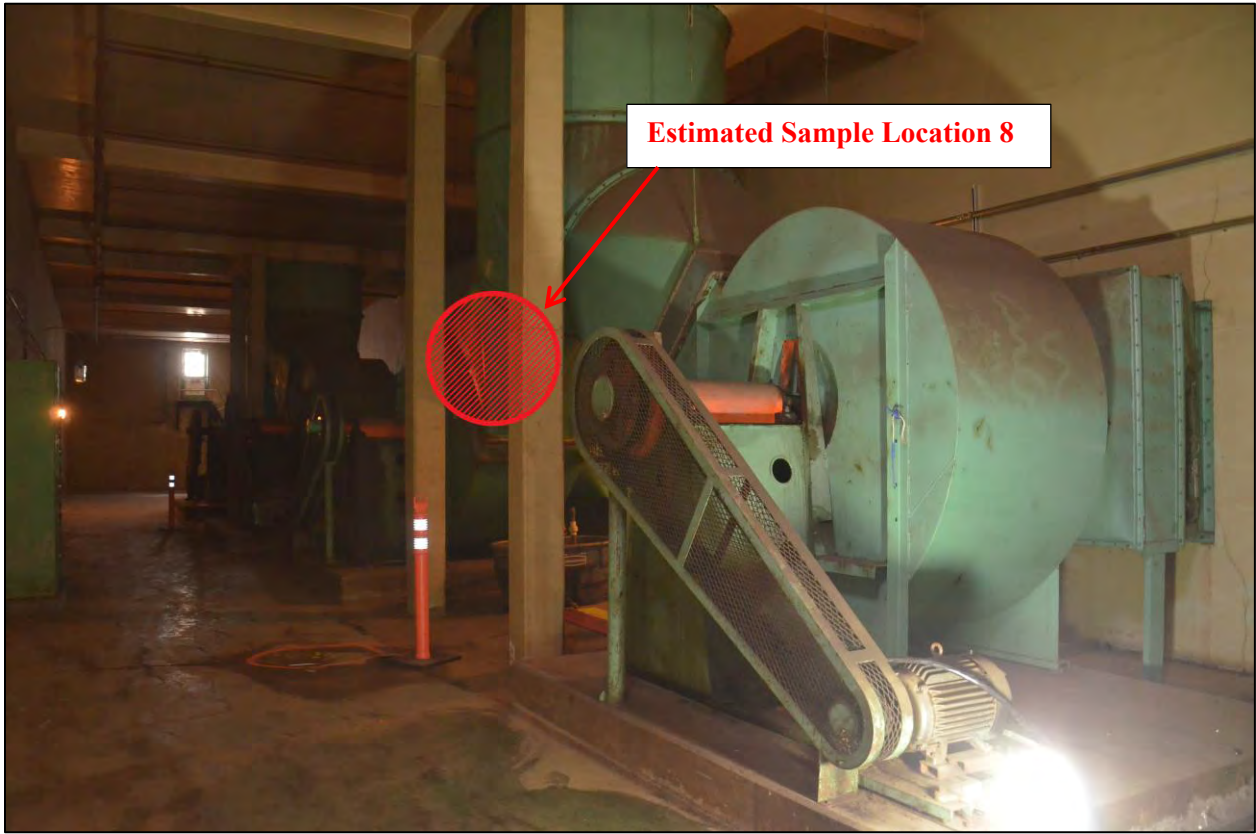
Figure D.8. Sample Location 8, Basement Fan Room Intake/Exhaust Plenum Fans 88/89

C-400 currently is ventilated with one of two available fans (~ 41,000 cfm design) located in a basement room in which proposed indoor air samples are located. The fans draw air through a below grade concrete plenum that is a potential entry point for VI. Comparison of the concentrations obtained from the exhaust fan samples will be compared to the other concentrations to determine if the plenum or other areas serve as points of vapor entry.
