**Groundwater Assessment Report
for the C-746-U Landfill at the
Paducah Gaseous Diffusion Plant,
Paducah, Kentucky**

Date Issued—May 2013

Prepared for the
U.S. DEPARTMENT OF ENERGY
Office of Environmental Management

Prepared by
LATA ENVIRONMENTAL SERVICES OF KENTUCKY, LLC
managing the
Environmental Remediation Activities at the
Paducah Gaseous Diffusion Plant
under contract DE-AC30-10CC40020

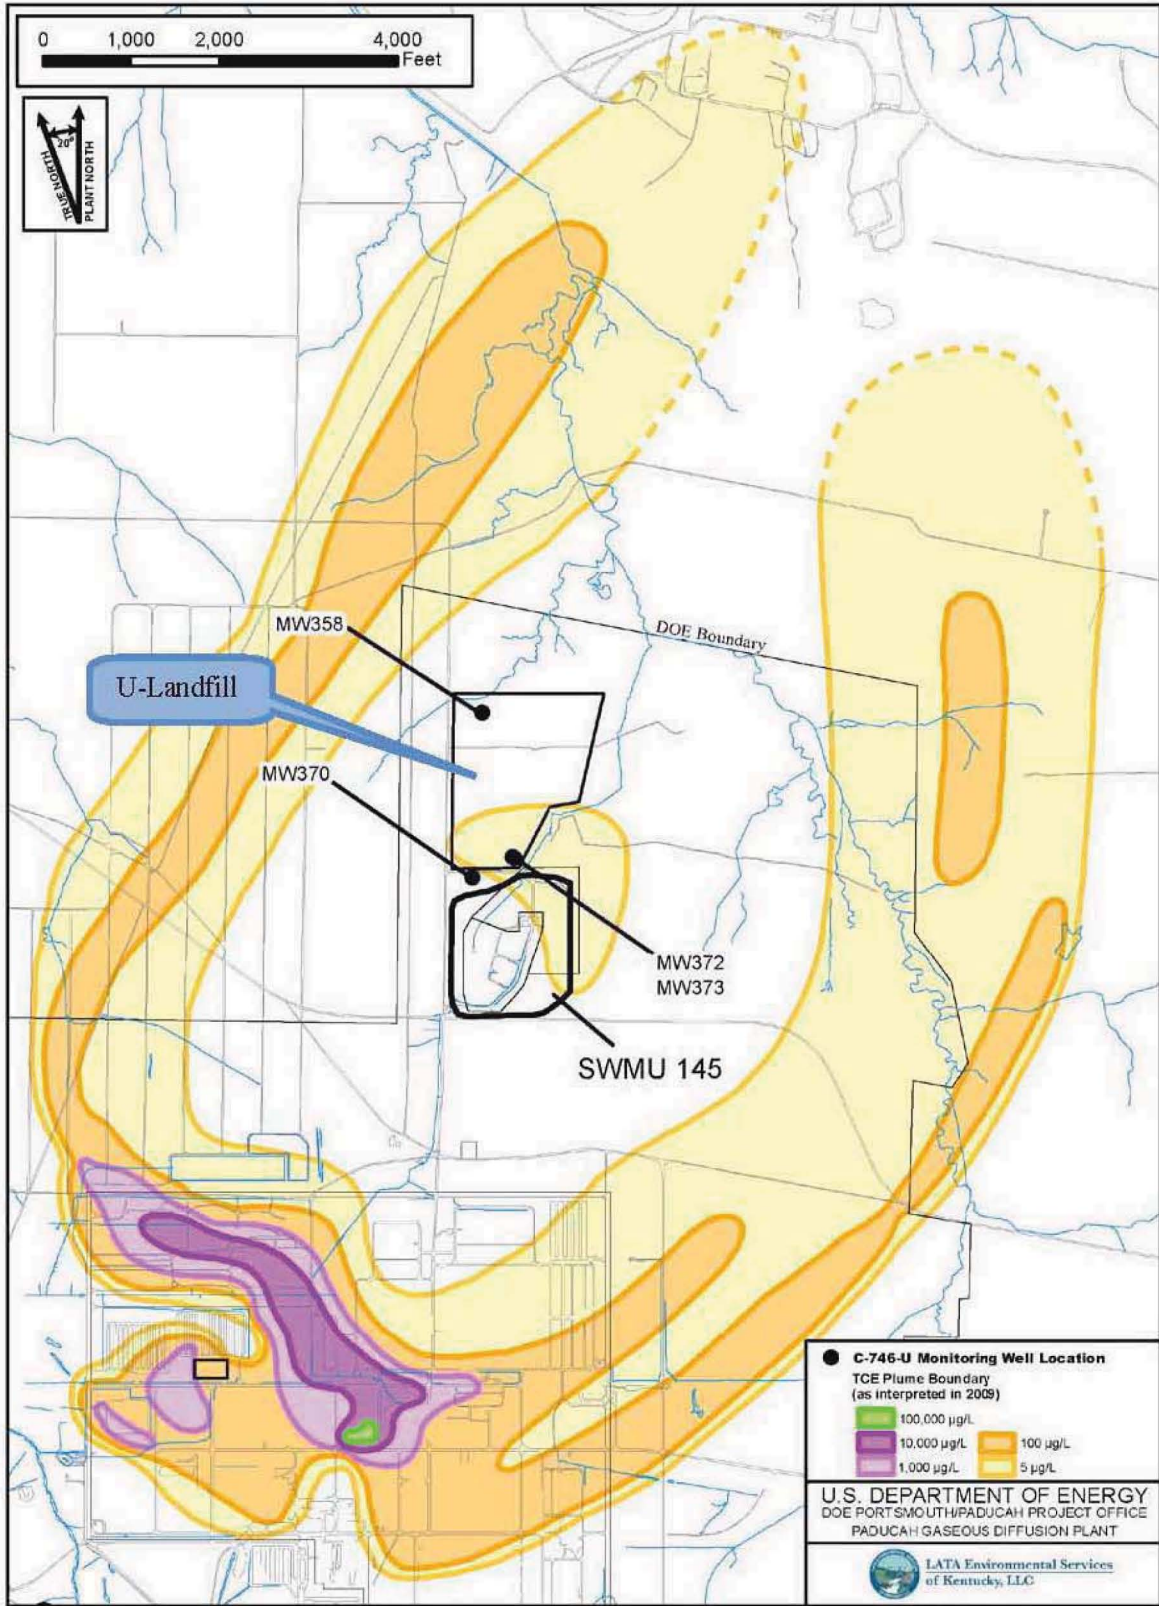
Figure 1. Location of the U-Landfill Depicted Relative to 2009 RGA TCE Plume Map

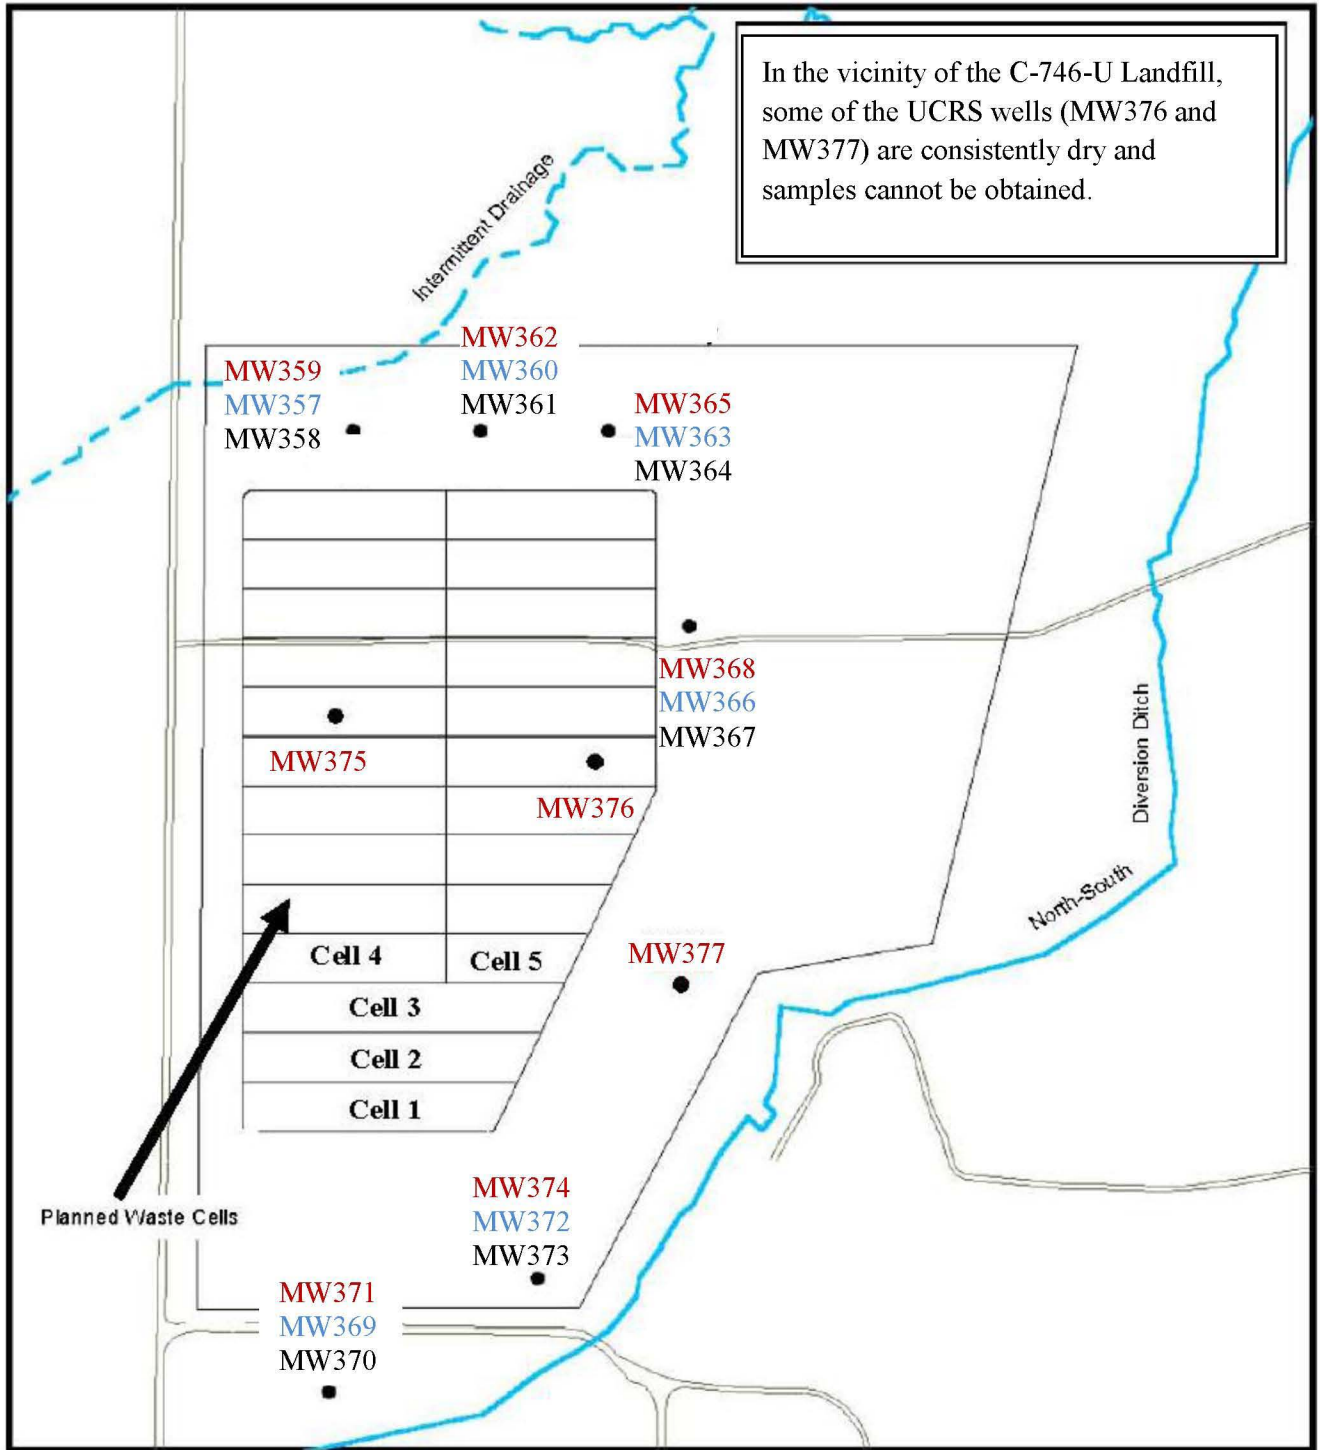
Figure 2 is a map of the C-746-U Landfill and the MWs located in the vicinity of the C-746-U Landfill. Soil boring logs, MW and piezometer water level records, soil geotechnical tests, and groundwater flow models of the area of the C-746-U Landfill provide sufficient data for the development of a Conceptual Site Model (CSM), described in Section 5. In general, groundwater flow is downward through the silts, clays, and fine sands of the Upper Continental Recharge System (UCRS). In contrast, the underlying Regional Gravel Aquifer (RGA) is conductive and provides the main conduit for lateral groundwater flow. Groundwater flow is in a north-northeasterly direction in the vicinity of the C-746-U Landfill. The Ohio River and lower reaches of Little Bayou and Bayou Creeks are the discharge areas for the RGA flow system.

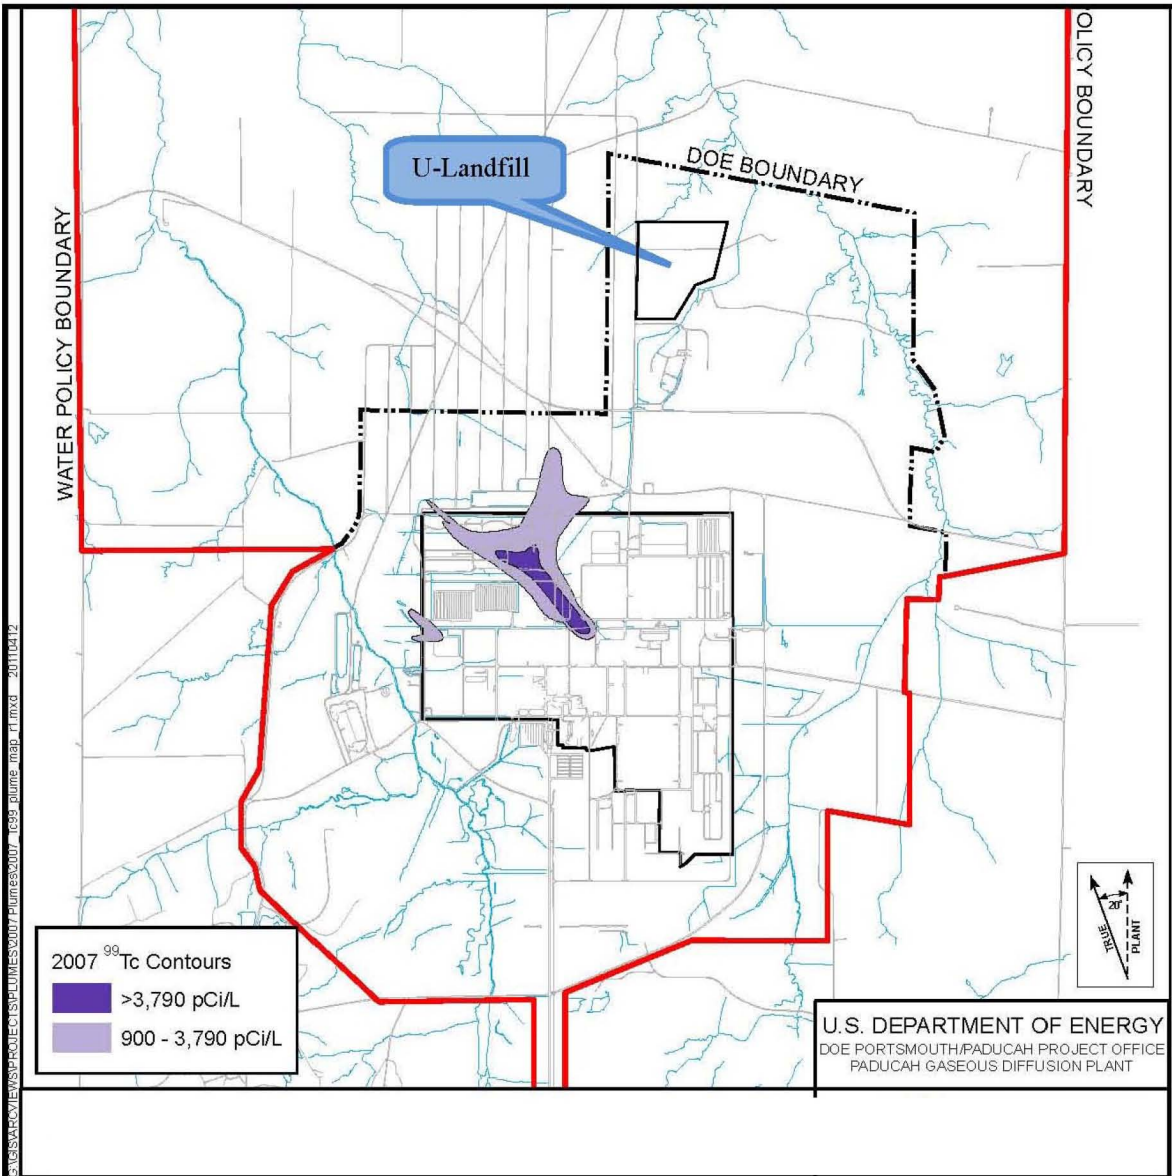
Tc-99 is a beta emitter. There is Tc-99 present in RGA groundwater at the PGDP site, as shown in Figure 3 (plume map established relative to the derived EPA MCL of 900 pCi/L). NOTE: Figure 3 also demonstrates that the C-746-U Landfill is located well within the boundaries of the Water Policy Box.

Figure 3. Location of C-746-U Landfill Relative to 2009 Tc-99 RGA Plume Map and Water Policy Boundary

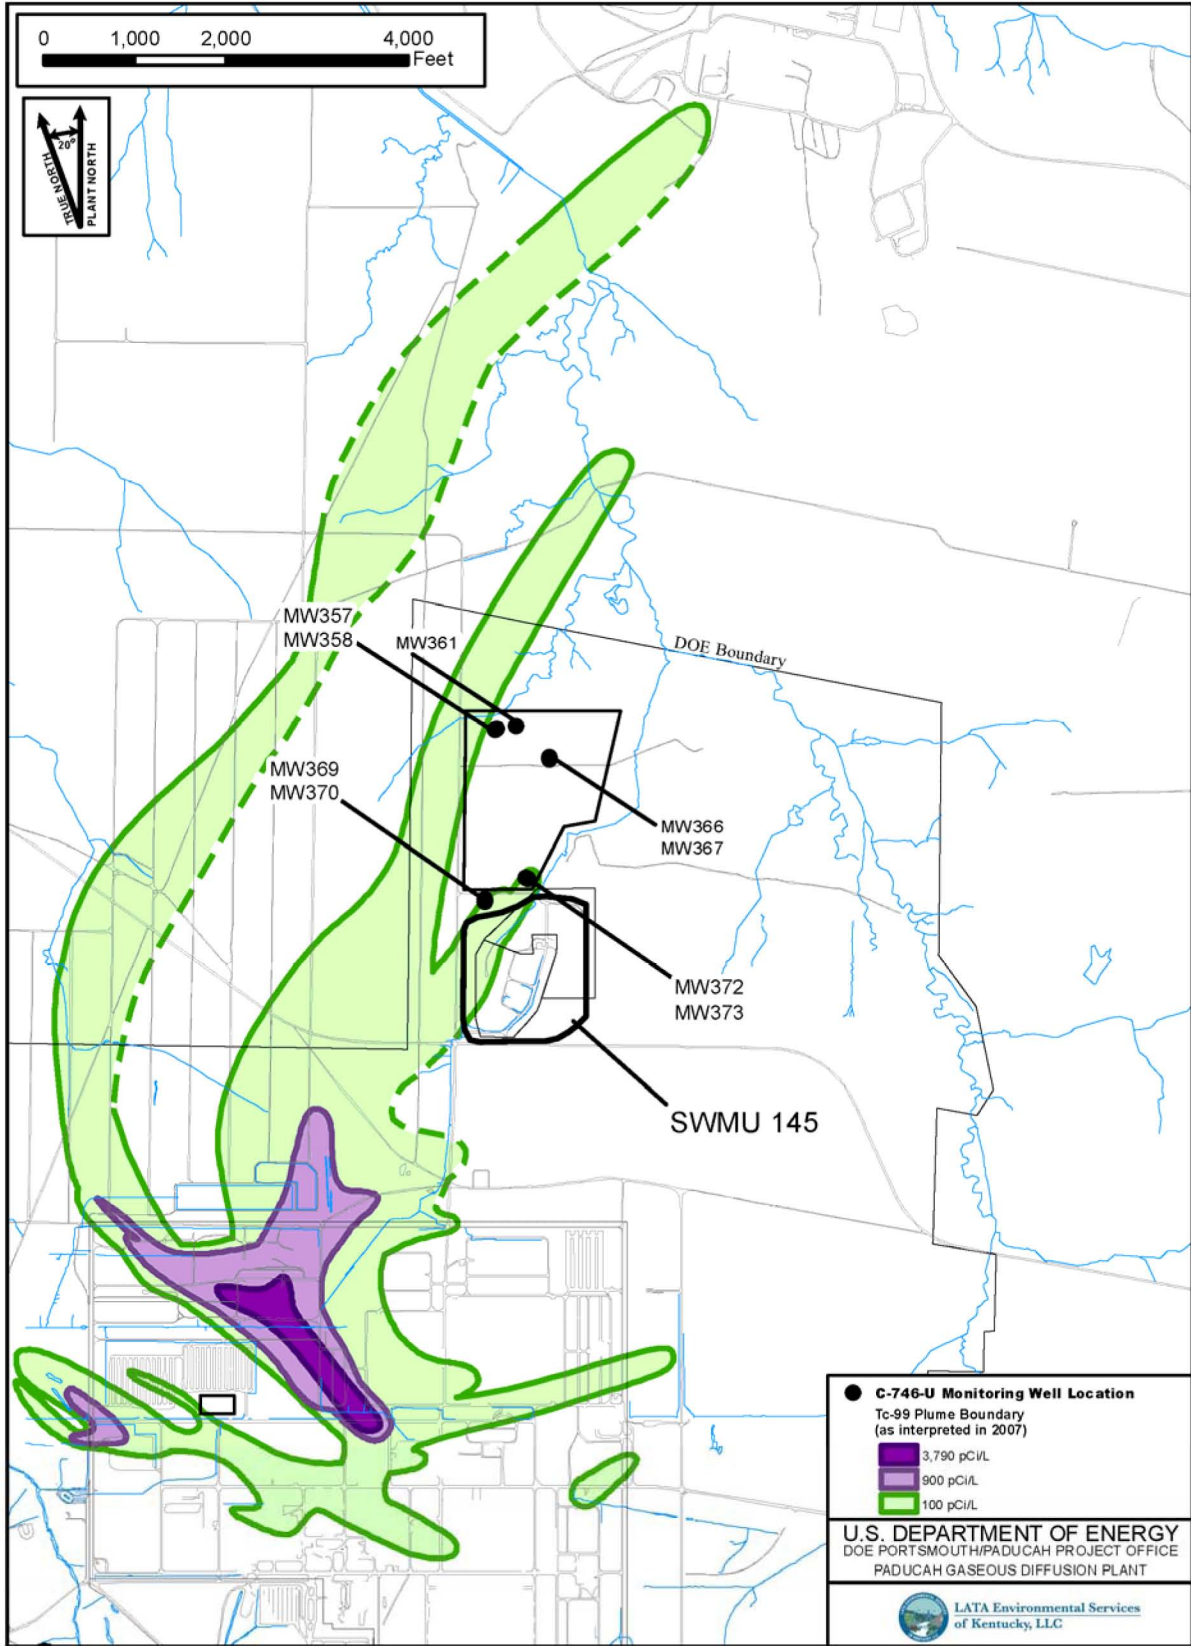
Figure 4. Technetium-99 Contours for the RGA

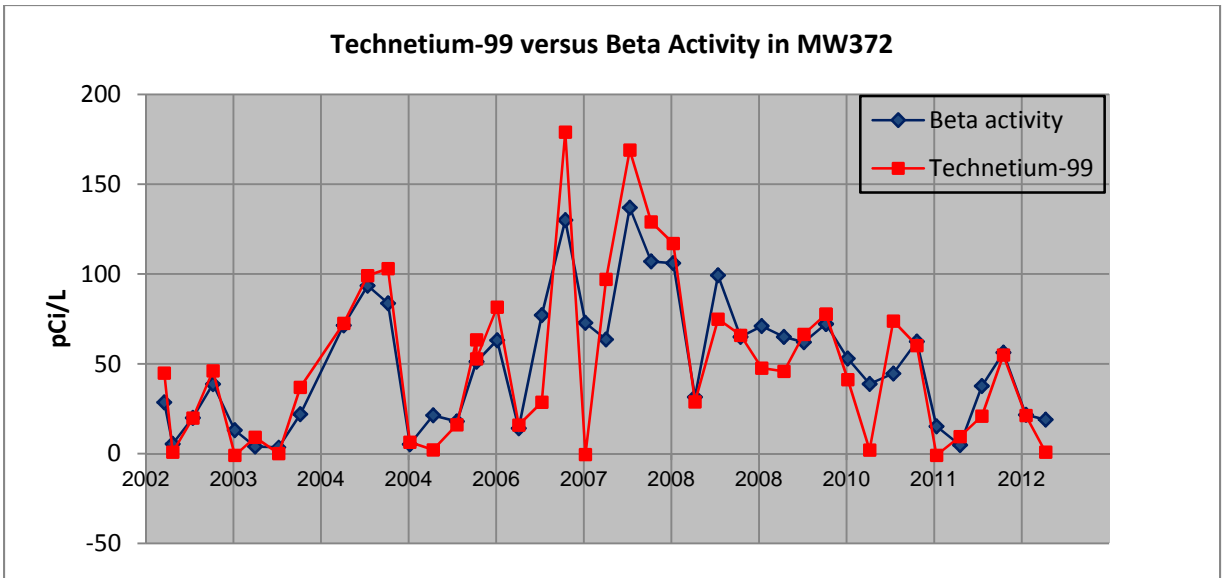
Figure 5. Technetium-99 versus Beta Activity in MW372 at the C-746-U Landfill

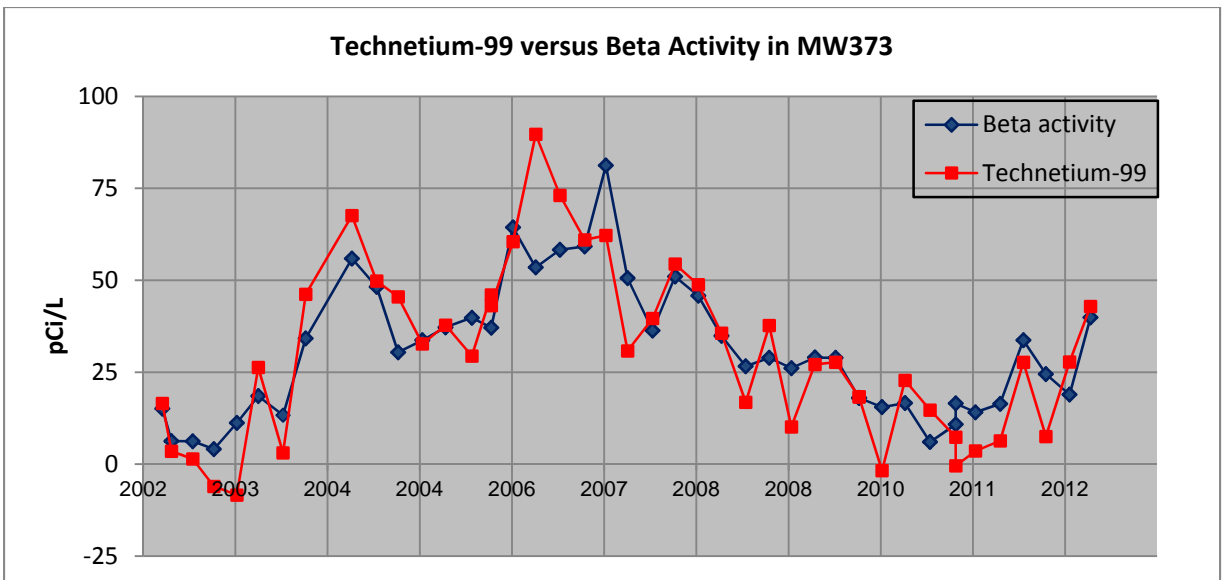
Figure 6. Technetium-99 versus Beta Activity in MW373 at the C-746-U Landfill

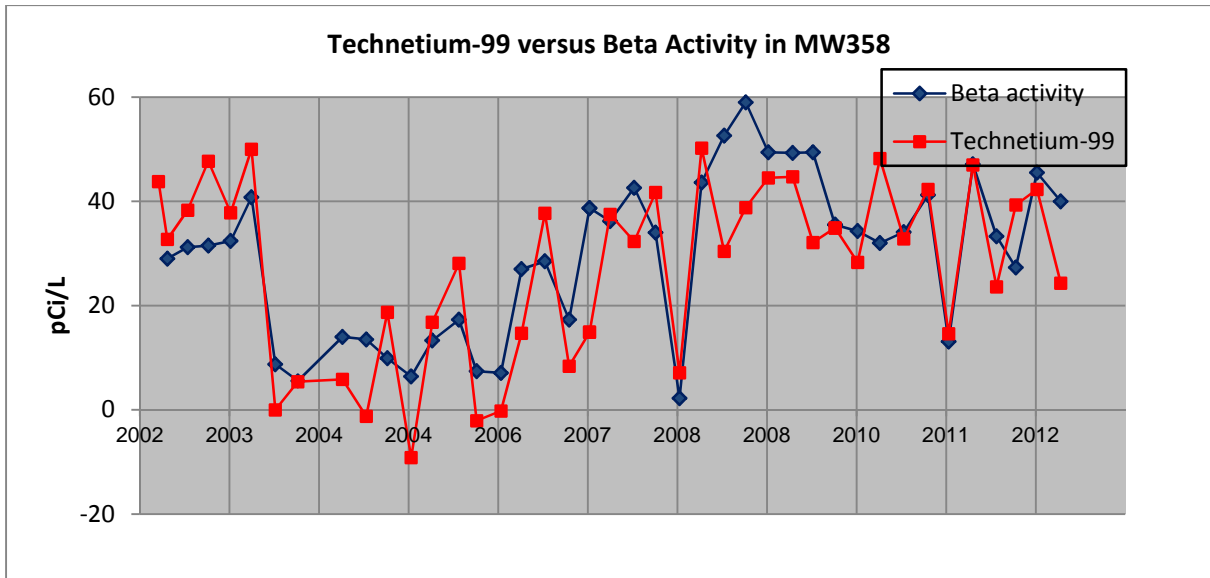
Figure 7. Technetium-99 versus Beta Activity in MW358 at the C-746-U Landfill

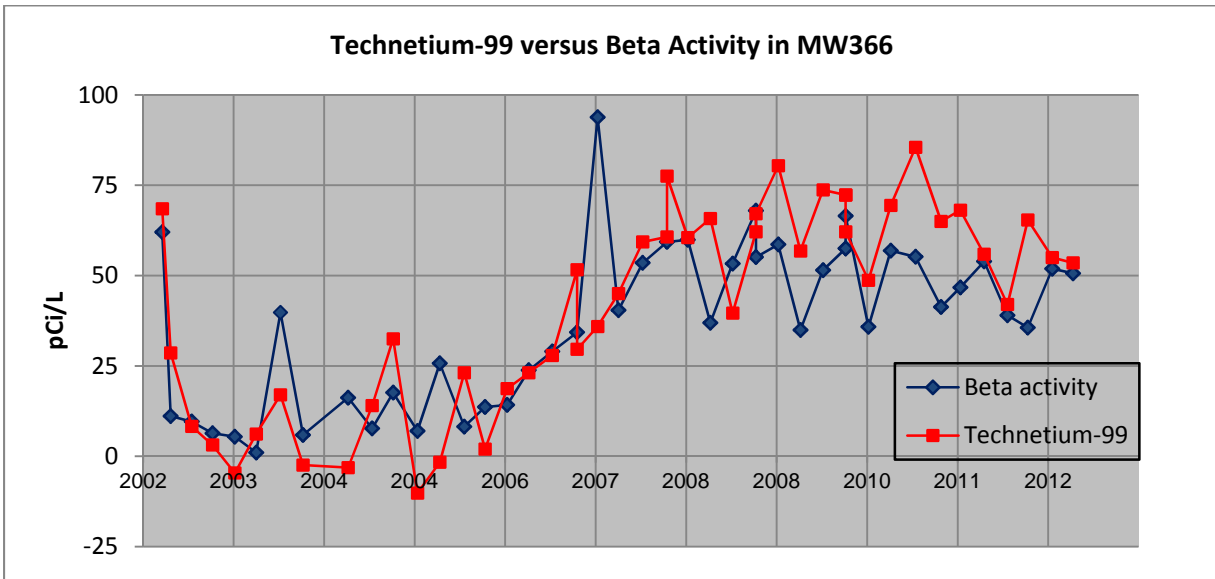
Figure 8. Technetium-99 versus Beta Activity in MW366 at the C-746-U Landfill

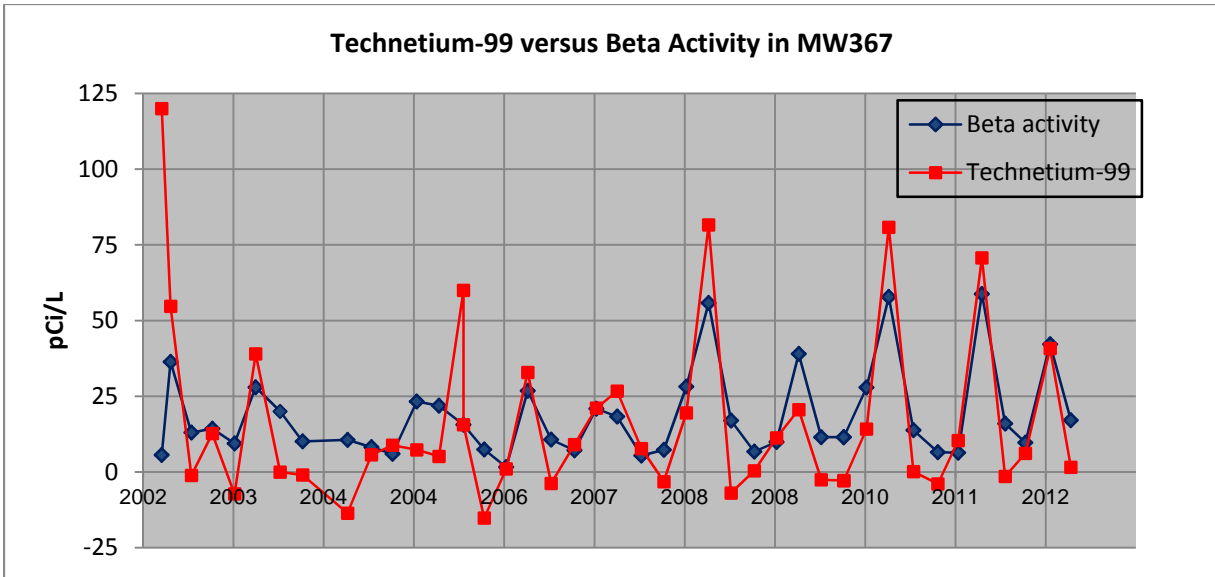
Figure 9. Technetium-99 versus Beta Activity in MW367 at the C-746-U Landfill

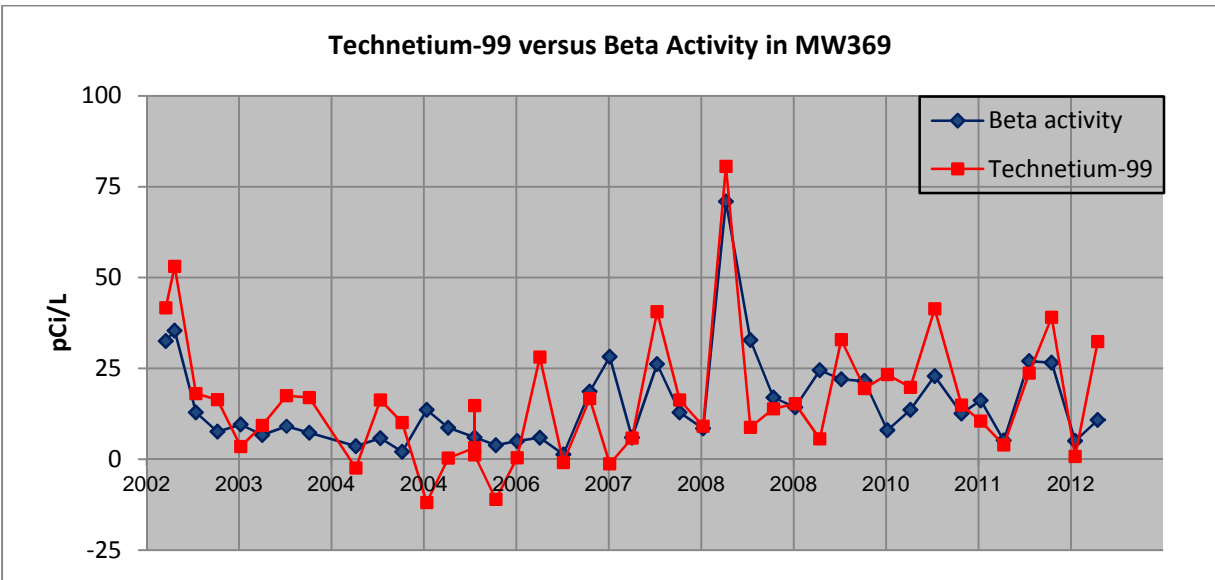
Figure 10. Technetium-99 versus Beta Activity in MW369 at the C-746-U Landfill

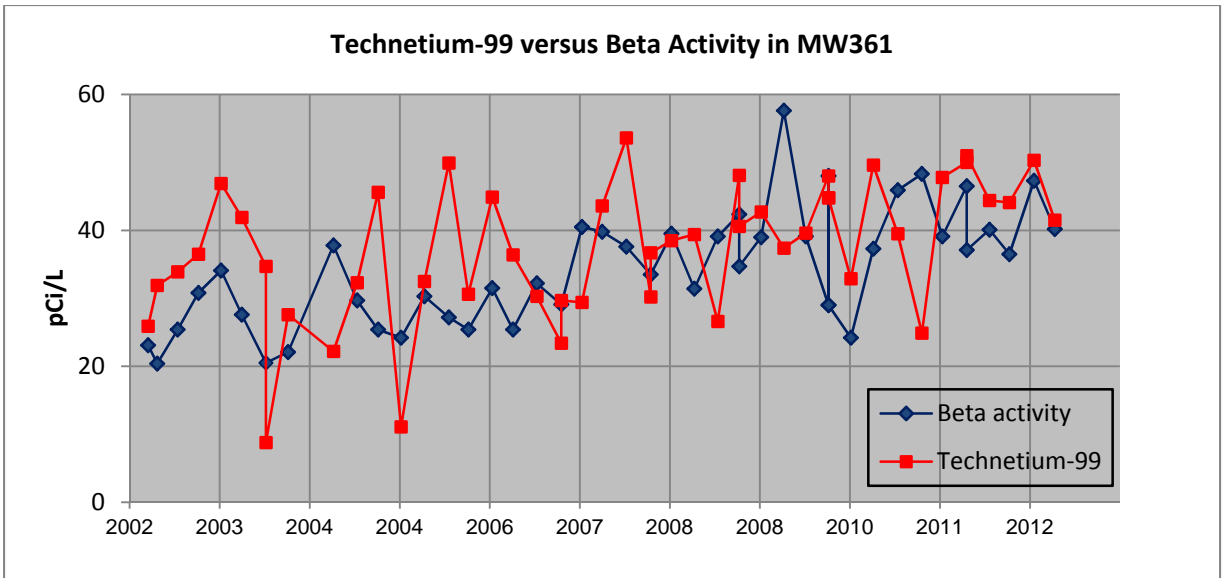
Figure 11. Technetium-99 versus Beta Activity in MW361 at the C-746-U Landfill

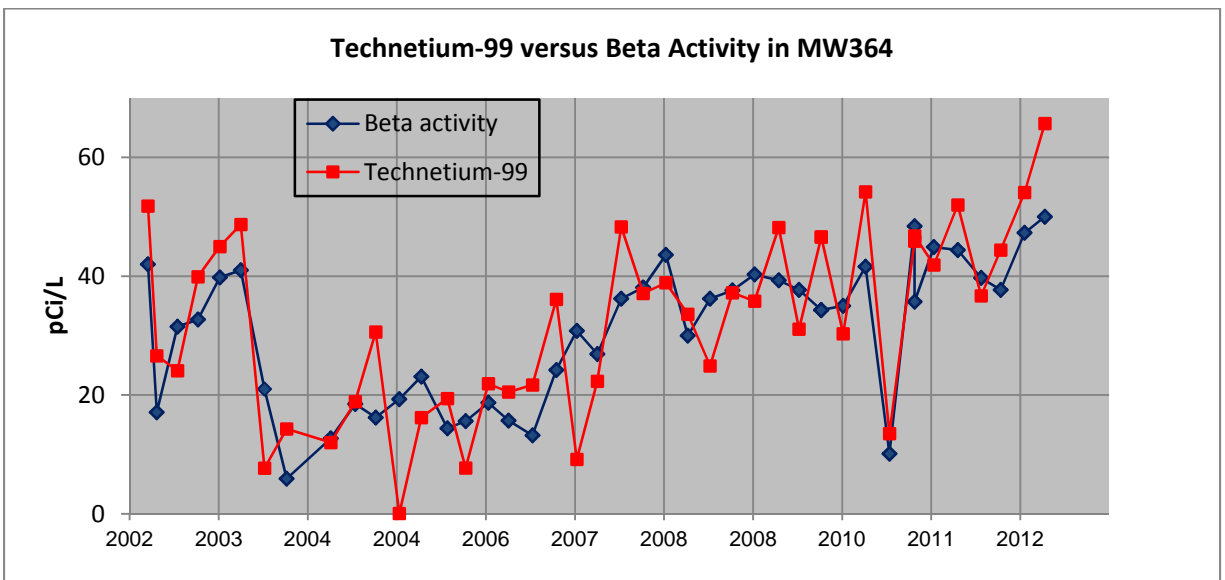
Figure 12. Technetium-99 versus Beta Activity in MW364 at the C-746-U Landfill

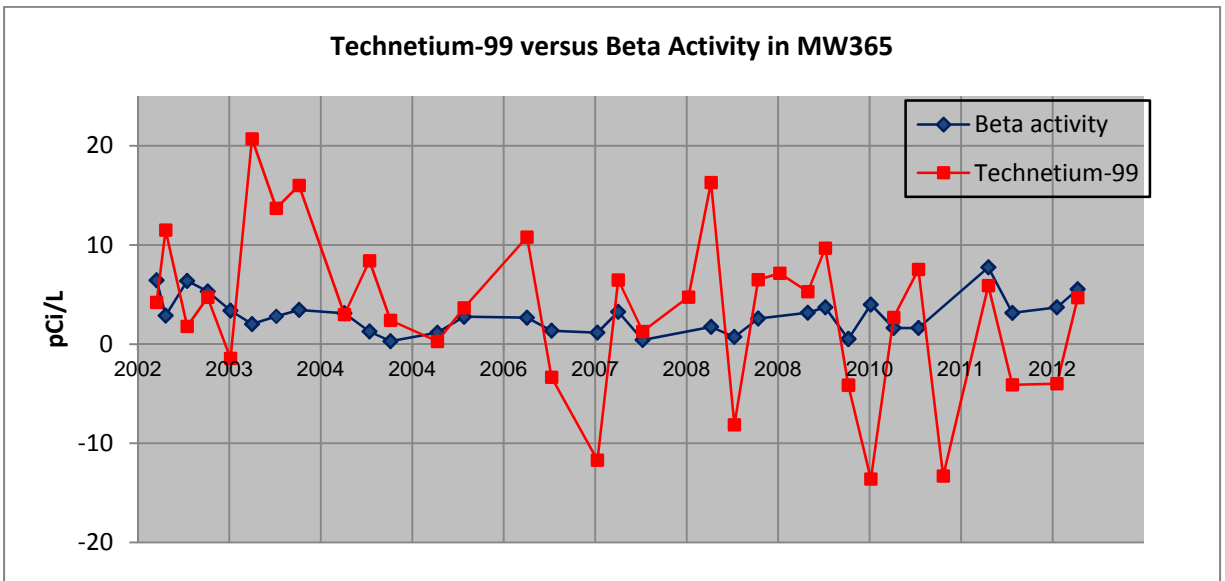
Figure 13. Technetium-99 versus Beta Activity in MW365 at the C-746-U Landfill

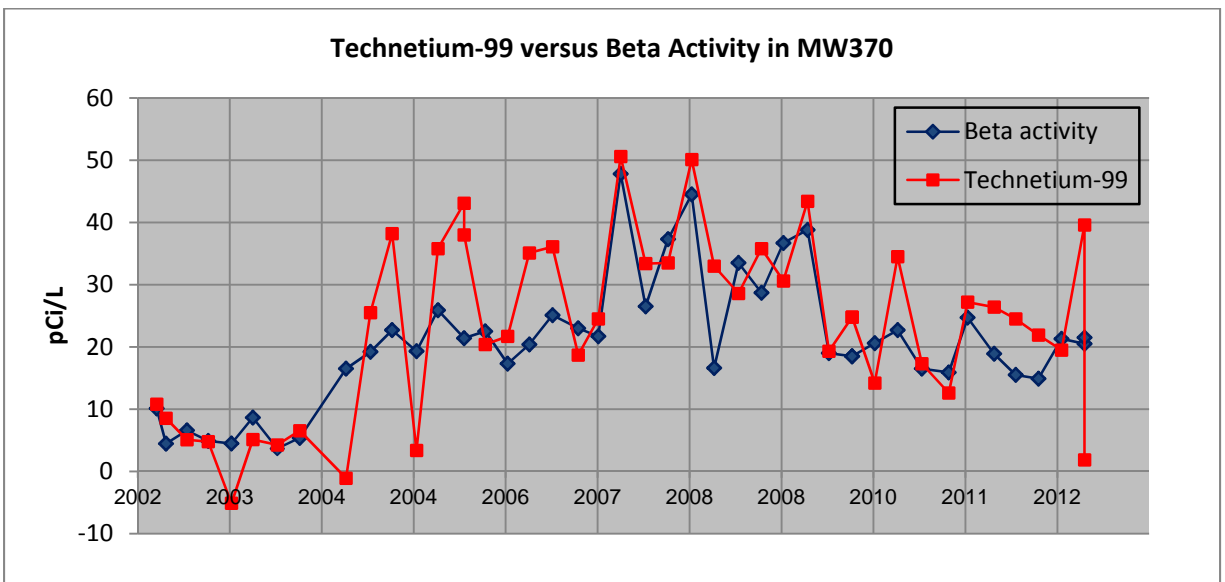
Figure 14. Technetium-99 versus Beta Activity in MW370 at the C-746-U Landfill

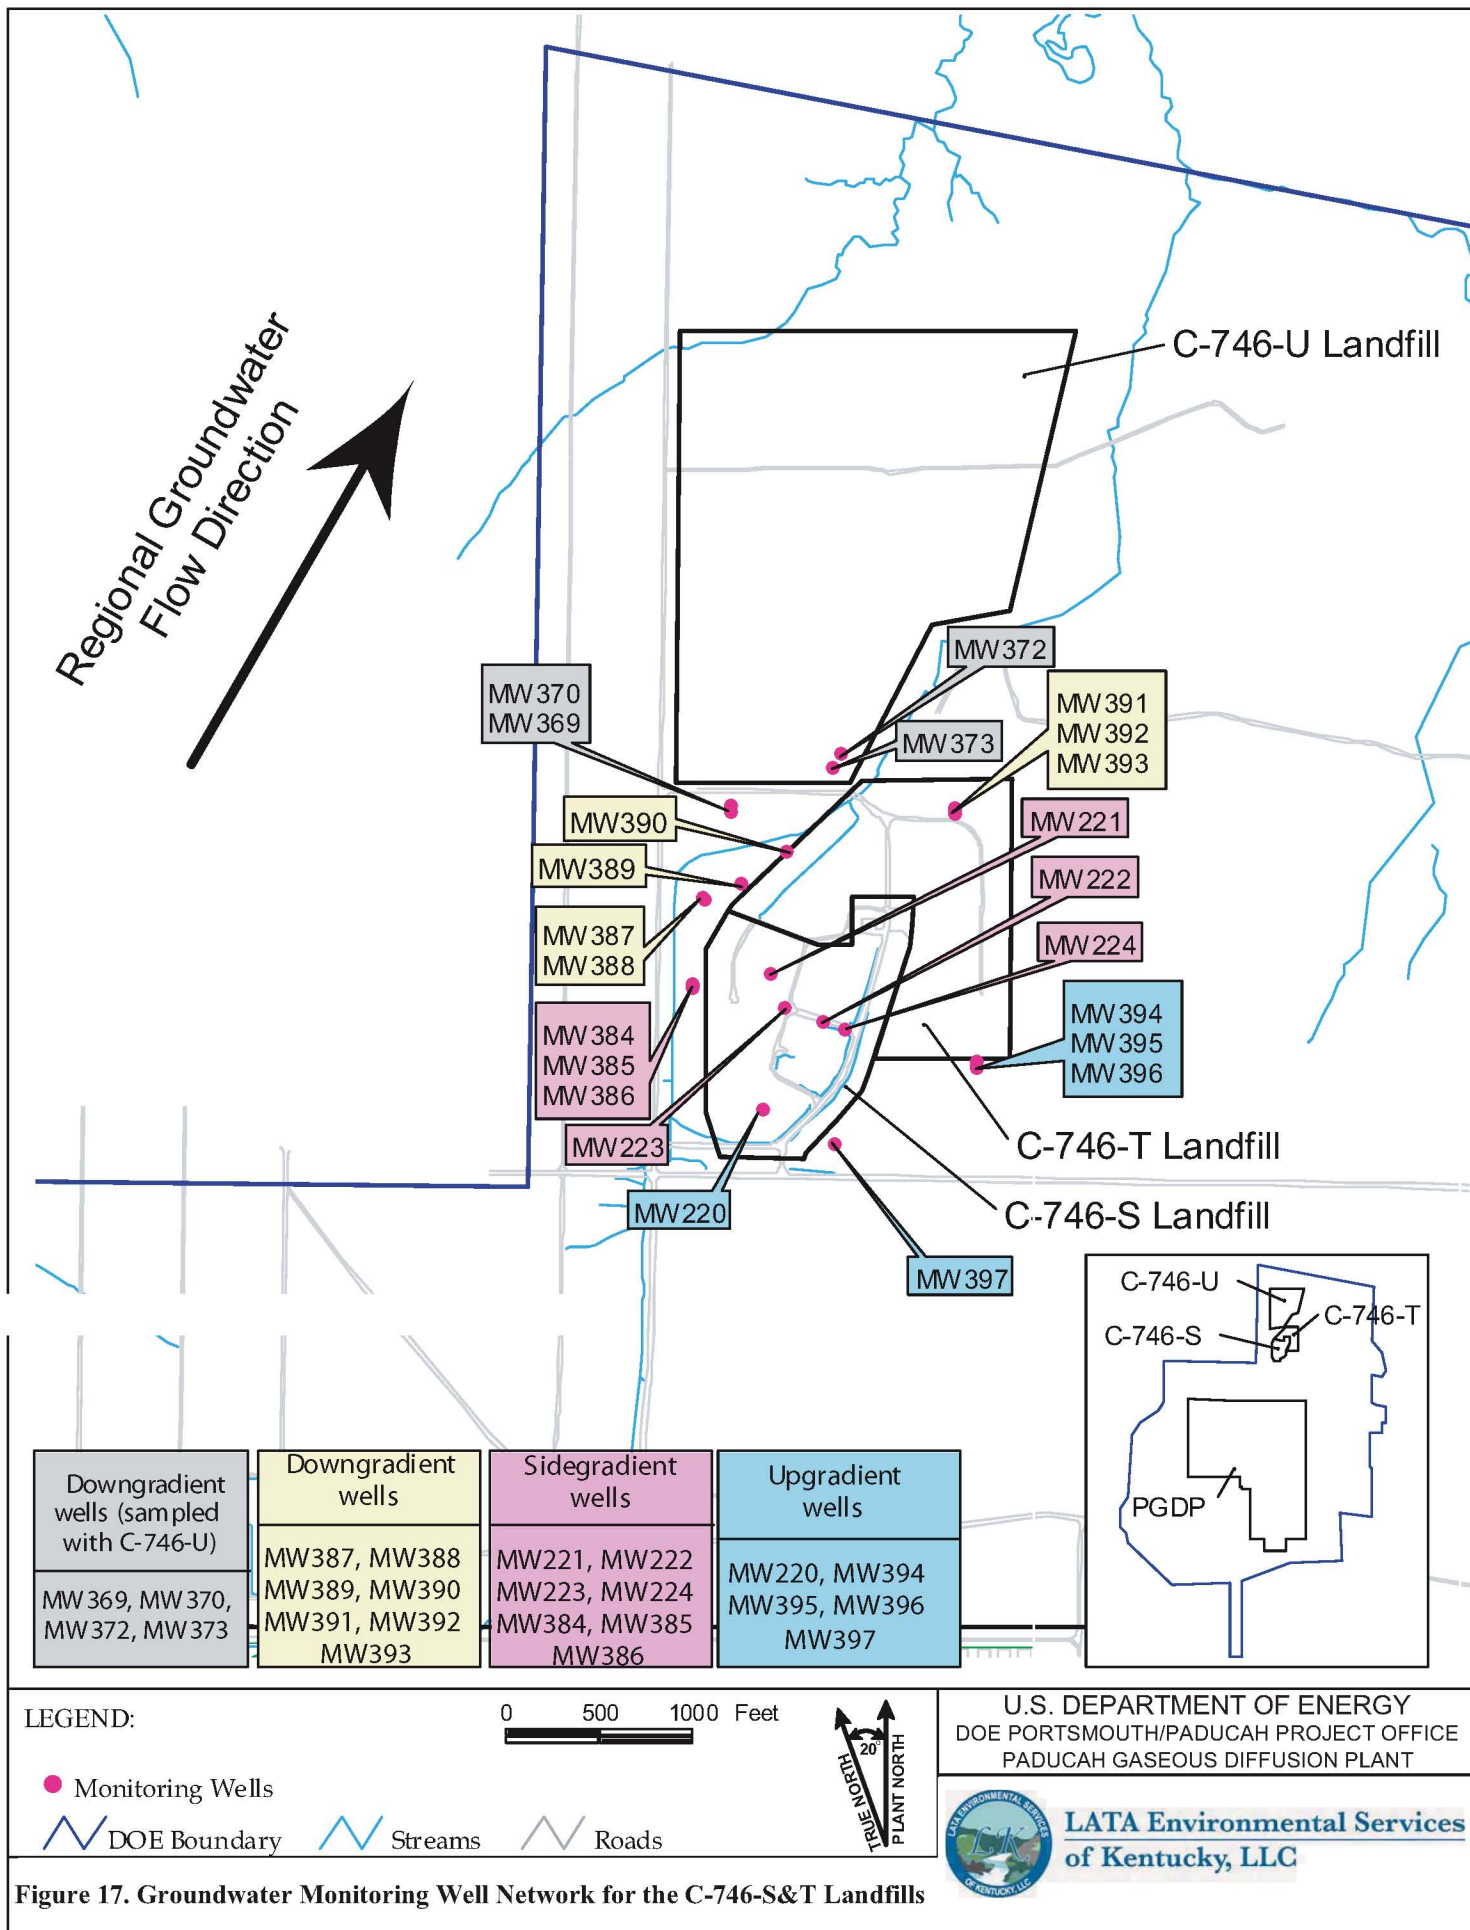
Figure 17. Groundwater Monitoring Well Network for the C-746-S&T Landfills

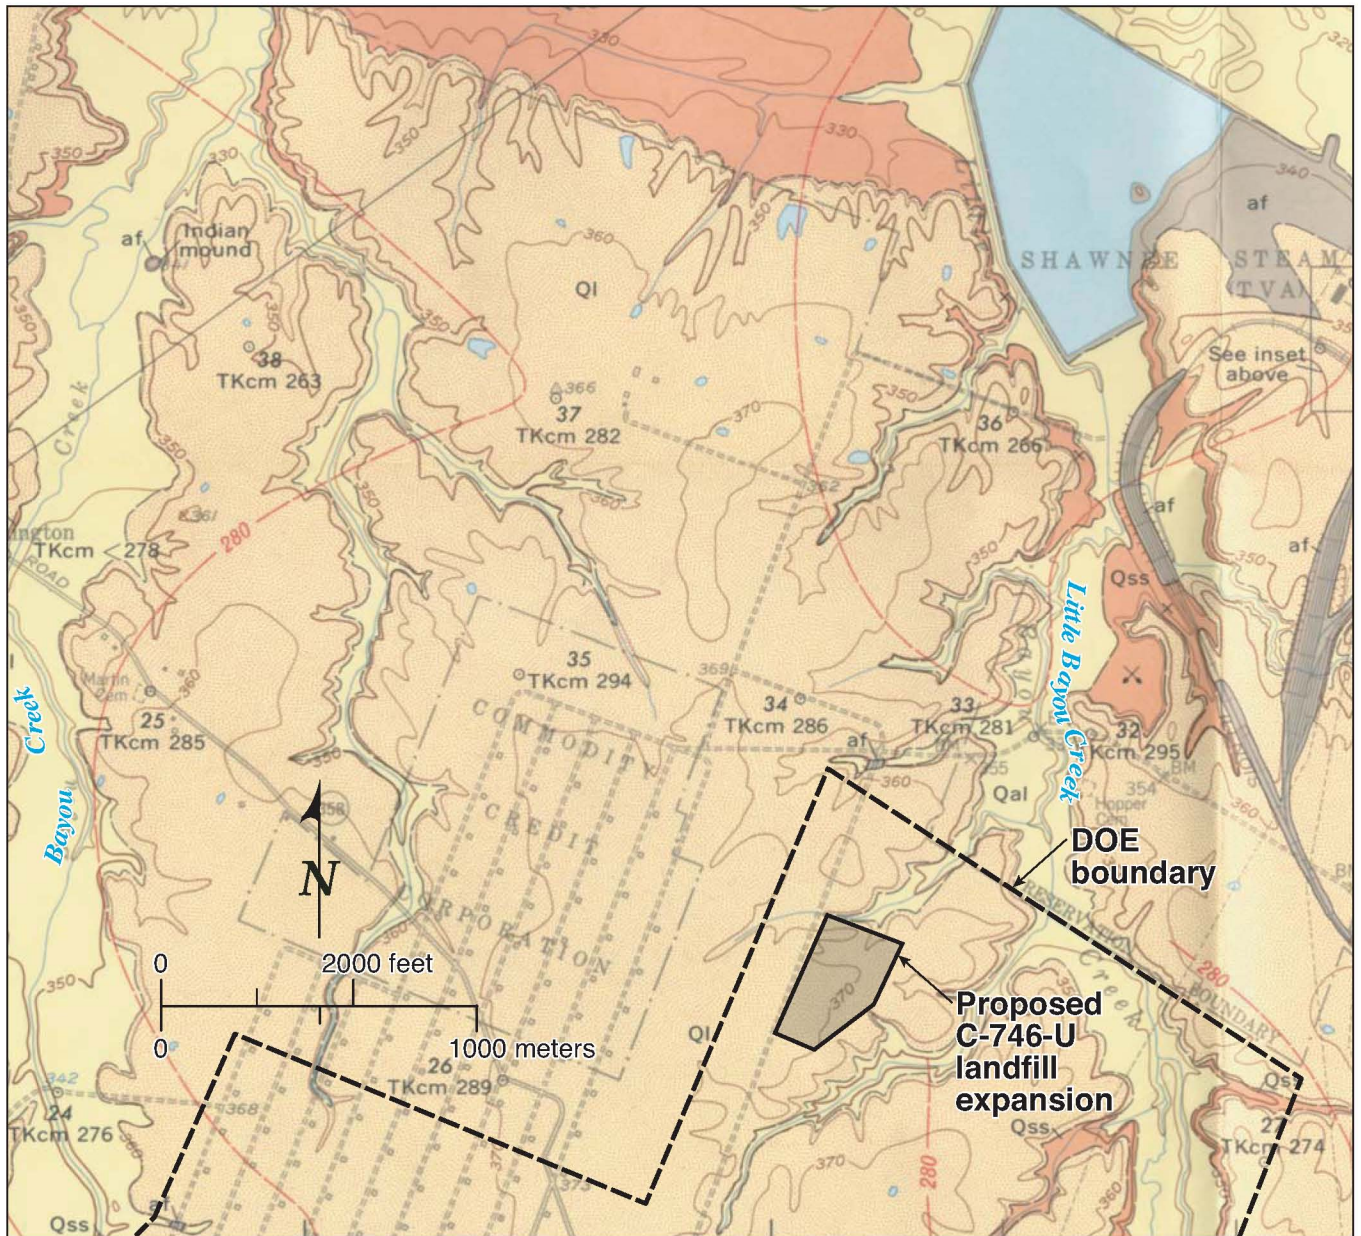
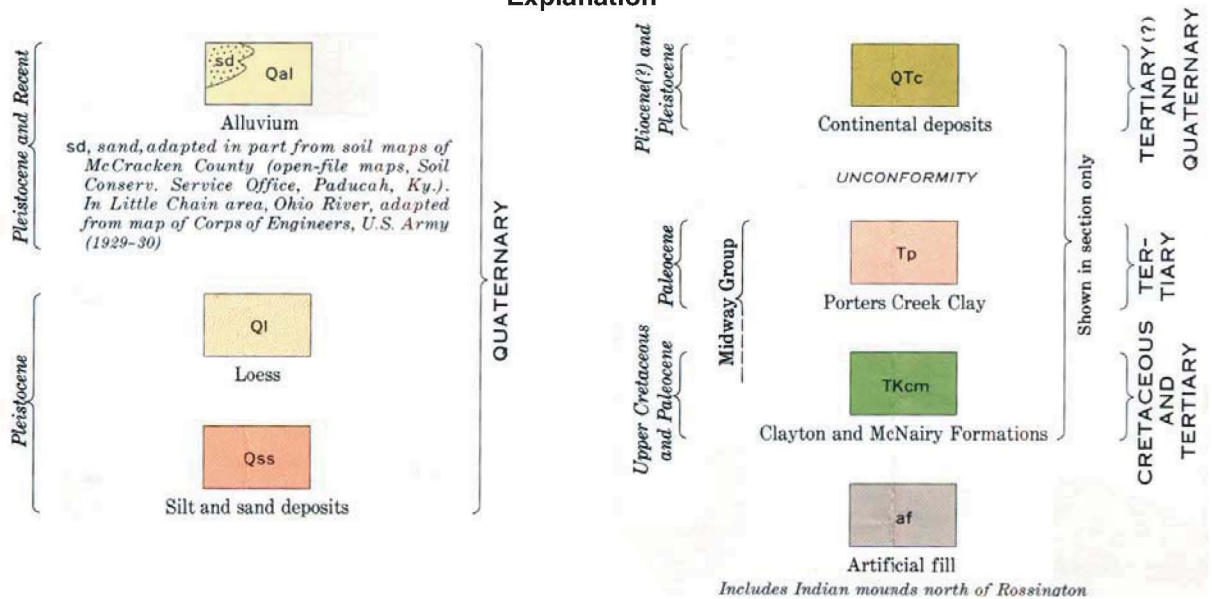
Figure 18. Regional Geologic Map (Modified from Finch 1967)

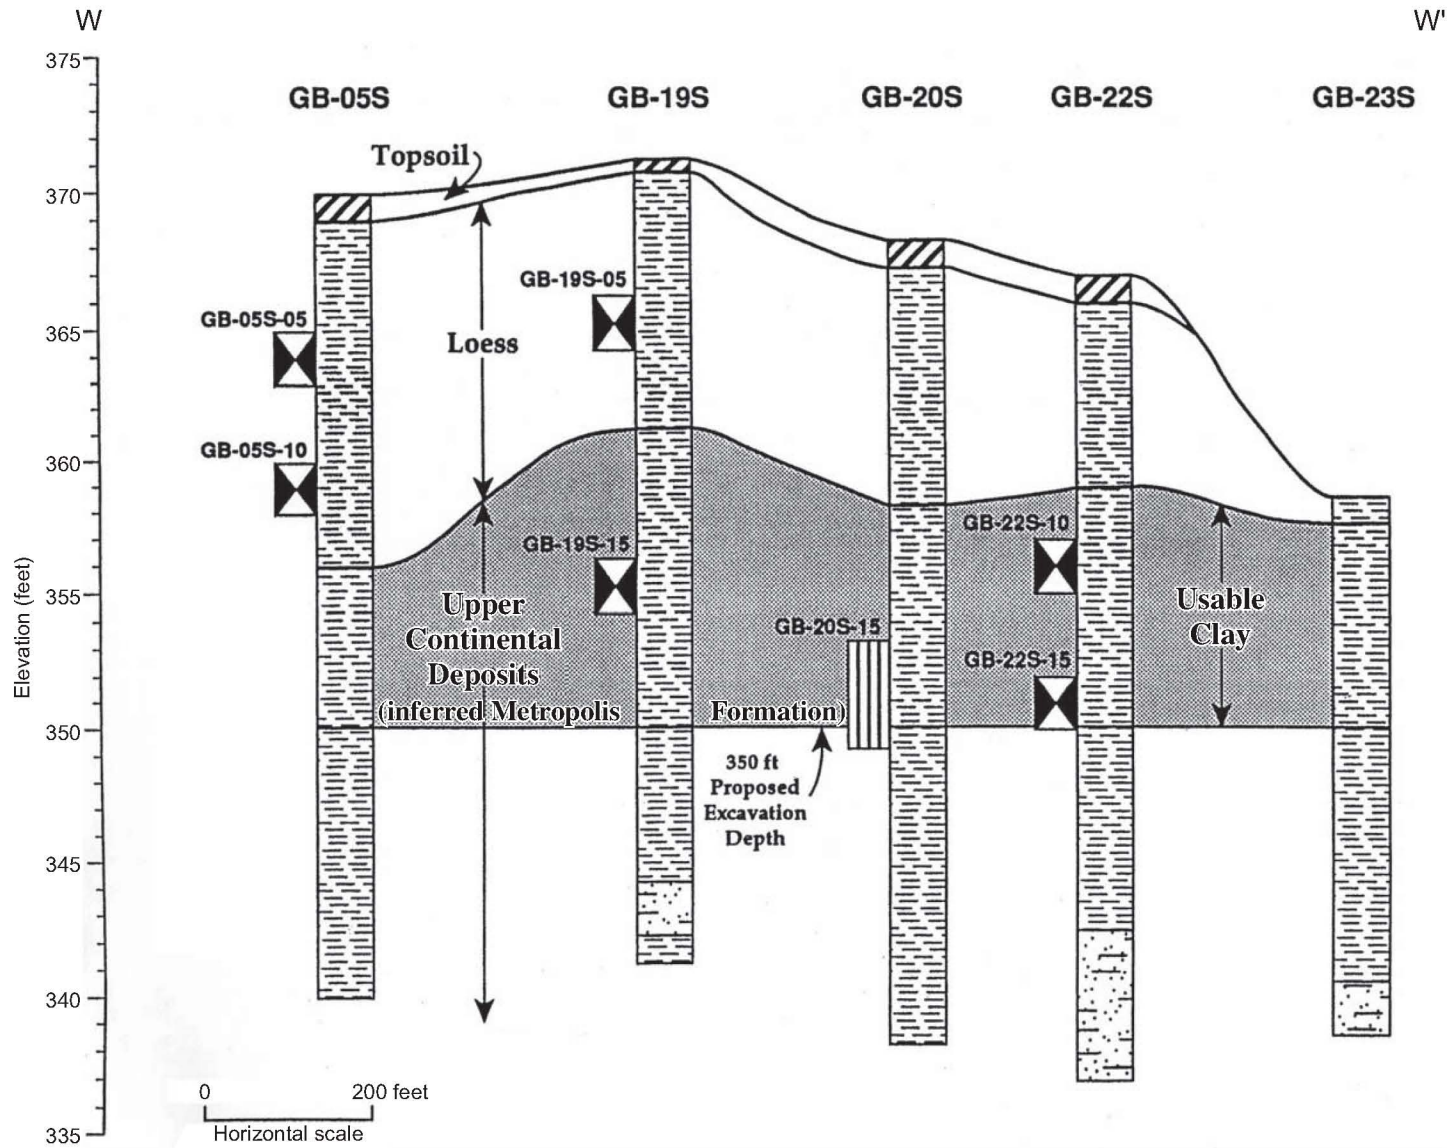
Figure 20. Geologic Section Depicting Generalized Stratigraphy Underlying C-764-U Landfill (from SAIC 1994)
