**Groundwater Assessment Report
for the C-746-U Landfill at the
Paducah Gaseous Diffusion Plant,
Paducah, Kentucky**

Date Issued—May 2013

Prepared for the
U.S. DEPARTMENT OF ENERGY
Office of Environmental Management

Prepared by
LATA ENVIRONMENTAL SERVICES OF KENTUCKY, LLC
managing the
Environmental Remediation Activities at the
Paducah Gaseous Diffusion Plant
under contract DE-AC30-10CC40020

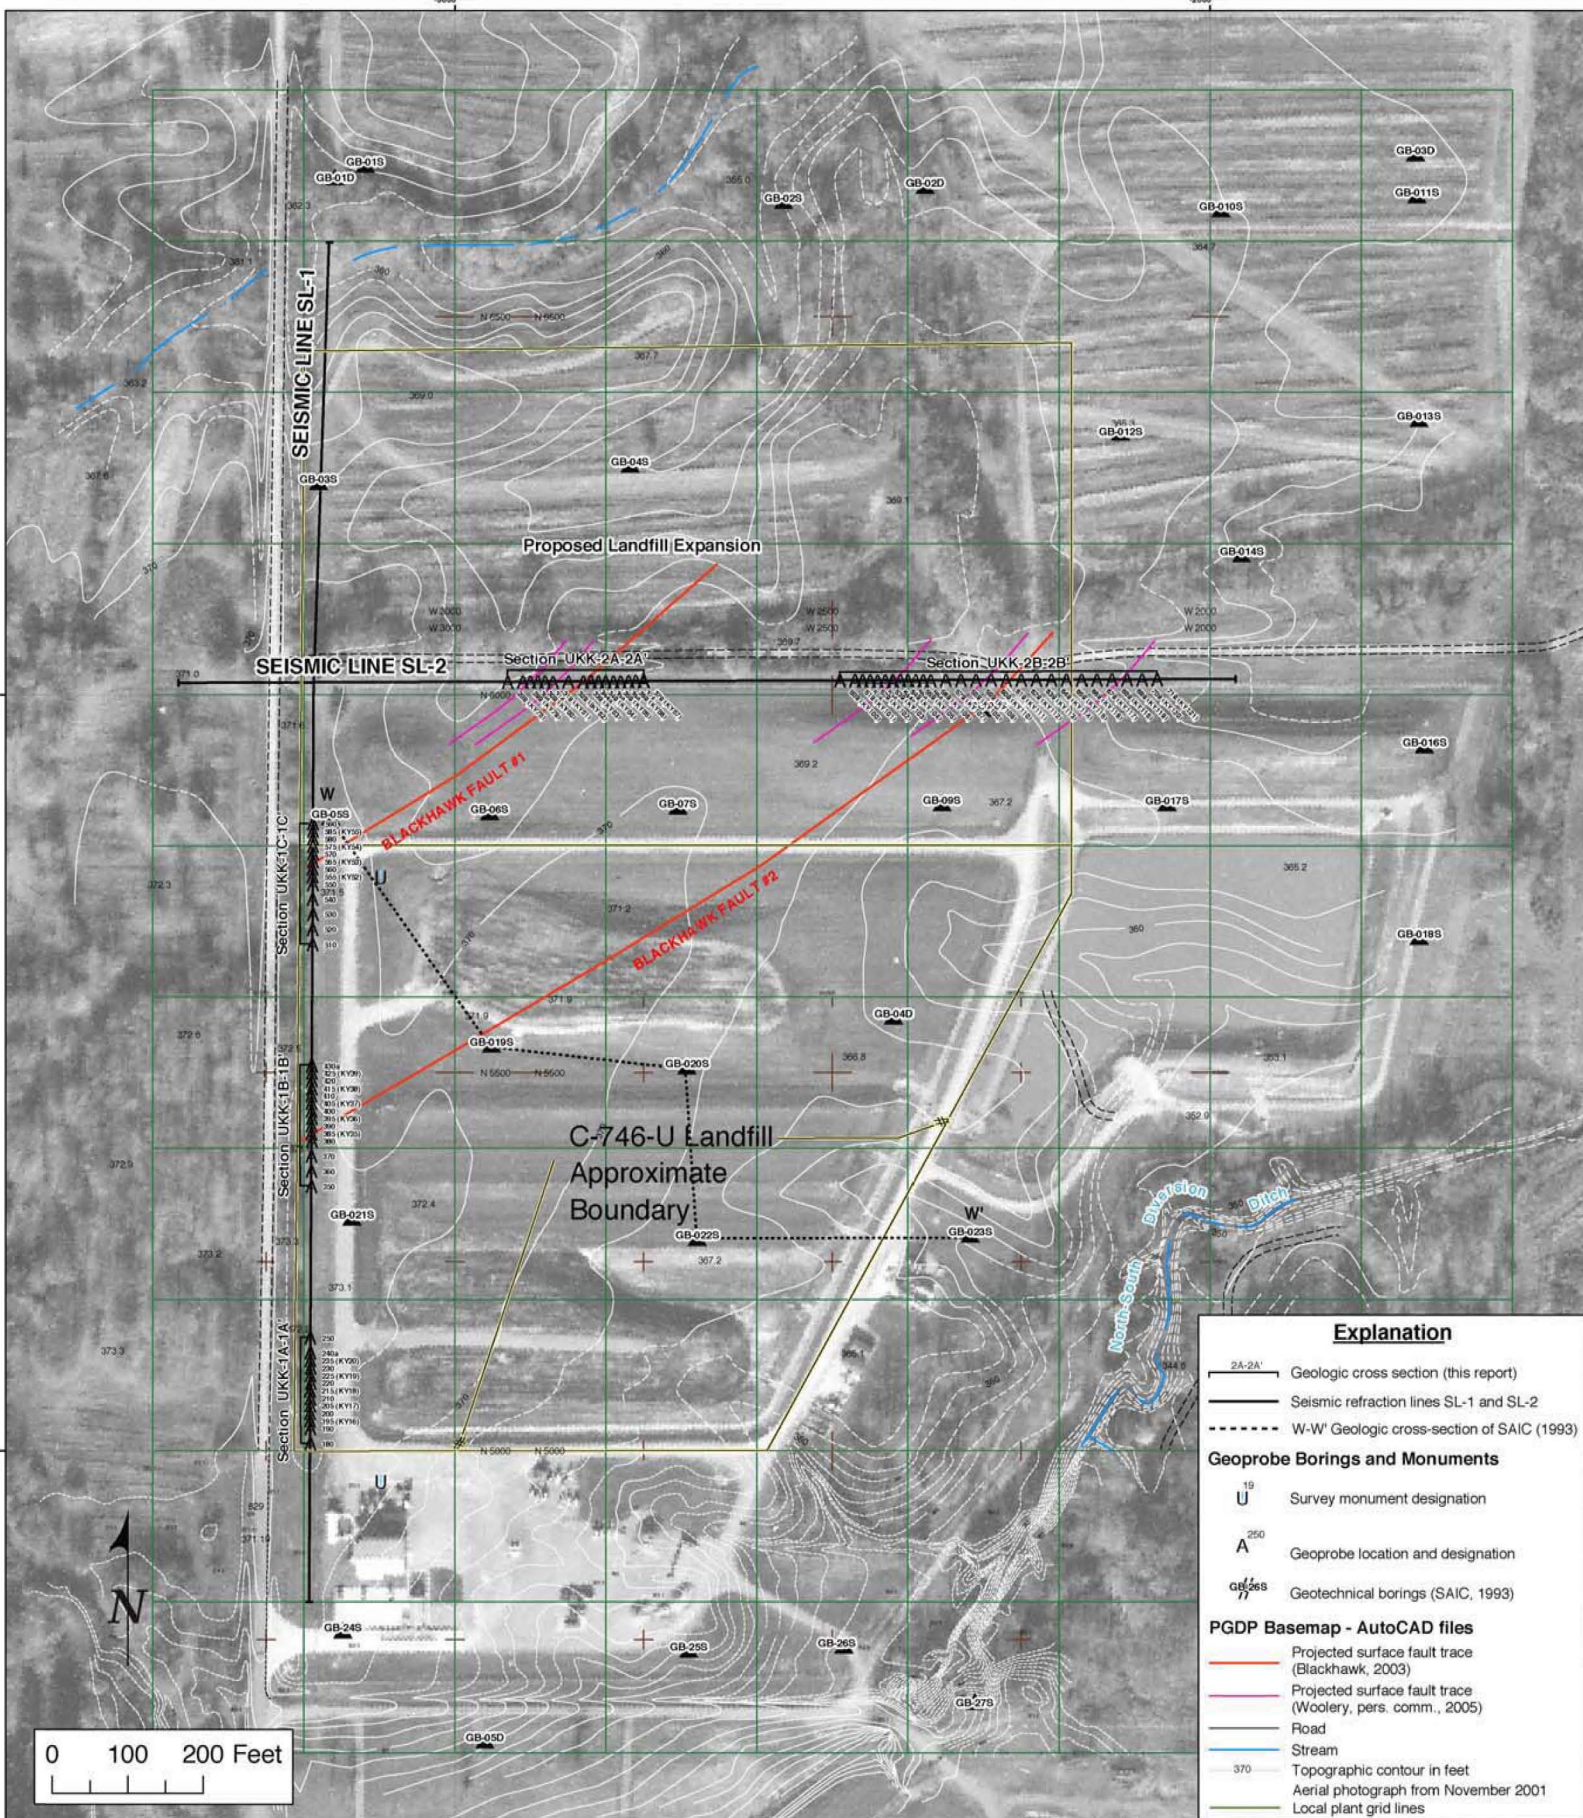
Figure 21. Topographic Map of the Paducah Gaseous Diffusion Plant C-746-U Landfill Expansion

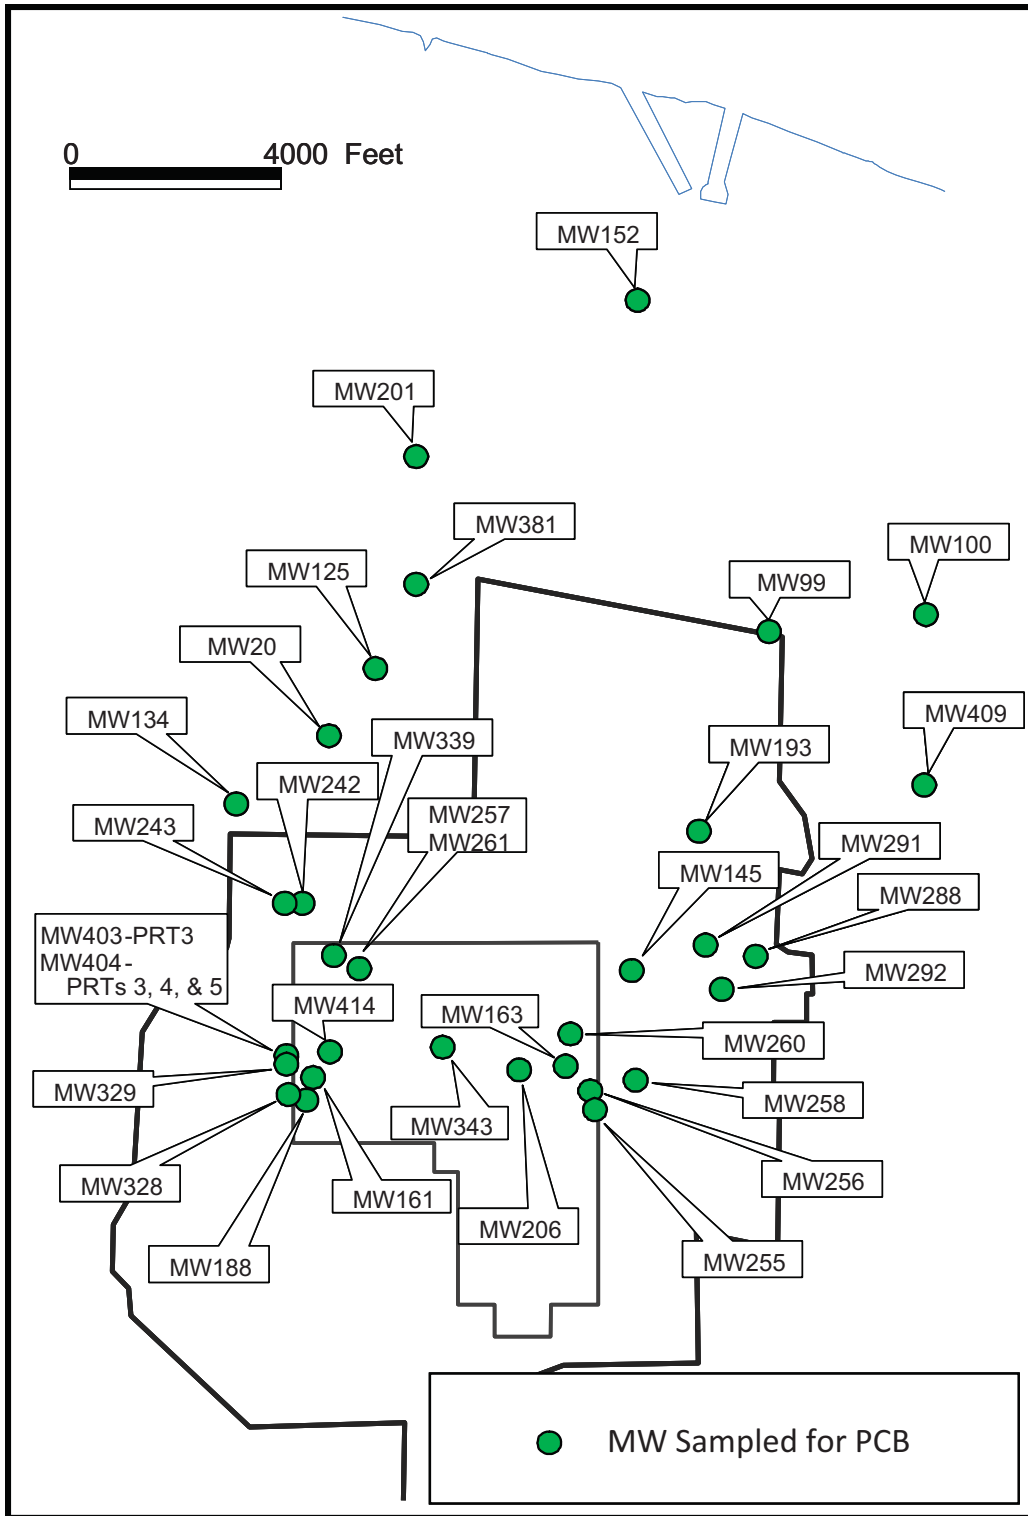
Figure 22. Location of RGA Wells with PCB Analyses to the C-746-S&T and C-746-U Landfill Wells

- Figure 22 and Table 9 shows that PCBs have not been an issue in other RGA wells at PGDP. This is consistent with the fact that PCBs are not soluble in water; thus, though PCBs were historically used at PGDP, they are not found in RGA groundwater at locations across the site.

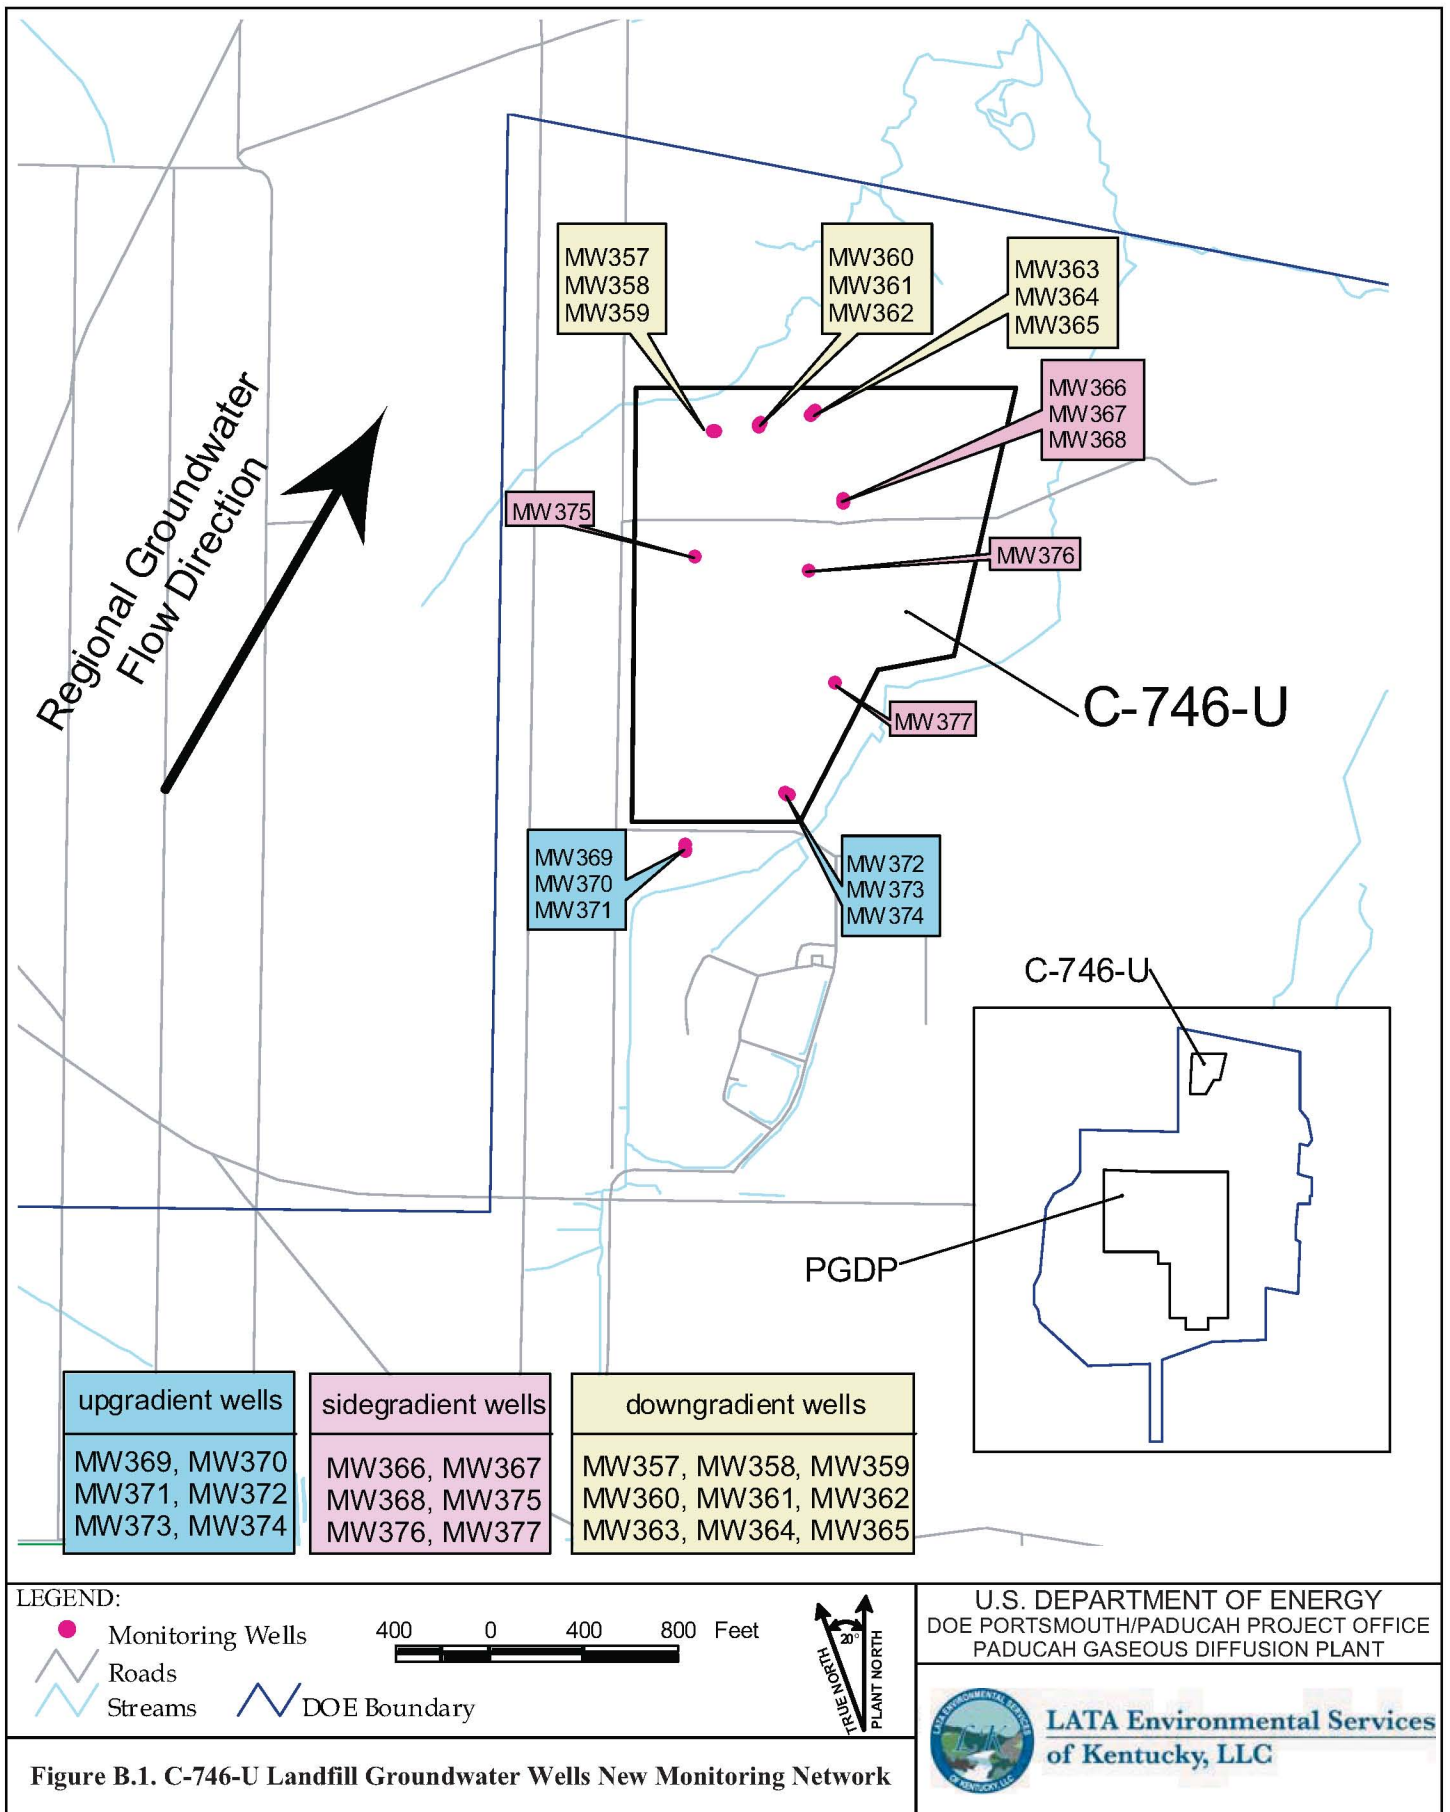
Figure B.1. C-746-U Landfill Groundwater Wells New Monitoring Network

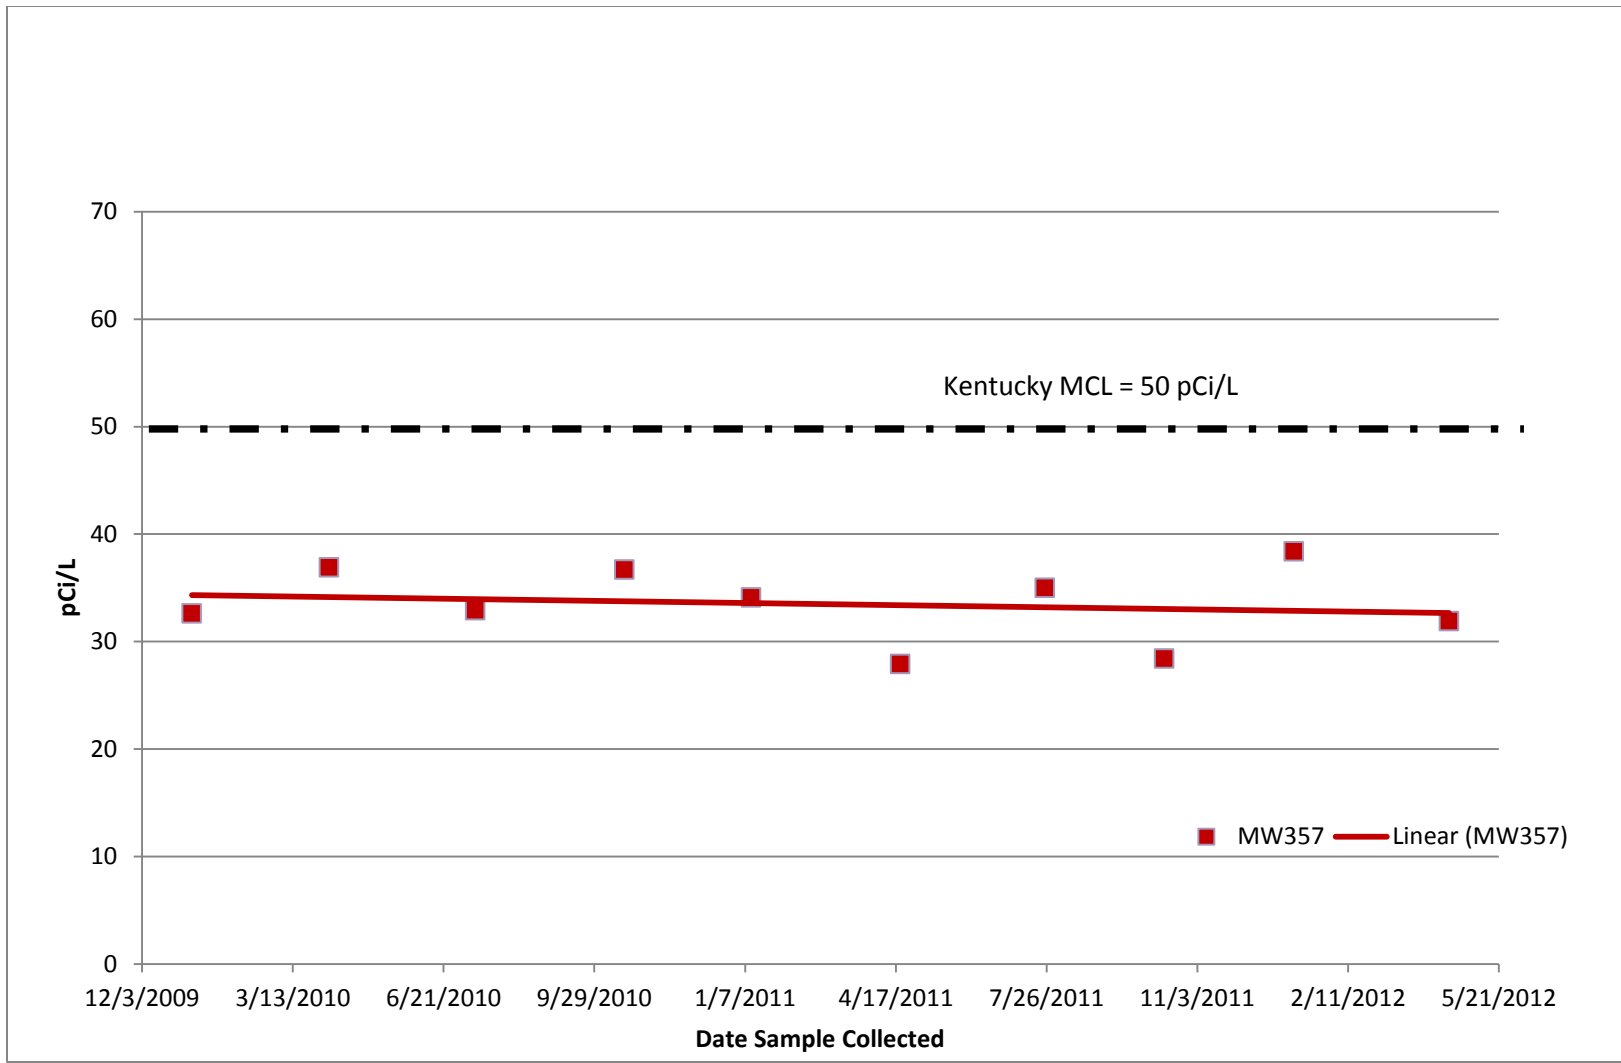
Figure B.3. MW357 Beta Activity since 2010

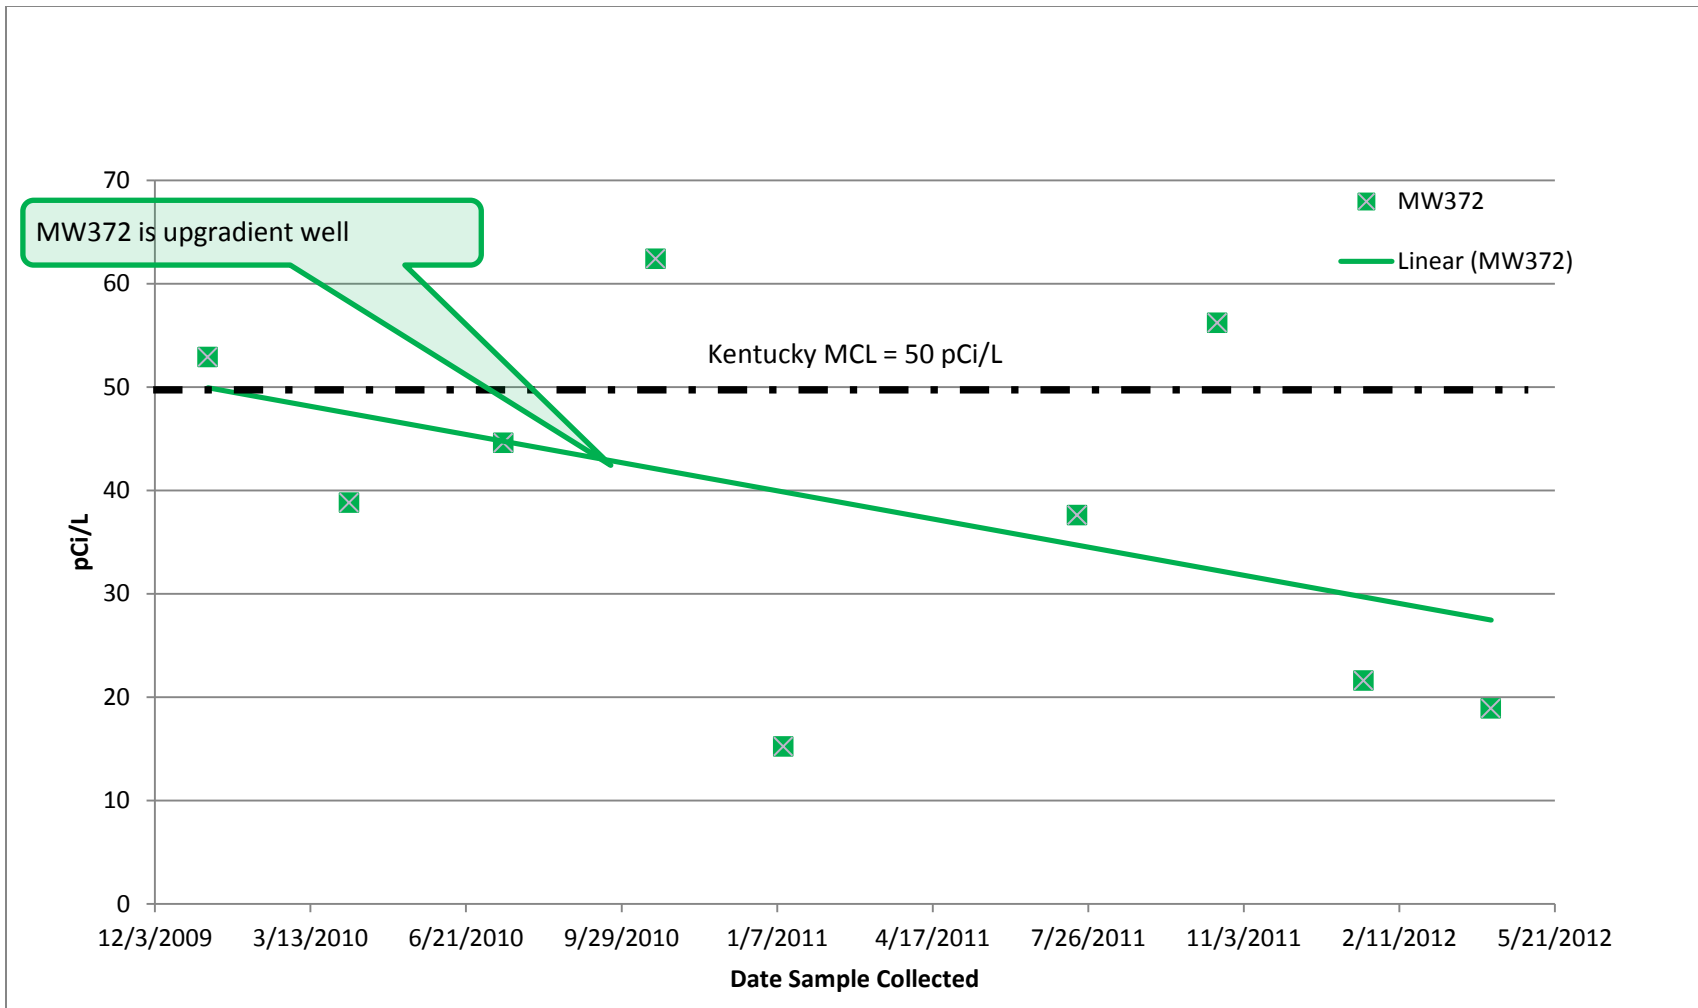
Figure B.4. Beta Activity since 2010 Upgradient Well Exceeds 50 pCi/L

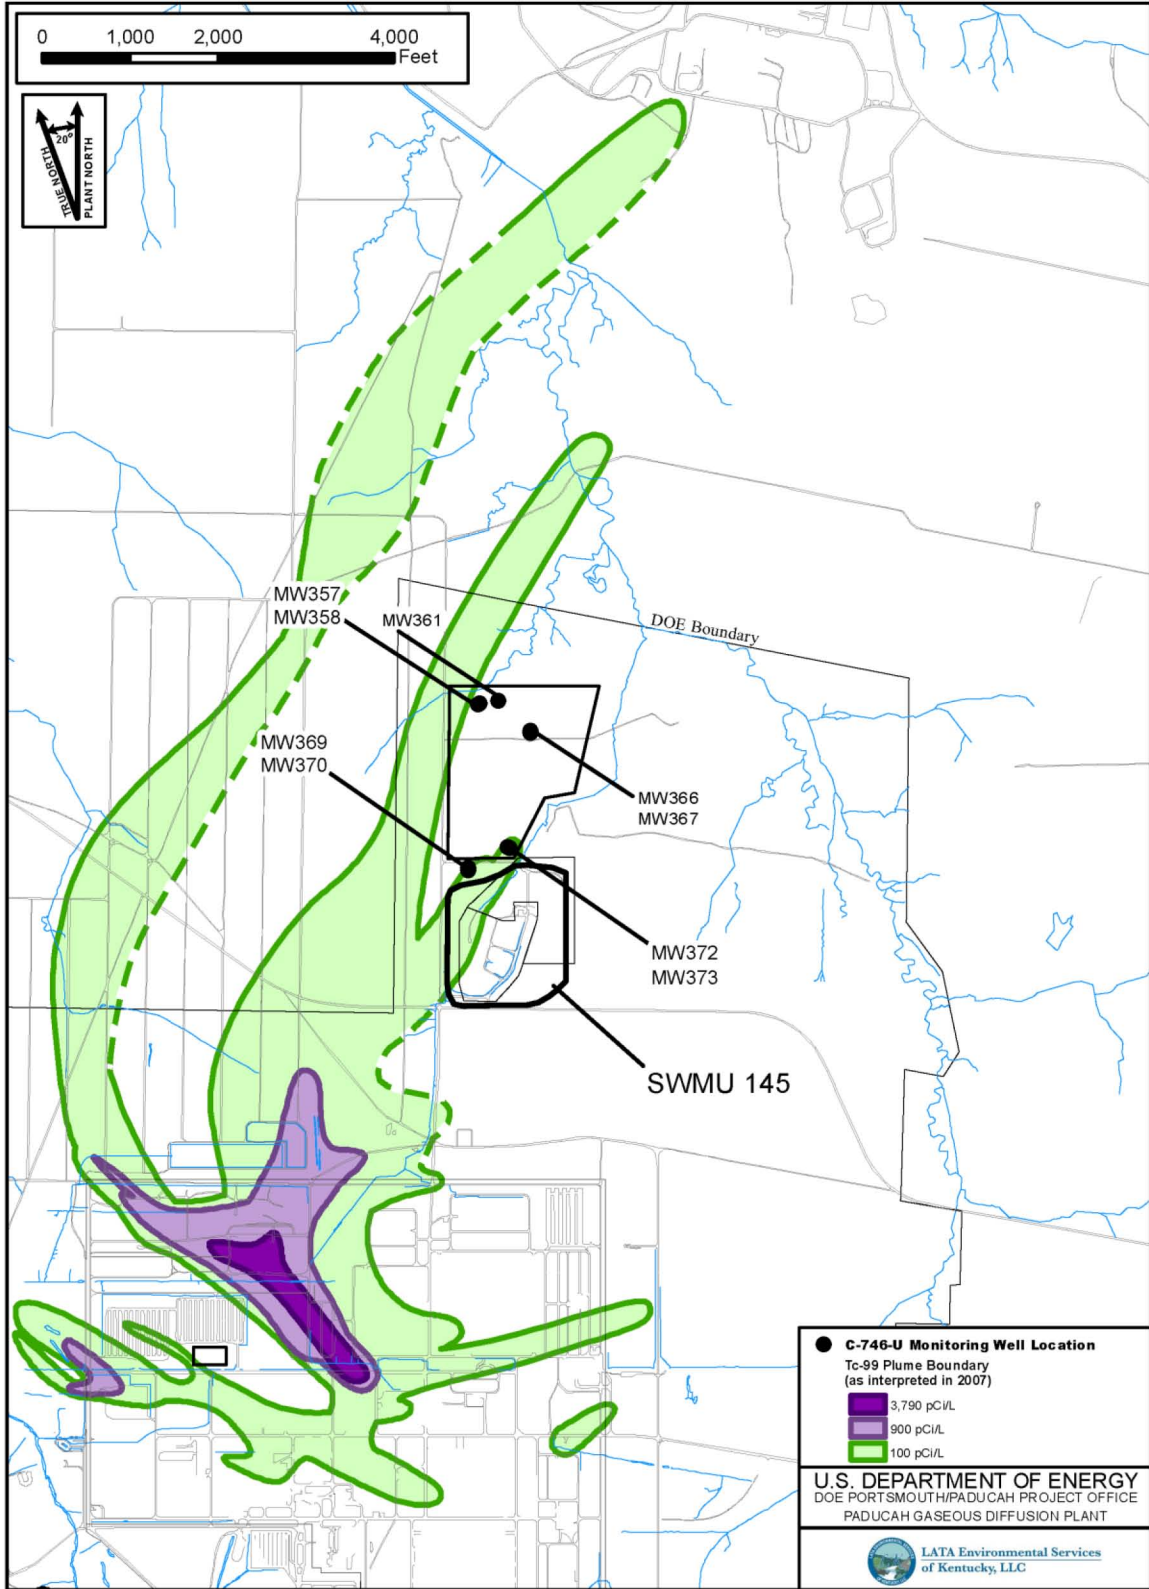
Figure B.5. Technetium-99 Contours for the RGA

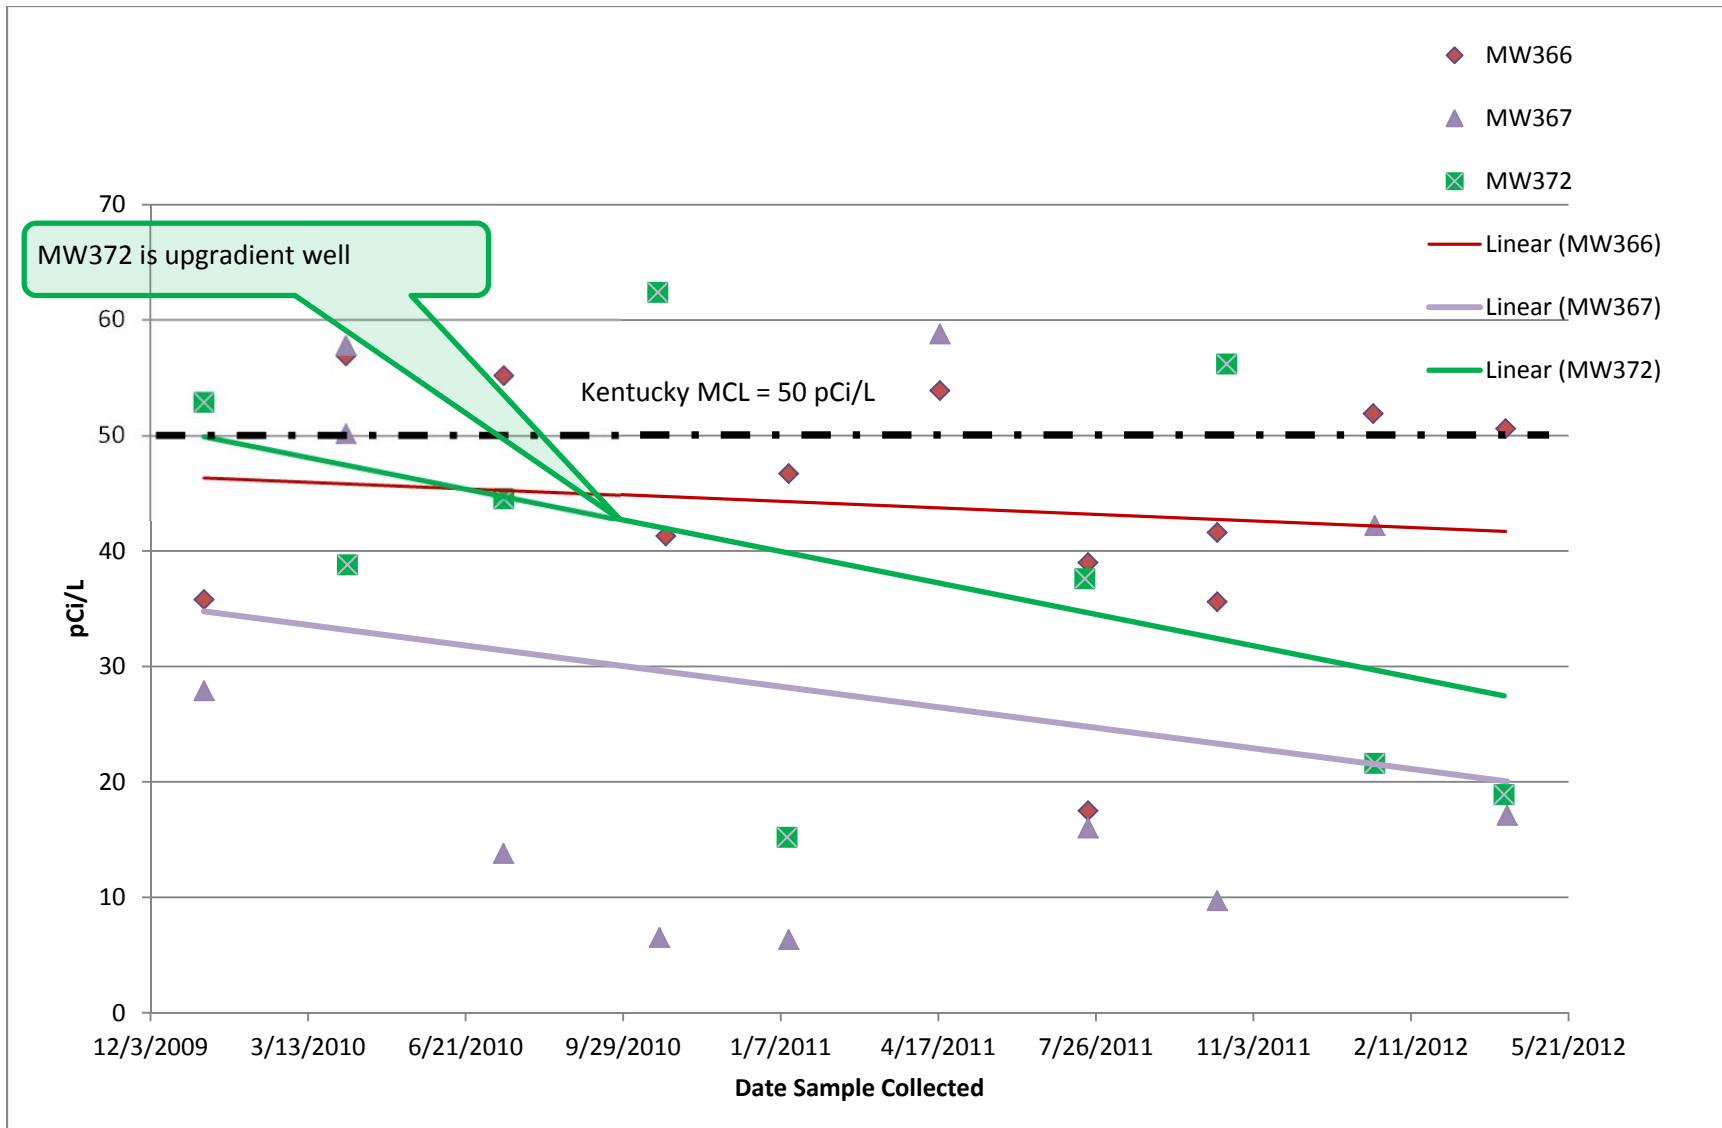
Figure B.6. Beta Activity since 2010 Wells with Any Exceedance of 50 pCi/L

Figure B.6 is a graph of beta activity concentrations for the three RGA wells with beta activity greater than the MCL over the past two years. MW366 and MW367 are on the same flow path as water passing through MW372. Concentrations in MW366 and MW367 are lower than in upgradient well MW372 and also are decreasing; thus, the concentrations in the downgradient wells are well-explained

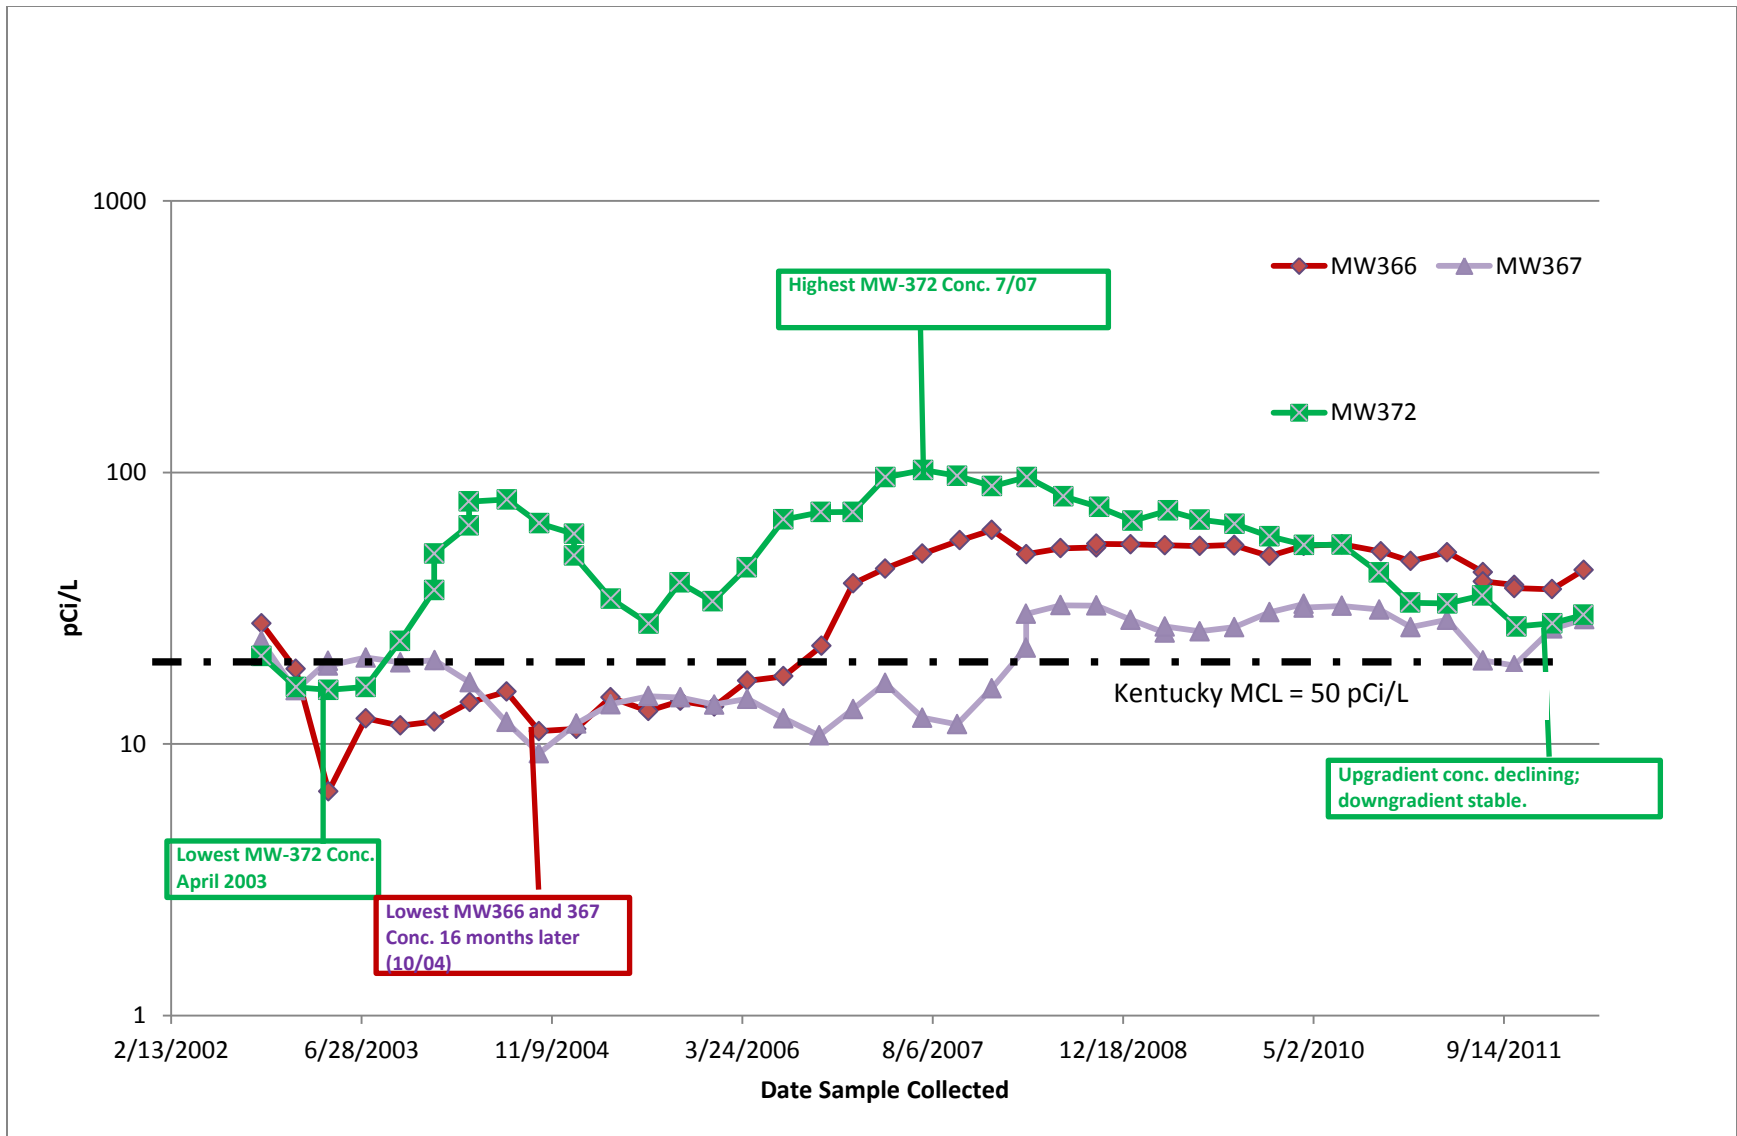
Figure B.7. Beta Activity 4 Event Rolling Average, Log Scale

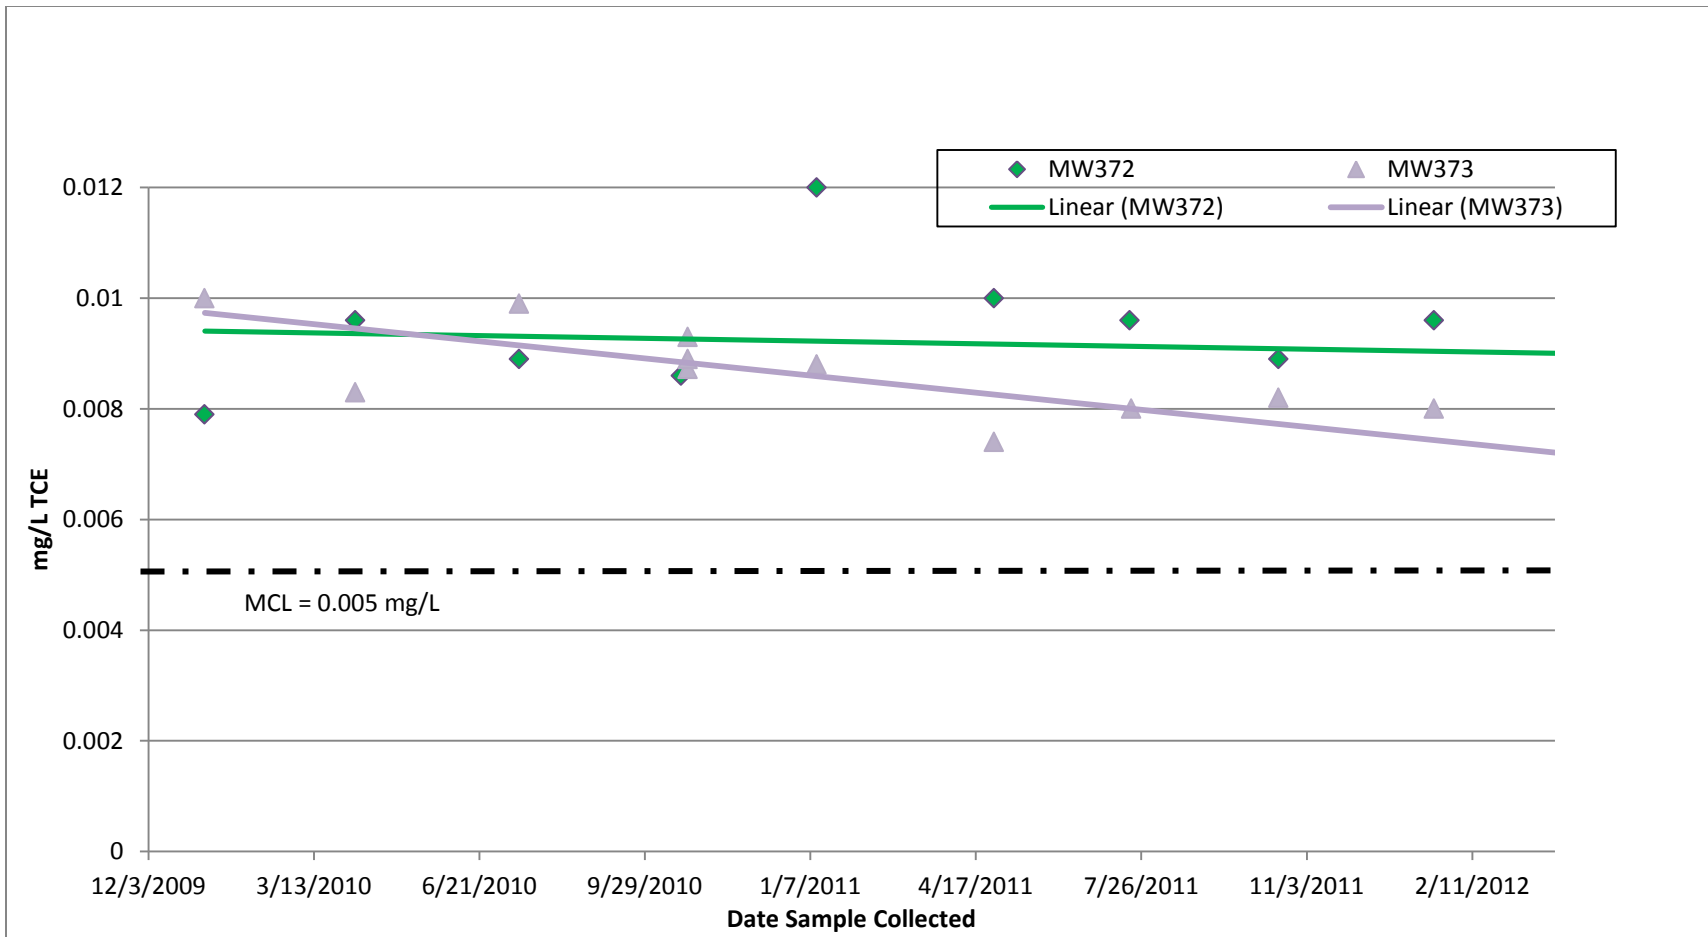
Figure B.8. TCE Concentration, Upgradient Wells

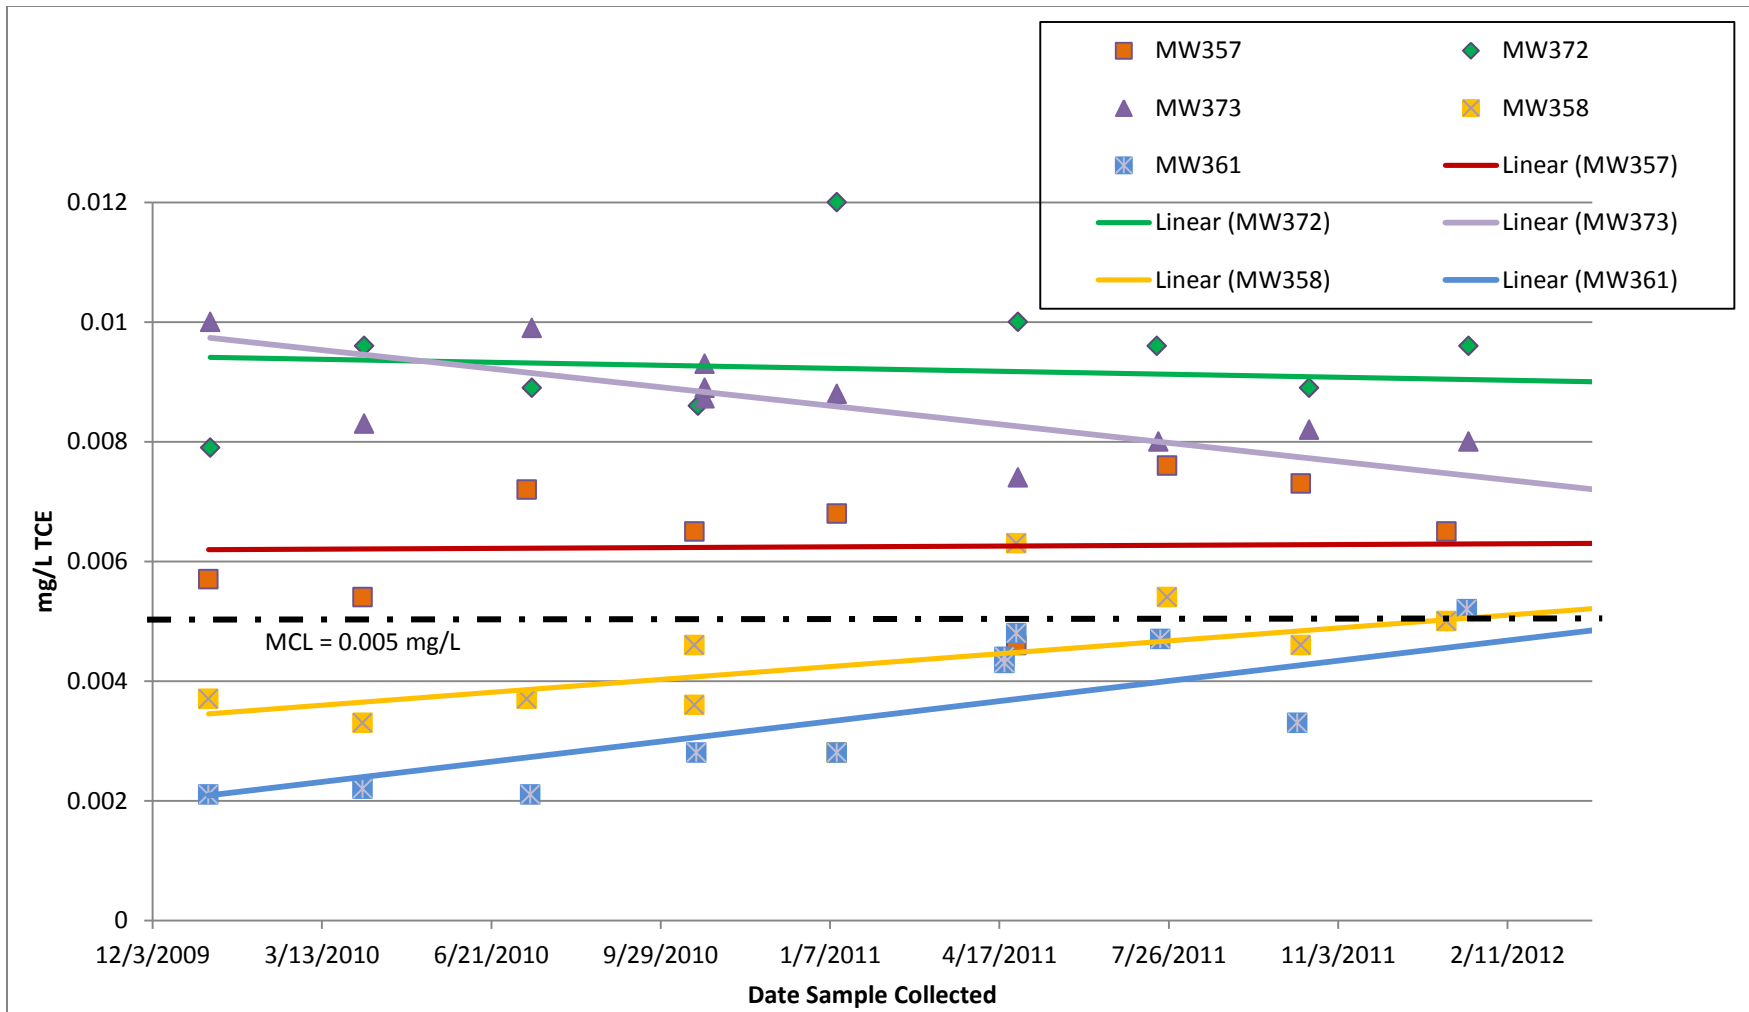
Figure B.9. TCE Concentration, All Wells w/TCE > 0.005
