**Groundwater Assessment Report
for the C-746-U Landfill at the
Paducah Gaseous Diffusion Plant,
Paducah, Kentucky**

Date Issued—May 2013

Prepared for the
U.S. DEPARTMENT OF ENERGY
Office of Environmental Management

Prepared by
LATA ENVIRONMENTAL SERVICES OF KENTUCKY, LLC
managing the
Environmental Remediation Activities at the
Paducah Gaseous Diffusion Plant
under contract DE-AC30-10CC40020

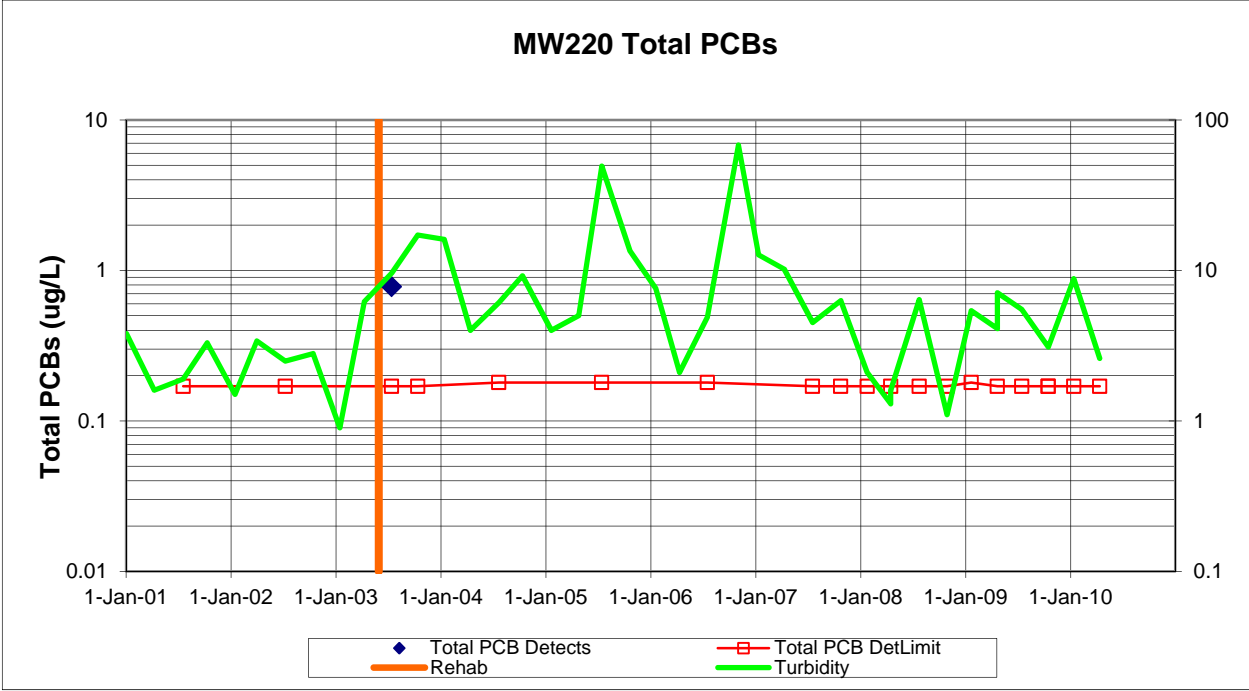
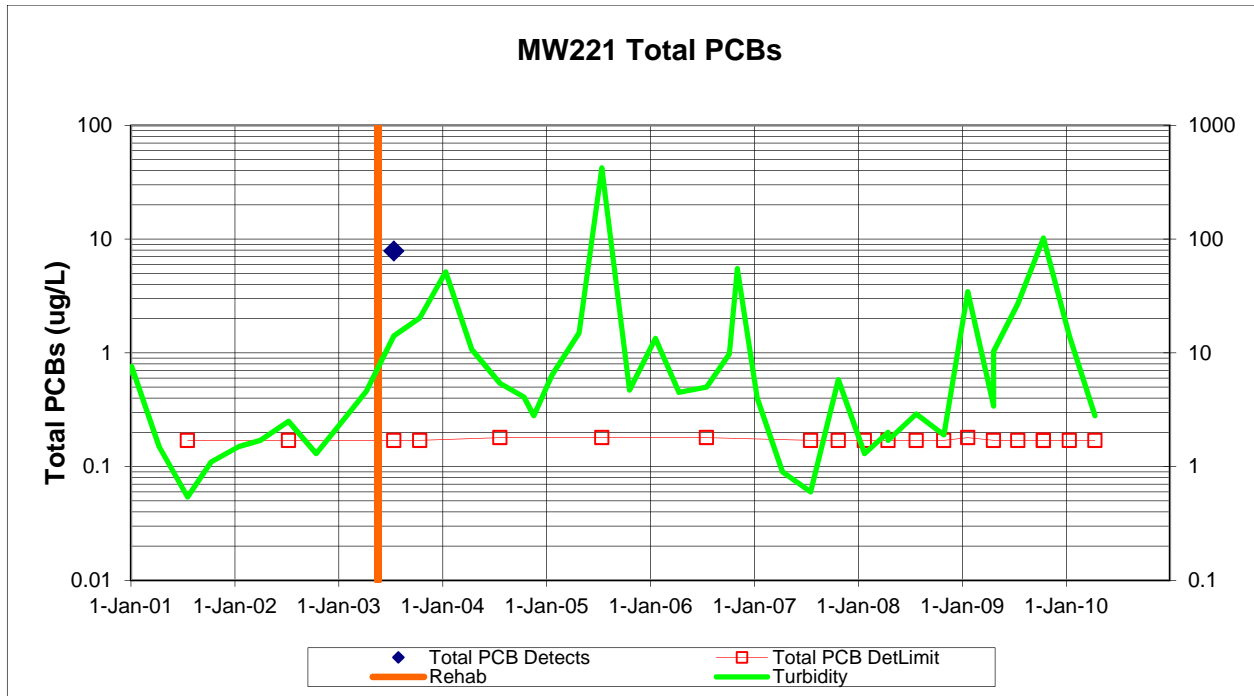
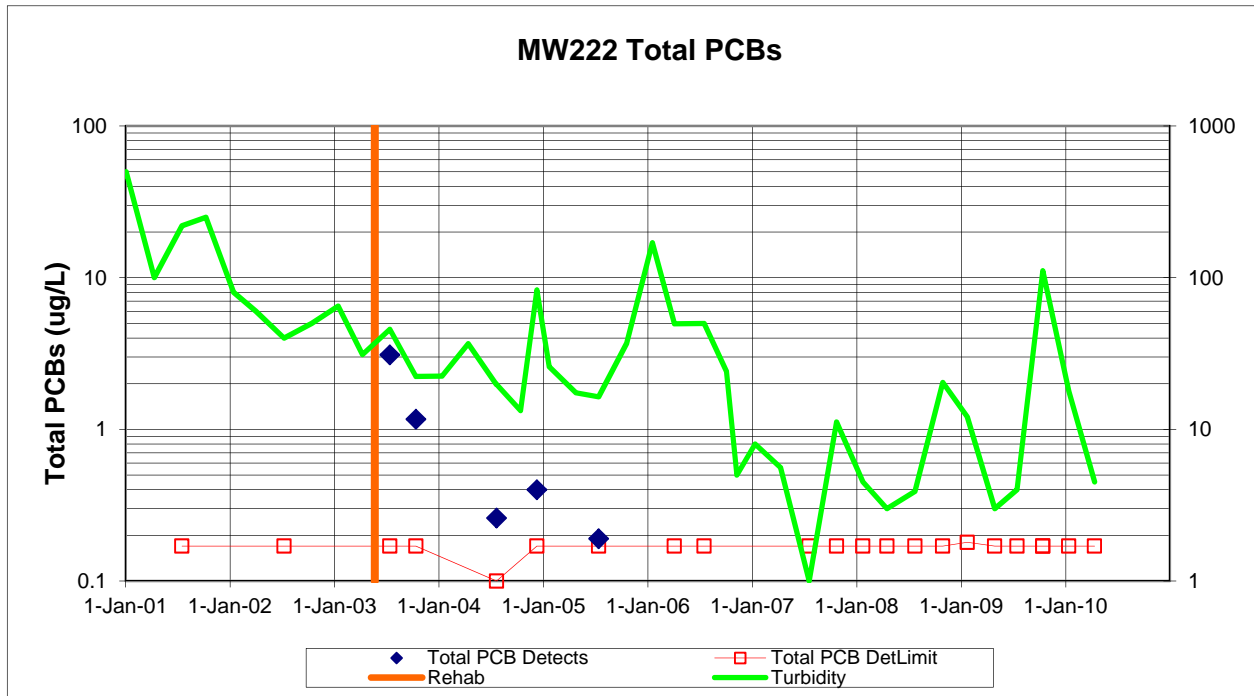
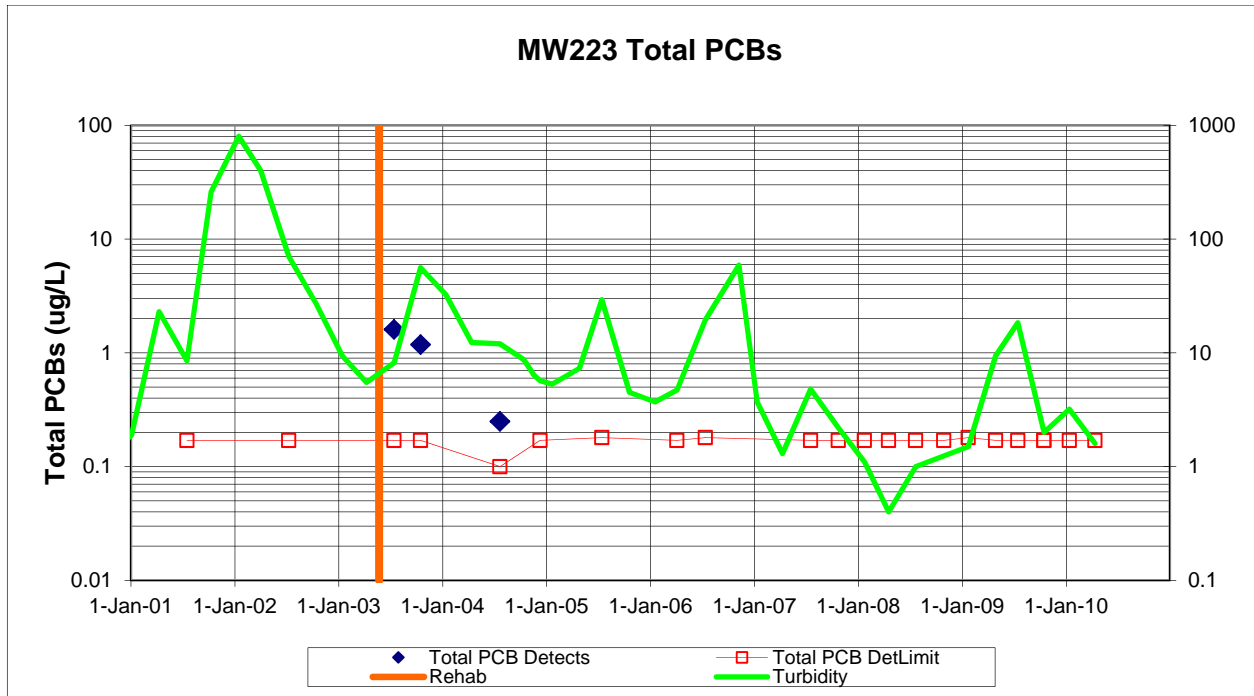
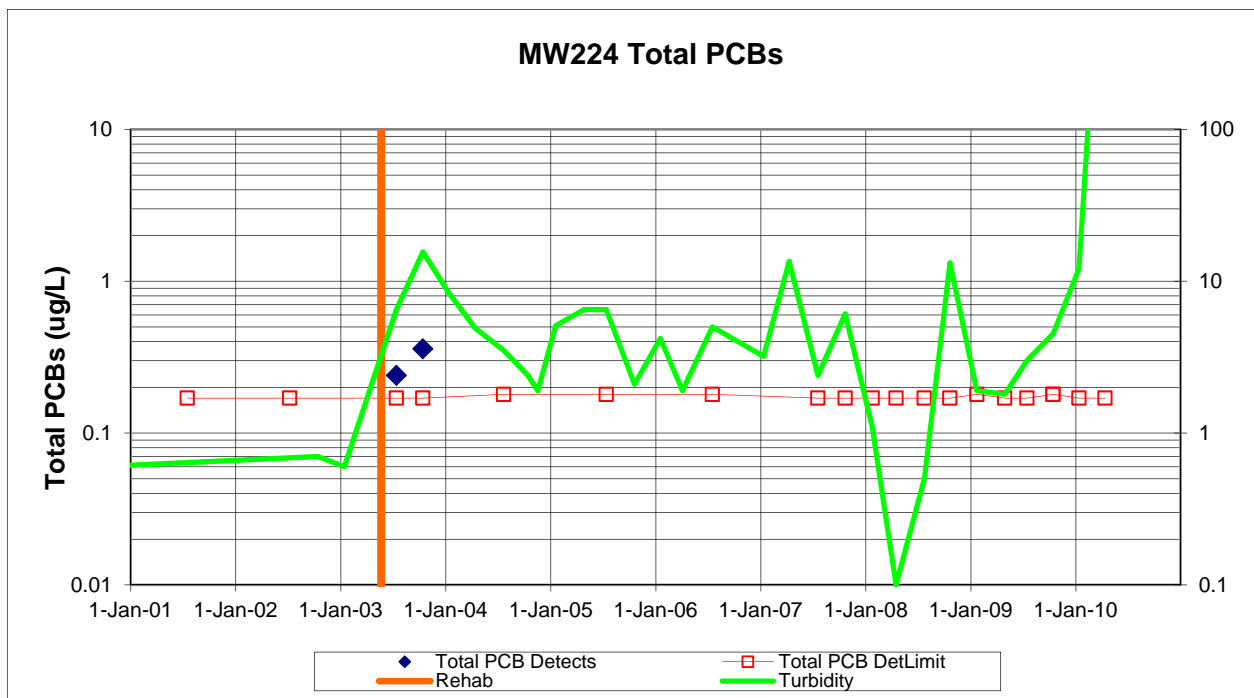
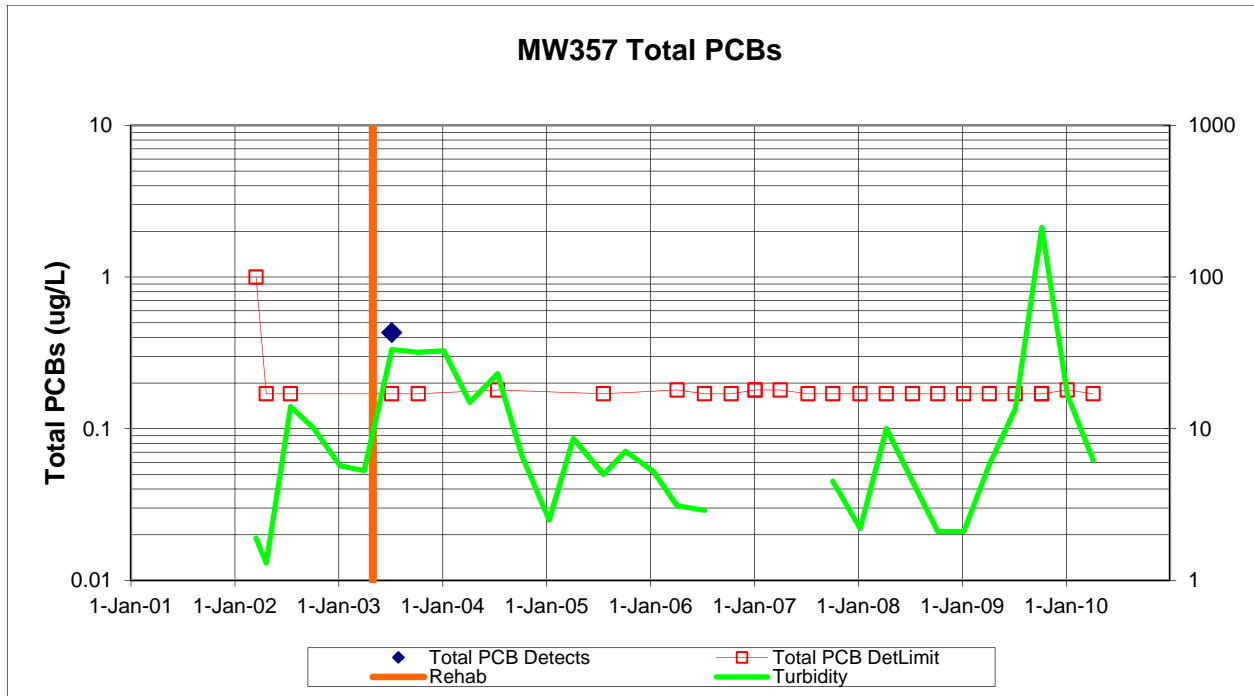
Figure E.1. PCB Analyses and Well Rehabilitation in MW220

Figure E.2. PCB Analyses and Well Rehabilitation in MW221

Figure E.3. PCB Analyses and Well Rehabilitation in MW222

Figure E.4. PCB Analyses and Well Rehabilitation in MW223

Figure E.5. PCB Analyses and Well Rehabilitation in MW224

Figure E.6. PCB Analyses and Well Rehabilitation in MW357

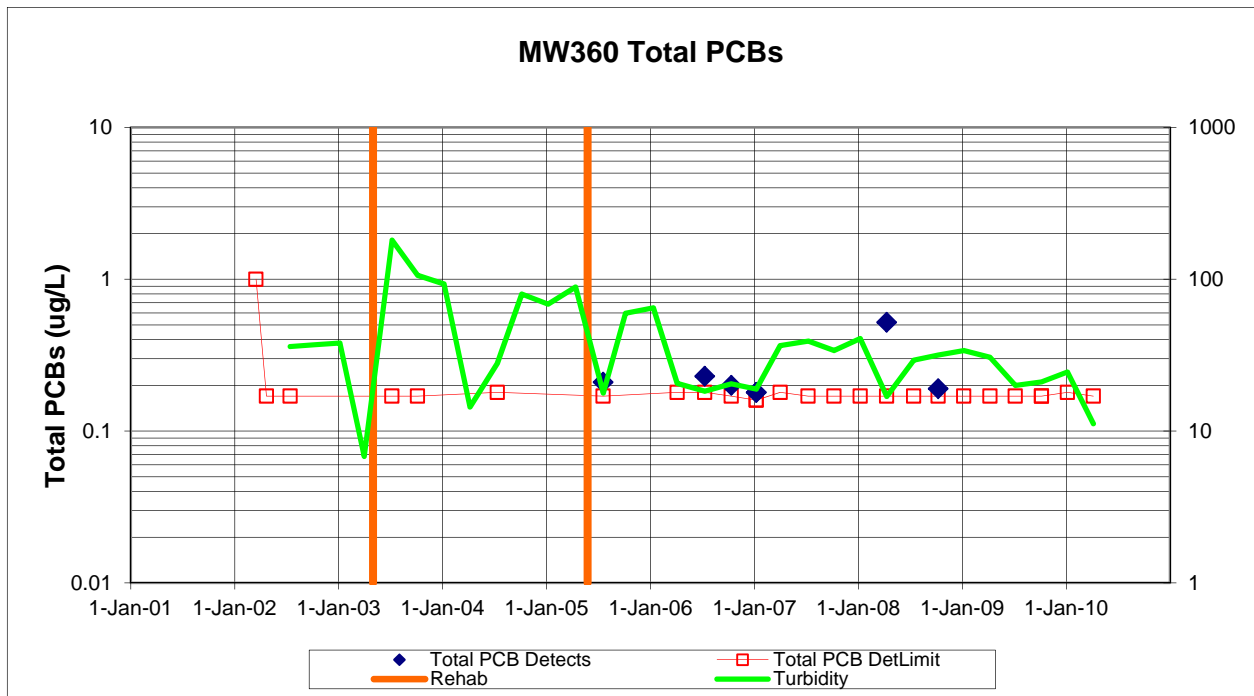
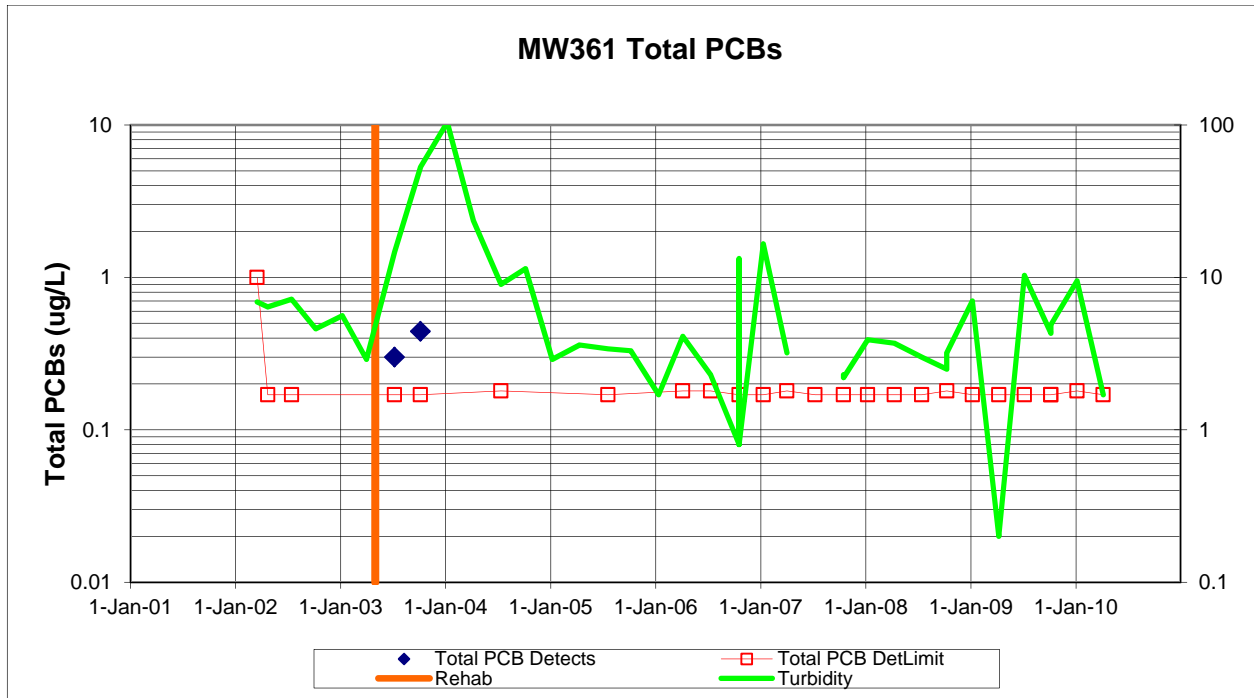
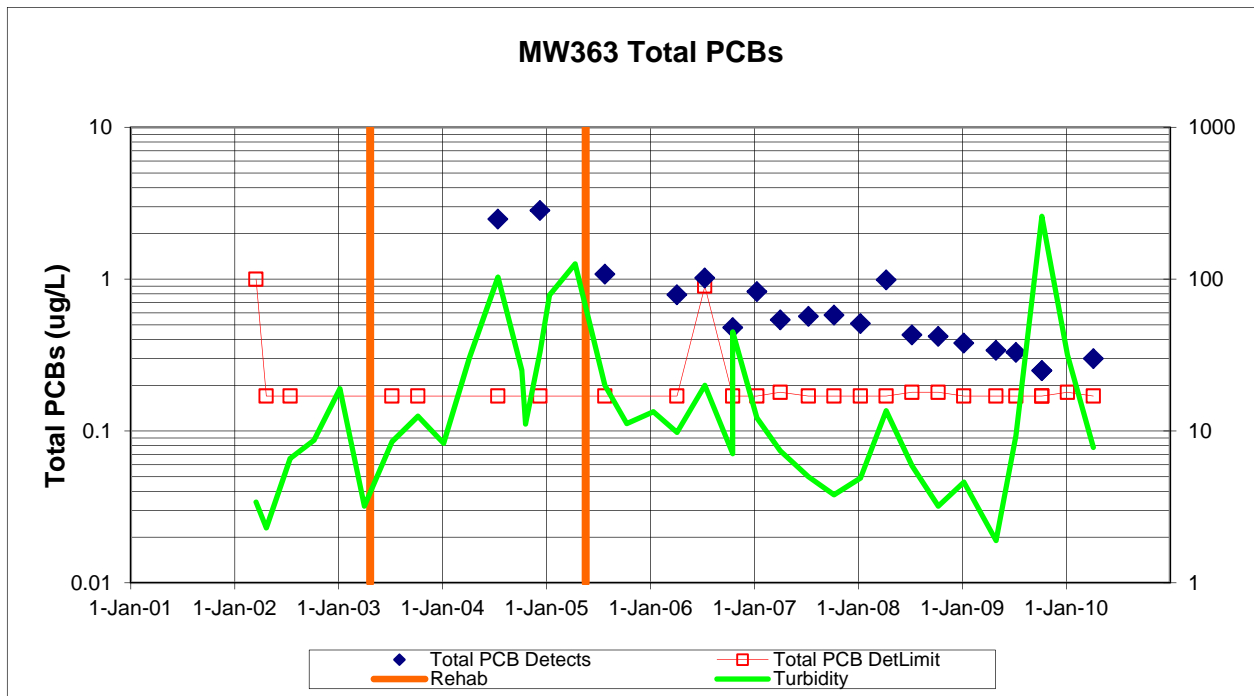
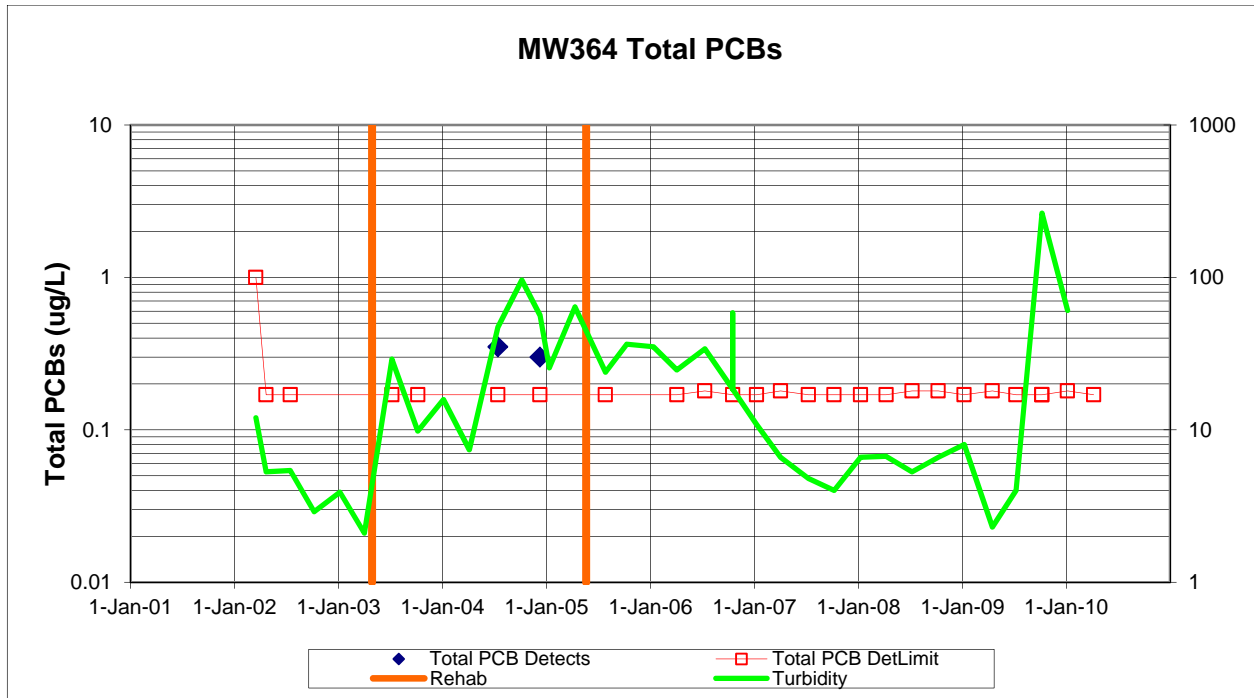
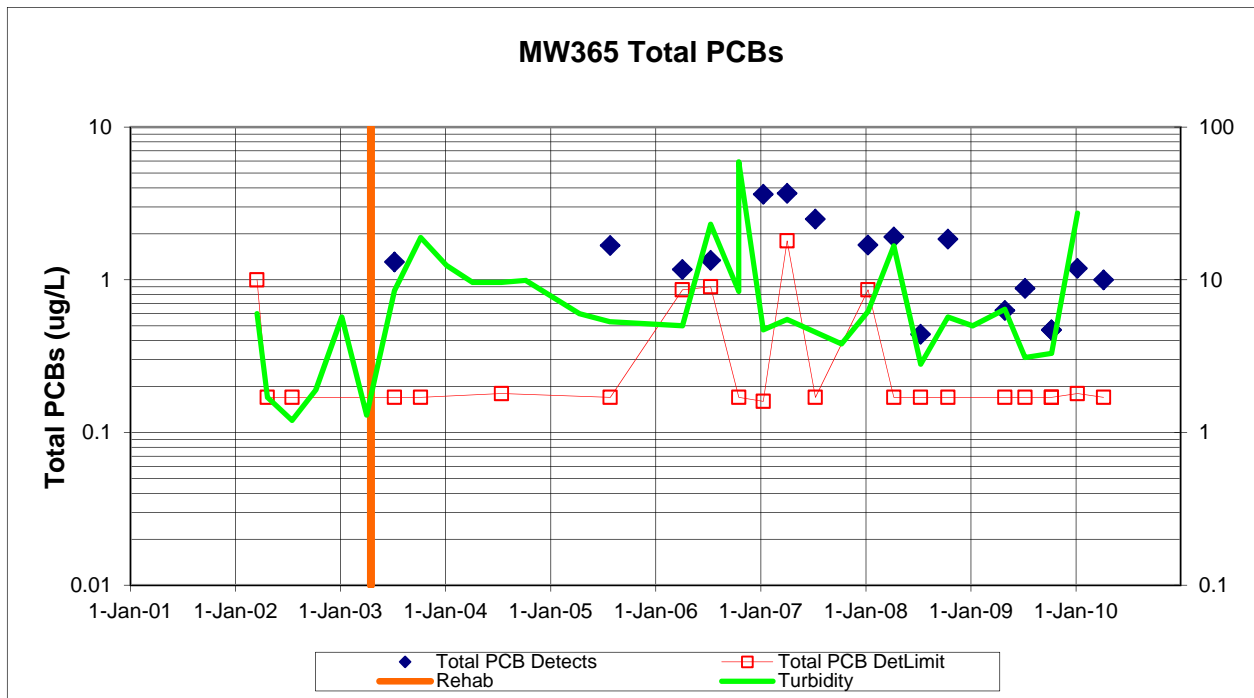
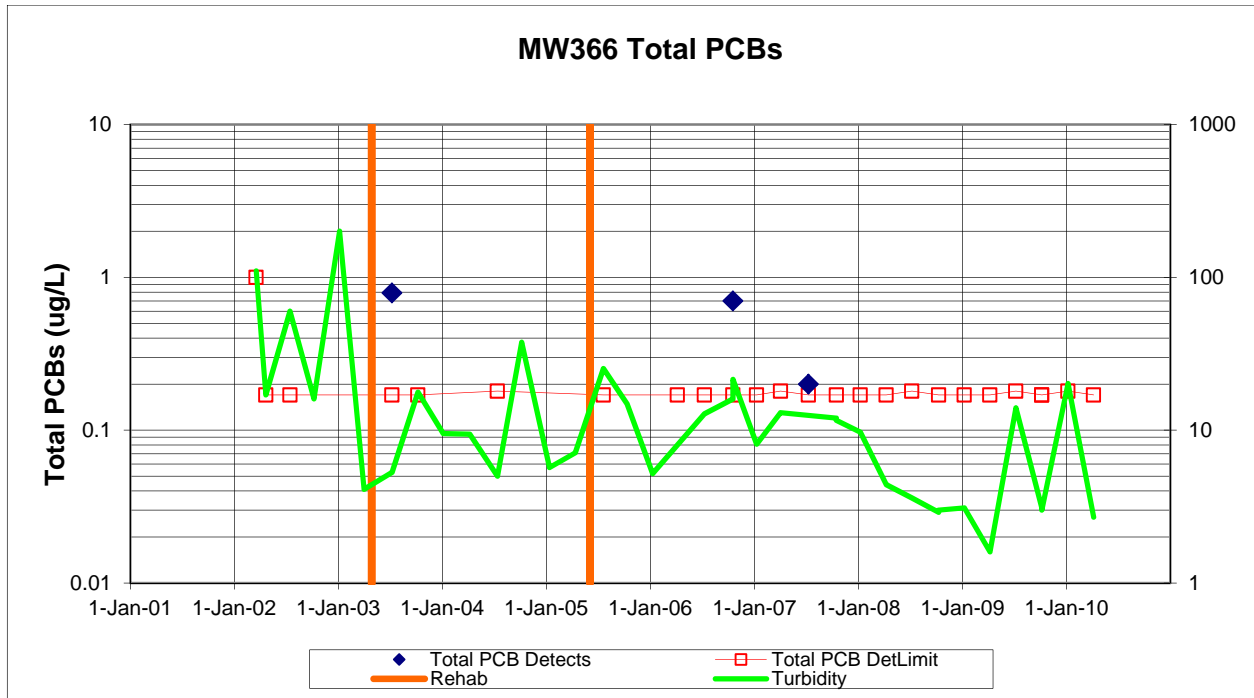
Figure E.7. PCB Analyses and Well Rehabilitation in MW360

Figure E.8. PCB Analyses and Well Rehabilitation in MW361

Figure E.9. PCB Analyses and Well Rehabilitation in MW363

Figure E.10. PCB Analyses and Well Rehabilitation in MW364

Figure E.11. PCB Analyses and Well Rehabilitation in MW365

Figure E.12. PCB Analyses and Well Rehabilitation in MW366

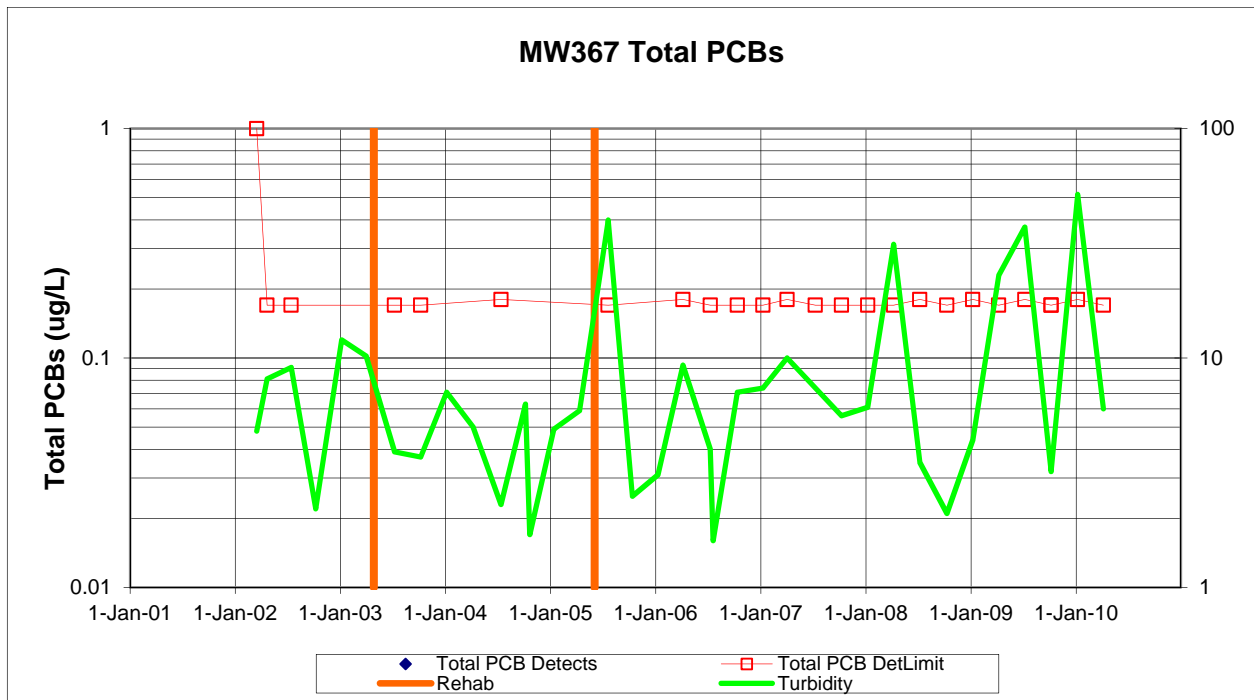
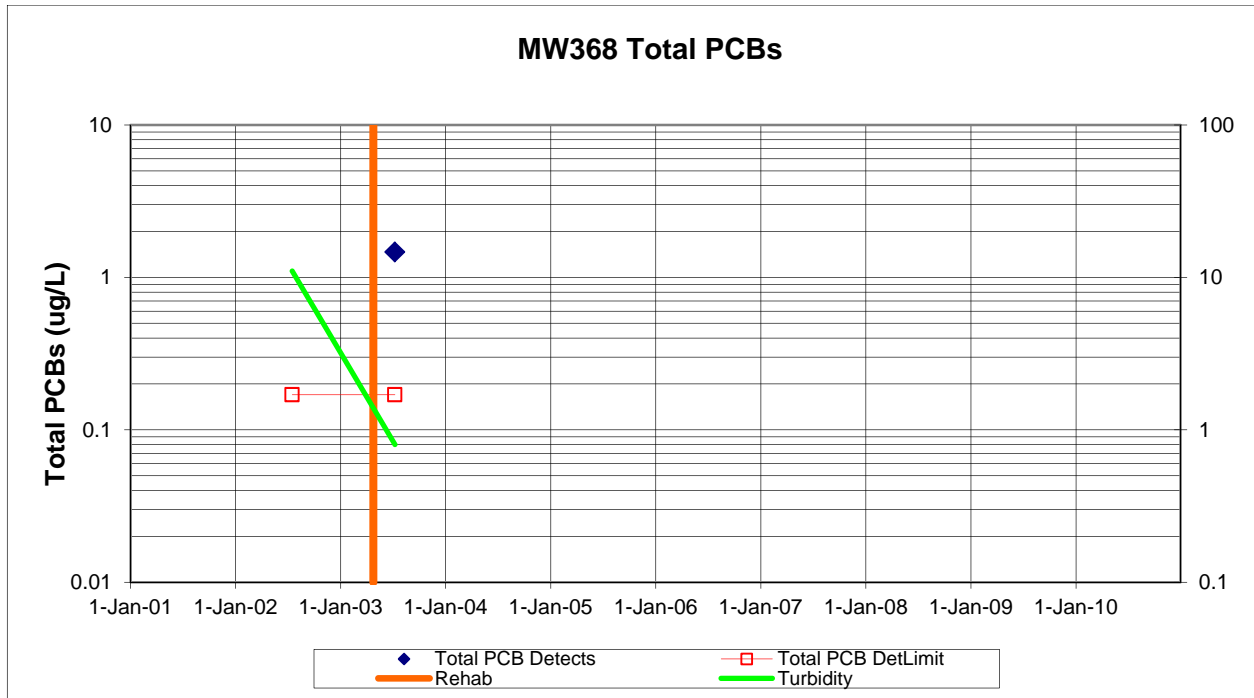
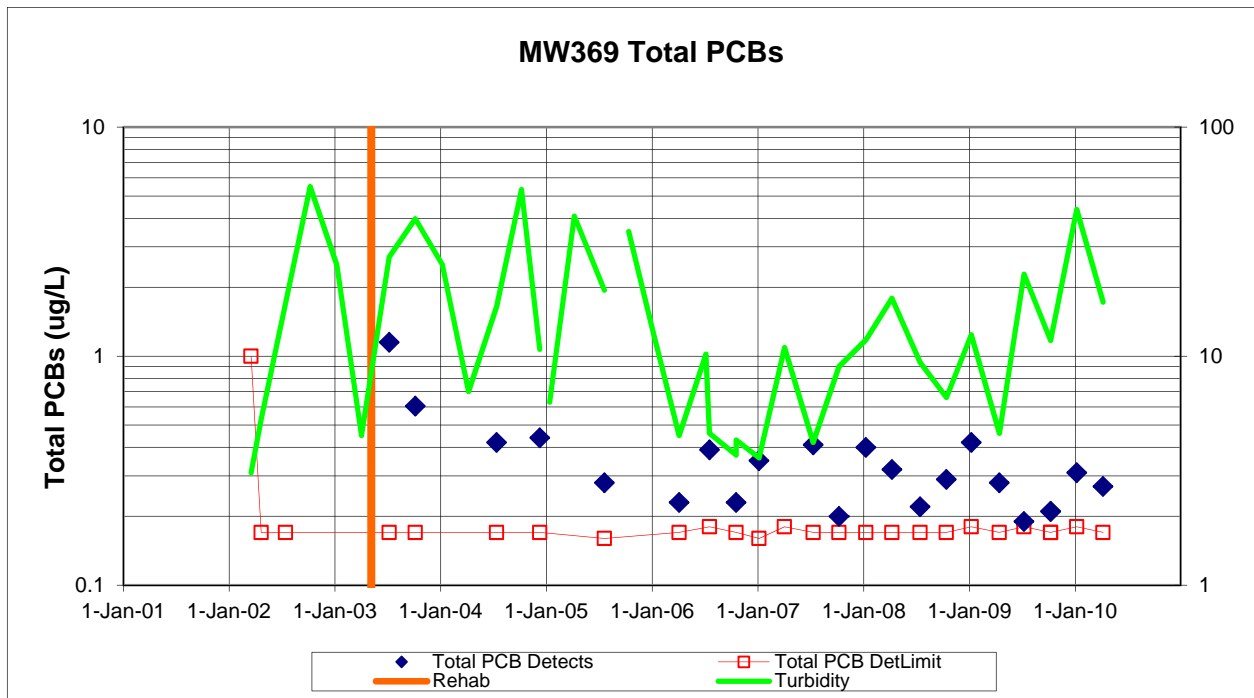
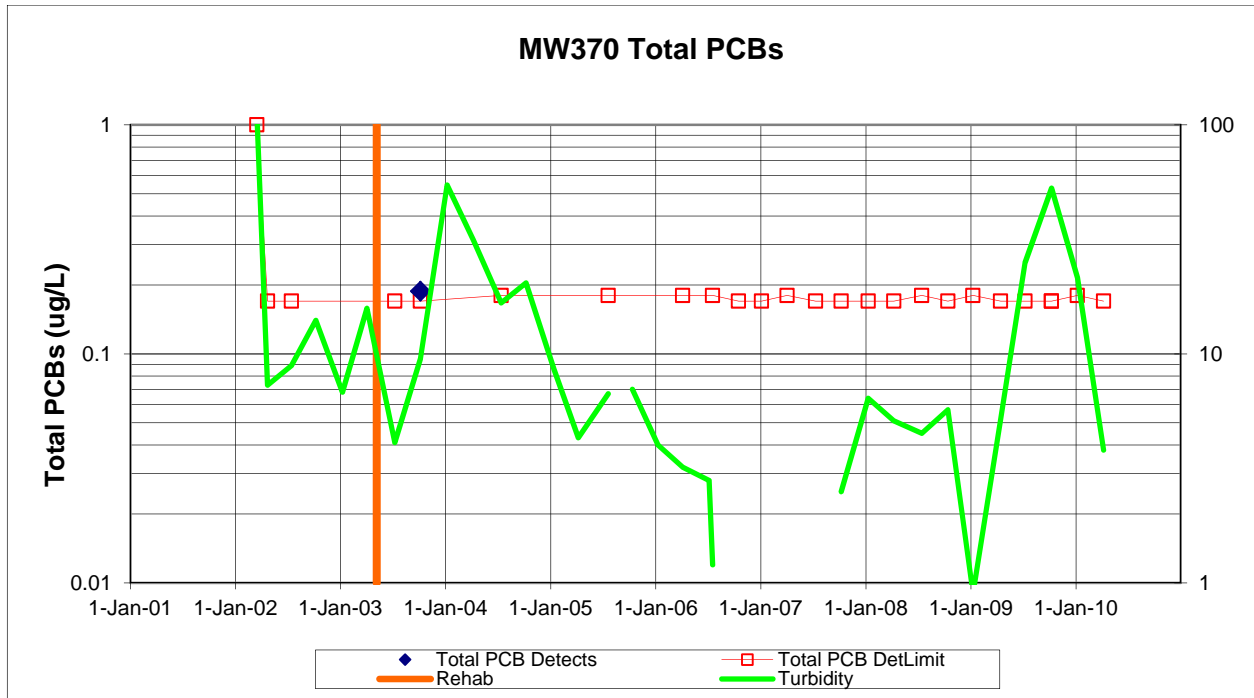
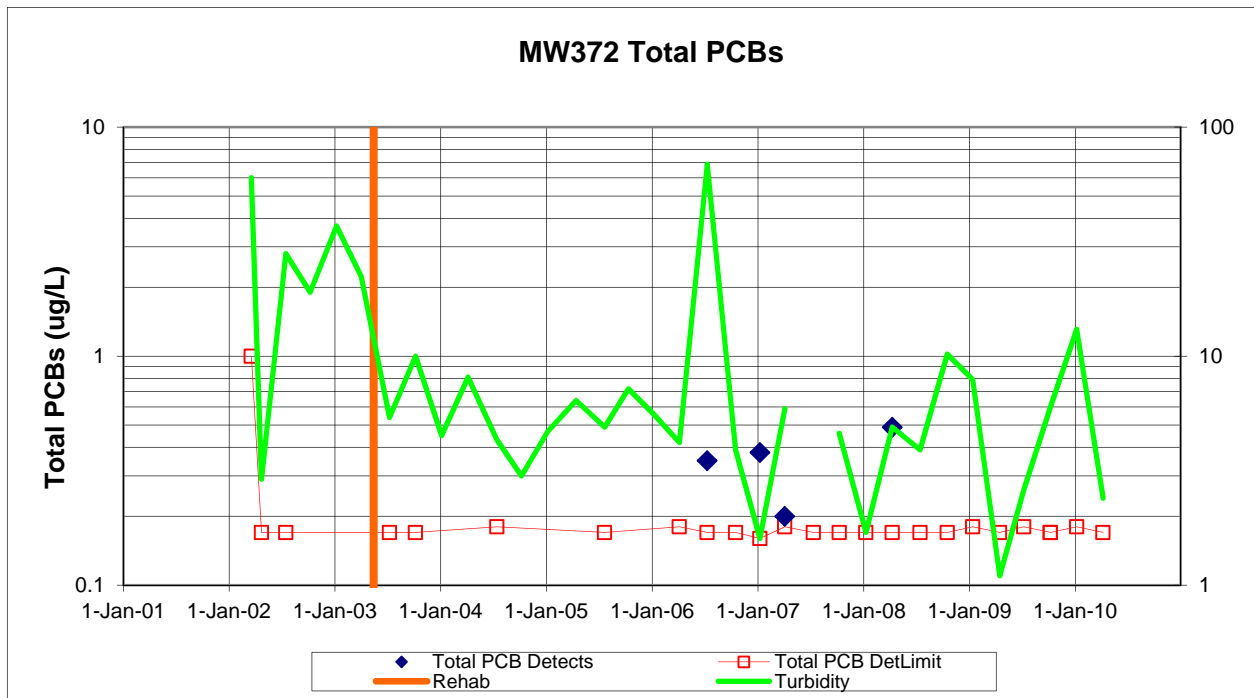
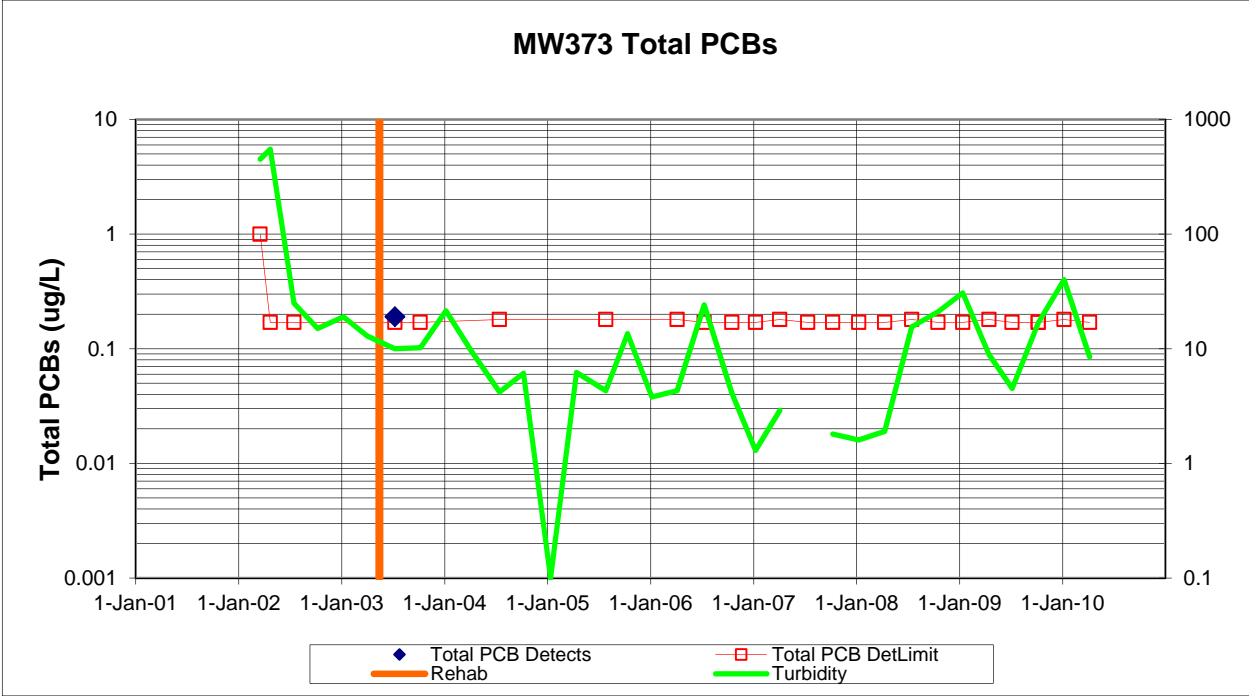
Figure E.13. PCB Analyses and Well Rehabilitation in MW367

Figure E.14. PCB Analyses and Well Rehabilitation in MW368

Figure E.15. PCB Analyses and Well Rehabilitation in MW369

Figure E.16. PCB Analyses and Well Rehabilitation in MW370

Figure E.17. PCB Analyses and Well Rehabilitation in MW372

Figure E.18. PCB Analyses and Well Rehabilitation in MW373

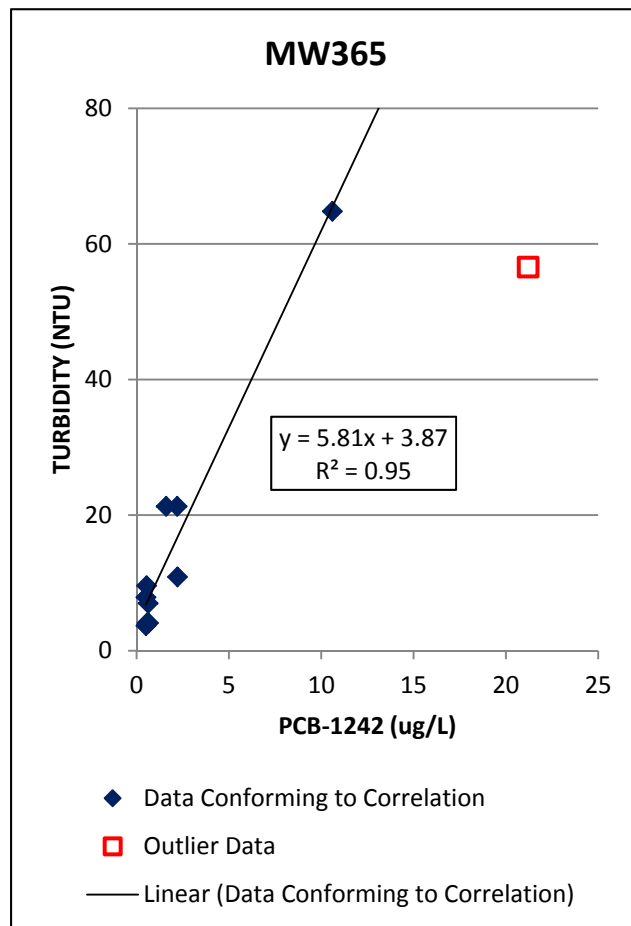
The 24 previous analyses of MW365 groundwater samples include 18 detections of PCBs (3.63–0.44 µg/L). PCB-1242 was detected in all 10 of the overpumping test samples and in the two duplicate samples (ranging from 0.50–21.2 µg/L). As in MW363, PCB-1242 levels closely relate to the turbidity of the groundwater in all but one sample (Figure F.2).

Figure F.2. PCB-1242 versus Turbidity in MW365
